National Transportation Safety Board

Pipeline Accident Brief

TransCanada Corporation Pipeline (Keystone Pipeline) Rupture Amherst, South Dakota

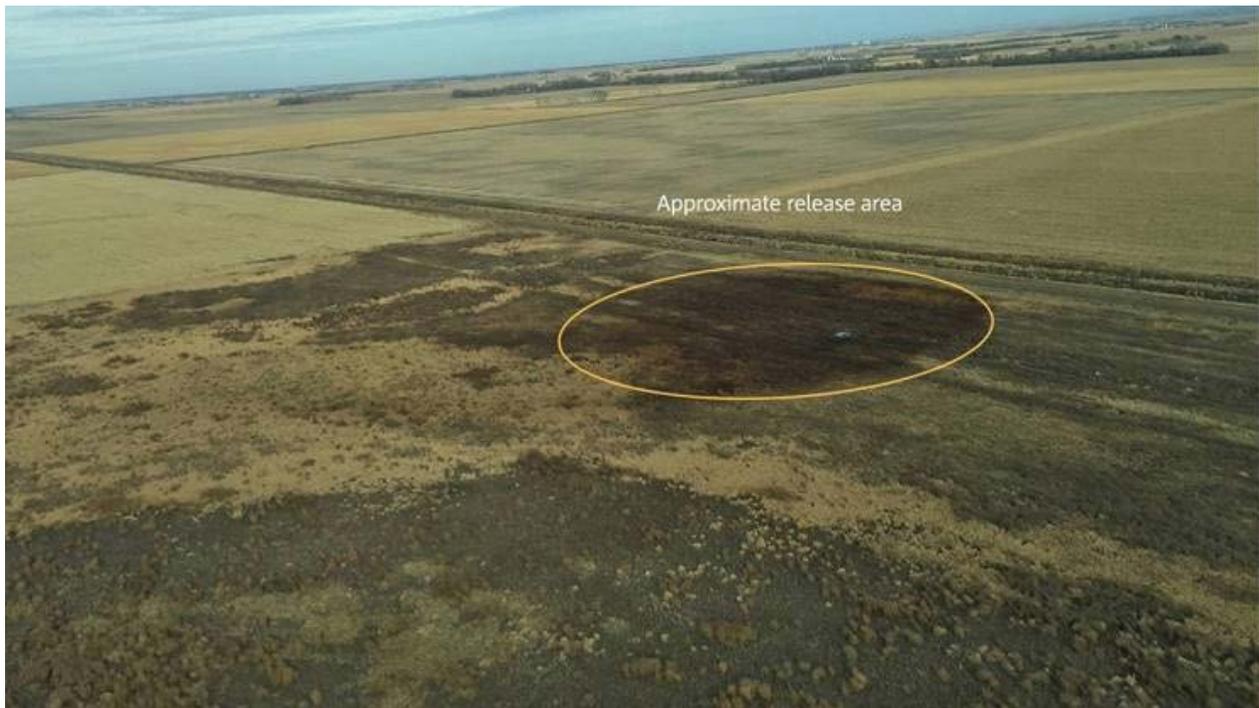
On November 16, 2017, at 4:34 a.m. mountain daylight time, a TransCanada Corporation, Keystone Pipeline (Keystone) ruptured near Amherst, South Dakota, between the Ludden, North Dakota, (Ludden) and Ferney, South Dakota, (Ferney) pump stations. Keystone's Operational Control Center (OCC), in Calgary, Alberta, Canada, was monitoring Keystone's Supervisory Control and Data Acquisition system that detected the leak and shut down the pipeline. Keystone's field staff traveled to the indicated leak location, confirmed that the pipeline had ruptured, and initiated their spill response plan. The approximate spill area was comprised of about 5,000 barrels of crude oil. (See figure 1.)

Figure 1. Accident scene in Amherst, South Dakota taken on November 16, 2017.
(source: <https://twitter.com/TransCanada>)

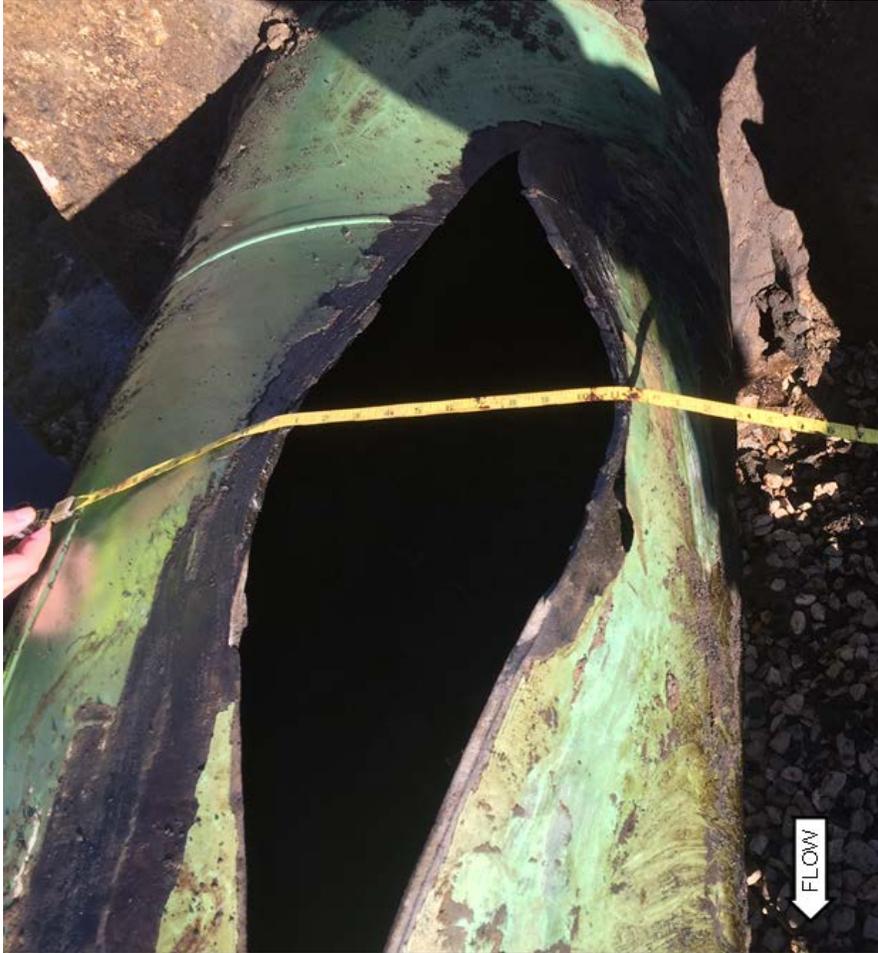
shipped to the NTSB materials laboratory for examination. Figure 2 shows the ruptured pipe after excavation and prior to shipment to the NTSB.

Figure 2. Ruptured pipe.

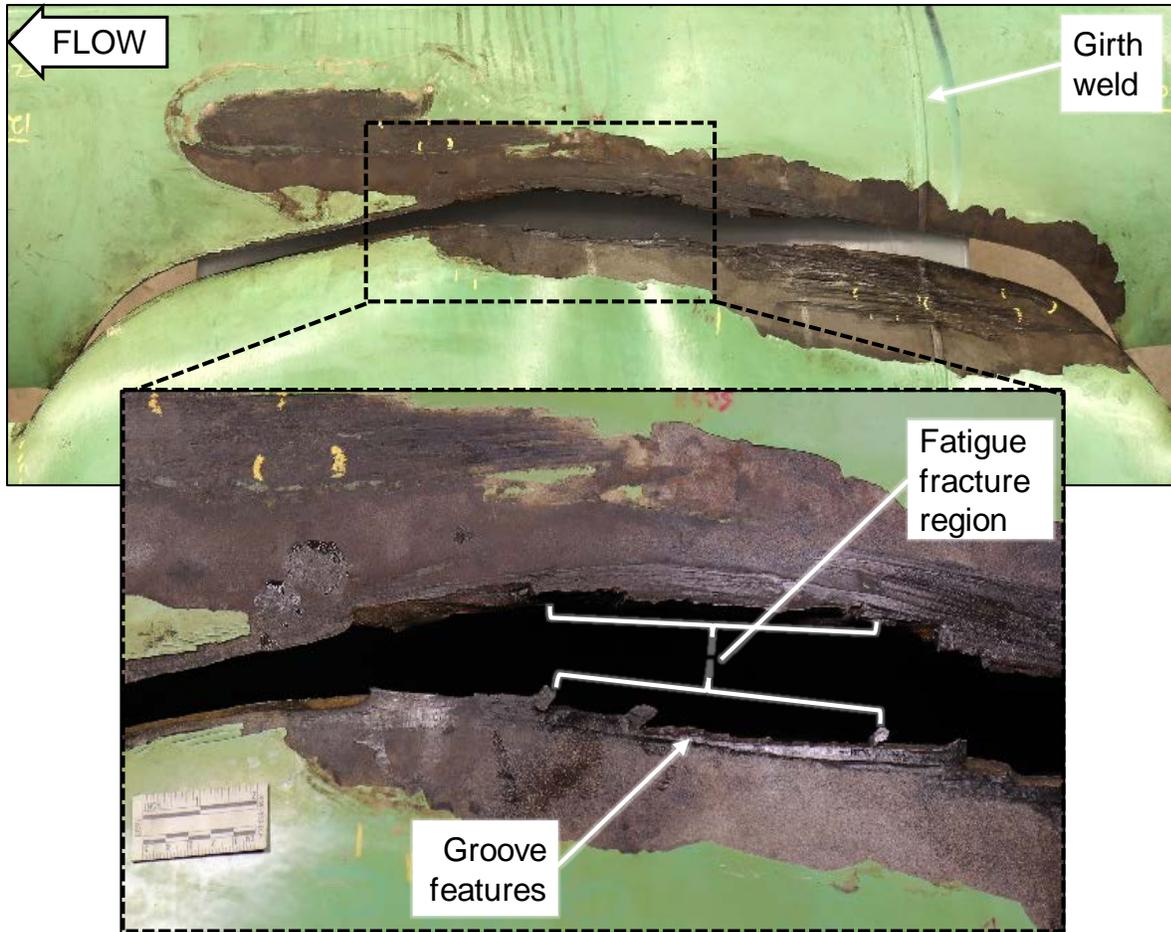
At the NTSB materials laboratory, the ruptured pipe piece was cleaned and visually examined. The metallurgists found midway along the length of the fracture face (a region of 5.52 inches long), ratchet marks, crack arrest lines, and other features consistent with a multiple-origin fatigue fracture that originated at an external groove in the pipe wall. (See figure 3.) The fatigue origin area was located near the top of the pipe about 6.5 inches away from the longitudinal seam. The pipe exterior exhibited areas of exposed metal and grooves formed by sliding contact that aligned nearly parallel to the pipe axis on the exterior surface coinciding and adjacent to the length of the fracture. Coating material was present and intermixed with the sliding contact marks, and many edges of the remaining coating adjacent to individual contact marks were curled and rounded consistent with sliding contact deformation. As shown on the right side of figure 3, a larger cluster of grooves was present toward the upstream end of the fracture.

Figure 3. Overview of the pipe fracture with mating sides of the fracture placed adjacent to each other. The inset image shows a closer view of the fatigue fracture initiation region and a colony of sliding-contact grooves.

Compositional analysis of the grooved surfaces and of cross-sections through the grooves near the fatigue crack origin area revealed that smeared metal in the trough of the sliding contact-grooves contained higher concentrations of chromium than the pipe material (as determined by energy dispersive spectroscopy and backscattered electron microscopy). This was consistent with the presence of a deposited layer.

The composition of the deposited metal in the grooves, and the morphology of the groove colonies is consistent with damage that would result from the pipe being run over by a metal-tracked construction vehicle. The composition of the concrete weights was examined and ruled out as a source of the mechanical damage to the pipe. A full report of the metallurgical examination can be found in accident docket PLD18LR001.

The NTSB determines that the probable cause of the failure of the Keystone Pipeline was a fatigue crack, likely originating from mechanical damage to the pipe exterior by a metal-tracked vehicle during pipeline installation, that grew and extended in-service to a critical size, resulting in the rupture of the pipeline.
