National Transportation Safety Board

Pipeline Accident Brief

Third-party Damage by Sure Shot Communications to Ameren Natural Gas Distribution System Canton, Illinois

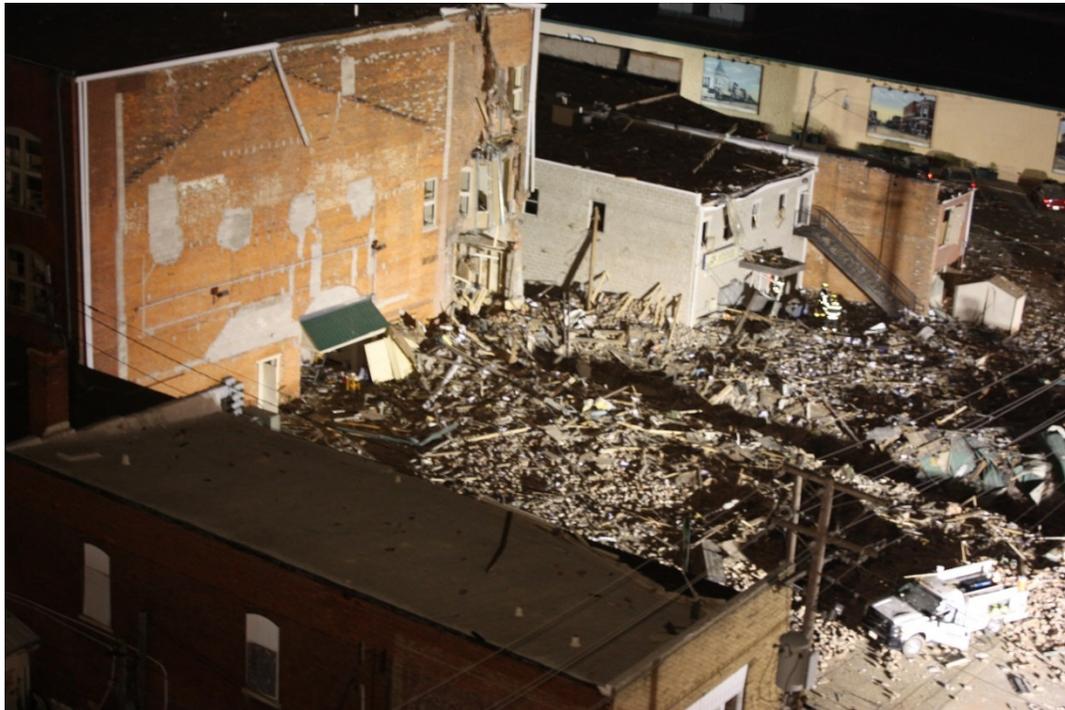
At 4:48 p.m., nearby customers called the Ameren Customer Contact Center to report natural gas odors both indoors and outdoors. According to Ameren, these customers were given safety instructions and told to leave their buildings if an odor was detected.² By 5:37 p.m., Ameren technicians shut off the natural gas flow to the service line by squeezing off the pipeline. At 5:44 p.m., the Opera House Annex behind the Opera House Professional Center exploded, killing one and injuring 11 who were impacted by debris from the blast. (See figures 1 and 2.)

Figure 2. Photograph of the accident site and debris from the Opera House Annex. (Courtesy of Canton Police Department.)

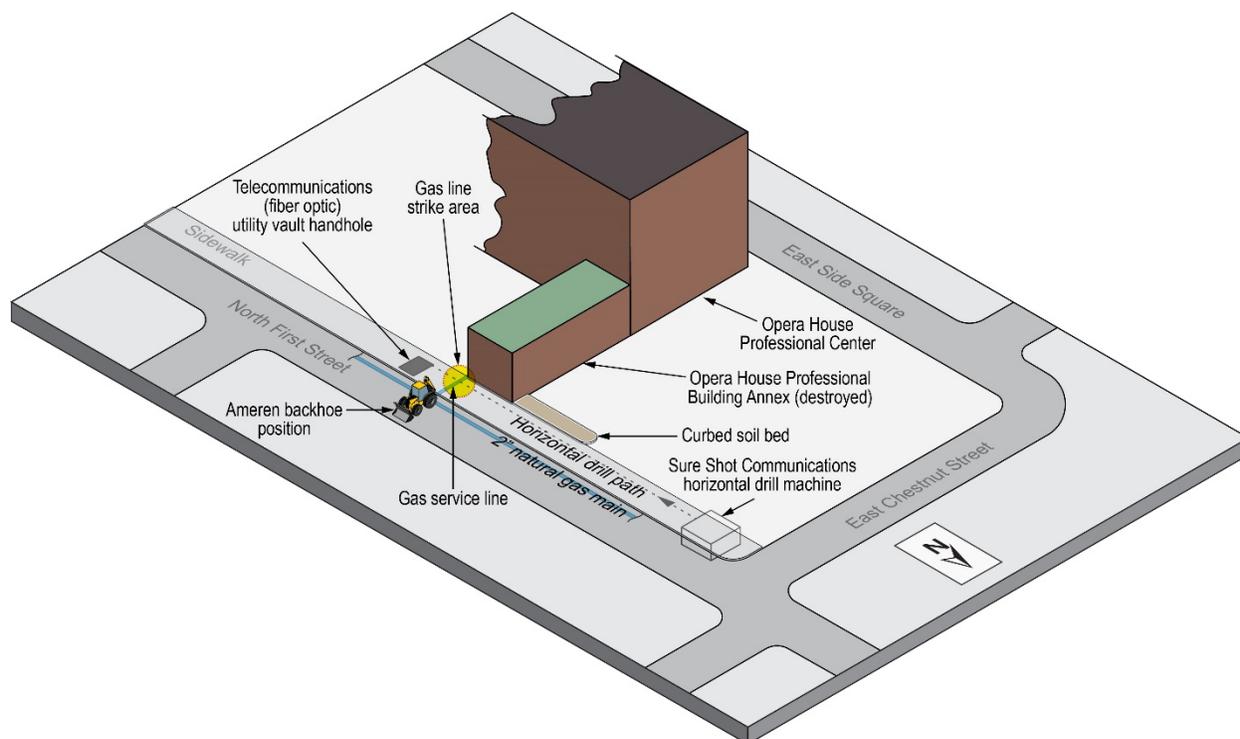
Figure 3. An illustration of the drill path and the location where the gas service line was struck.

The location of the natural gas service line damage was underneath the concrete sidewalk adjacent to the destroyed structure. Sure Shot did not excavate the utility crossing location before starting the drilling work, as required by Illinois statute.⁵ According to Illinois law, during directional drilling, each location where the drill path crosses underground, utilities must be excavated using methods such as hand or vacuum excavation. The excavator must visually inspect the work, while in progress, until clear of the underground utilities.

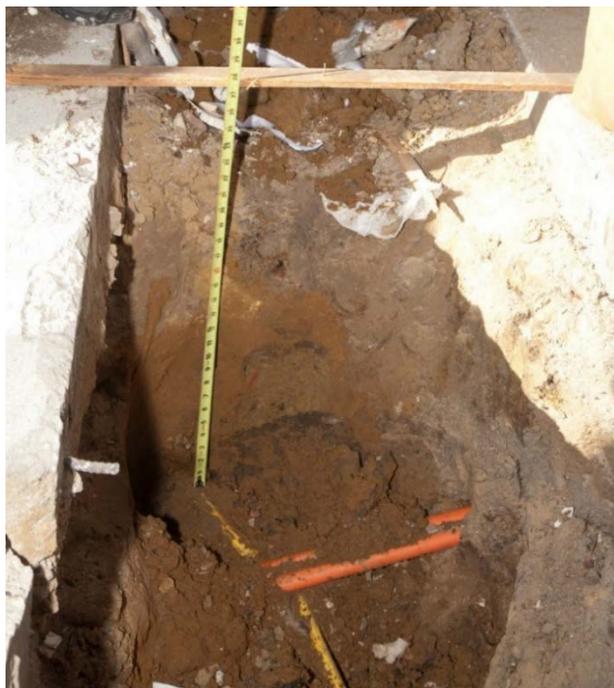
The crew leader was concerned about the failure to expose the gas line; however, he thought it would be adequate since the crew was drilling 30 inches underground or below the depth of the natural gas line that he believed was buried 18 inches.⁷ (See figure 5.)

Figure 5. Image showing the damaged yellow service line intersected by the orange fiber optic cable conduit.

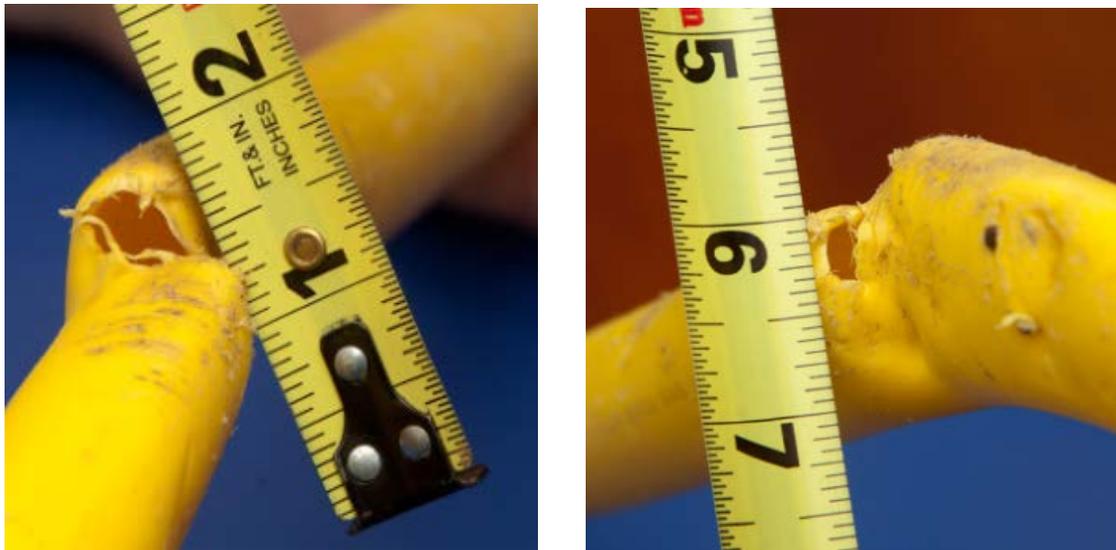
An Ameren utility crew excavated and visually examined the damaged service line at the accident scene. The top of the 1-inch polyethylene line showed clear damage as a result of being struck by drilling equipment. The damage to the service line from the directional drilling is shown in figure 6.

Figure 6. Damaged service line to the exploded building from two different angles.

The National Transportation Safety Board determines that the probable cause of the natural gas release and subsequent explosion was third party damage from Sure Shot's directional drilling to install underground fiber optic conduit. Contributing to the pipeline damage was Sure Shot's decision not to excavate at the utility crossing to visually inspect the work, while in progress, until clear of the underground utilities, as required by Illinois law. Contributing to the severity of the accident was the failure of Sure Shot and Ameren to evacuate the area.
