National Transportation Safety Board

Pipeline Accident Brief

UGI Utilities Natural Gas-Fueled Explosion

Millersville, Pennsylvania

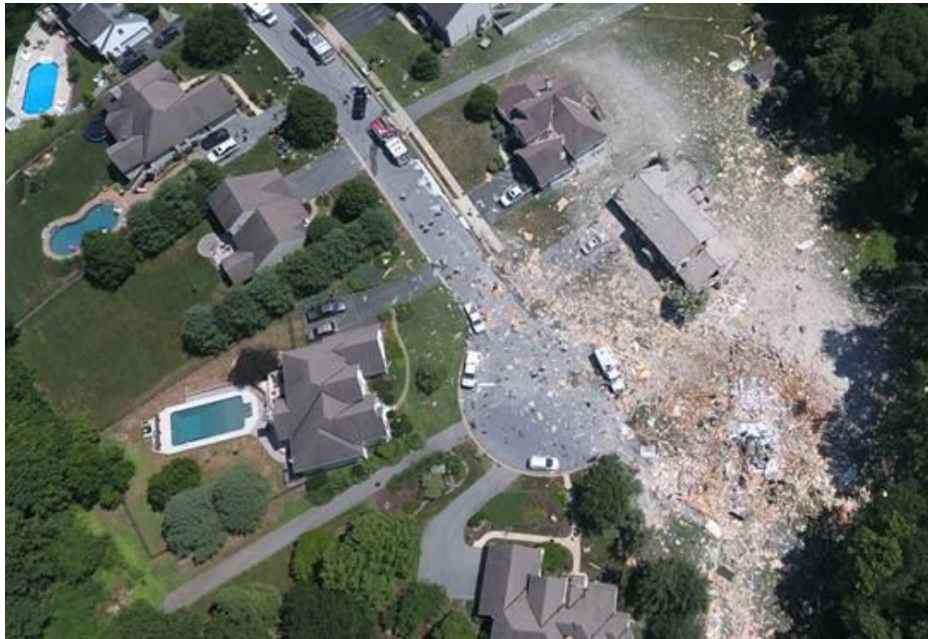
On July 2, 2017, at 12:32 p.m. eastern daylight time, a natural gas-fueled explosion occurred at a single-family residence at 206 Springdale Lane, Millersville, Pennsylvania.¹ The explosion killed one person and injured three others, destroyed the residence and significantly damaged six neighboring homes, one of which was subsequently condemned.² (See figure 1.)

Figure 1. Debris field at cul-de-sac area where explosion occurred.

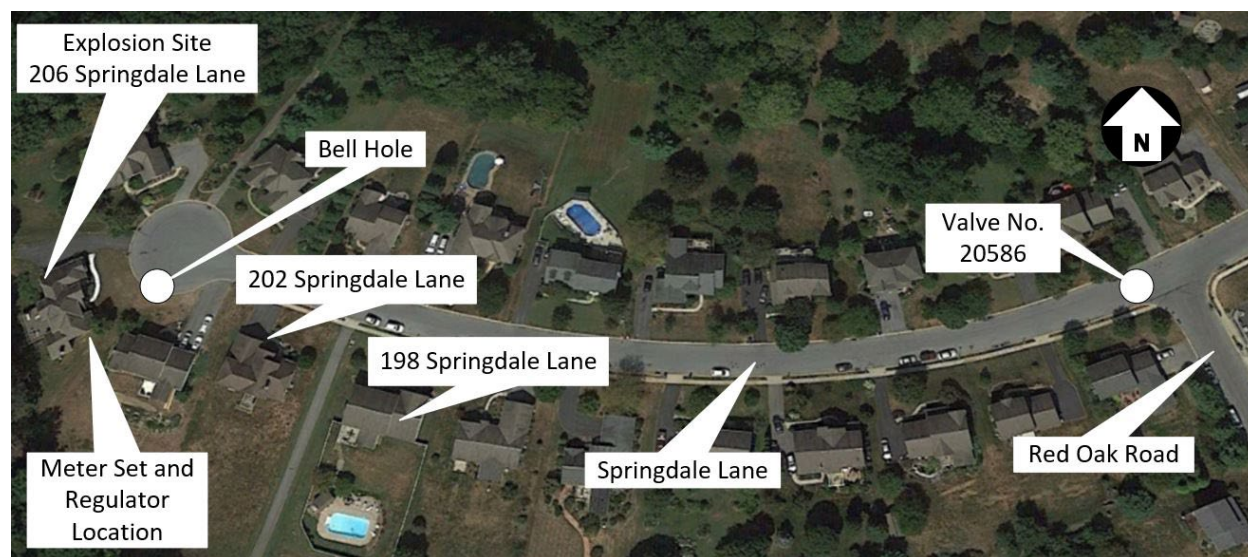
After identifying the response crew, the senior supervisor traveled to the scene. The senior supervisor told National Transportation Safety Board (NTSB) investigators that prior to arriving on-scene he reviewed the location of the closest shutoff valve to the site. On his way to the shutoff valve, he contacted the UGI engineer and informed her that he expected to shut down a main line. As the duty supervisor, the senior supervisor could exercise judgement to determine whether it was appropriate to either squeeze off the line or close a gas valve.⁸ After the discussion with other responding UGI employees, the senior supervisor decided to squeeze off the main line rather than closing the mainline valve, because he thought this action was the fastest way of stopping the flow of gas. Figure 2 shows the location of the valve.

Figure 2. Location of gas shut-off valve in relation to accident site.
