# National Transportation Safety Board

## Pipeline Accident Brief

### Natural Gas Explosion at Family Residence

#### Firestone, Colorado

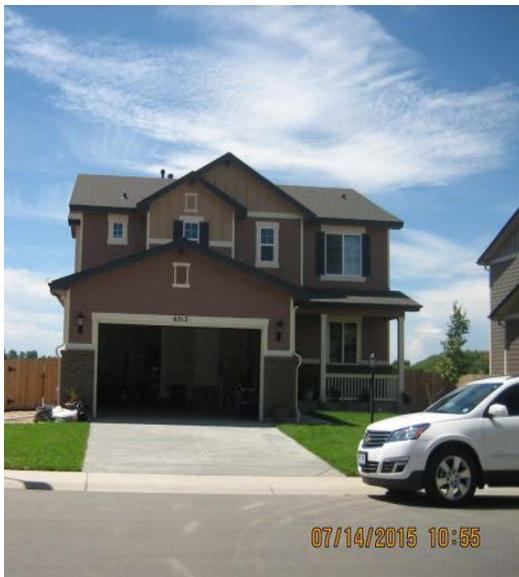
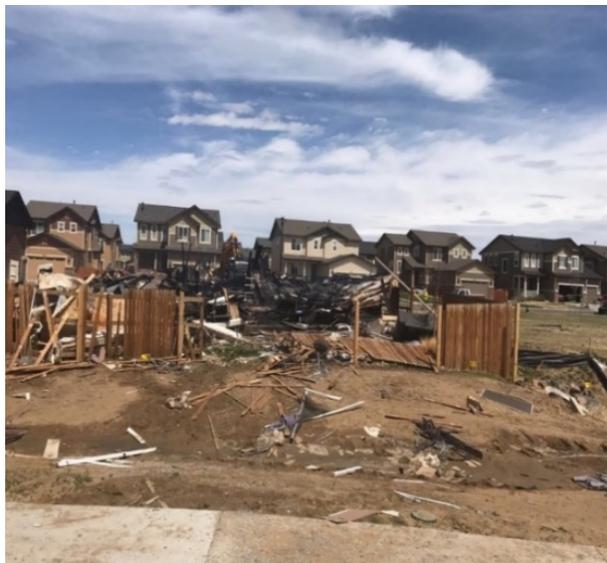
On April 17, 2017, about 4:45 p.m. local time, a single-family home in Firestone, Colorado, was destroyed by an explosion. (See figure 1.) A resident and a plumber who was working at the house died in the explosion, and two other residents were injured. At the time of the explosion, the fatally injured resident and plumber were replacing a water heater in the basement.

**Figure 1.** Photograph of the residence before and after the accident. Photograph on the left was provided by Weld County, photograph on the right was provided by the Pipeline and Hazardous Materials Safety Administration.

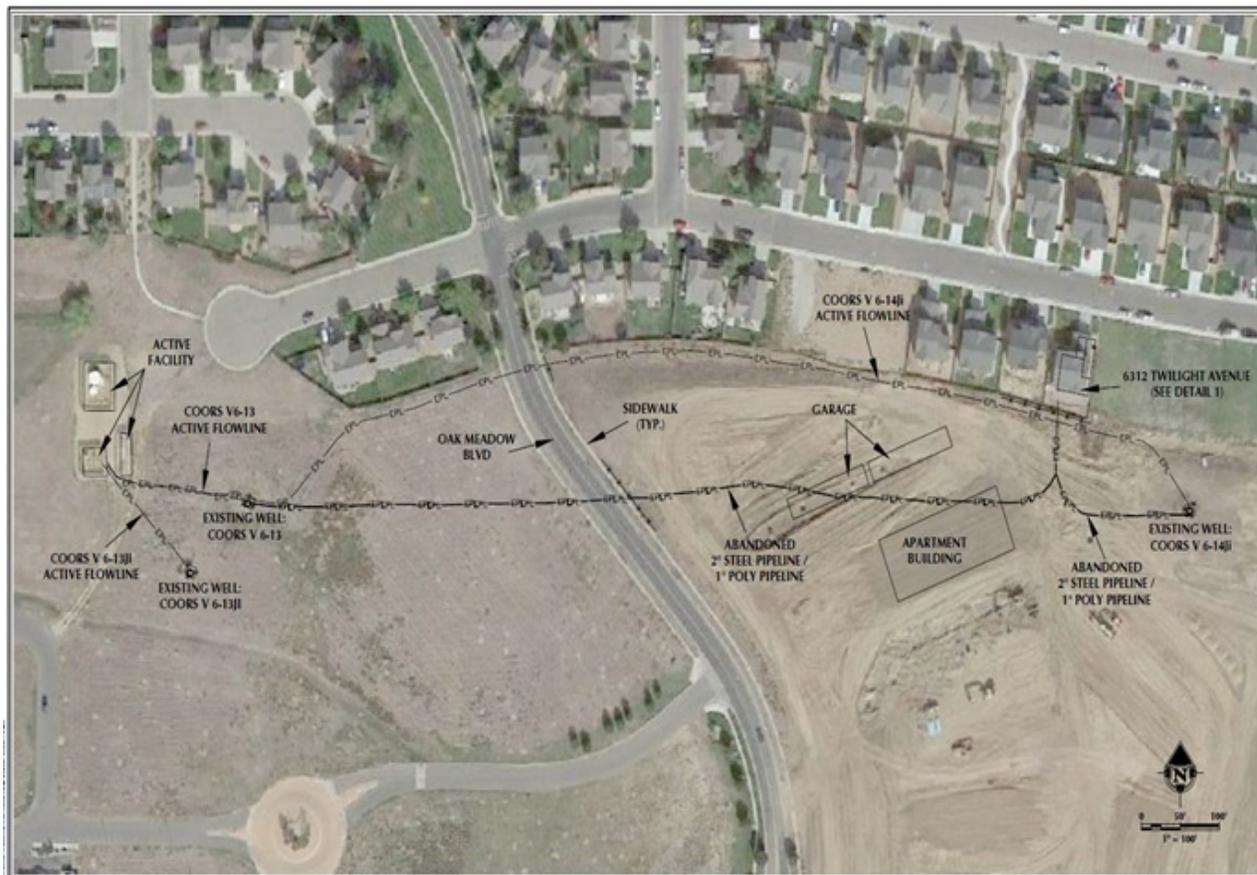
Three severed pipelines were found beneath a concrete pad about 6 feet from the foundation of the house. The three lines were originally connected to natural gas wells as part of a production field. The lines included one 1-inch diameter polyethylene (PE) line and two 2-inch diameter steel lines. The PE line had a tee connection south of the residence, with one branch of the line connected to the Coors V6-14Ji well southeast of the residence, and the other branch running to the Coors V6-13 well to the south and farther west of the residence. (See figure 2.) One of the steel lines had been previously connected to the Coors V6-14Ji well and was later disconnected and abandoned. The other severed steel line was a discontinuous abandoned line which went in the direction of the nearby Coors V6-13 well.

**Figure 2.** Aerial view of Anadarko production field from late 2015 with illustration of the pipelines and the Coors V6-14Ji well location.

Information gathered during the investigation found that the most likely source of the natural gas that fueled the explosion was the Coors V6-14Ji well, and the pathway for the natural gas to reach the residence was the 1-inch PE line.
