National Transportation Safety Board
Pipeline Accident Brief
Natural Gas Explosion at Educational Facility
Minneapolis, Minnesota
August 2, 2017

Minneapolis Natural Gas Explosion

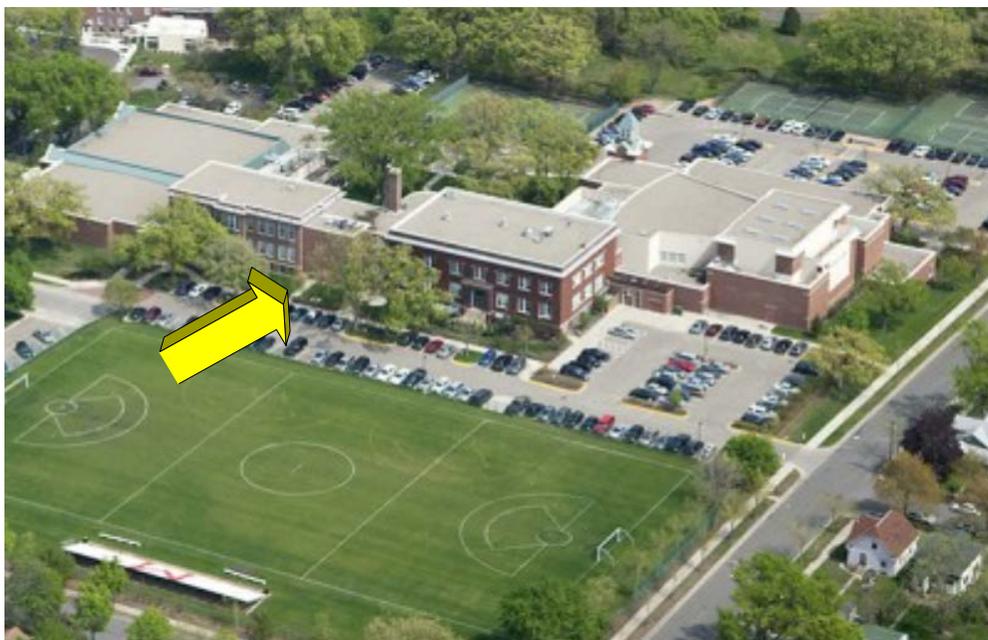
Figure 1. Photograph of north campus area at Minnehaha Academy prior to explosion. (Source: minnehahaacademy.net.)

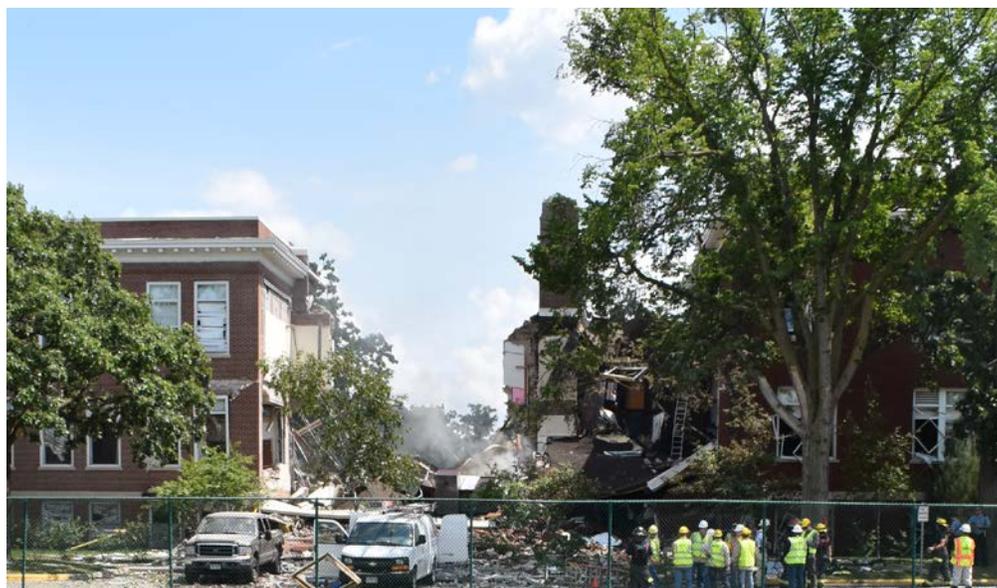
Figure 1. Photo of accident site taken after building explosion. (Source: Minneapolis Fire Department.)

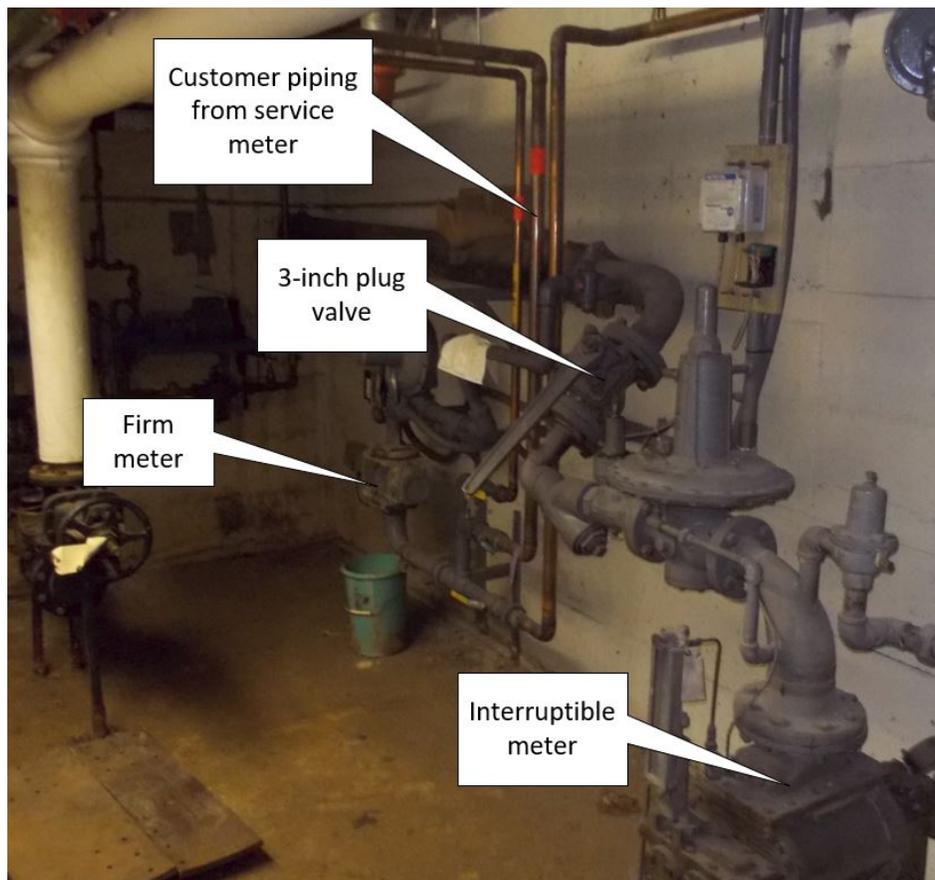
On the day of the accident, the two-person MMI pipefitting contractor crew was making modifications to piping upstream of the firm and interruptible meters, meaning the two-person crew was working on jurisdictional piping. Figure 3 is a photo taken before the accident showing the vault area of the center section of the building basement and describing the individual damaged piping elements involved in the accident. The photo depicts the location of the nonjurisdictional section of gas pipe and the jurisdictional piping that was being dismantled by the contractor work crew during the accident.

Figure 3. Photo taken before the accident of vault area of the center section of the building basement. (Source: CPEMG.)
