# National Transportation Safety Board

## Pipeline Accident Brief

### Gasoline Transmission Pipeline Explosion/Fire

Helena, Alabama

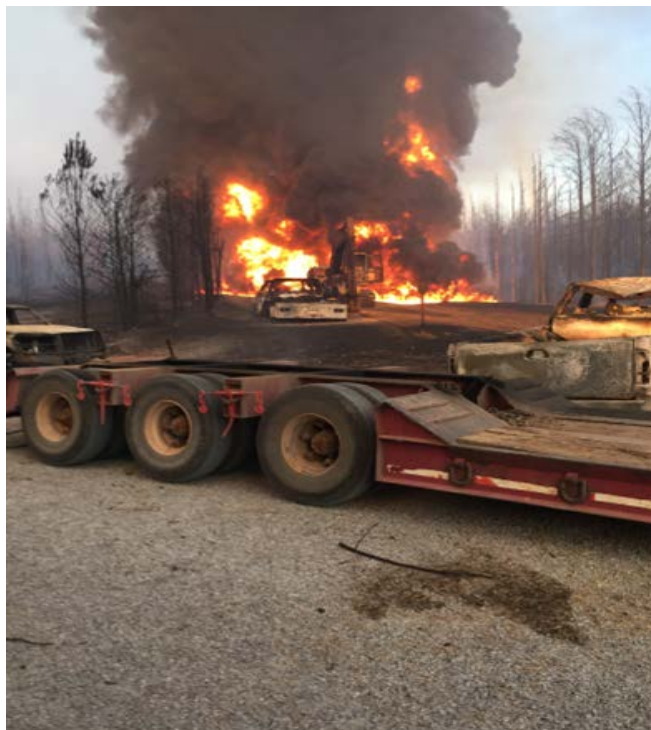
**Figure 1.** Ground-level view of active fire. (Source first responders.)

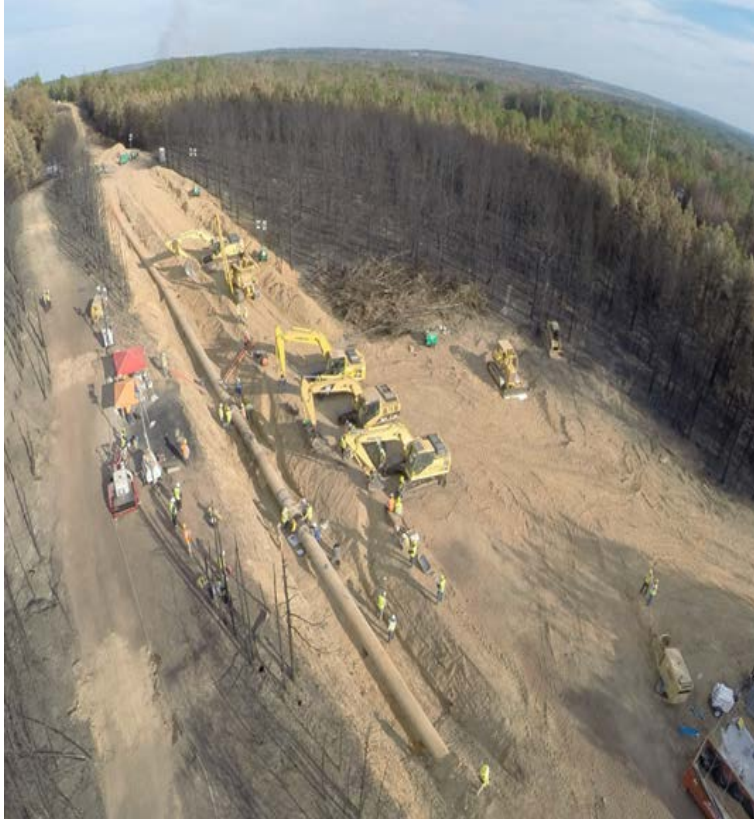
**Figure 2.** Aerial view of environmental damage. (Source: ESI, a Colonial technical contractor.)

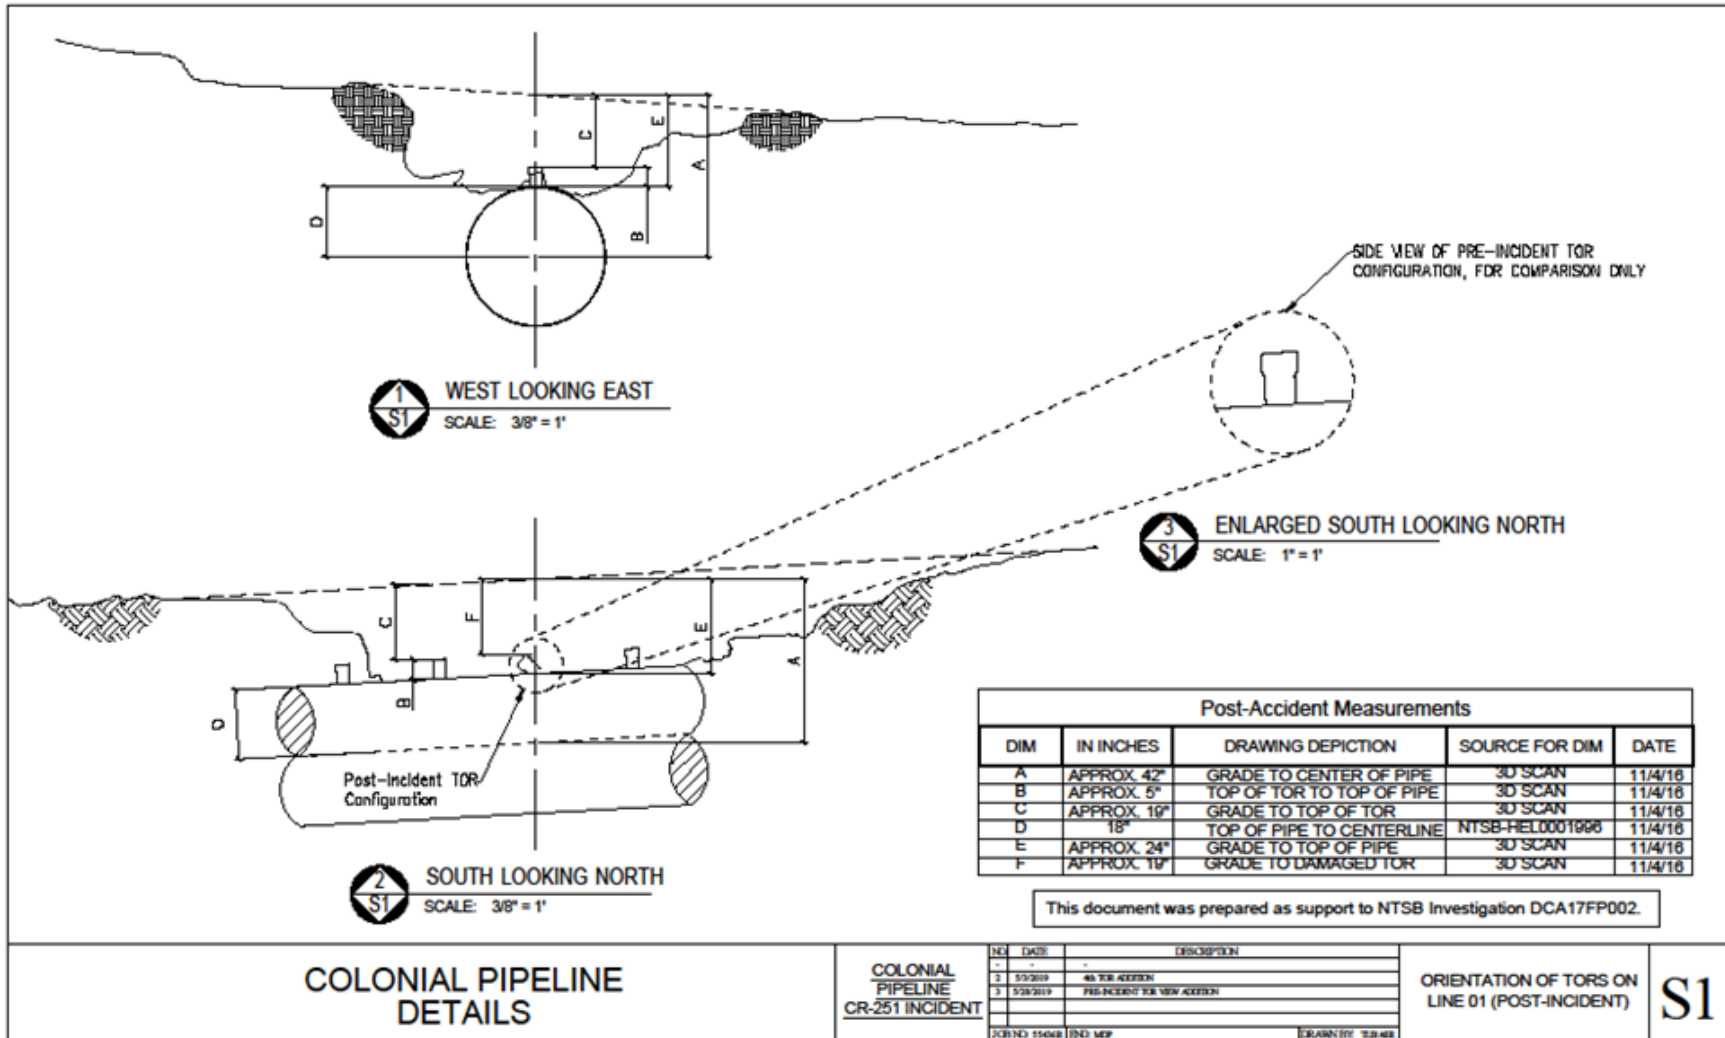
Colonial uses THREAD-O-RING (TOR) fittings welded to the pipe for maintenance work. (See figure 3.) TORs consist of a short length of pipe that contains mechanical components such as a pipe cap, an O-ring, and a pipe plug. The outward end is threaded for the attachment of a hose line, which can be used during field maintenance or testing (nitrogen injection/pressure testing of the pipeline). The TOR fittings at the accident site were fabricated from NPS 2 pipe and were about 5 inches long.<sup>5</sup> There were four TOR fittings positioned along the top of the Line 1 pipeline at the accident site, spaced about 20 inches apart.

Figure 3. Postaccident Illustration of TORs on Line 1 at the accident site. (Source: Colonial.)

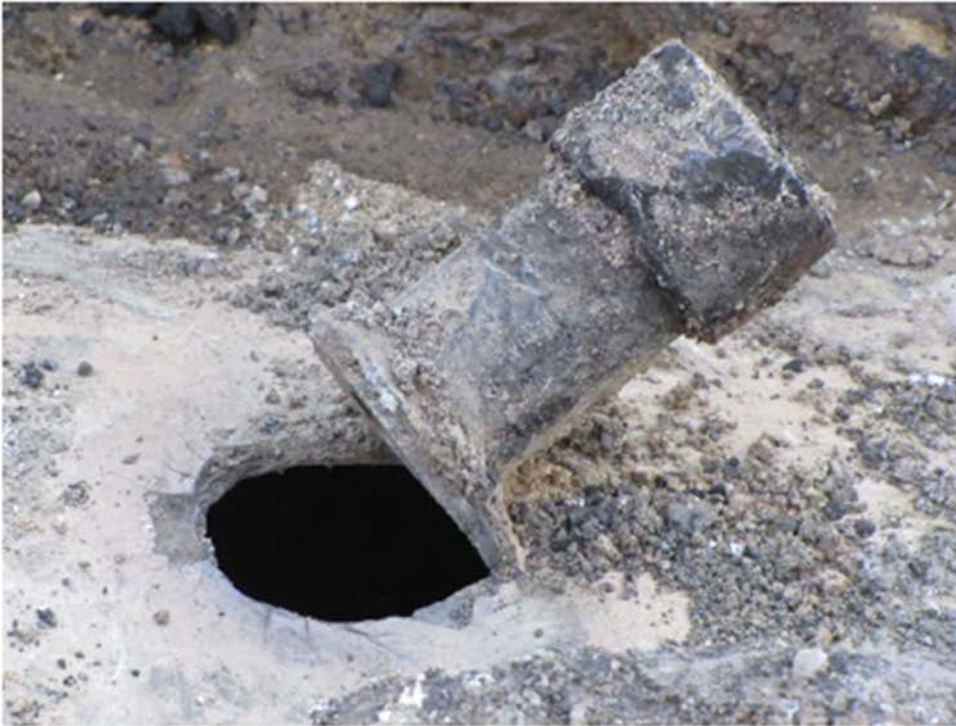
During the investigation of this accident, an area of the accident site was excavated by hand, which exposed a segment of the pipeline and the four TOR fittings that were attached to the top surface of the pipe. The examination revealed that one of the TOR fittings had been damaged

in the accident. Figure 4 shows a close-up view of the base of the damaged TOR fitting and the breach in the pipe at the point of the TOR attachment to the pipe surface.

**Figure 4.** Close-up photo of base of damaged TOR fitting and breach in pipe at point of TOR attachment to pipe. (Source: Colonial.)

The National Transportation Safety Board determines that the probable cause of the explosion was the excavation crew's inadequate planning, coordination, and communication during the excavation and failure to adhere to company policy requiring hand excavation if closer than 2 feet from the top or bottom of the pipeline until the pipeline has been exposed, which allowed the track-hoe to damage the pipeline.
