National Transportation Safety Board

Pipeline Accident Brief

Magellan Pipeline Anhydrous Ammonia Release

Near Tekamah, Nebraska

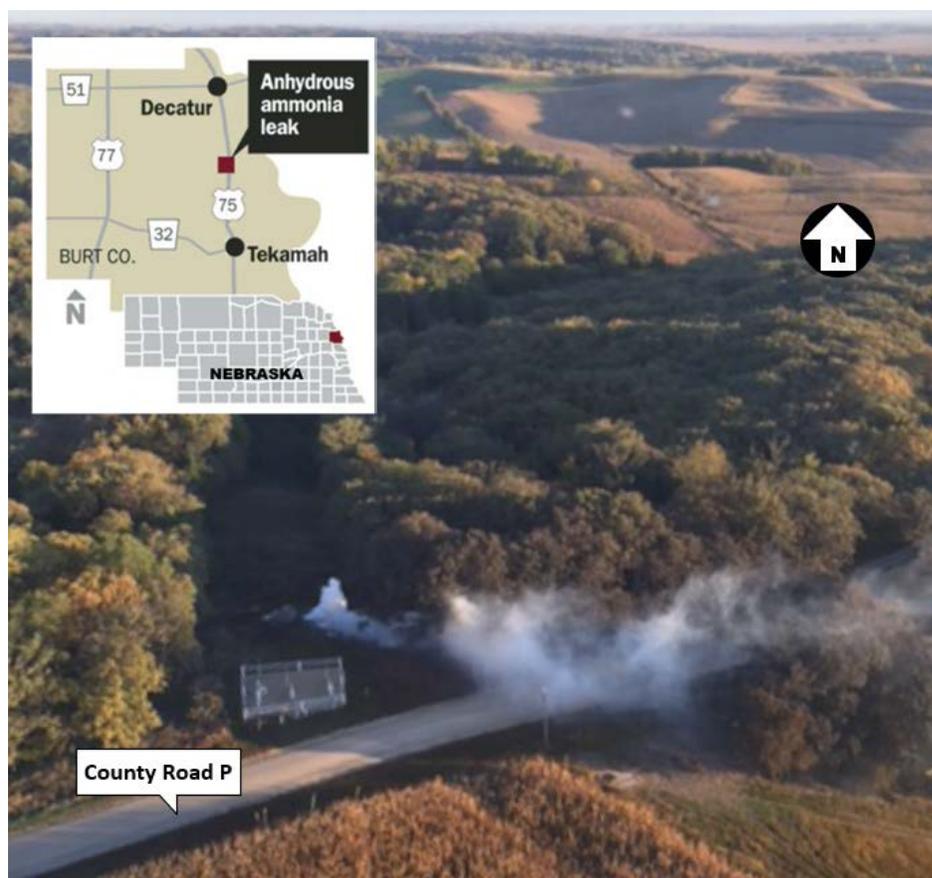
Figure 1. Aerial photograph of active anhydrous ammonia release with map insert showing release location. (Source: Magellan.)

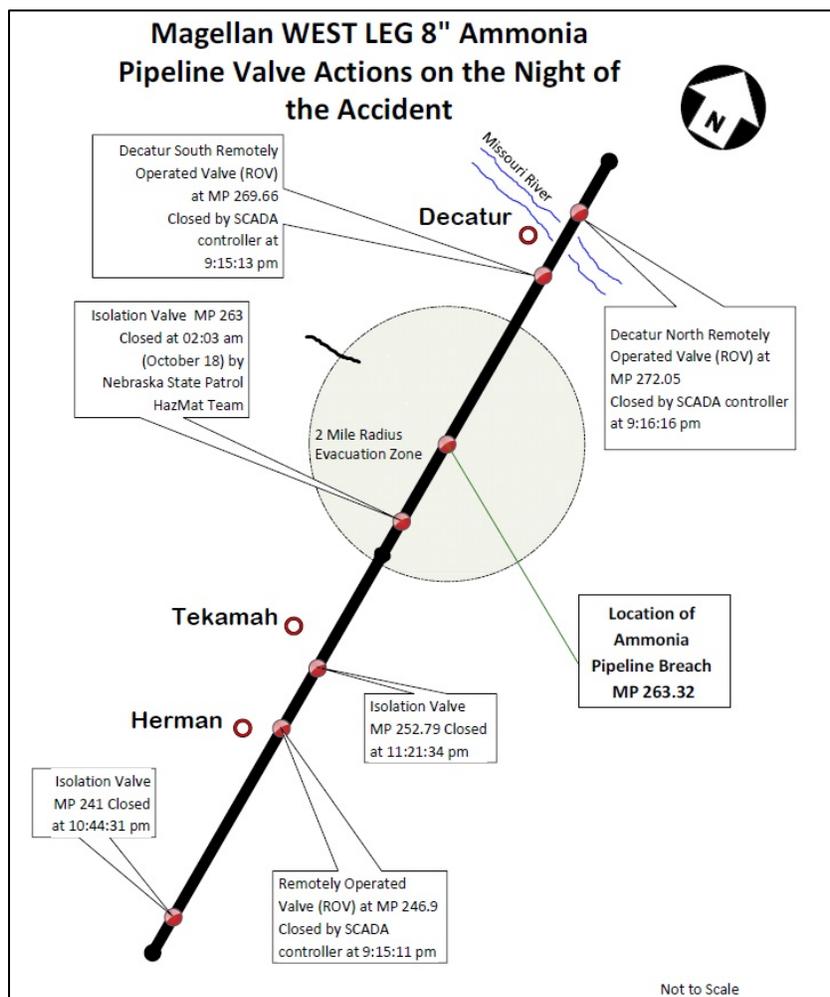
Following the 9:14:40 p.m. alert, Magellan's on-duty controller began isolating the pipeline rupture by shutting down pumps and closing valves. The sequence of valves closed to stop the discharge of ammonia is shown in figure 2.

Figure 2. Magellan ammonia pipeline showing valves located at mileposts surrounding the release site.

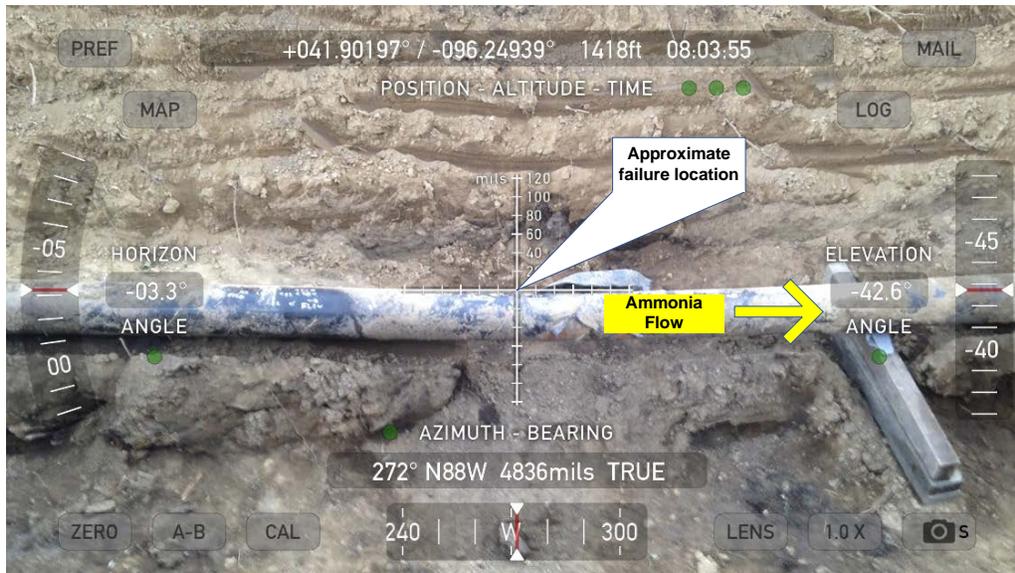
On October 20, 2016, the ruptured section of ammonia pipeline was unearthed. The pipe had fracture on its underside (6 o'clock position) and exhibited downward bending proximal to the fracture location. (See figure 3.) The fracture followed the spiral seam pattern of the field-applied polyethylene tape wrap (See figure 4.) The fracture ran roughly 45° from the longitudinal axis of the pipe in a spiral path. The fracture had sawtooth-like features, with numerous short cracks merging into the main fracture. The total length of the fracture was 11 7/8 inches, and the widest opening of the fracture was 0.19 inch. About a 60-inch section of the pipeline containing the fracture was removed and was shipped to the NTSB Materials Laboratory in Washington, DC for further examination.

Figure 3. Photograph of failed section of ammonia pipeline.

The residual curvature of the pipe section after removal from the pipeline indicated that the stress from the bending loads had exceeded the yield stress of the steel. The tensile stress from bending would have been the greatest on the bottom of the pipe, at the external surface, in the area where cracking initiated. The hoop stress from the MOP at the rupture location is about 70 percent of the specified yield stress of the steel.

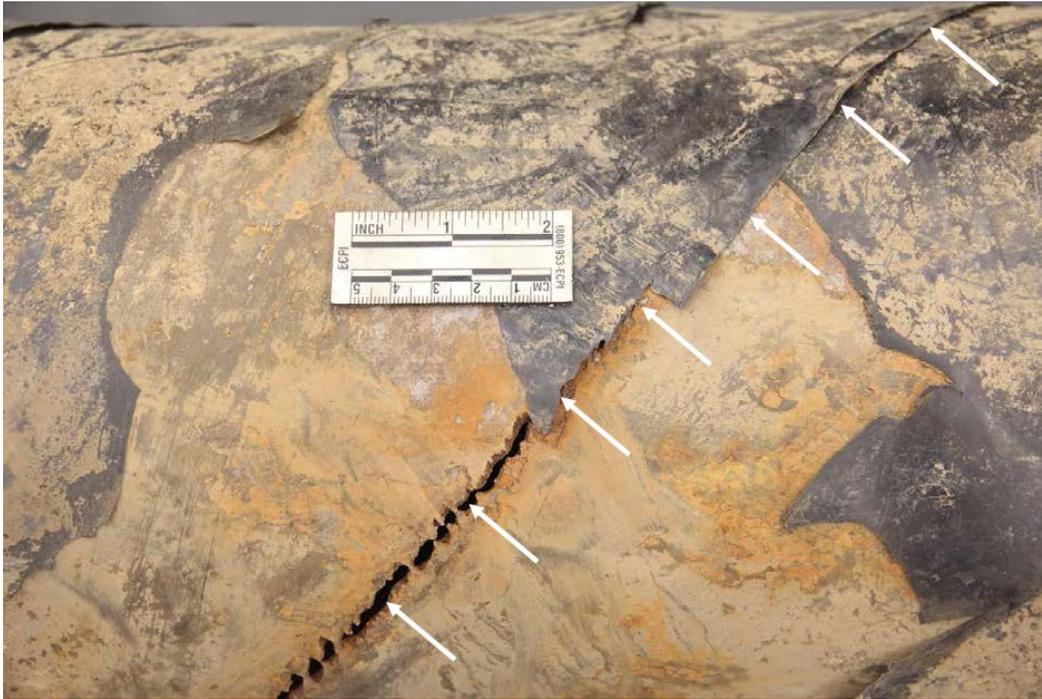
Portions of the protective polyethylene tape coating adjacent to the fracture were displaced from the pipe but recovered during the investigation. When loose pieces of tape were positioned on the pipe surface, the fracture aligned with the edges of successive windings of the tape, where the tape overlapped. Also, there were areas on the pipe segment where the tape wrap had visibly shifted. One area of the tape had its edges folded over, exposing the pipe surface. Brown-colored corrosion was visible on the exposed pipe surface. Tenting of the tape wrap was observed longitudinally along the 6 o'clock position of the pipe, roughly in line with the fracture.⁶

Numerous thumbnail-shaped cracks consistent with fatigue cracks were visible on the fracture surfaces. The patterns were oriented such that the thumbnail-shaped cracks emanated from the outside diameter of the pipe. The presence of numerous thumbnail-shaped cracks was consistent with multiple initiation fatigue cracking. The deepest thumbnail-shaped fatigue crack extended through approximately 75 percent of the pipe wall thickness. The areas between the thumbnails and adjacent to the inside diameter of the pipe exhibited microvoid coalescence consistent with overstress fracture. Overall, the fracture features were consistent with corrosion fatigue.

Figure 4. Photograph of ammonia pipeline crack showing alignment with seam in protective tape and sawtooth crack features.

The National Transportation Safety Board determines that the probable cause of the pipeline rupture was corrosion fatigue cracks that grew and coalesced under disbanded polyethylene tape coating. Contributing to the location of the cracking was external loading that caused bending stress in the pipe in addition to the cyclic stresses in the pipe from the internal pressure of the ammonia transported.
