# National Transportation Safety Board

## Pipeline Accident Brief

Accident No.:	DCA-97-FP-005
Type of System:	Transmission pipeline
Type of Accident:	Rupture and fire
Location:	Indianapolis, Indiana
Date and Time:	July 21, 1997; 2:33 p.m. CST
Owner/Operator:	Citizens Gas & Coke Utility
Property Damage and Losses:	In excess of \$2 million
Fatalities:	1
Injuries:	1
Evacuated:	75
Material Released:	Natural gas
Pressure:	310 psig
Type of Failure:	Excavation damage
Component Affected:	20-inch-diameter buried steel transmission pipeline

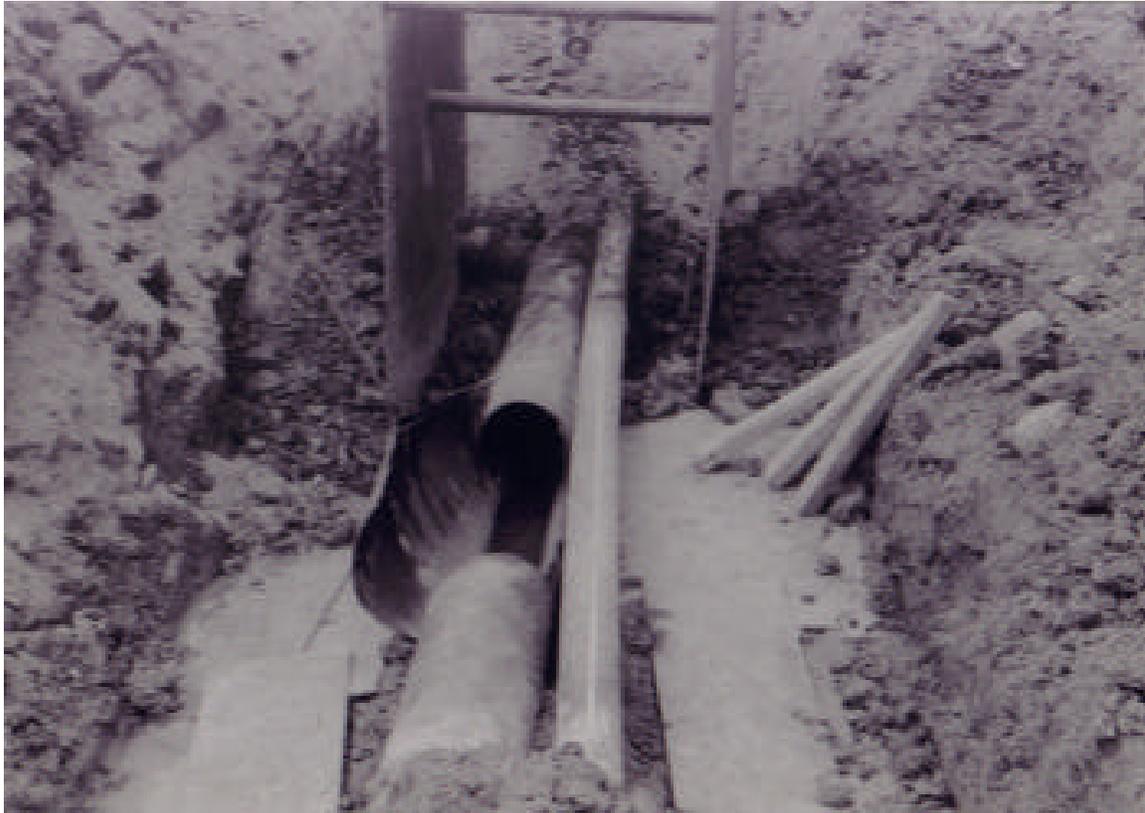
On-site inspection of the ruptured pipe revealed a near-longitudinal gaping fracture about 5.8 feet long. Along the entire length of the longitudinal fracture, the newly installed 8-inch distribution main was within approximately 4 inches of the 20-inch transmission pipeline. (See figure 1.)

**Figure 1. Postaccident excavation revealing relative positions of 8-inch distribution main and 20-inch transmission pipeline at site of rupture**

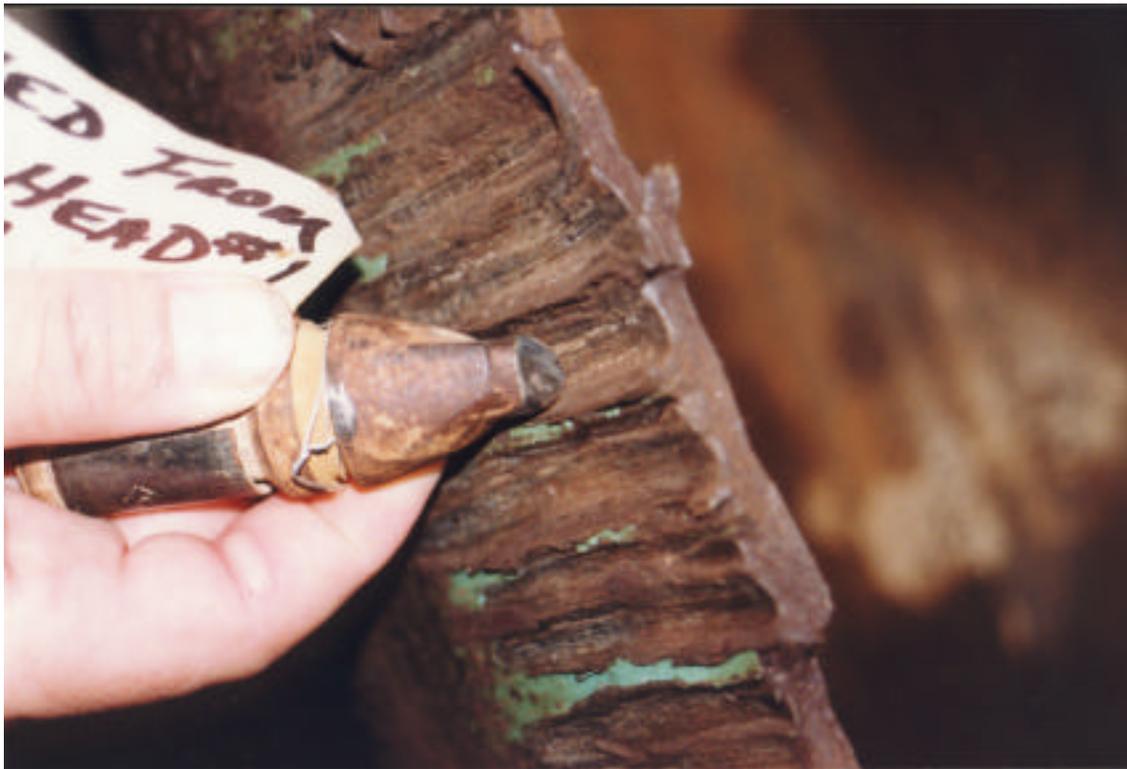
The ruptured segment of the 20-inch pipe was removed and sent to the National Transportation Safety Board's Materials Laboratory for examination. Safety Board examination revealed that the pipeline fractures contained features typical of overstress separation. The fractures contained no arrest marks, which is consistent with a crack in the pipe that, once initiated, propagated continuously. The exterior pipeline surface along the entire length of the longitudinal fracture contained circumferential gouge marks that intersected both halves of the fracture. The gouge marks typically measured approximately 4 inches long in the circumferential direction. Wall thicknesses in the deepest area of two gouge marks adjacent to the longitudinal fracture were 0.168 inch and 0.175 inch, which were 60 and 62 percent, respectively, of the original 0.281-inch wall thickness.

Safety Board investigators obtained a tooth from the reaming tool that was used in the drilling operation to install the 8-inch distribution main. Direct comparisons of the tooth with the gouge marks revealed that the size and shape of the tooth tip were

consistent with the size and shape of the gouge marks in the vicinity of the rupture. (See figure 2.)

**Figure 2. Comparison of cutting tool tooth with gouges found at rupture site**

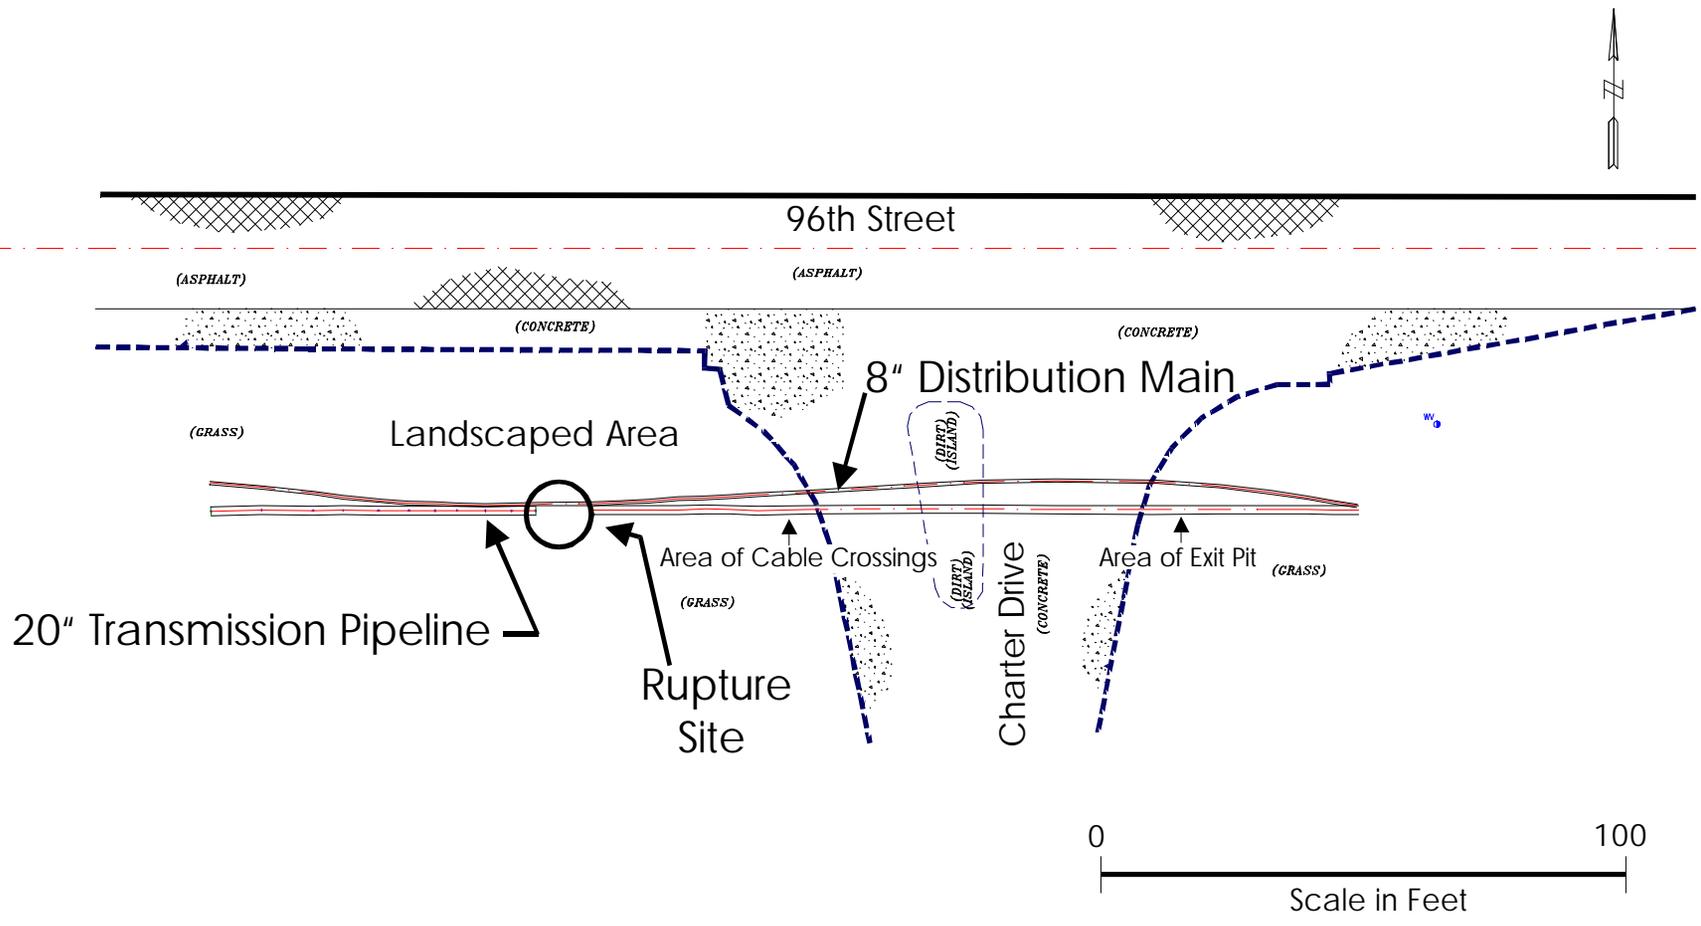
After the accident, the two pipelines were excavated at points along the bore path to determine the exact horizontal centerline-to-centerline separation between the pipelines and the depth of cover over each one. These excavations revealed that the 8-inch distribution main was located at a horizontal centerline-to-centerline distance of 5.5 feet north of the 20-inch transmission pipeline at the entrance point of the bore (west end). Progressing eastward, the 8-inch distribution main veered sharply toward the 20-inch transmission pipeline. Approximately 40 feet east of the entrance point of the bore, the 8-inch distribution main was within a few inches of the existing 20-inch transmission pipeline. At the rupture site, approximately 68 feet east of the entrance point of the bore, the two pipelines were about 4 inches apart. As the 8-inch pipeline continued toward the

east, it veered away from the 20-inch pipeline to a horizontal centerline-to-centerline separation of 3.3 feet about 113 feet east of the entrance point of the bore. From this point eastward, the horizontal centerline-to-centerline separation ranged from 4 to 6 feet until the 8-inch distribution main angled toward the 20-inch transmission pipeline at the east end of the bore, as originally planned. (See figure 3.)

Figure 3. Relative locations of new 8-inch and existing 20-inch pipelines
