# National Transportation Safety Board

## Pipeline Accident Brief

Pipeline Accident Number:	DCA-97-FP-002
Type of System:	Hazardous liquid petroleum products
Accident Type:	Overpressure rupture
Location:	Murfreesboro, Tennessee
Date and Time:	November 5, 1996, about 9:36 a.m. EST
Owner/Operator:	Colonial Pipeline Company
Fatalities/Injuries:	None
Property Damage:	\$5.7 million
Material Released:	Diesel fuel
Quantity Released:	About 84,700 gallons (about 2,017 barrels)
Pipeline Pressure:	Approximately 1,820 psig
Component Affected:	8-inch diameter, Grade X-42, 0.188 inch wall thickness, Electric Resistance Weld (ERW) steel pipe

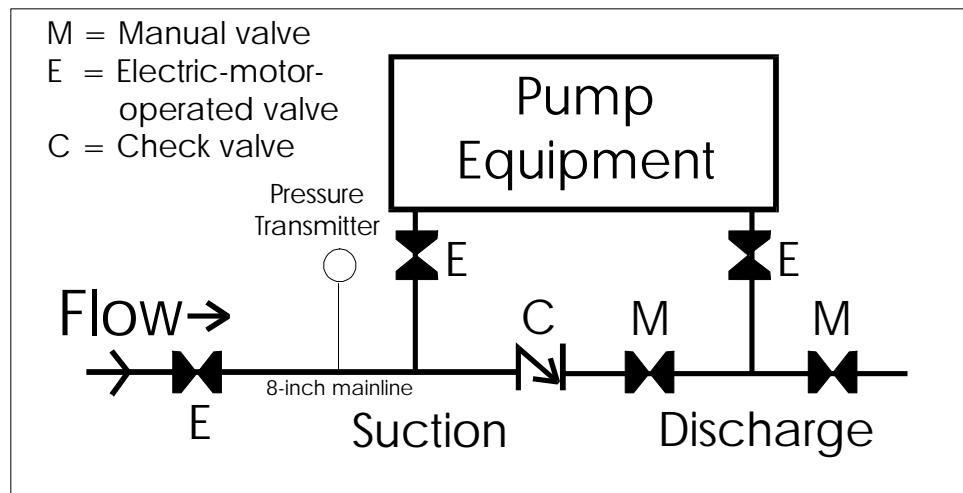
With the pipeline continuing to operate, pressure was increasing at Murfreesboro. The controller did not note the overpressure condition that had developed at Murfreesboro, because the pressure transmitter for the station was downstream of the closed mainline block valve. (See figure 2a.) The controller was not aware of the actual pressure transmitter location because the supervisory control and data acquisition (SCADA) system<sup>1</sup> schematic for the Murfreesboro station erroneously depicted the pressure transmitter as located upstream of the electric block valve, as it was at most other stations on the pipeline. (See figure 2b.)

Figure 2A. Valve configuration at Murfreesboro station. Note that pressure transmitter is downstream of electrically operated mainline block valve.

Following the accident, Colonial changed the location of the pressure transmitter at Murfreesboro so the upstream pressure can be observed when the remotely operated mainline block valve is closed. Colonial evaluated the hydraulic conditions for its entire pipeline system and then corrected overpressure protection set points to help prevent an overpressure condition in the future. Colonial has also reviewed and updated the SCADA schematic displays for its pipeline system to eliminate inaccuracies.
