PIPELINE ACCIDENT REPORT

LONE STAR GAS COMPANY
NORTH RICHLAND HILLS, TEXAS
OCTOBER 4, 1971

NATIONAL TRANSPORTATION SAFETY BOARD
Washington, D. C. 20591
REPORT NUMBER: NTSB-PAR-72-3

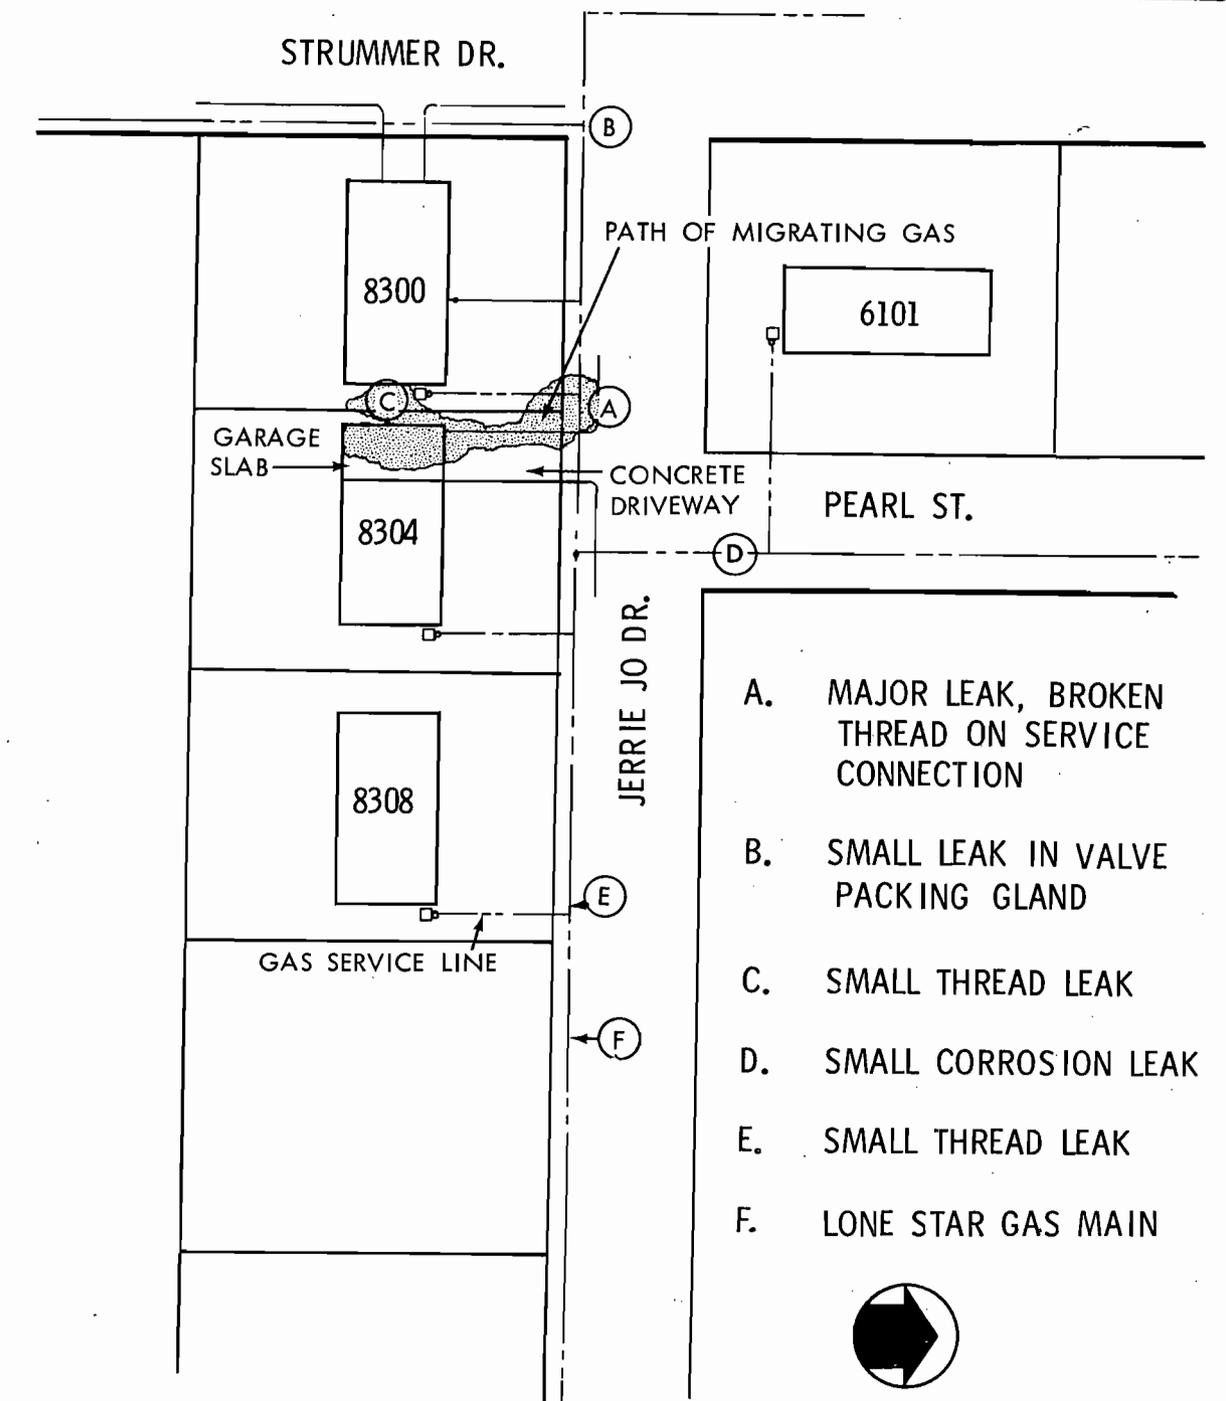
Figure 1
**PLOT PLAN OF ACCIDENT SITE AT
 8300 AND 8304 JERRIE JO DRIVE**

The two houses directly involved in the accident were located 20 feet apart, side by side, at 8300 and 8304 Jerrie Jo Drive, about 40 feet south of the gas main. The concrete driveway of the house at 8304 was parallel to and 10 feet east of the gas service line which supplied the house at 8300. (See Figure 1.)

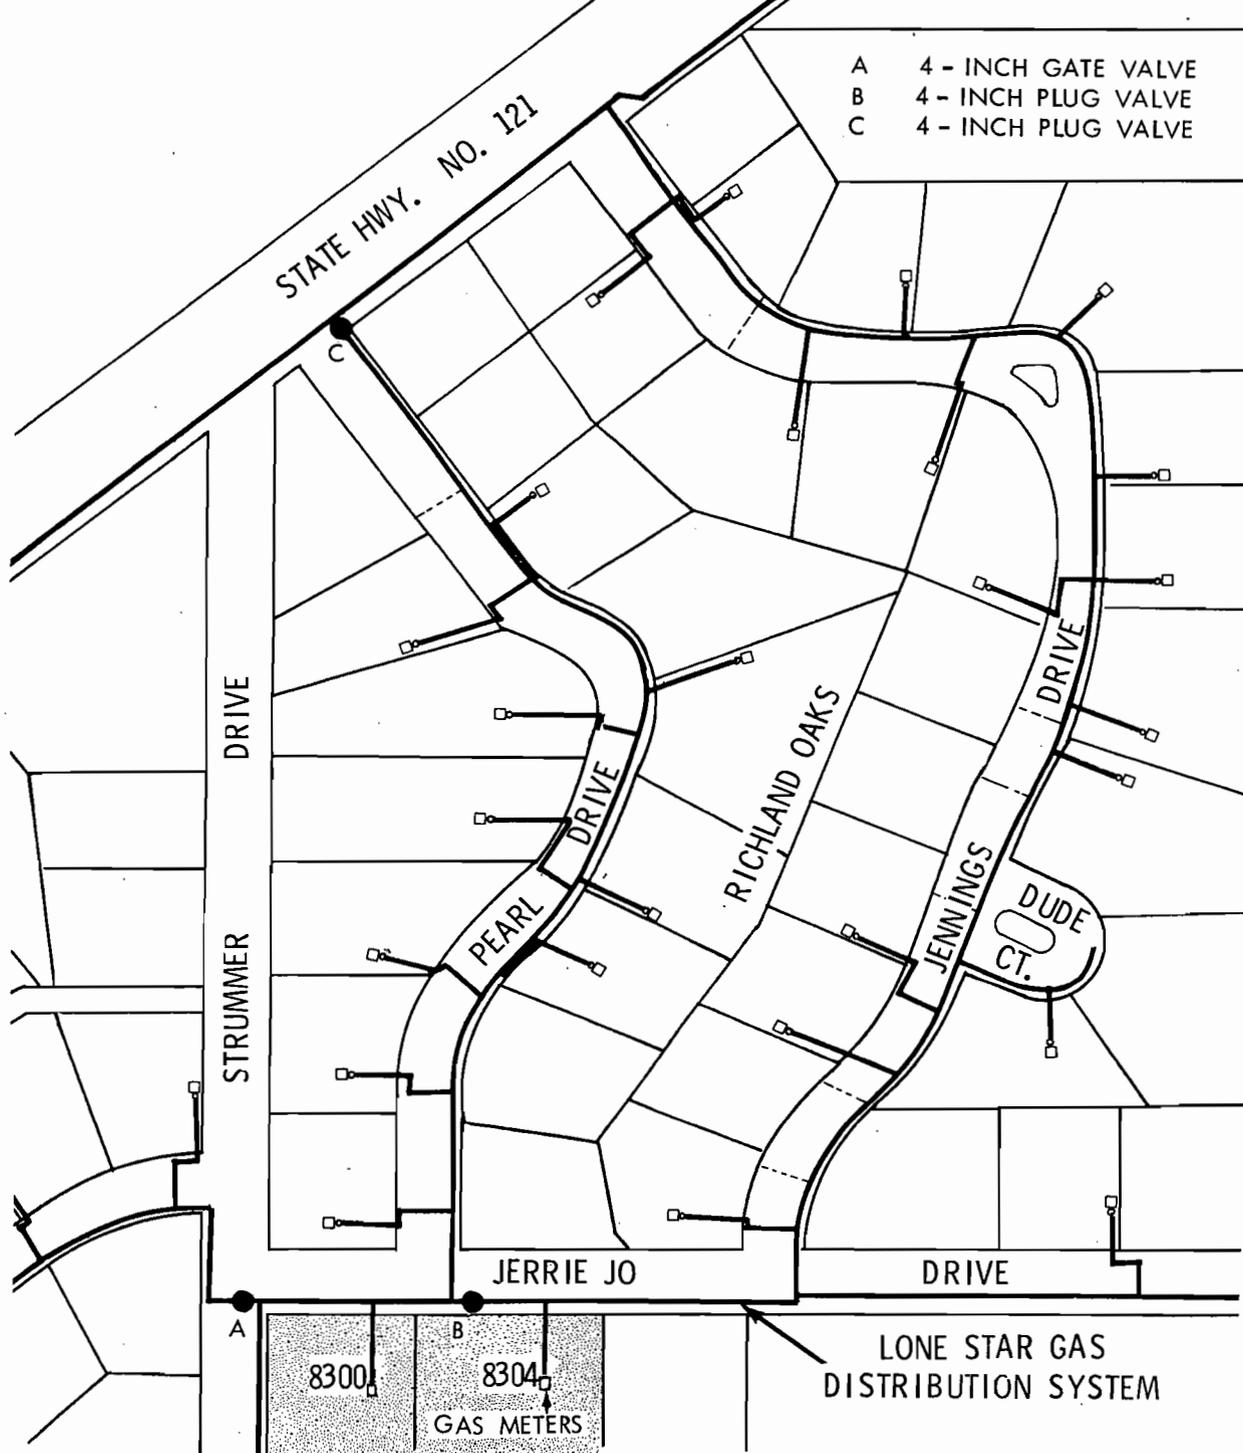
Figure 2
VALVES ON GAS MAIN IN THE ACCIDENT AREA

Valves designed to shut off the flow of gas are located at strategic points along the gas main. Three such valves had been installed at the intersections of Strummer and Jerrie Jo Drives, Jerrie Jo and Pearl Drives, and Pearl Drive and State Highway 121. Closure of these three valves would have shut off the gas flow to the two houses involved in the accident as well as to 35 to 40 other houses in the neighborhood.

If, when they realized a leak existed, the gas crew had closed the three valves that would have shut off the gas supply to the affected area, the second accident might have been averted.

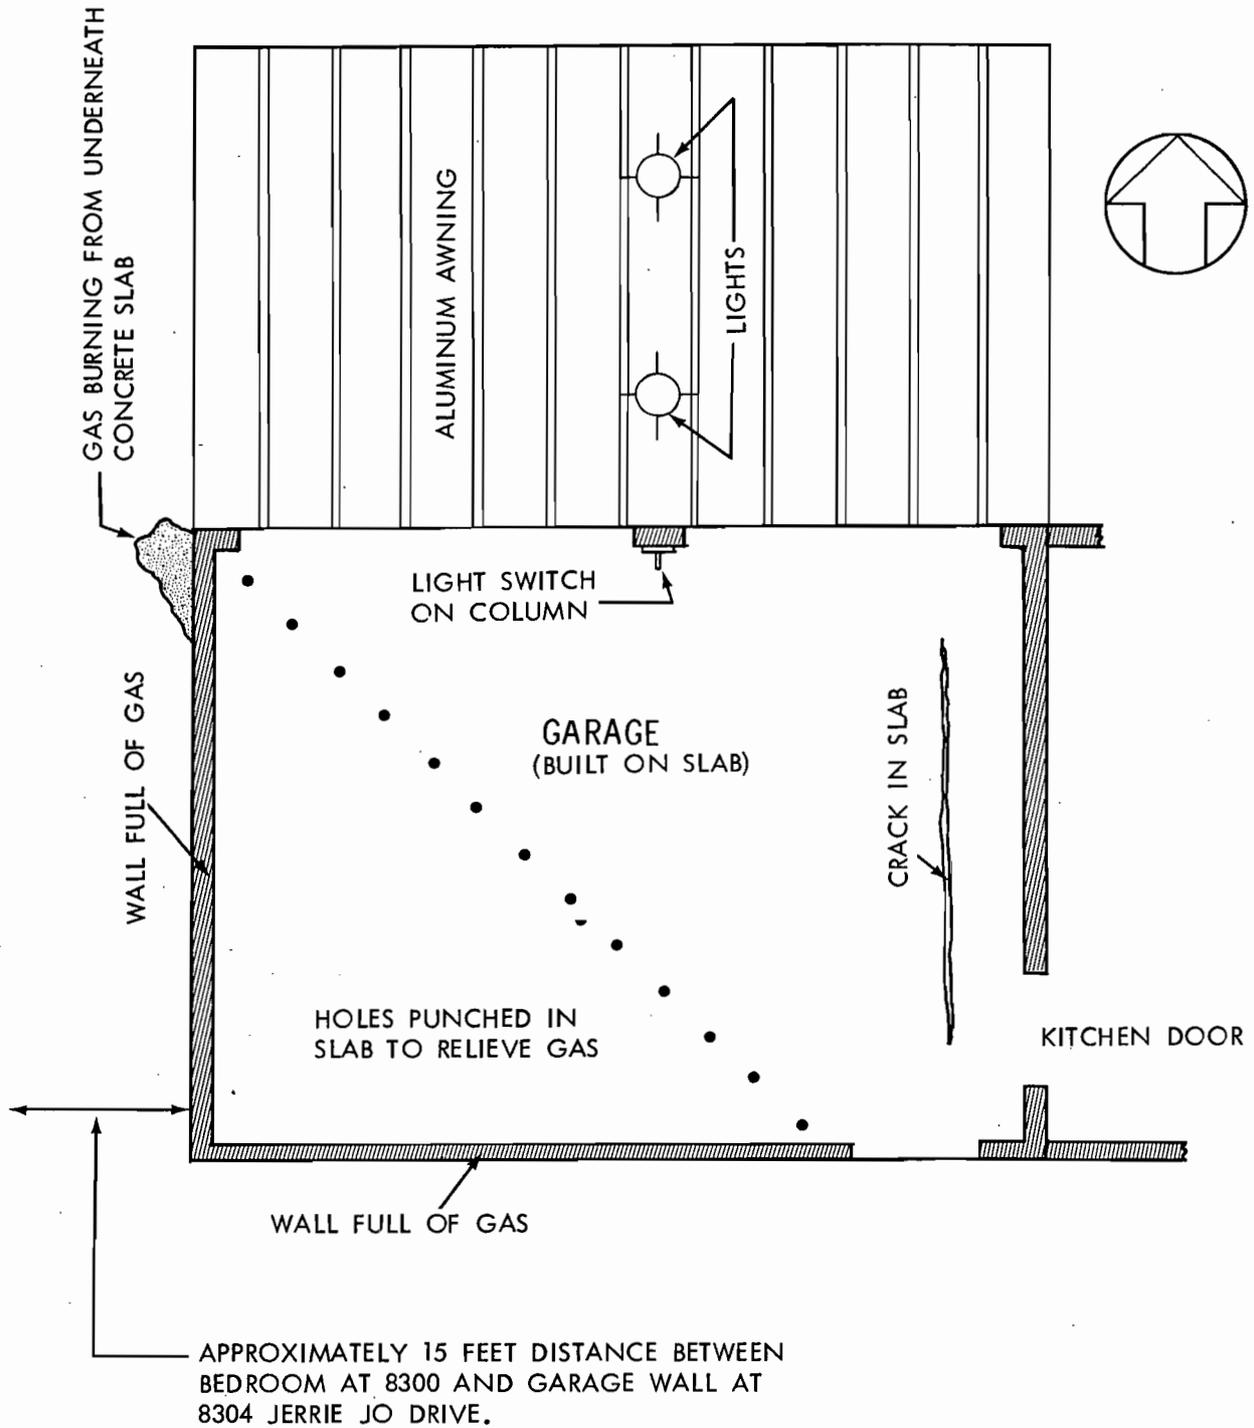
Figure 4

At approximately 7:39 a.m., while firemen were still inside the house at 8300 Jerrie Jo Drive and while gas company personnel were still checking for leakage in front of this house, the woman who lived at 8304 Jerrie Jo Drive walked into her garage to turn off the lights. As she moved the switch, a violent explosion occurred, followed by an intense, but short-lived fire in the garage itself. (See Figure 4.) The woman was hurled across the

The garage burned, and fires also started at the west edge of the concrete driveway and underneath the concrete slab at the northwest corner of the garage. The firemen who were already on the scene extinguished the garage fire immediately, but allowed the flames underneath the garage and driveway to burn themselves out.

GAS IN WALLS AND UNDER GARAGE SLAB AT 8304 JERRIE JO DRIVE

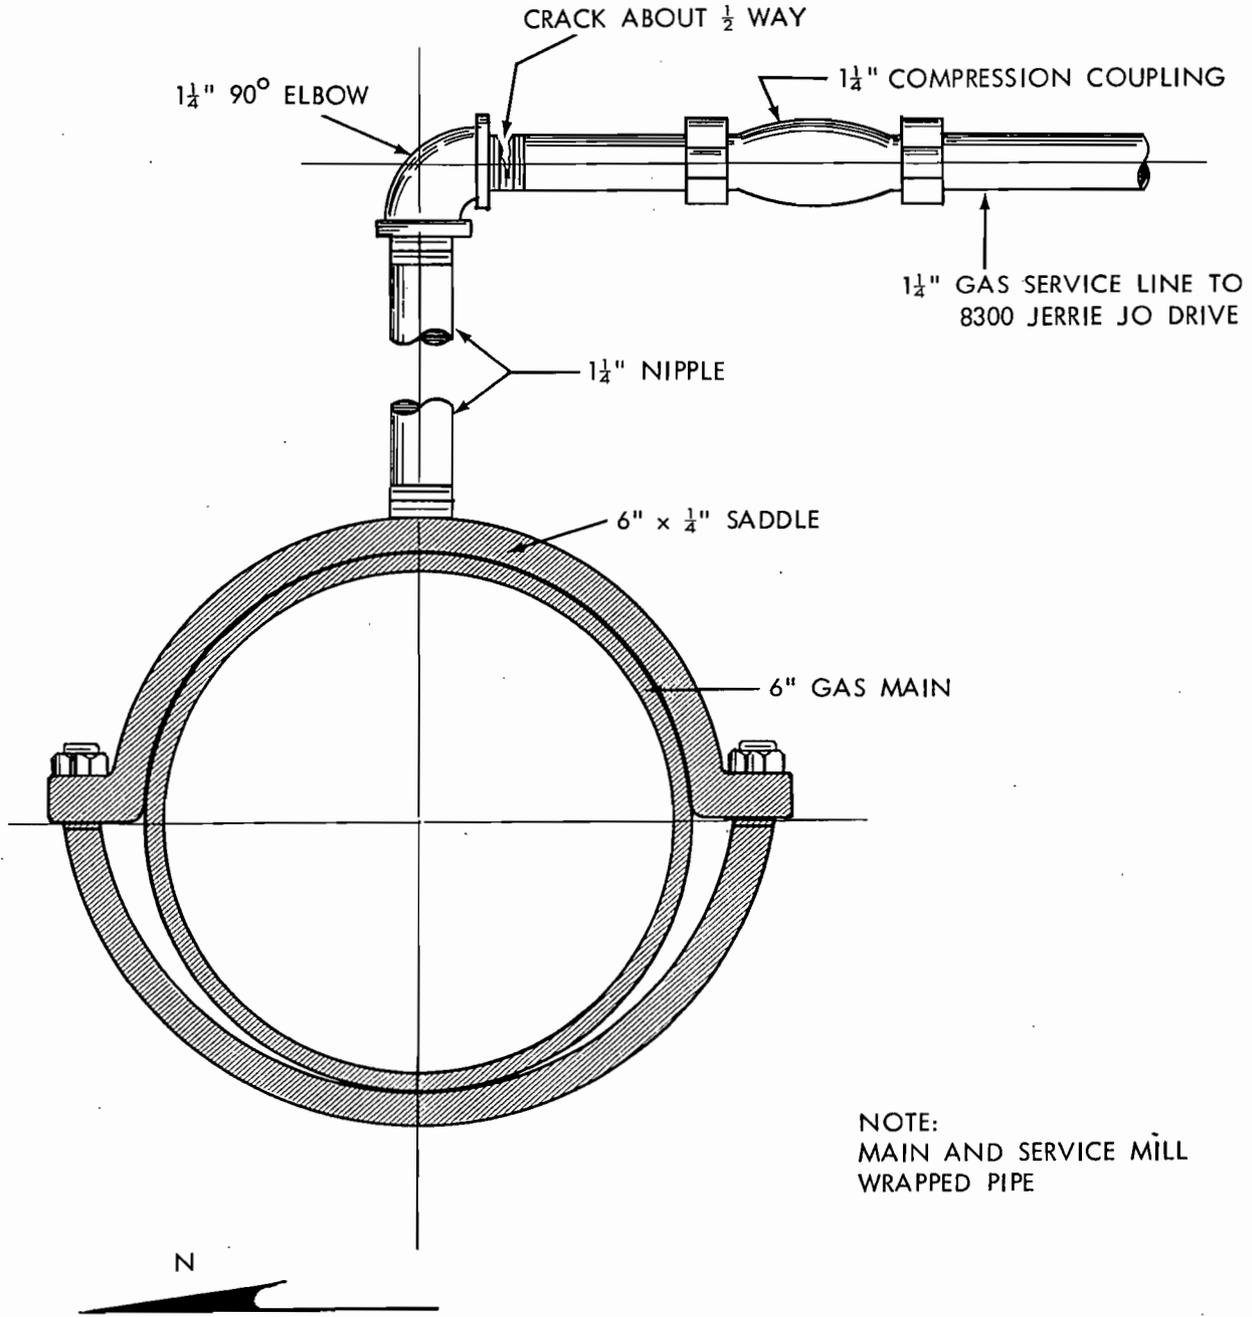
Figure 5

gas main. Gas was leaking at 20 to 25 p.s.i.g. from a crack in the threaded connection where the service line was screwed into the 90-degree elbow. (See Figure 5.) The break in the pipe thread was bright and shiny; corrosion had not started.²

Pipe metallurgical analysis by the National Bureau of Standards. The broken service line and the 90-degree elbow into which it had been screwed were sent to the National Bureau of Standards for analysis. The failed pipe section, which had a 1¼-inch nominal outer diameter and a nominal wall thickness of 1/8 inch, consisted of a standard steel pipe with a thin zinc coating over the exterior surface. The pipe thread had cut through this galvanized coating completely, penetrated into the iron base metal, and exposed both

A test using an electron microscope revealed that the pipe section had suffered a brittle, faceted cleavage, rather than a ductile, tensile failure.

BROKEN SERVICE LINE CONNECTION

zone due to hydrogenation. Because the ability of the pipe to stretch and yield in tension without failure had been limited severely, the safety factor had been reduced. Ungalvanized pipe or the same galvanized pipe without the hydrogenation effects would have been able to withstand over 30 percent more tensile force and to suffer more than 20 times the elongation before fracture occurred.

The dense clay soil had exerted stresses on this pipe through the years every time rain saturated the soil sufficiently to cause it to swell. This soil-stress condition was recognized and, because full basements would ultimately buckle, most houses were built on concrete slabs. The soil swelling caused by the heavy rains preceding the accident finally broke the embrittled pipe and allowed gas to escape.

cause a dissimilar metal condition and to set up a galvanic action which ultimately produced the hydrogenation brittle, faceted cleavage of the pipe.

2. The service line, weakened after repeated soil stresses over a period of years and embrittled by hydrogenation, finally failed due to the forces exerted on it by the swelling clay, which was saturated by recent heavy rains.

(a) Amend 49 CFR 192 to include a section based on a review of the suitability of threaded galvanized pipe, or pipe coated with other dissimilar metals, for the transportation of natural and other gas. (Recommendation No. P-72-34)

(a) Undertake a program acceptable to the Railroad Commission of the State of Texas, to inspect, on a random-sample basis, the service line - gas main connections similar to those at the accident site, to determine their current condition and the existing stress on the piping. The results of this program will determine the action to be taken on other installations in the Lone Star system. Copies of these test results should be forwarded to the Railroad Commission of the State of Texas and the Office of Pipeline Safety of the Department of Transportation. (Recommendation No. P-72-37)

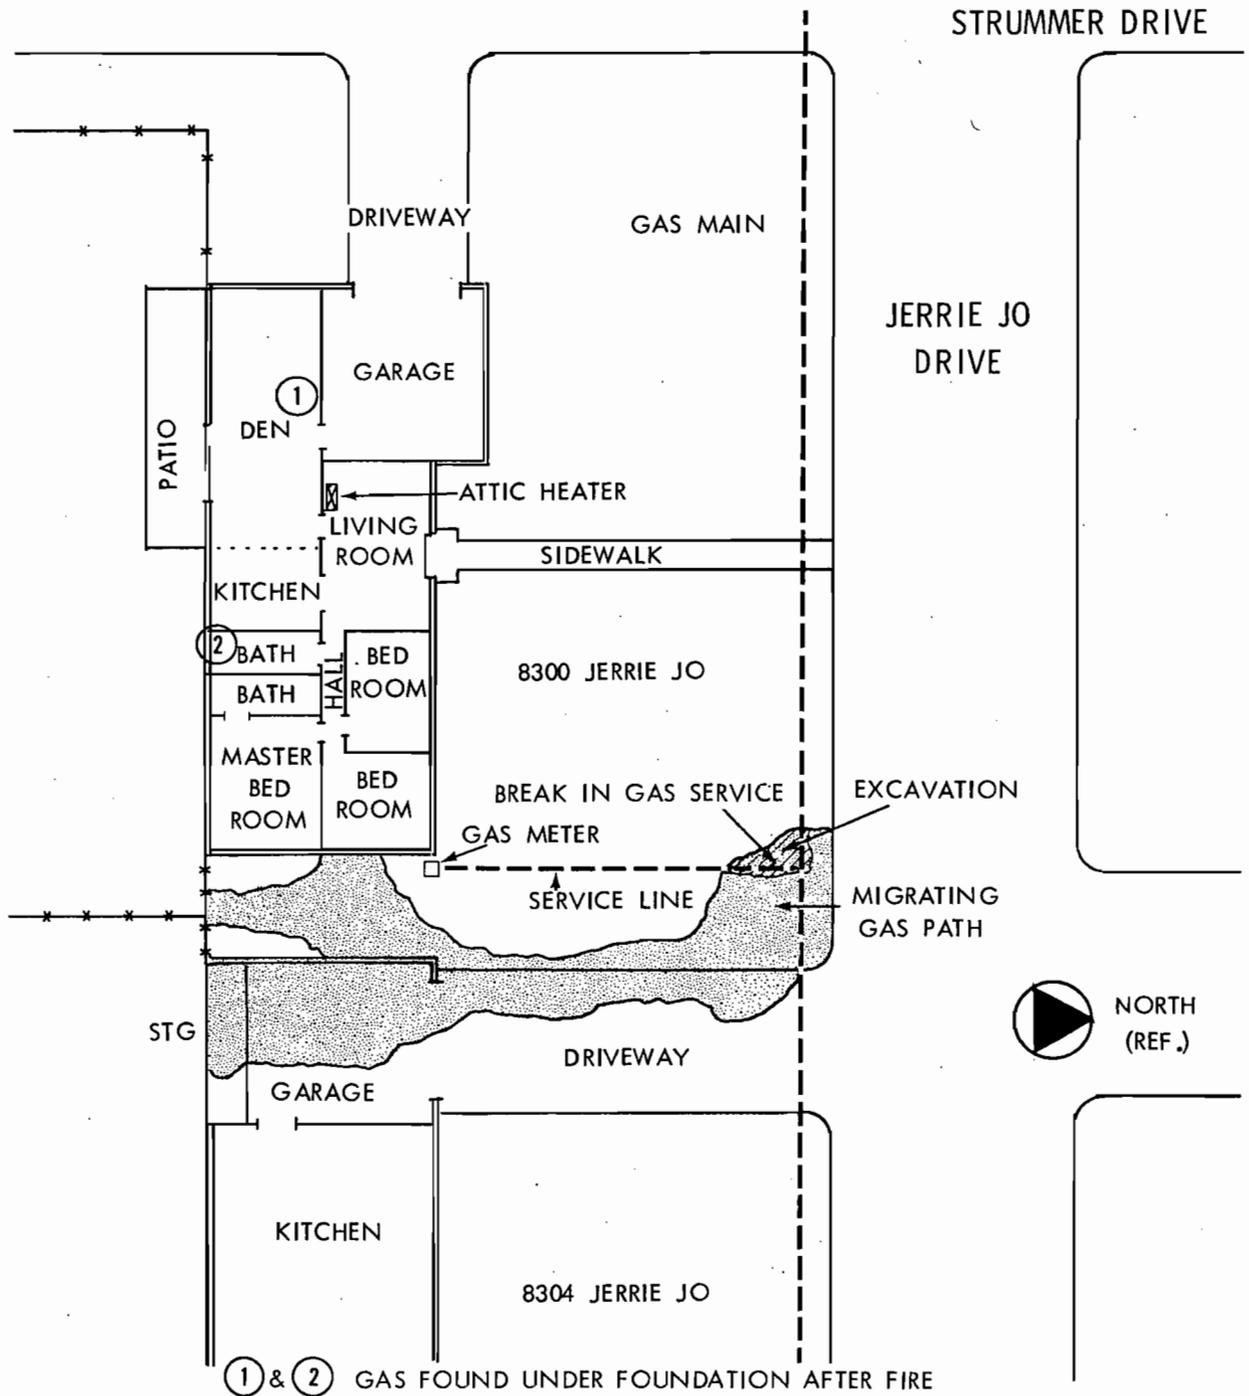
Figure 6
**PATH OF MIGRATING GAS BETWEEN
 8300 AND 8304 JERRIE JO DRIVE**

Consulting engineers investigation. Lone Star retained a professional engineering company to investigate the accident site and report on the fires and explosions. This investigation revealed migration of gas in a well-defined but narrow area, extending from the leak at the main and service-line junction up under the driveway and garage at 8304 to the concrete foundation slab at 8300 Jerrie Jo Drive. At 8300, accumulations of gas were found under a bathtub and around an anchor bolt between the den and garage of the house. (See Figure 6.)

The dense clay, having caused the pipe failure, prevented the escaping gas from dissipating to the air above and caused it to flow away from the break laterally into the more porous, graveled soil under the driveway, 10 feet east of the leak. Once the gas, induced by the 20-p.s.i.g. pressure, had established an avenue into the more porous area, it migrated up under the driveway and flowed into and accumulated under the concrete slabs of both houses. Throughout this migration, the gas was effectively capped, first by the clay over the leak site and then by the concrete driveway and foundation slabs under the two houses.

4. The explosion and fire in the house at 8304 Jerrie Jo Drive, which occurred almost 3 hours later, were due to natural gas still leaking at 20 to 25 p.s.i.g. from the break at the junction of the gas main and service line and migrating in a well-defined path up under the concrete driveway and garage slab.

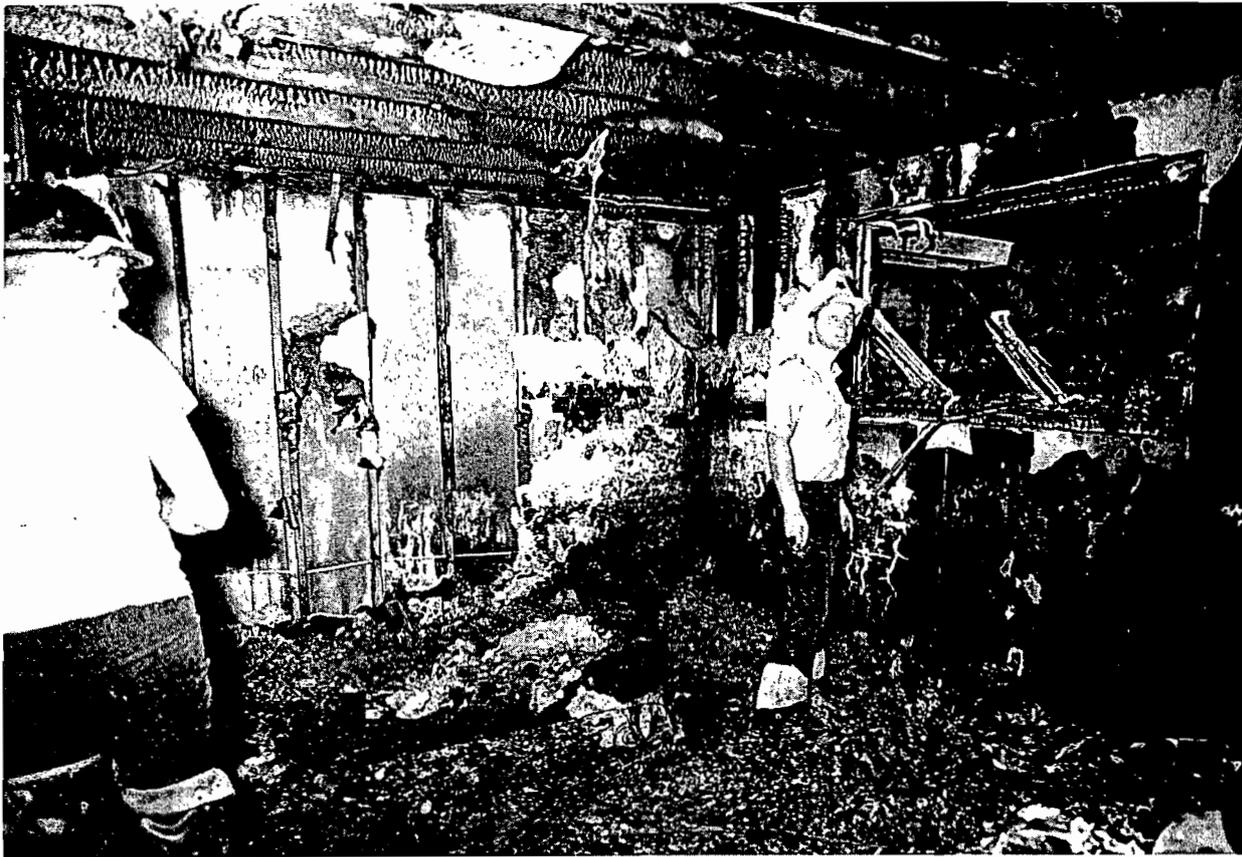
8300 Jerrie Jo Drive. The fire involved mostly the center and east section of the house, i.e., the living room, dining room, kitchen, and den. The cedar shingle roof over this area was burned through completely. The remainder of the house showed the effects of extreme heat and heavy smoke. (See Figure 7.) The damage was judged later to be irreparable and the house was a total loss.

Figure 7: Interior of house at 8300 Jerrie Jo Drive after the explosion and fire.
