**PIPELINE ACCIDENT REPORT
WASHINGTON GAS LIGHT COMPANY
NATURAL GAS EXPLOSIONS
AT ANNANDALE, VIRGINIA
MARCH 24, 1972**

**NATIONAL TRANSPORTATION SAFETY BOARD
Washington, D. C. 20591
REPORT NUMBER: NTSB-PAR-72-4**

Adopted: November 22, 1972

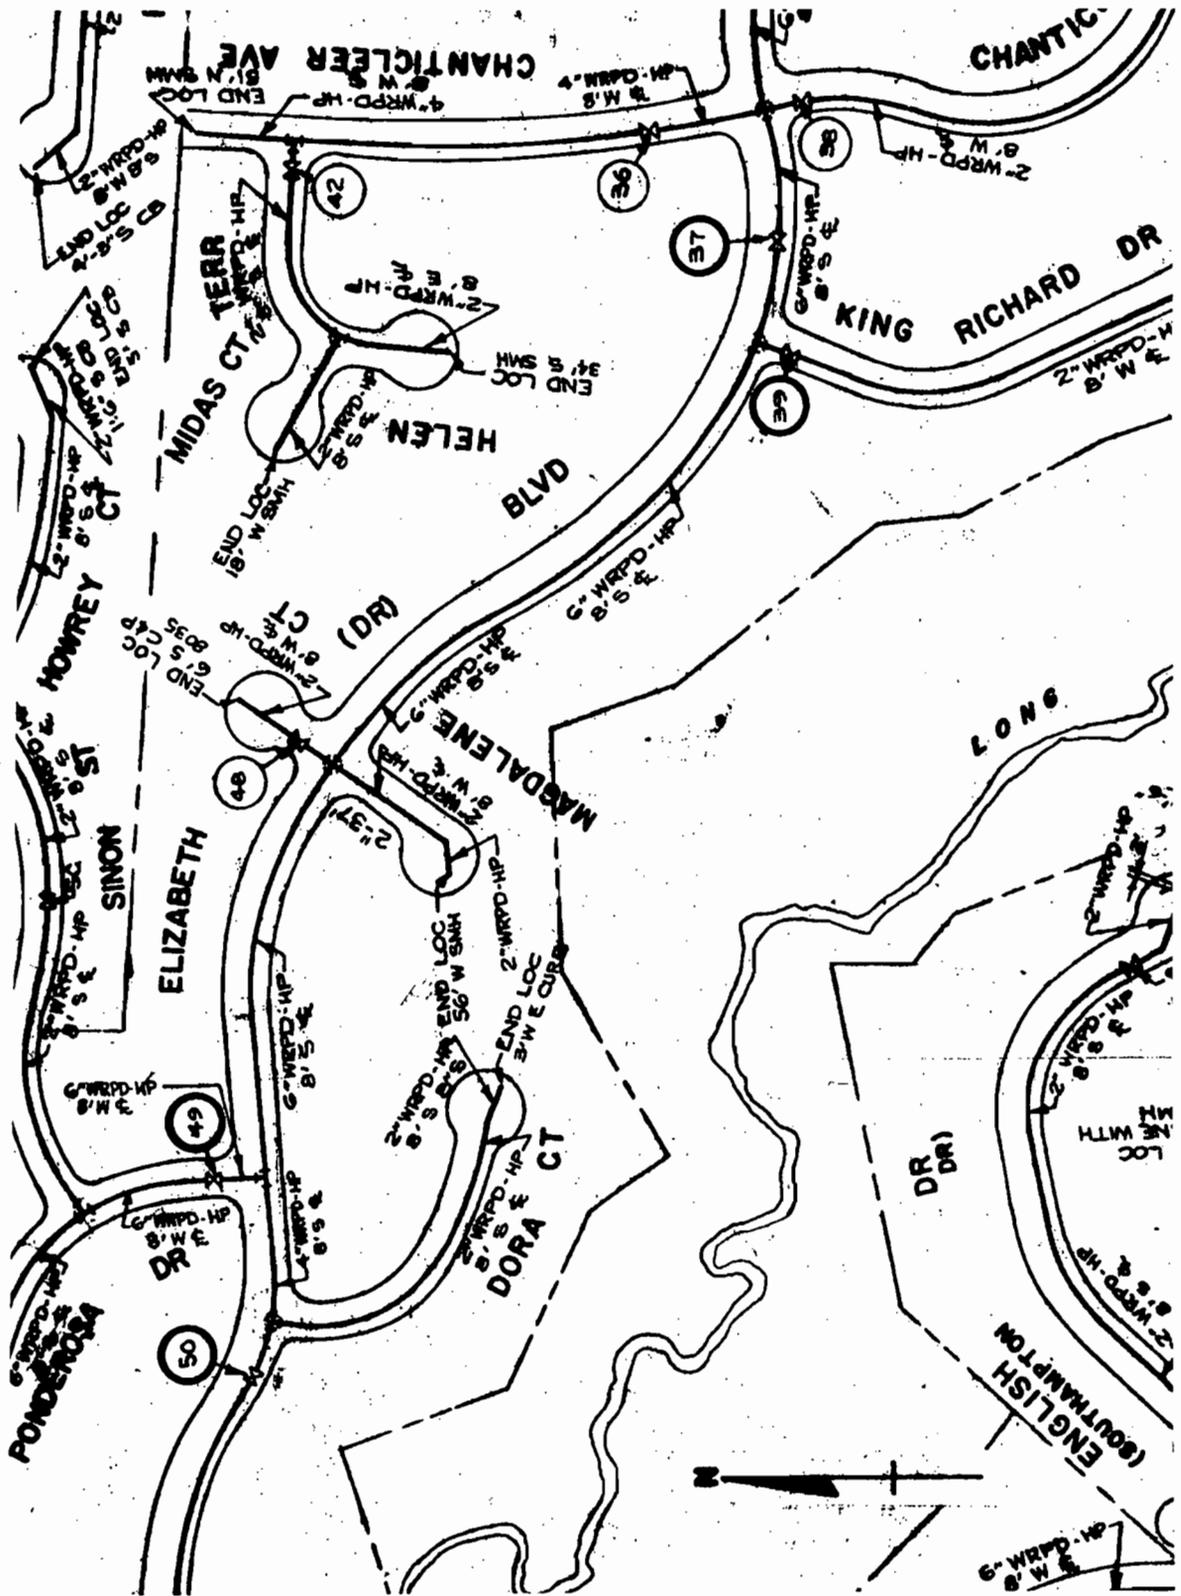
Figure 2. Location of the valves used to isolate the leak.

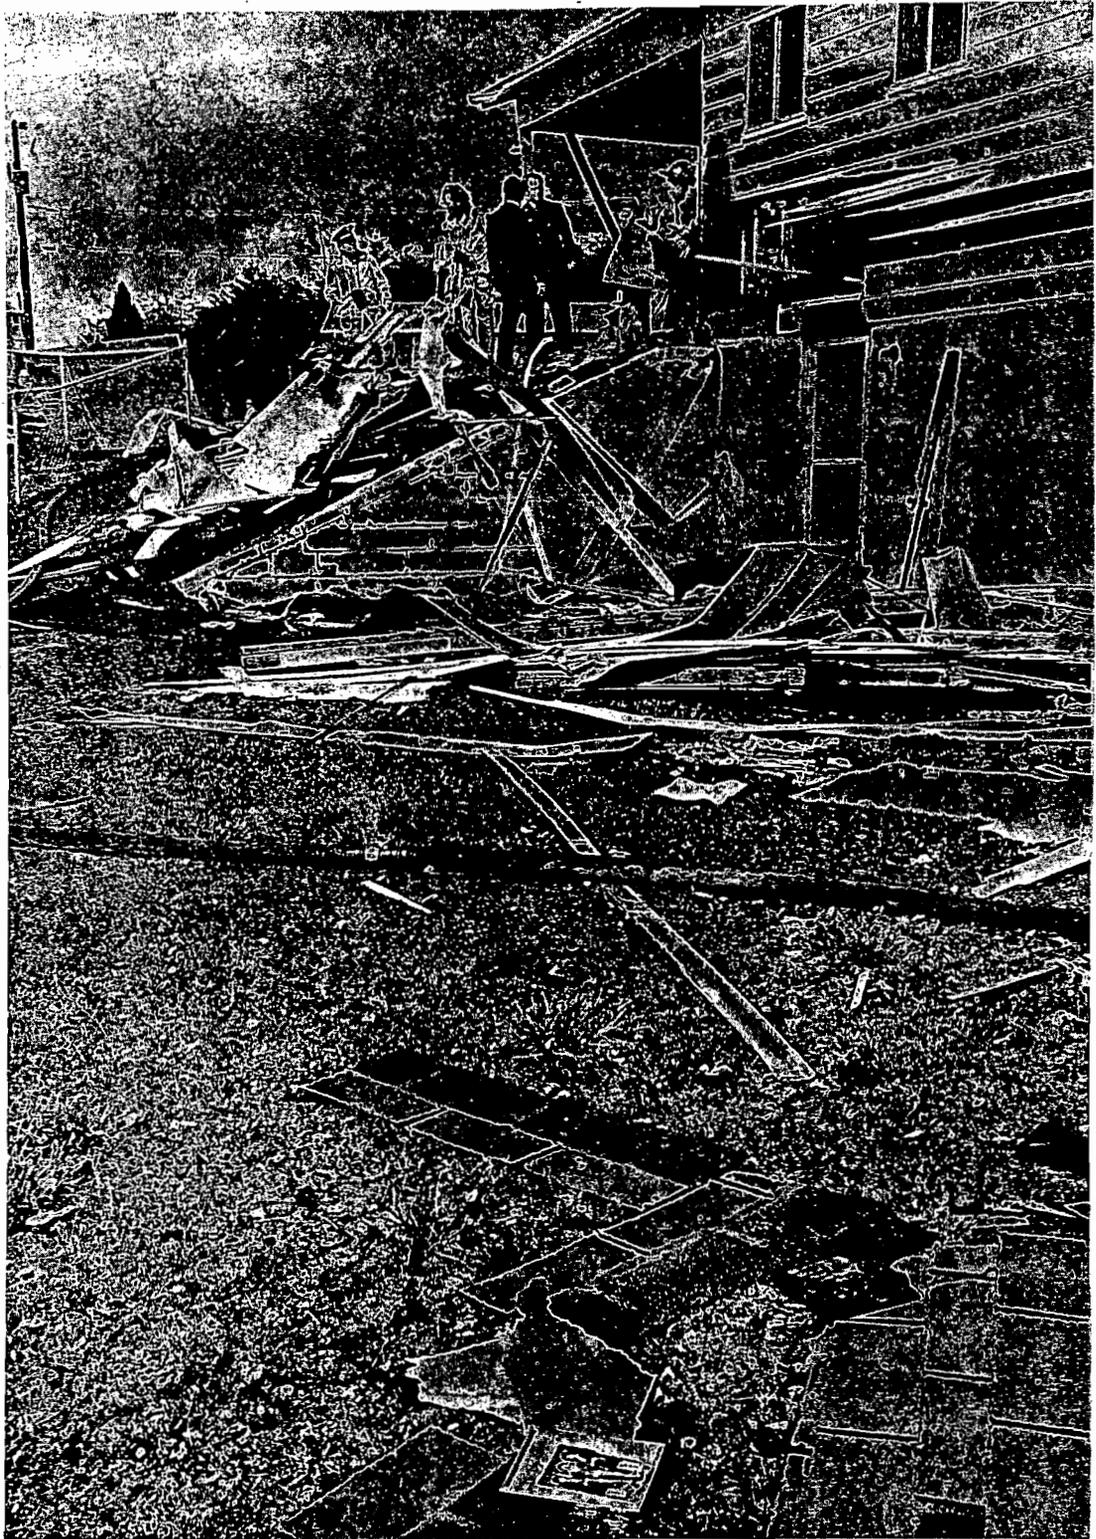
Figure 6. 4907 Magdalene Court (picture taken facing west).

The house at 4907 Magdalene Court was intact and was burning in the carport and basement area. The firemen entered the building from the kitchen door on the ground level and from a basement door at the rear of the build-

ing. A combustible gas meter brought into the building indicated high concentrations of gas in the basement, and personnel withdrew from the building because of the danger of further explosions. While in the basement, firemen noticed that gas was burning from the top row of cinderblocks.

After leaving the building, the firemen were able to contain the fire. It appeared to them that an explosion which occurred in an ashpit located beneath the carport had blown out approximately five or six cinderblocks from their normal position. Small gas-fueled fires, which flared up and died down, were observed at the expansion joint where the carport at 4907 joined the driveway. Gas-fed flames were also observed in the wall area of the house at 4909 Magdalene Court and along the street in front of 4909 Magdalene Court where the blacktop joined the concrete curb. Gas was also detected coming up through cracks in the blacktop nearer to the excavation.
