# **PIPELINE ACCIDENT REPORT**

**LONE STAR GAS COMPANY**

**Fort Worth, Texas  
October 4, 1971**

**REPORT NUMBER: NTSB-PAR-72-5**

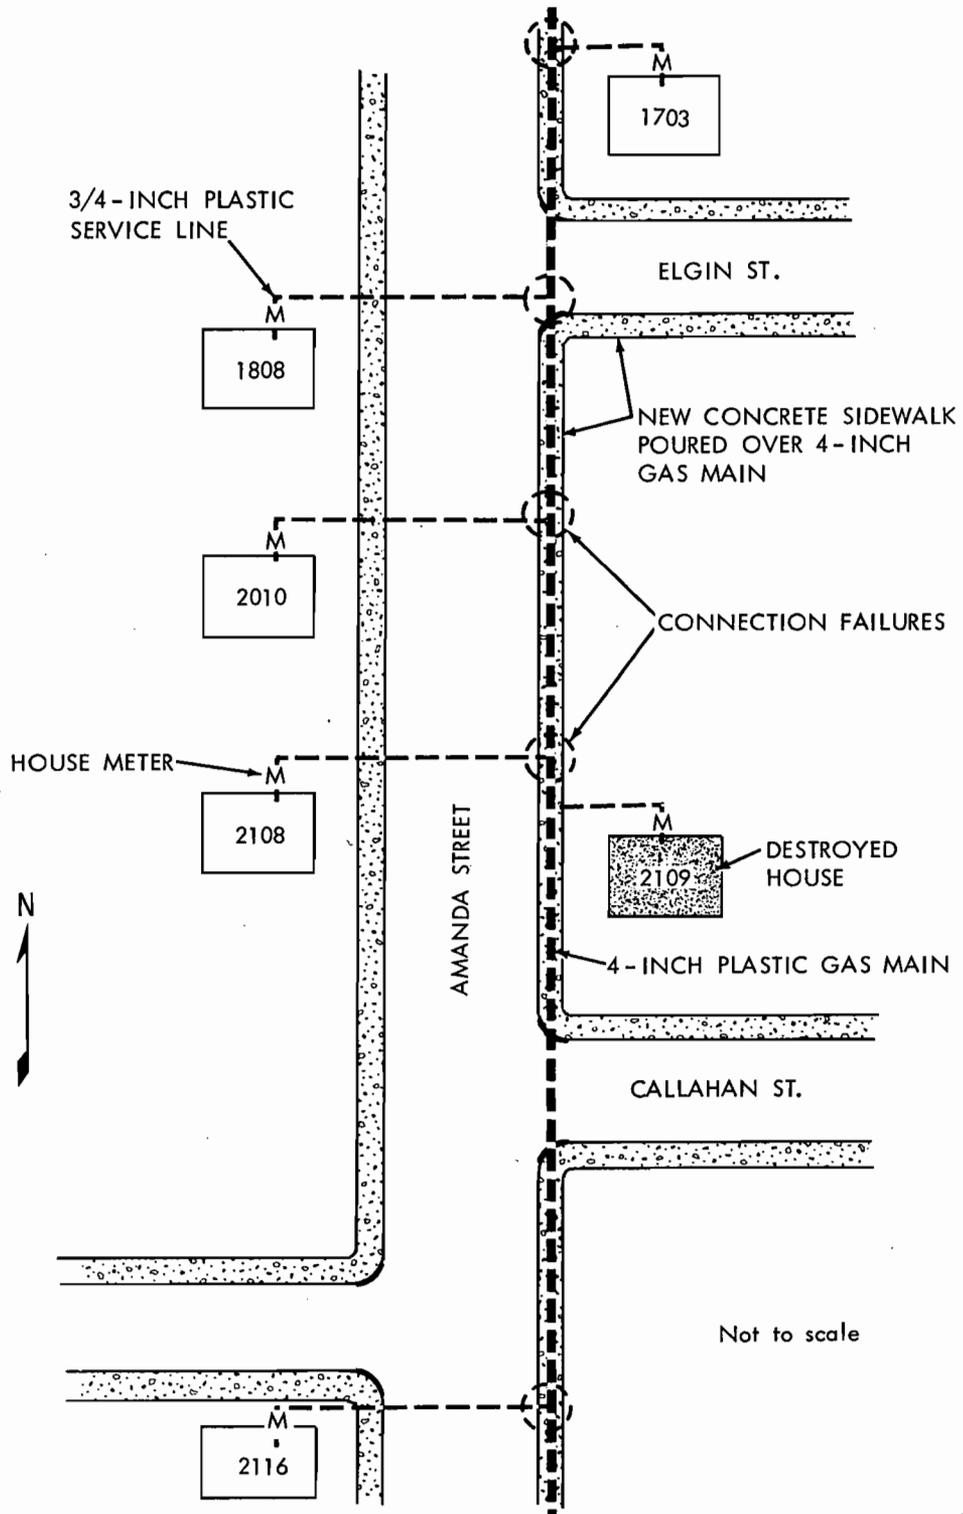
This accident occurred at 2109 Amanda Street, in an older suburb of Fort Worth, Texas. The houses on Amanda Street are generally small, one-story, frame types, with considerable distance between individual units. (See Figure 1.)

Figure 1.—Plan of the accident site.

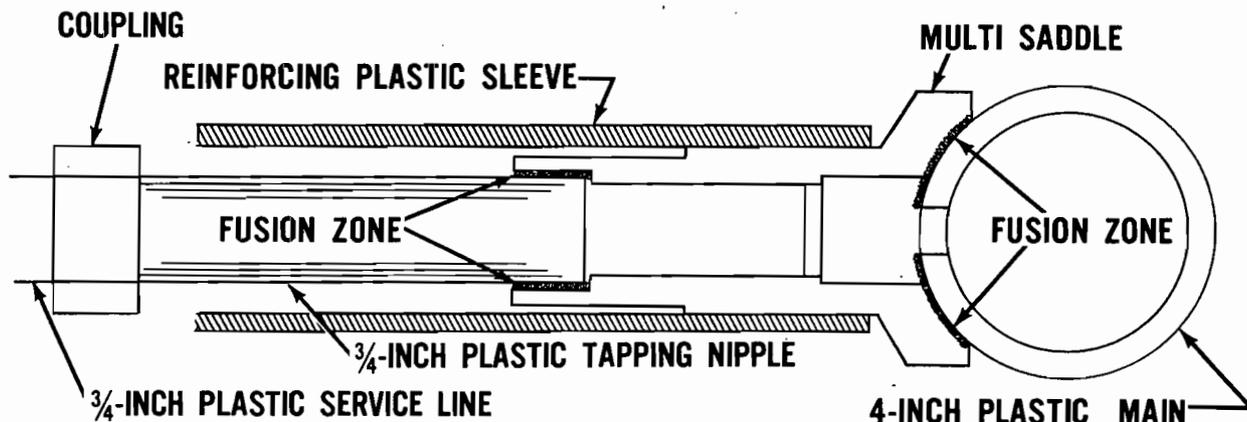
The contractor, under the direct supervision of Lone Star inspectors, used Lone Star specifications for the installation of plastic pipe. The plastic main, operated at a pressure of 20 p.s.i.g., extended in a north-south direction parallel with Amanda Street at a depth of 4 feet. The 3/4-inch-diameter plastic service lines which connected the main with the customers' houses were heat-fused to the main by means of a special polyethylene saddle. (See Figure 2.)

The Lone Star specifications called for reinforcing sleeves to be fitted over the heat-fused joint between the service saddle and the 3/4-inch tapping nipple. However, these sleeves were not immediately available. Shorter lengths, not specifically designed for this task, were cut from a coil of plastic pipe and were substituted for the required sleeves. The work was inspected by the Lone Star inspectors, the connections were tested, and the line was backfilled.

Figure 2.—Plastic service line-gas main connection.

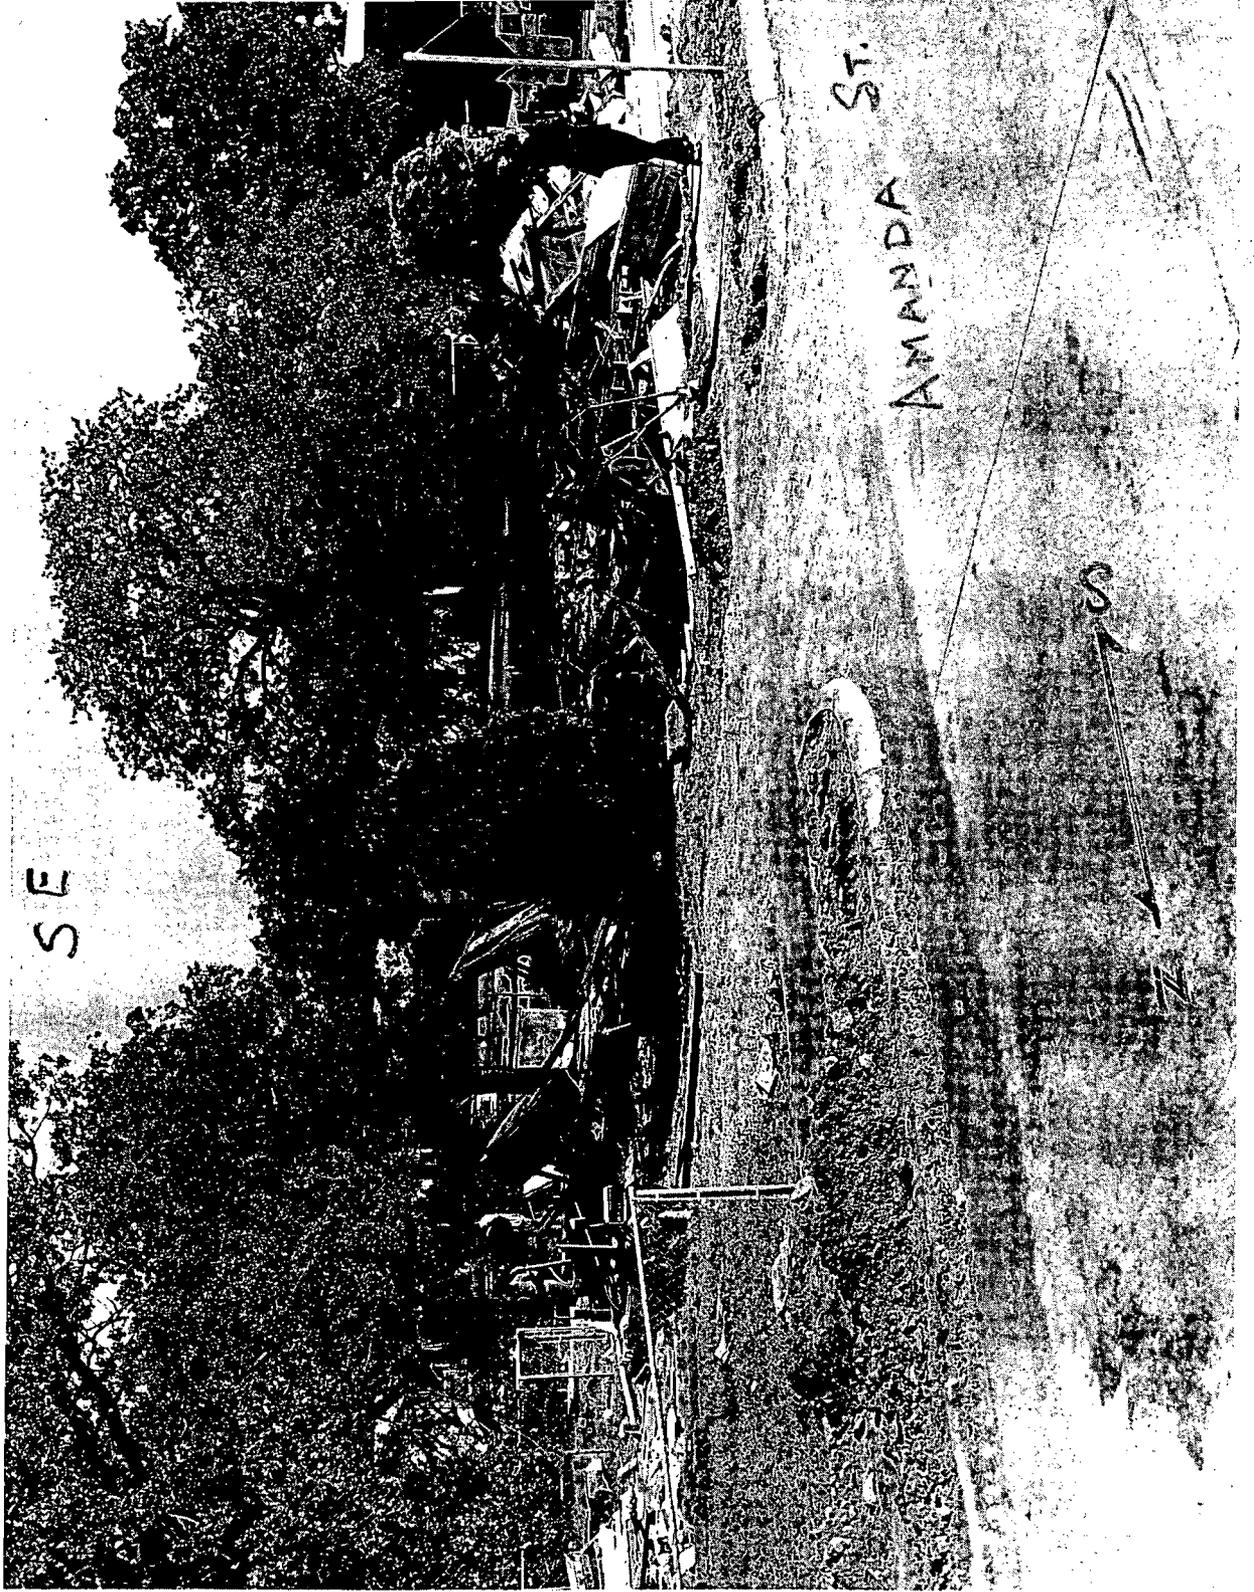
Shortly before 4:30 a.m. on October 4, a woman, who lived in the single-story frame house at 2109 Amanda Street attempted to light a gas stove. An explosion occurred which blew the roof off the house, blasted out the four walls, and kindled an intense fire. The roof fell back into the blazing rubble. The woman, who either ran or was blown out into the street, awakened a neighbor. An ambulance was summoned and the woman was taken to the hospital. She survived the accident, but sustained second- and third-degree burns over 50 percent of her body. The house was completely destroyed. No other houses in the area were seriously affected.

Figure 4.—Remains of the house at 2109 Amanda Street.

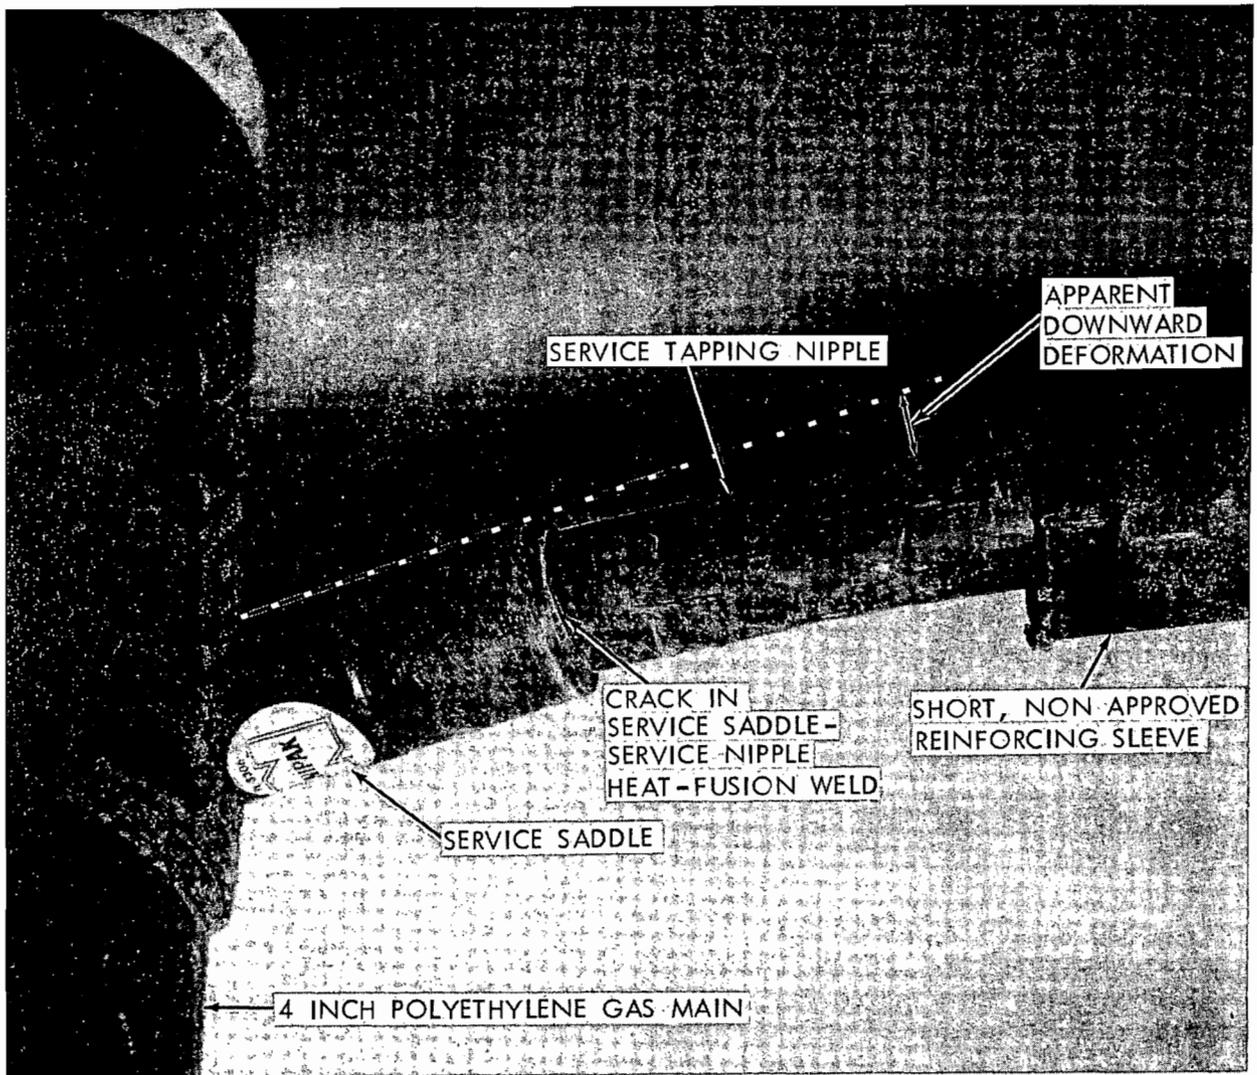
Figure 6.—Broken service saddle-service line connection.

failures were found to resemble each other, i.e., the breaks occurred across the top half of the 3/4-inch plastic pipe, from the 9 to 3 o'clock position at the fusion point between the service saddle and the tapping nipple. (See Figure 6.) When uncovered, each of these failures was found to have been installed with the short, substitute reinforcing sleeve.

The plastic service saddle-tapping nipple connection for the house at 2108 Amanda Street did not have the required reinforcement needed to protect the heat-fusion weld, because the reinforcing sleeve used was too short for the installation. Although Lone Star's construction specifications call for a reinforcing sleeve to be placed over this fused joint, no details are given concerning the length and inside diameter of the sleeve.

Visual inspection by the NBS revealed that the tapping nipples on the service lines to 2108 and 2116 Amanda Street were permanently deformed downward with respect to the crack location. This creep deformation indicated that the nipples had been subjected to high compressive loadings. The reinforcing sleeves which ac-

As a result of the sleeves' being too short, external forces exerted on these connections flexed the fusion welds and were not absorbed by the sleeves.

Examination of all the welds showed that a bead of resin had extended past the end of the nipple near the bottom of the saddle socket on the lines for 2108, 2116 and 2110. The beads from 2108 and 2116 were badly discolored and exhibited evidence of overheating due to higher-than-specified temperature and/or longer-than-specified heating time. The resin bead from 2110 was not discolored, but appeared to have been heated to such a temperature that, when cooled, it shrank and pulled away from the socket wall.

Tests conducted on the beads from 2108 and 2116 showed that the density changed from 0.945 gm/cm<sup>3</sup> (obtained from specimen in another area of the nipple) to 0.95 gm/cm<sup>3</sup>. The polyethylene resin had been thermally degraded with a resultant embrittlement of the weld material. The fact that the resin bead from 2110 shrank and pulled away from the socket wall raises the possibility that either the heating of the joint was improperly performed or that the joint was disturbed after having been set. Because the heat-fusion joint itself at 2108 was poorly made, the resin bead became embrittled and the weld was further weakened.

(a) Revise its plastic pipe construction specifications to include the specific type and size reinforcing sleeve to be used with each type of service saddle-tapping nipple connection. (Recommendation No. P-72-66).
