# PIPELINE ACCIDENT REPORT

SOUTHERN UNION GAS COMPANY

EL PASO, TEXAS

APRIL 22, 1973

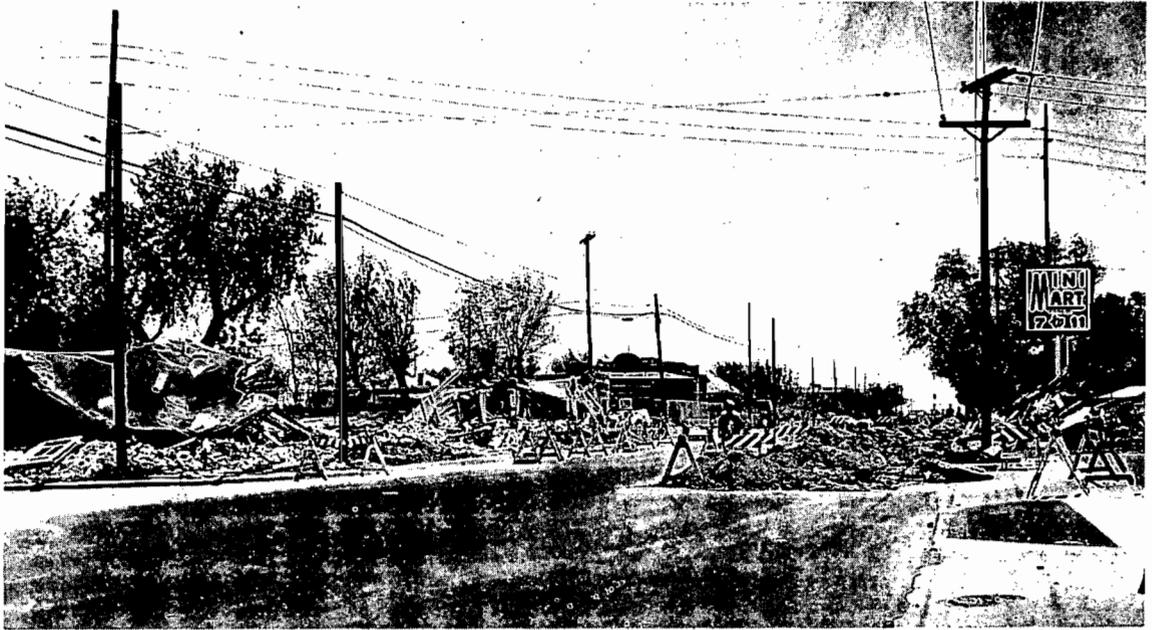
Figure 1. Accident site (picture taken facing south on Piedras Street).

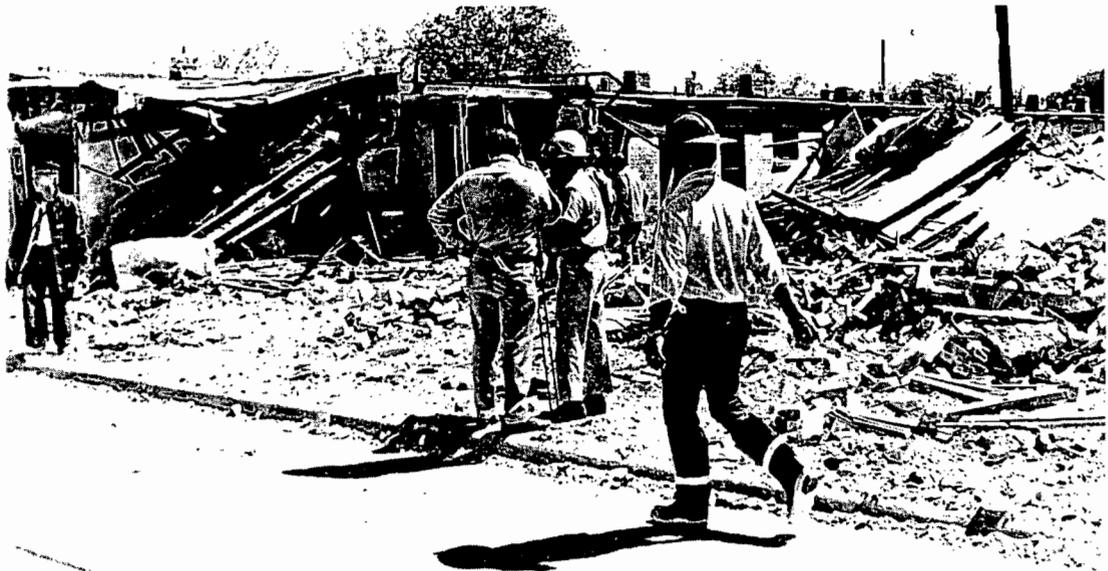
Figure 2. The demolished apartments.

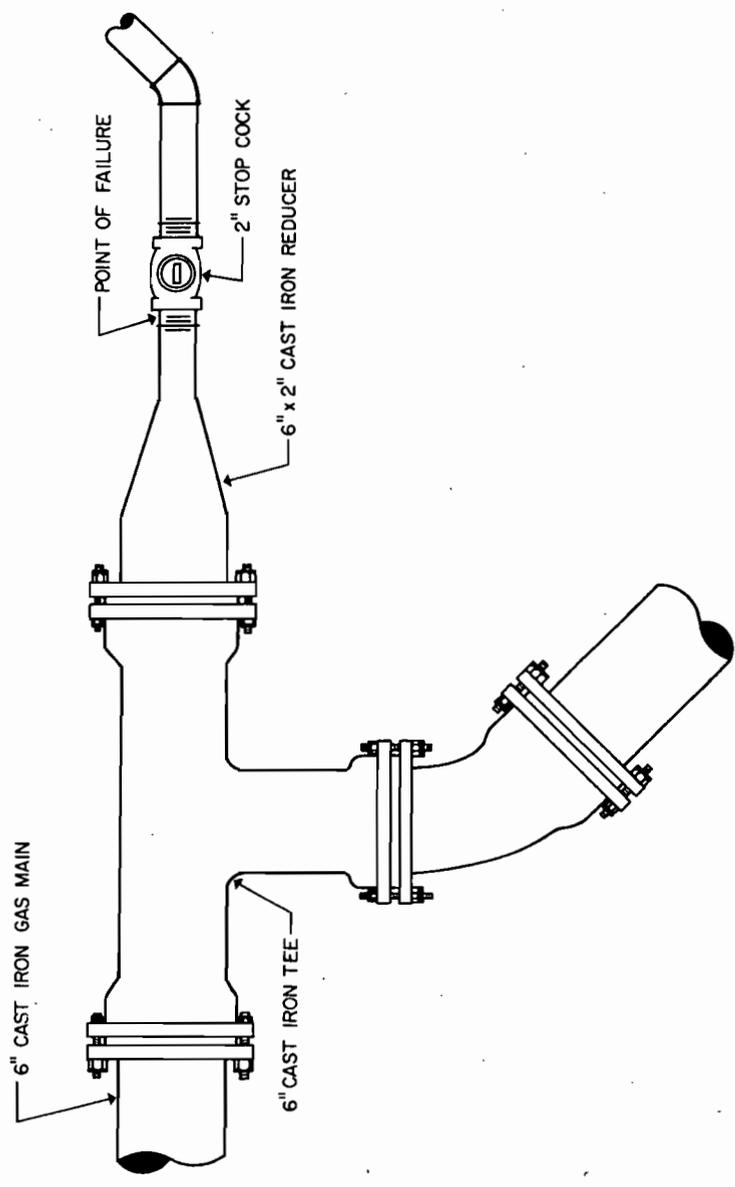
Figure 5. Diagram of failed pipe section.
