PIPELINE ACCIDENT REPORT

MISSOURI PUBLIC SERVICE COMPANY

CLINTON, MISSOURI

DECEMBER 9, 1972

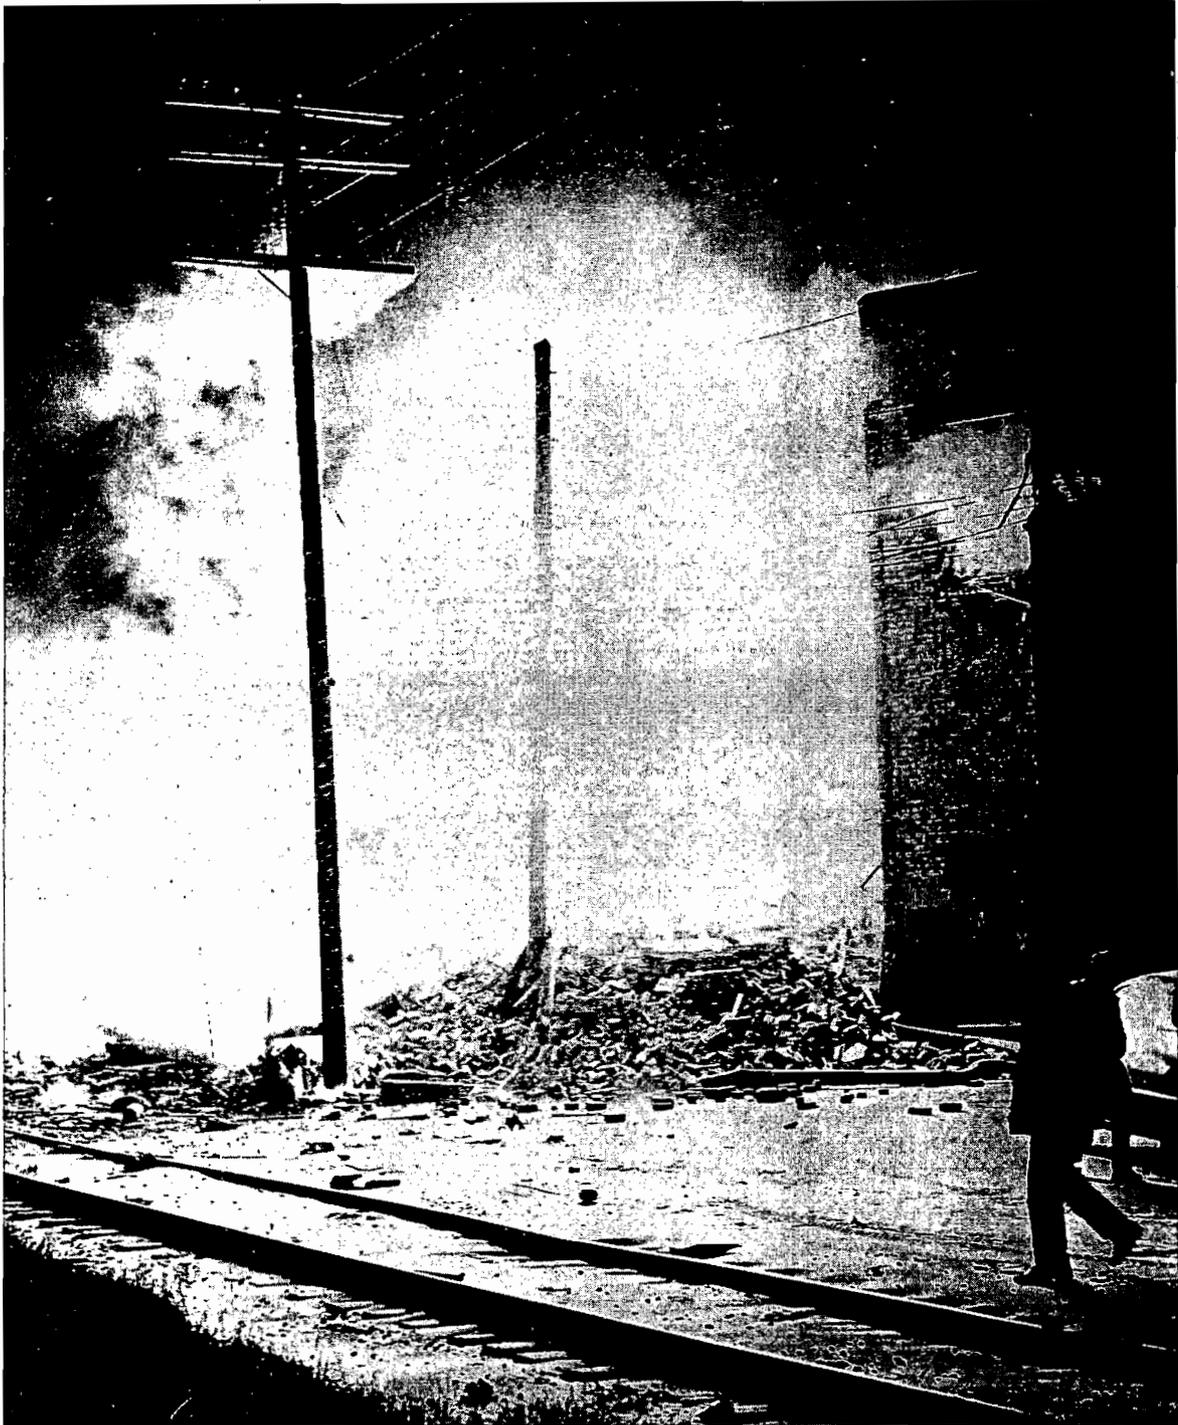
The building was demolished by the explosion; a neighboring building to the north, which was separated from the office building by a 10-foot-wide alley, was damaged structurally and was partially collapsed. (See Figure 2.) Windows were shattered in a 3-square-block area.

Figure 2. Rear of office building in which the initial explosion occurred (shown on left) and neighboring building north across the alley (shown on right).

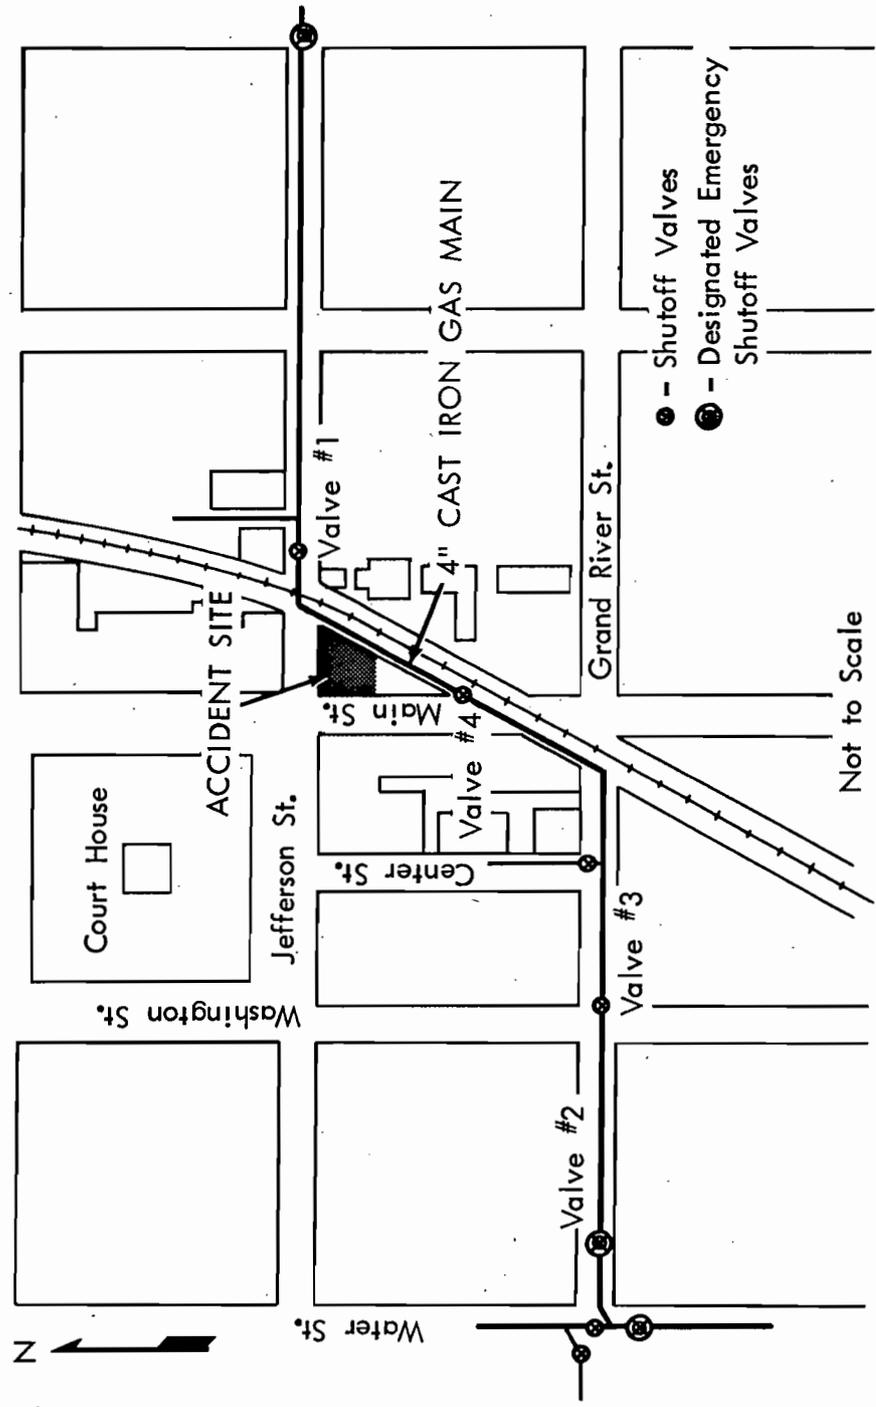
Additional MPS crews were sent to the leak site, along with maps which showed valve locations in the accident vicinity. At 6:30 p.m., one crew turned off Valve #1 on East Jefferson Street east of South Main Street. (Figure 5 shows the locations of the valves at the leak site.) Simultaneously, a second crew was trying to locate and turn off Valve #3 on Washington Street. The search for this valve lasted nearly an hour. The valve, however, was covered by 8 to 10 inches of gravel and frost, and the crew did not have a jackhammer. For that reason, the crew could not locate Valve #3 and had to move instead to Valve #2 on Water Street. They turned off the valve on Water Street at 7:45. Thus, valves on both sides of the leak site were finally shut off 2 hours 40 minutes after the leak report and 1 hour 40 minutes after the explosion. Closing these valves affected gas service to 17 customers.

Only Valve #2 was listed as an emergency valve. Valve #1 was quickly located because it had been serviced shortly before the accident in conjunction with routine maintenance work. The MPS personnel at the leak site did not know of the existence of Valve #4, located in the alley next to the office building, because the MPS maps which had been sent did not clearly show the valve.

Figure 5. Valve locations at the accident site.

After the explosion, MPS crews arrived at the scene to turn off the valves to isolate the leak. They did not proceed to the designated emergency valves, which are inspected more frequently and are probably more readily accessible. Instead, they attempted to locate and operate the valves closest to the leak site. One valve was located and operated quite quickly, but the second, covered by frost and gravel, could not be found. The crew searched for this valve for an hour. Even after this delay, it was necessary to proceed to an emergency valve located farther away from the leak to shut down the failed section.

- (c) Require that designated emergency valves be the valves closed initially when a section of main is required to be isolated in an emergency. (Recommendation No. P-74-18)
