PIPELINE ACCIDENT REPORT

WASHINGTON GAS LIGHT COMPANY

BOWIE, MARYLAND

JUNE 23, 1973

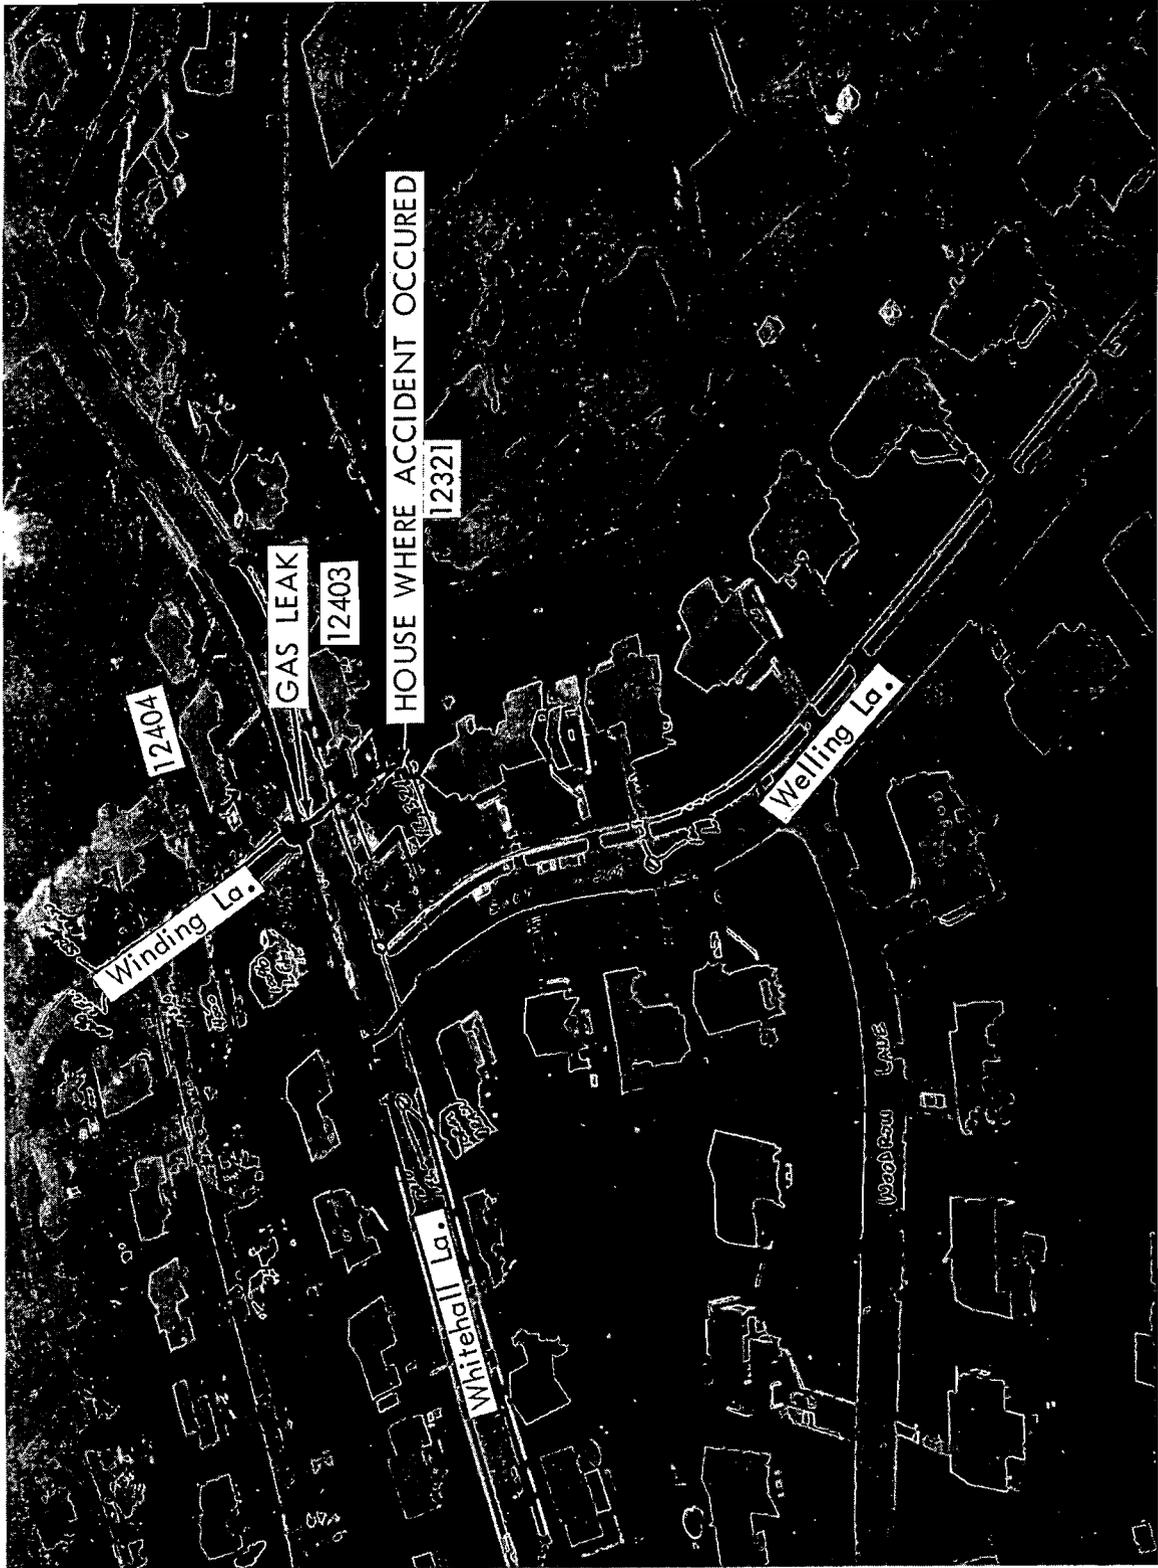
Prince George's County Fire Dep.
Figure 1. Aerial view of accident site showing explosive readings taken after accident.

locations included: Heating ducts in 12435 Winding Lane; bar holes around the water main and water service outside 12435 Winding Lane; the storm sewer along Whitehall Drive and Winding Lane; water meter pits in front of 12321 Welling Lane, 12435 Winding Lane, and 4000, 4002, and 4004 William Lane; and bar holes drilled in the intersection of Welling and Whitehall.

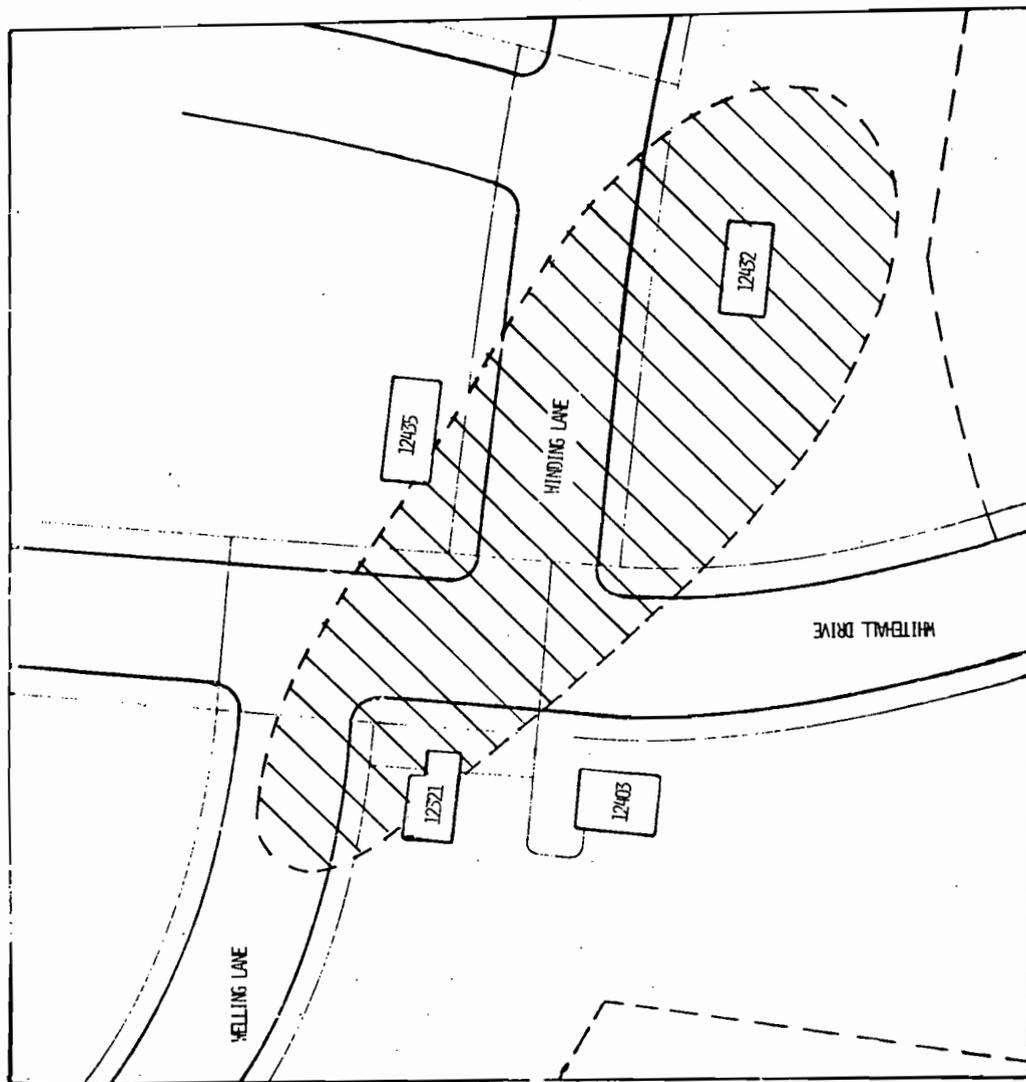
Figure 4. Location of gas reservoir -- indicated by hatching.

The fire department and WGL set up a monitoring system in which combustible gas indicator readings were taken at 184 locations in the area every hour. The frequency of readings was later reduced to every 2 hours. The test points were bar holes in streets, yards, water boxes, and manholes. For 2 months after the accident, WGL continued aspiration of the barholes using air compressors and ventilation of the strata through a number of open cuts made into gas and water trenches to a depth just below the pipe. Although gas concentrations decreased in the soil, the gas did not dissipate as quickly as expected.

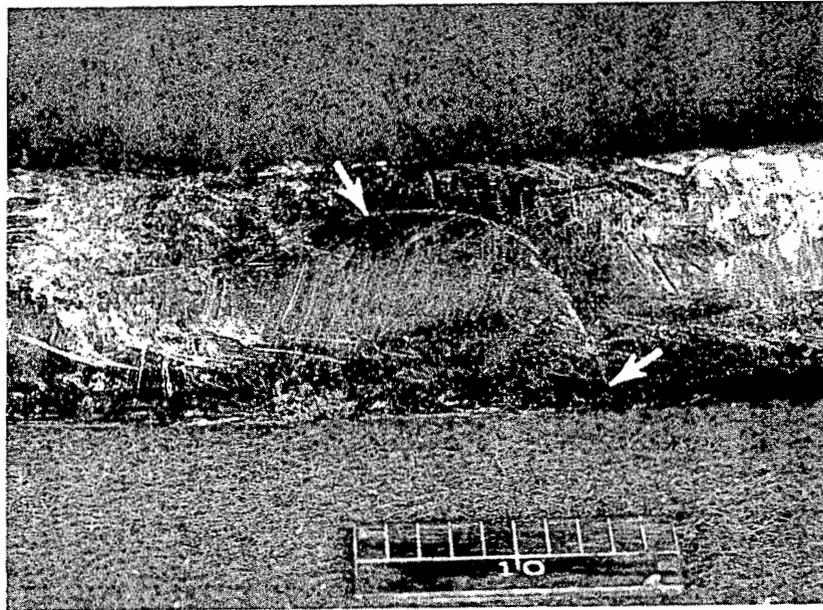
The failed section of plastic pipe was analyzed by the National Bureau of Standards (NBS). The NBS found a 1.5-in. long, J-shaped crack in the pipe. (See Figure 6.) The pipe was found to be visibly flattened just beyond the end of the longitudinal portion of the crack.

Figure 6. Closeup of crack with arrows showing extent of crack on the outer surface of the pipe.

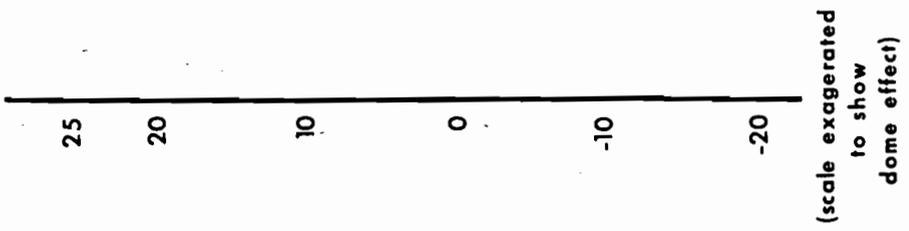
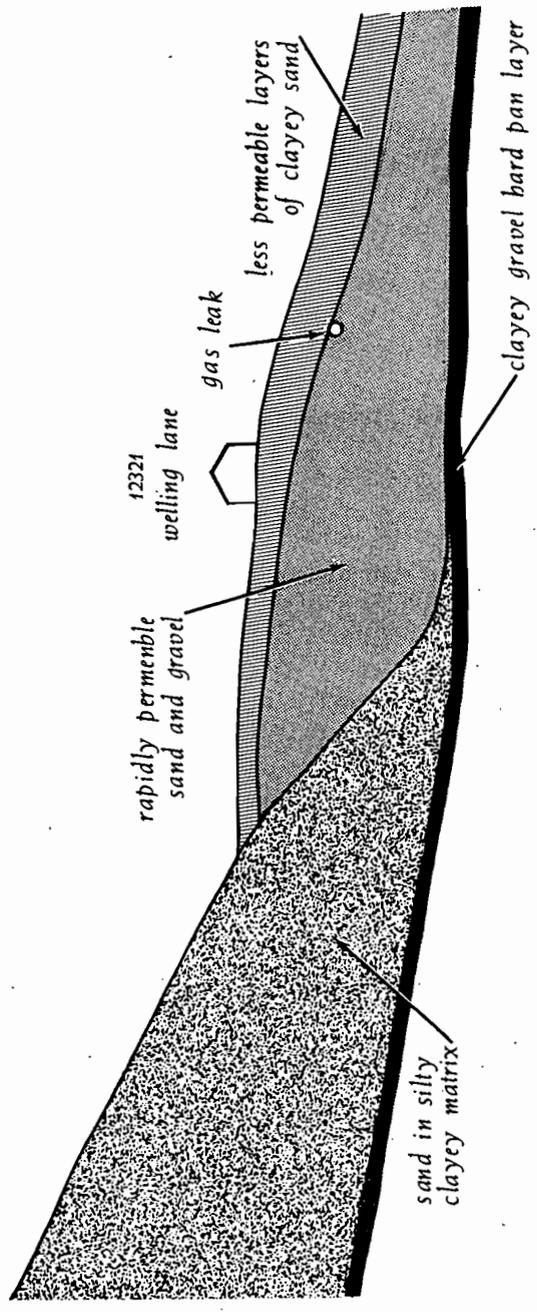
- PROPERTIES OF SOIL FORMATIONS**
-

The gas flowed from the leak and accumulated in the porous sand and gravel and formed a "gas reservoir." The formation was covered by less permeable clayey materials. (See Figure 8.) The heavy rainfall in the days before the accident had a dual effect. First, it caused the water table to rise, which reduced the volume of the gas reservoir and increased the pressure on the trapped gas. Second, the overlying material became wet and relatively impermeable, which sealed off the trapped gas. The increased gas pressure in the reservoir caused some of the gas in the sand and gravel layers to flow through the less permeable soil under the concrete slabs of the two houses; through their heat ducts; registers, and other openings in the slab; and into the houses.
