PIPELINE ACCIDENT REPORT

**UNION LIGHT, HEAT AND POWER COMPANY
NATURAL GAS EXPLOSION AND FIRE
SIMON KENTON HIGH SCHOOL
INDEPENDENCE, KENTUCKY
OCTOBER 9, 1980**

NTSB-PAR-81-1

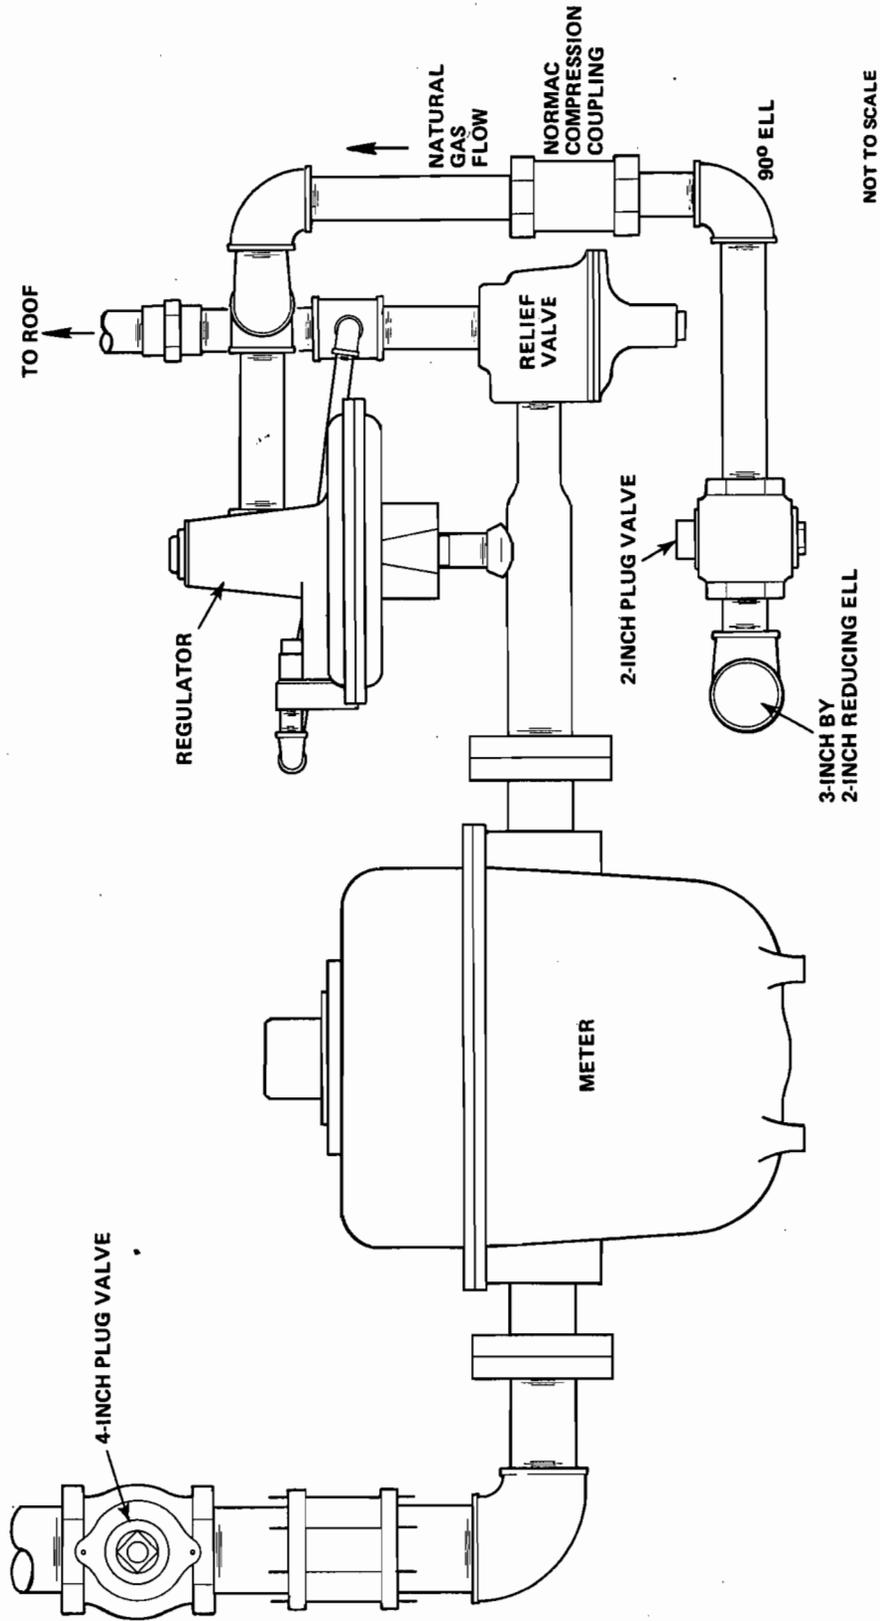
Figure 3.— Gas meter set assembly in boilerroom at Simon Kenton High School.

compression coupling. The meter set assembly was located in the boilerroom near a water heater and a boiler. Ventilation was accomplished by louvers in a window in the outside wall. The boilerroom was located on a lower level of the school which was a half basement. The boilerroom window was located about 4 feet above the floor. The meter set assembly was located by this window and below ground level. The school's service line entered the building through the boilerroom wall about 1 foot above the floor. From the point where it entered the building, the 3-inch-diameter line was reduced to 2 inches in diameter and then connected to the rest of the pipe fittings and components which included the compression coupling, the regulator, the relief valve, and the meter. (See figure 3.)

The increase in pressure on the upstream side of the regulator from 60 psig to 165 psig led to an increase in pressure on the low-pressure side of the regulator from approximately 10 inches of w.c. to approximately 12 to 15 inches of w.c., which is negligible. An increase to 15 inches of w.c. on the regulator's downstream side would not have caused venting because the relief valve located between the regulator and the meter was set at 21 inches of w.c. The only result would have been a slight overfiring of the boiler which probably would not have damaged the boiler, the meter, or the relief valve.

Relief valves are connected to regulators to protect the downstream system from overpressure if regulators fail. With the relief valve set at 21 inches of w.c., or approximately 3/4 psig, the valve was capable of venting 13,500 cfh of gas and, therefore, was capable of handling any failure of the regulator. The flow rate of the escaping gas at 165 psig was estimated to be approximately 10,000 cfh.

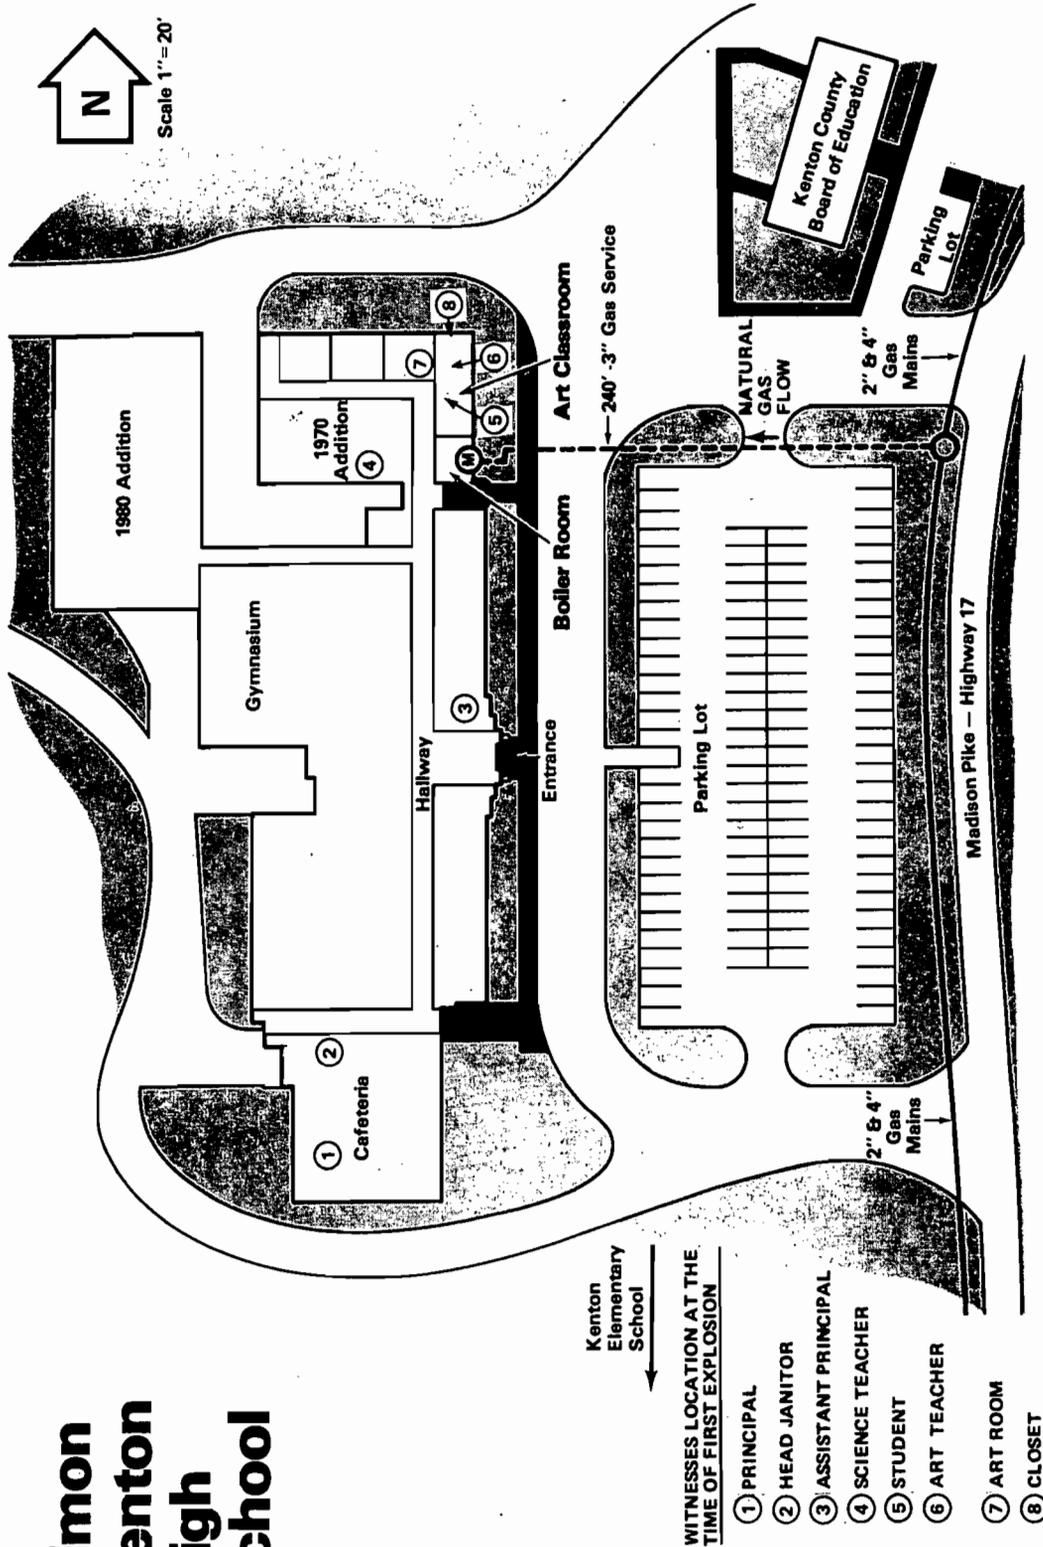
Figure 5.— Plan view of Simon Kenton High School.

At the time of the first explosion, an art class with 12 students and a teacher was being held in the room adjacent to the boilerroom. The teacher and some of the students stated that there was a very loud hissing noise that lasted about 5 seconds before the explosion which blew out the wall that separated the boilerroom from the classroom and caused the only fatal injury. The explosion also showered debris on the other students and the teacher, but no one was injured seriously. (See figure 12.) The teacher and the students left the room through a walk-through closet into another room and escaped through windows within seconds after the first explosion.

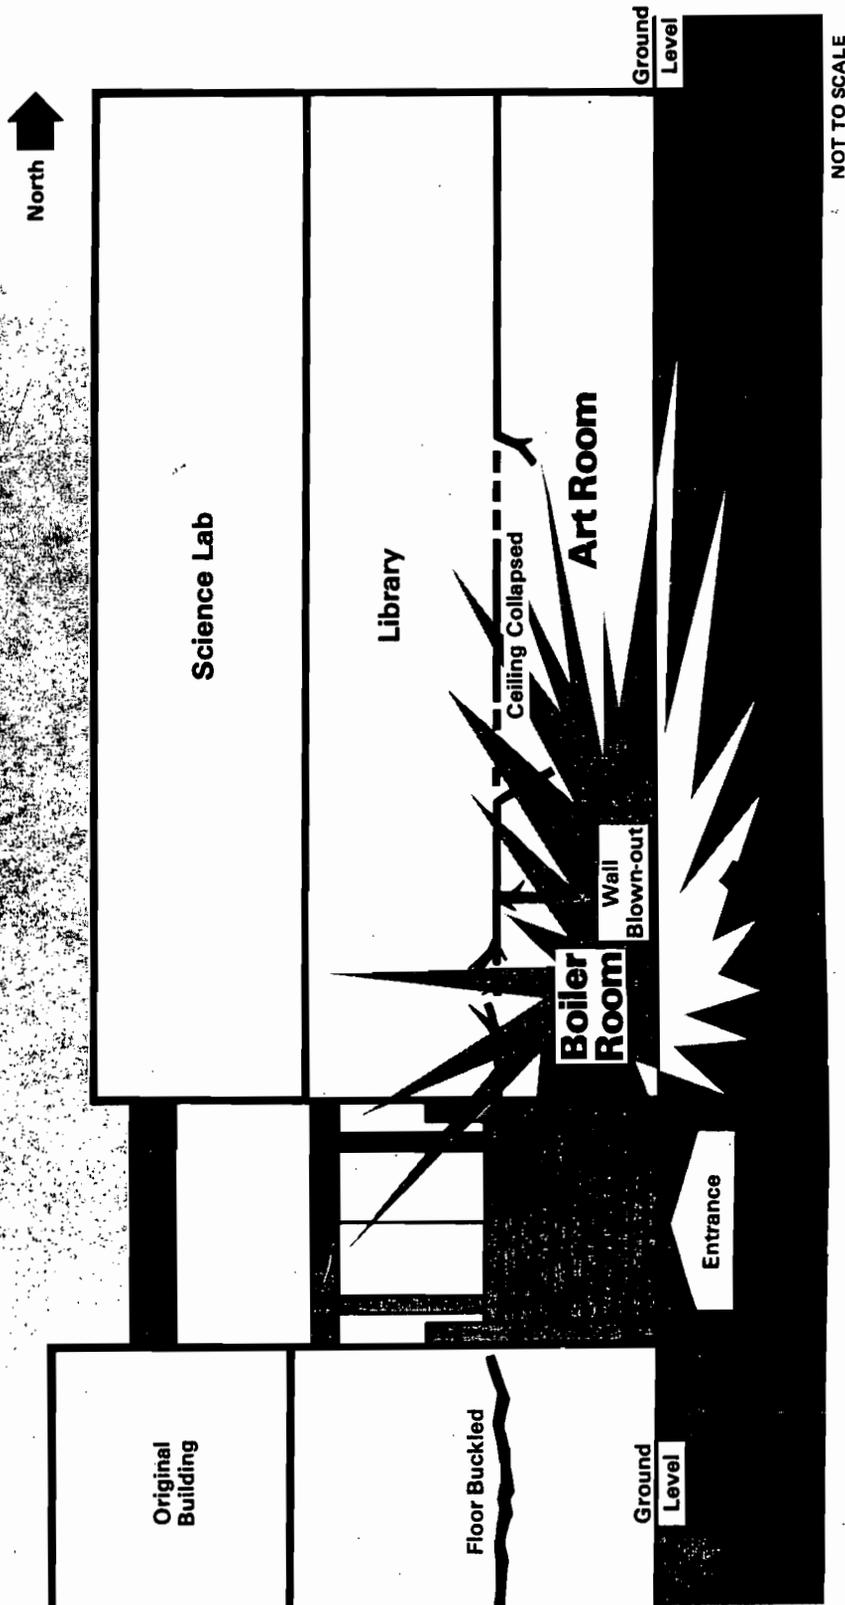
Figure 6.— Partial profile view of Simon Kenton High School showing origin of 11:55 a.m. explosion.

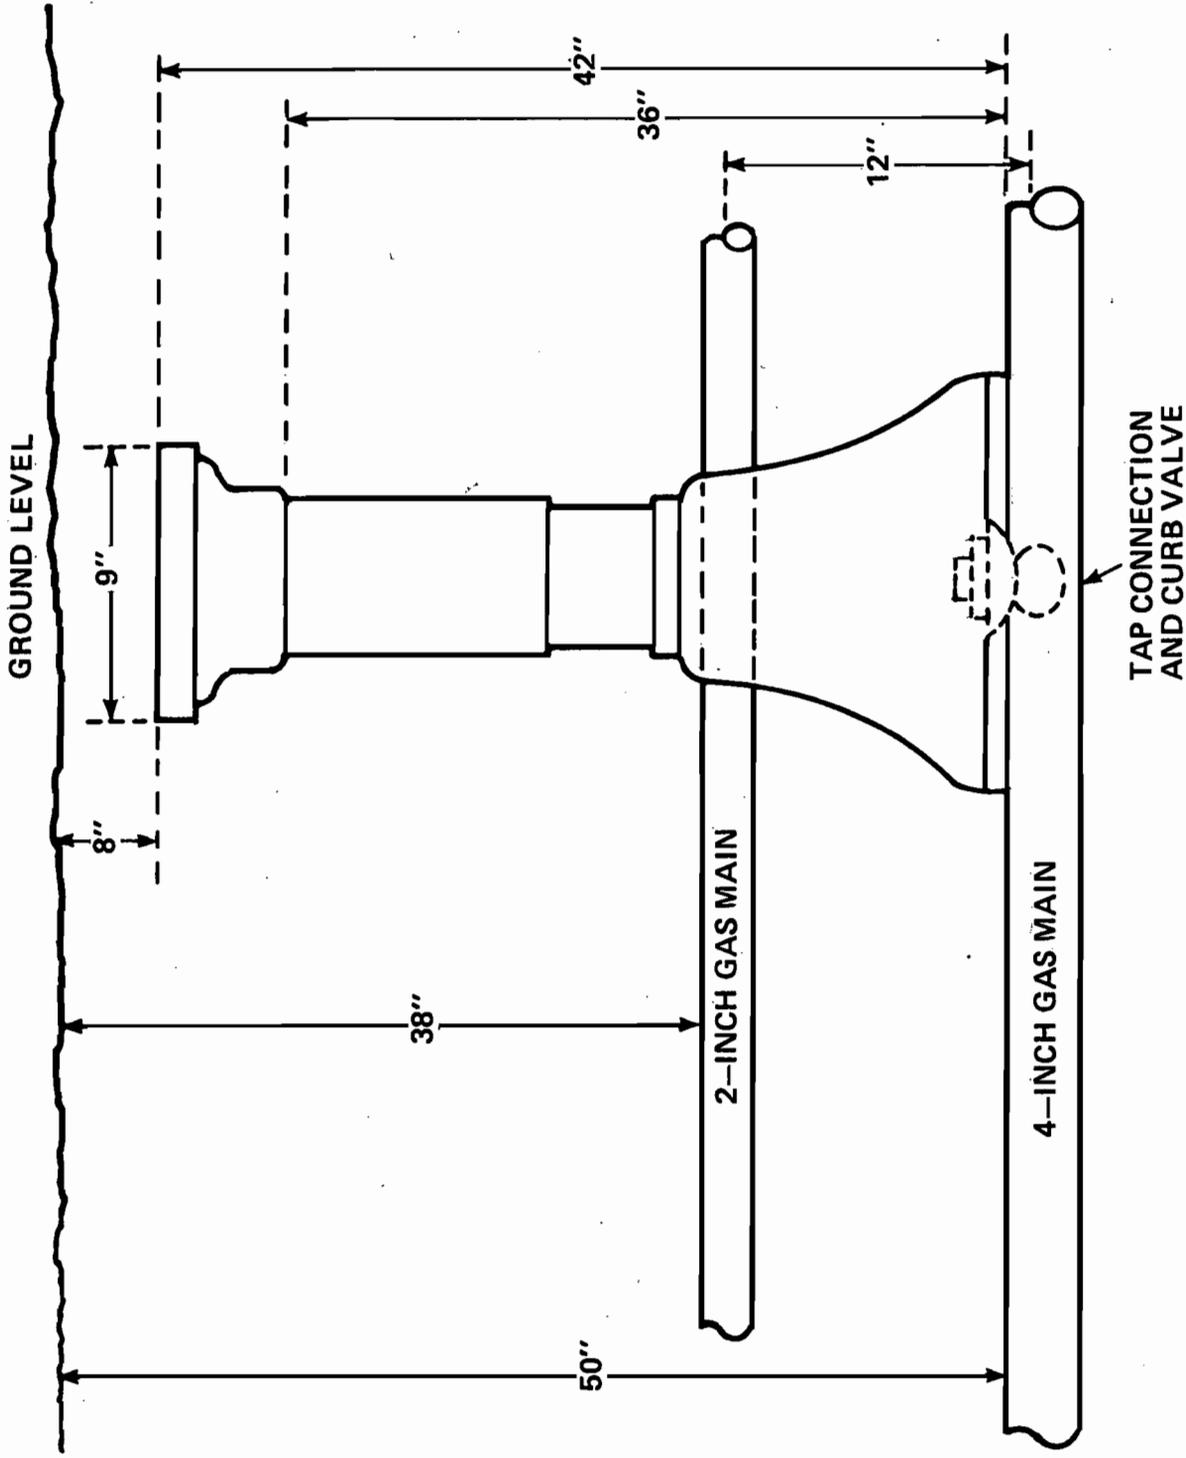
Figure 8.--Profile view of curb valve box assembly.

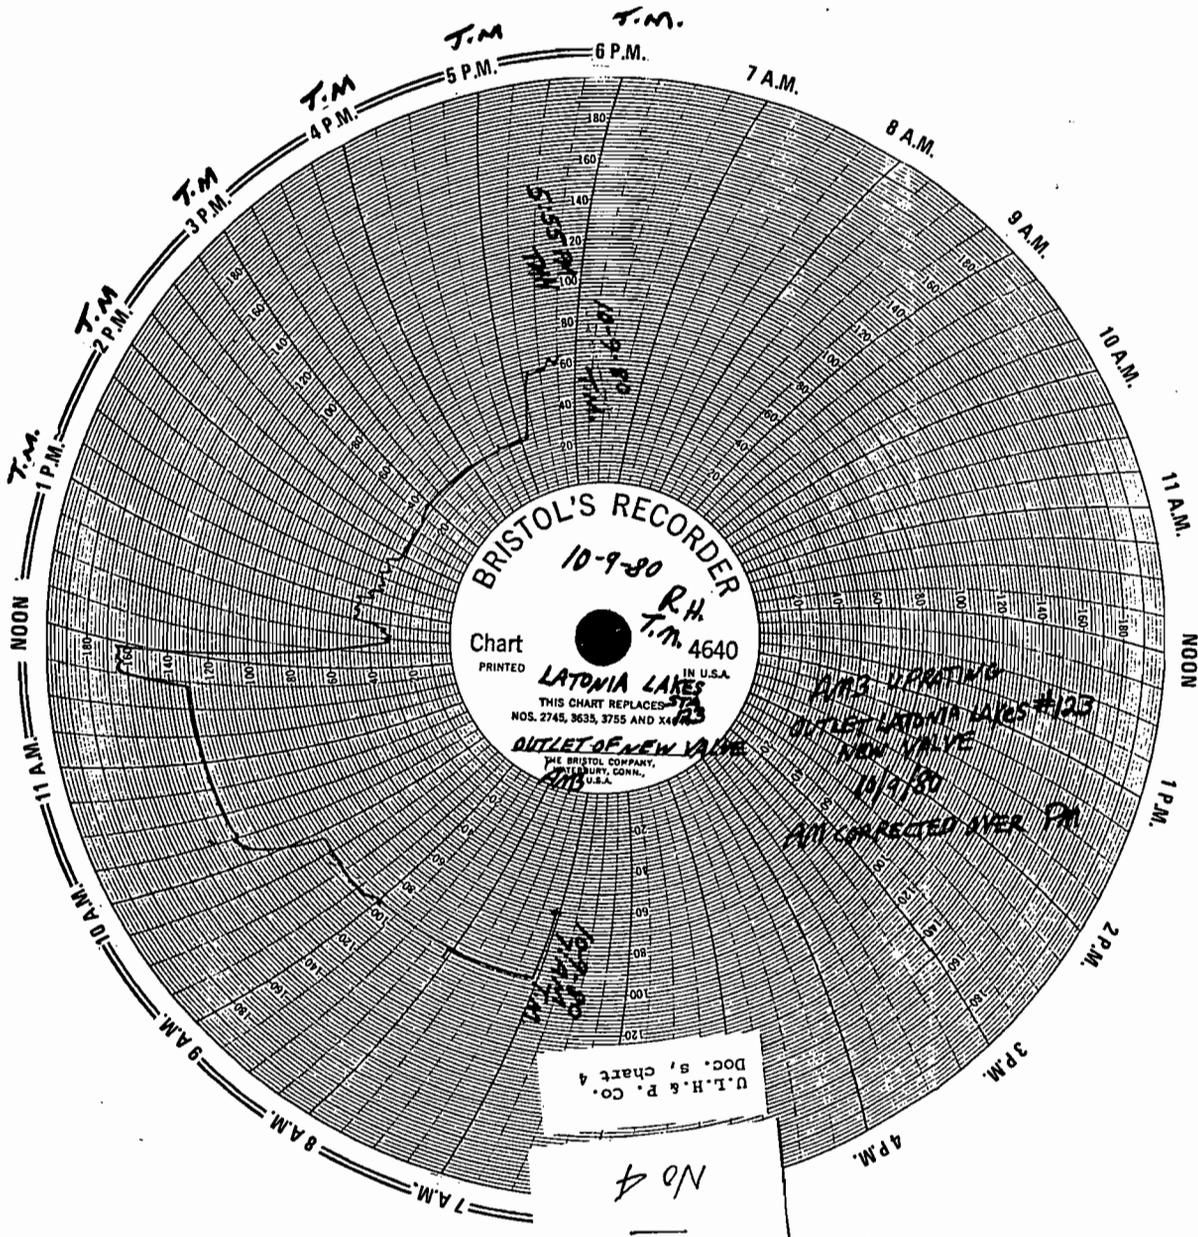
Figure 11.— Pressure recording chart at station 123 throttle valve.

did not turn as time progressed, because it was not tight enough on the chart wheel hub. The chart was therefore advanced by hand to the correct time and tightened at 8:15 a.m. The chart should have indicated a curved line from 7:05 a.m. to 8:15 a.m., similar to the line from 9:55 a.m. to 10:10 a.m.

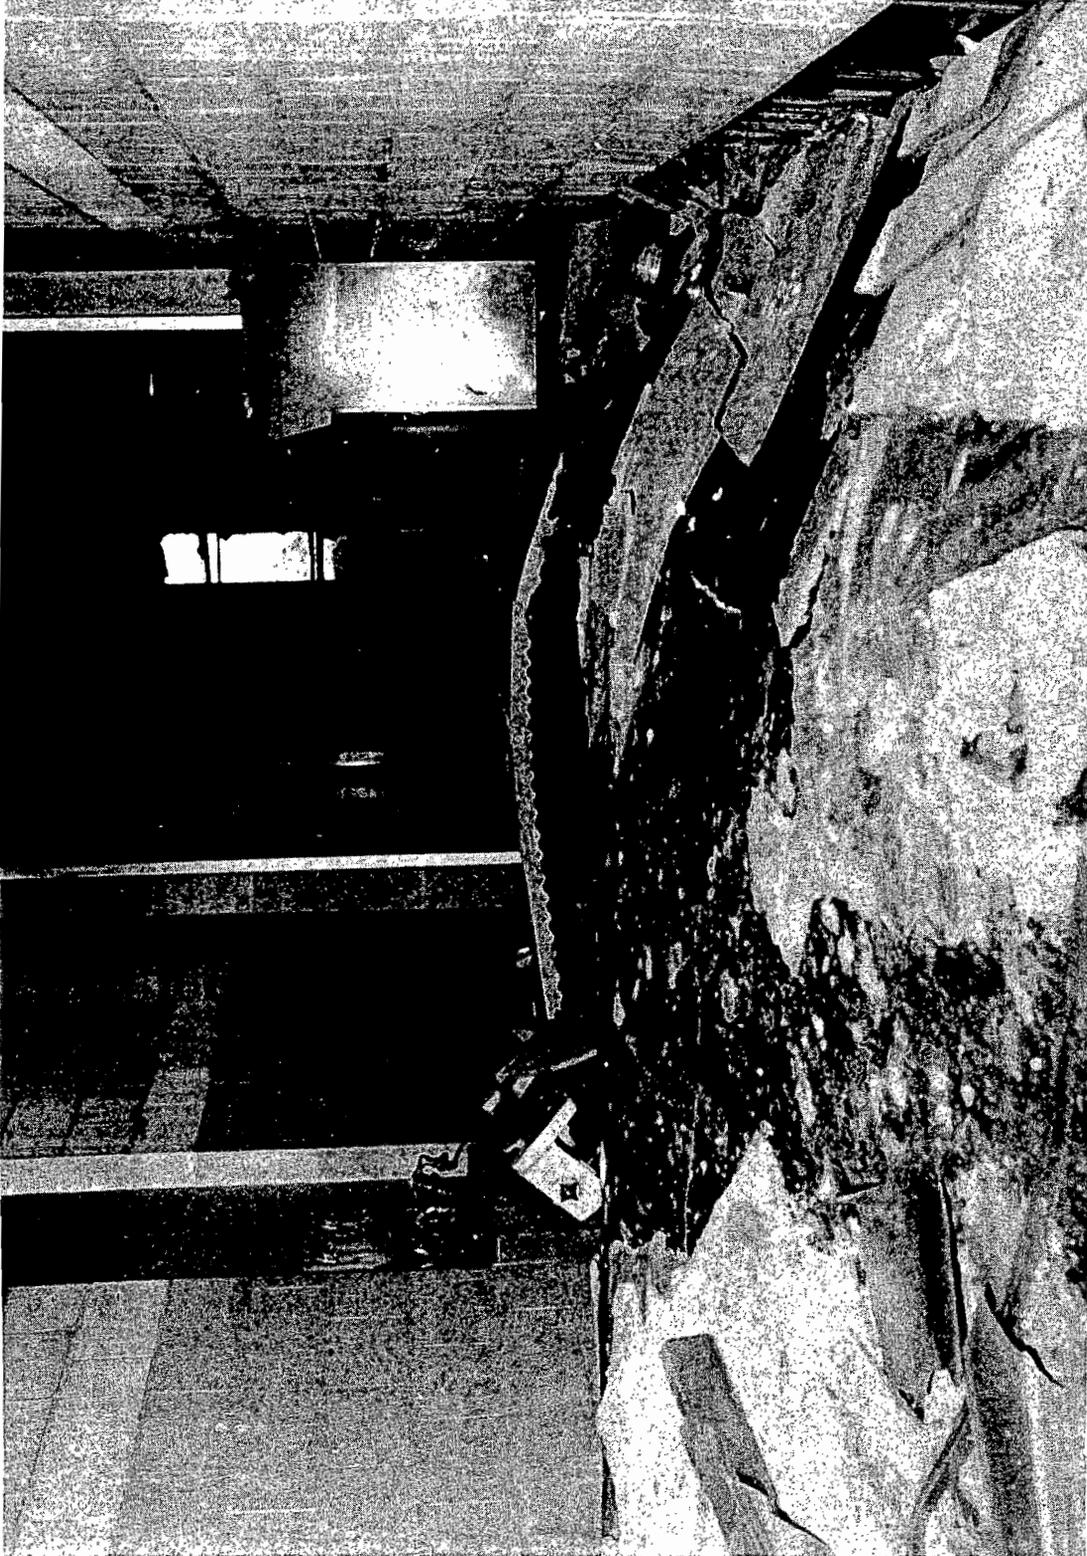
Figure 13.— Damaged upper hall floors in Simon Kenton High School.
