PIPELINE ACCIDENT REPORT

**WILLIAMS PIPE LINE COMPANY
GASOLINE EXPLOSION AND FIRE
ROSEVILLE, MINNESOTA
APRIL 16, 1981**

NTSB-PAR-81-3

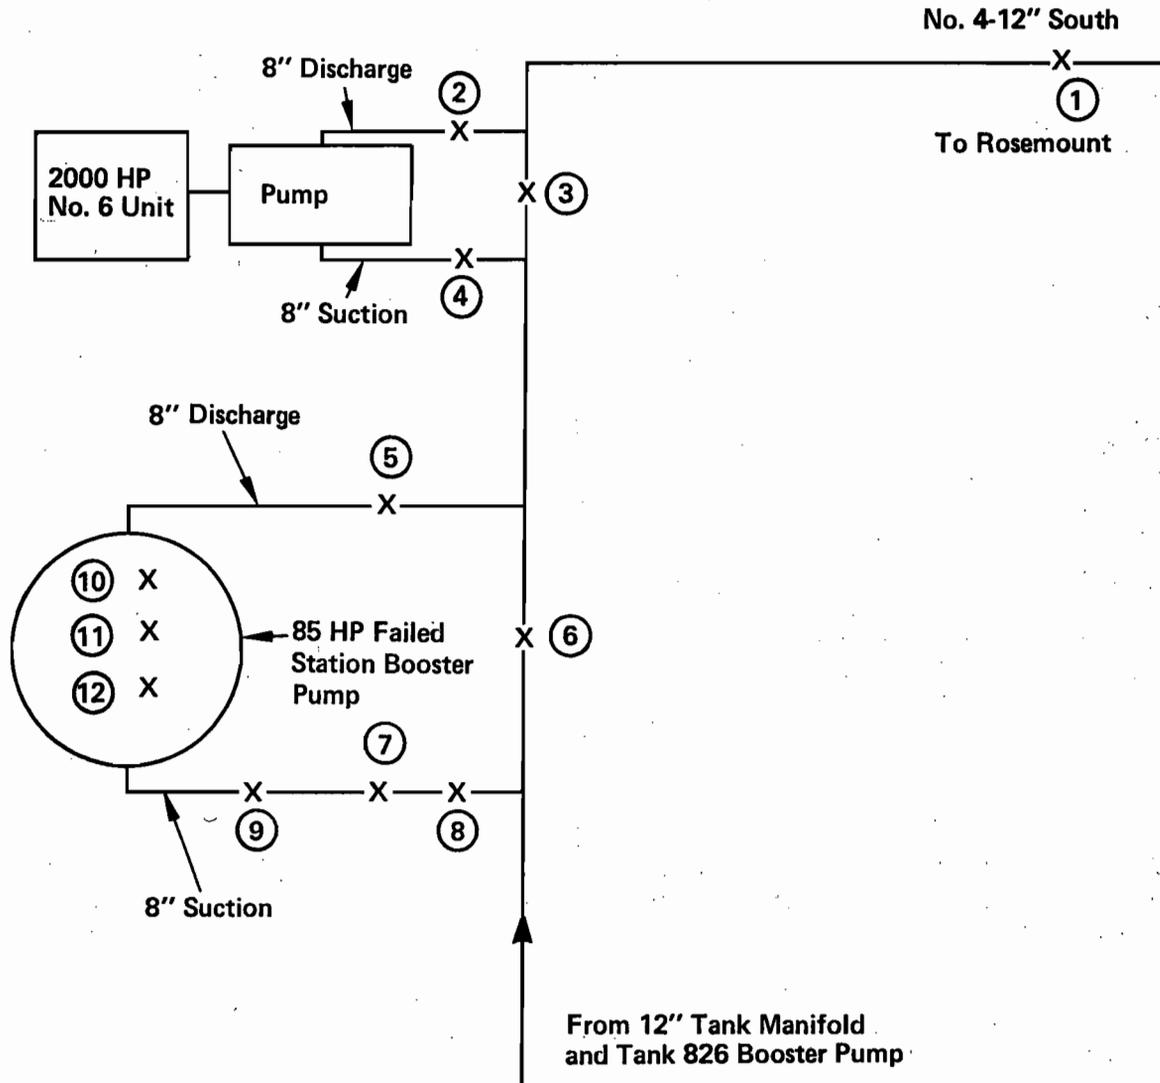
Figure 1.—85-horsepower station booster pump.

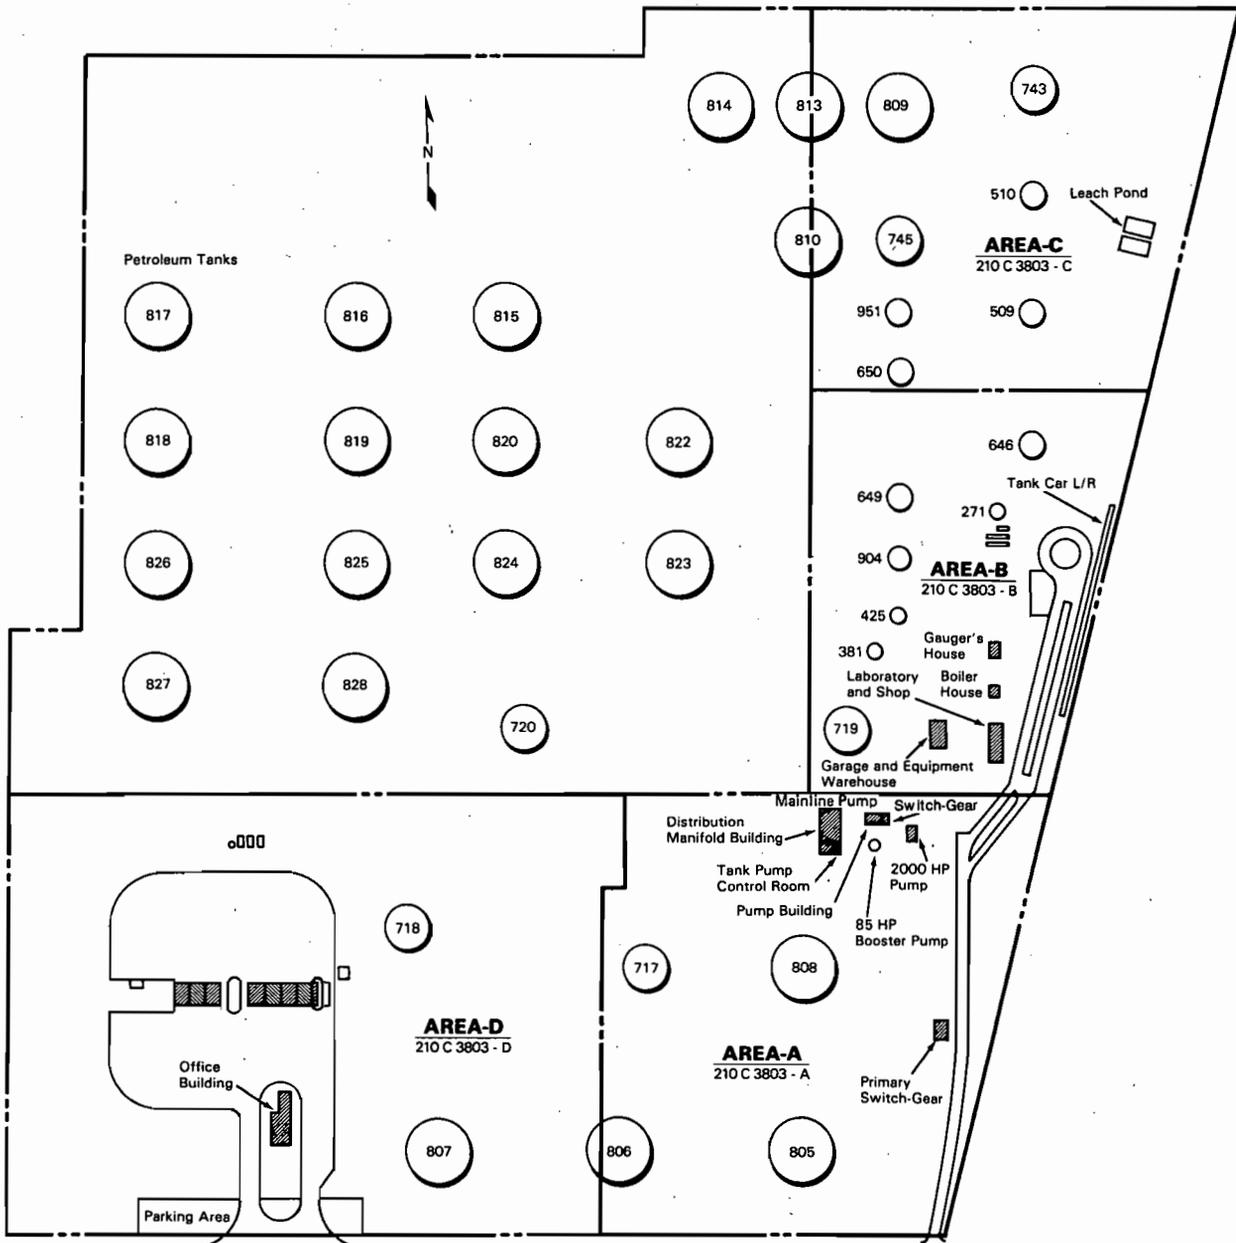
Figure 4.--Minneapolis Terminal.

The gauger ran to the tank pump control room and turned off the booster tank pump being used to supply pressure during the purging. This pump had a capacity of about 1,800 barrels per hour (75,600 gallons), and the gasoline being pumped continued to escape and spray into the air. The gauger then ran to the mainline pump control room, located 50 feet downwind of the ruptured pump, to attempt to shut down unit No. 1, a 400-hp unit, which was the only mainline pump in operation, in order to eliminate any source of ignition. (See figure 4.)

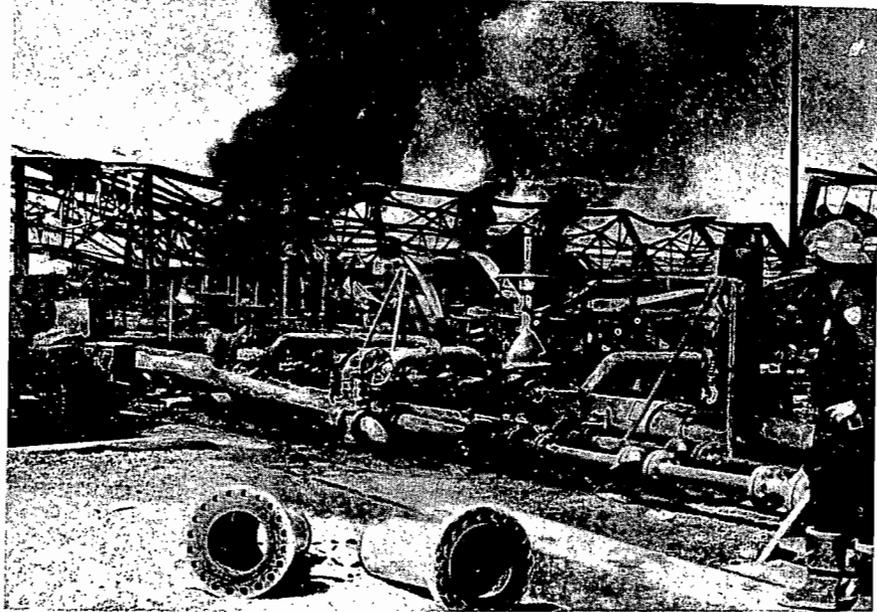
Figure 6.--Booster pump and piping after fire.

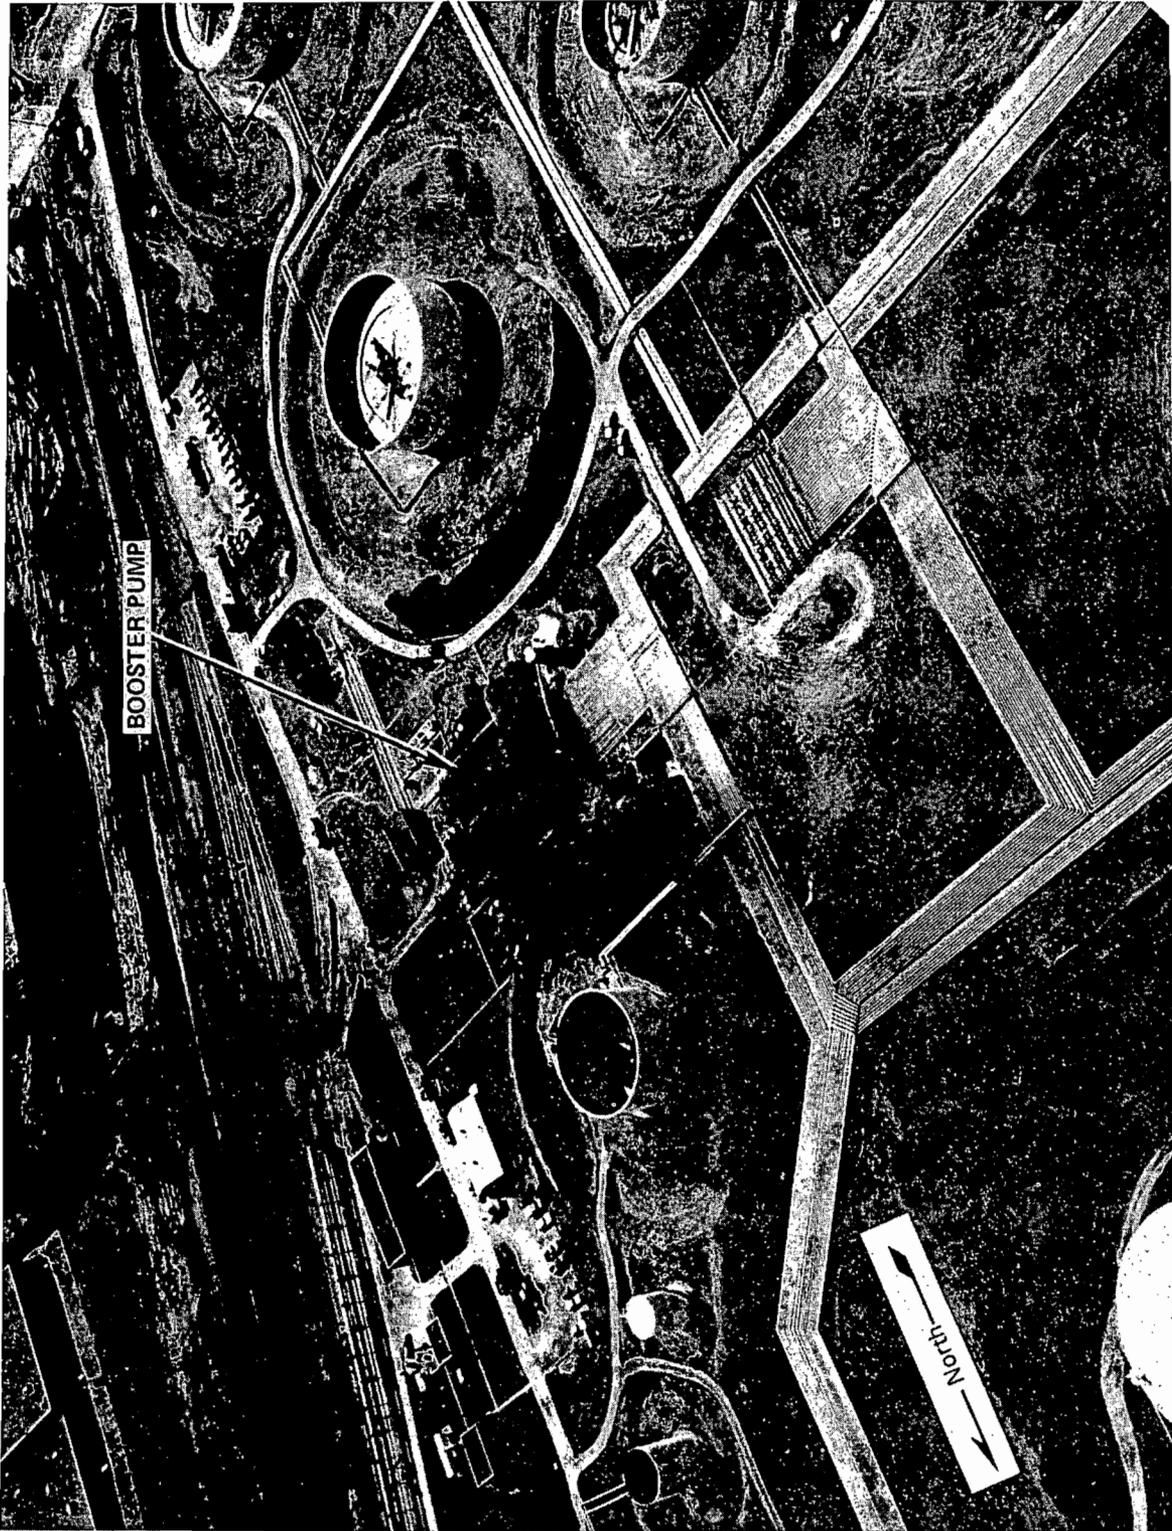
The area damaged by fire covered 20,000 square feet and grass fires extended beyond this area. Although the fire bridged the dikes of several nearby storage tanks, it did not reach the tanks. The largest of the mainline pumps, the 2,000-hp unit, was located only 50 feet southeast of the source of ignition, but winds carried the vapors away from it and prevented damage to it. Two pickup trucks and two vans were destroyed. Total property damage and product loss was estimated at \$3 million. Over 147,000 gallons of fuel oil and gasoline were consumed by fire. (See figure 8.)

Figure 8.--Roseville terminal showing fire damage.

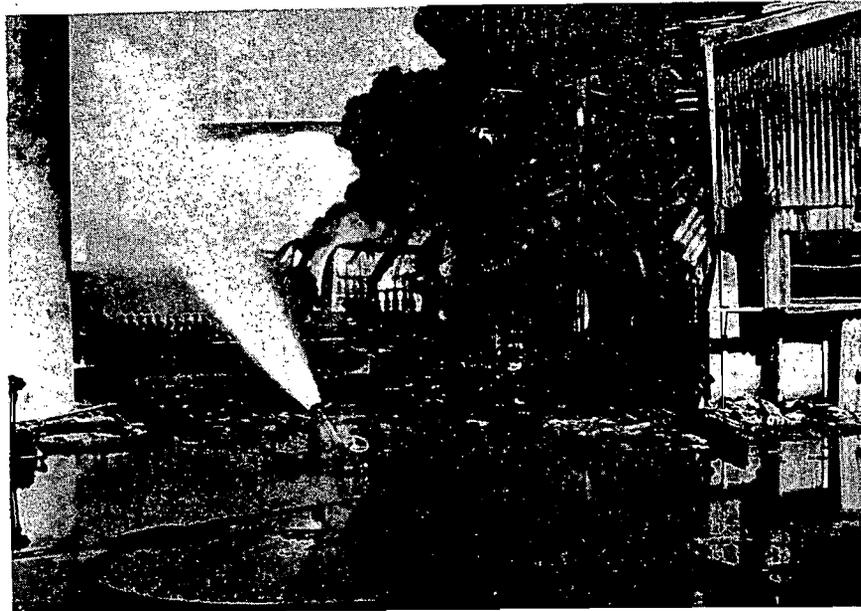
Emergency response was excellent. The Roseville Fire Department was on scene within 5 minutes, at 4:50 p.m. after being notified by AMOCO just after the explosion; 68 Roseville volunteers, some of whom were Williams employees, were joined by units of 6 other suburban fire departments. Traffic control and security were provided by the Minnesota State Police, the Ramsey County Sheriff's Department, the Roseville Police Department, and volunteers. The fire was contained by 6:30 p.m., although it was allowed to burn for almost 48 hours under controlled conditions until all of the gasoline from the draining tank lines had burned. (See figures 10 and 11.)

Figure 10.--Fire at the valve manifold.

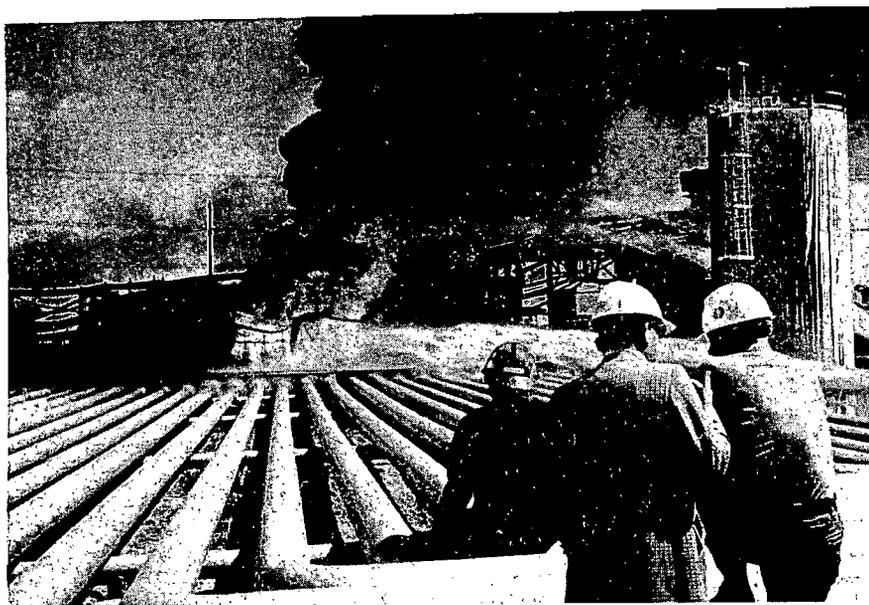
Figure 11.--Tank lines connecting the valve manifold.

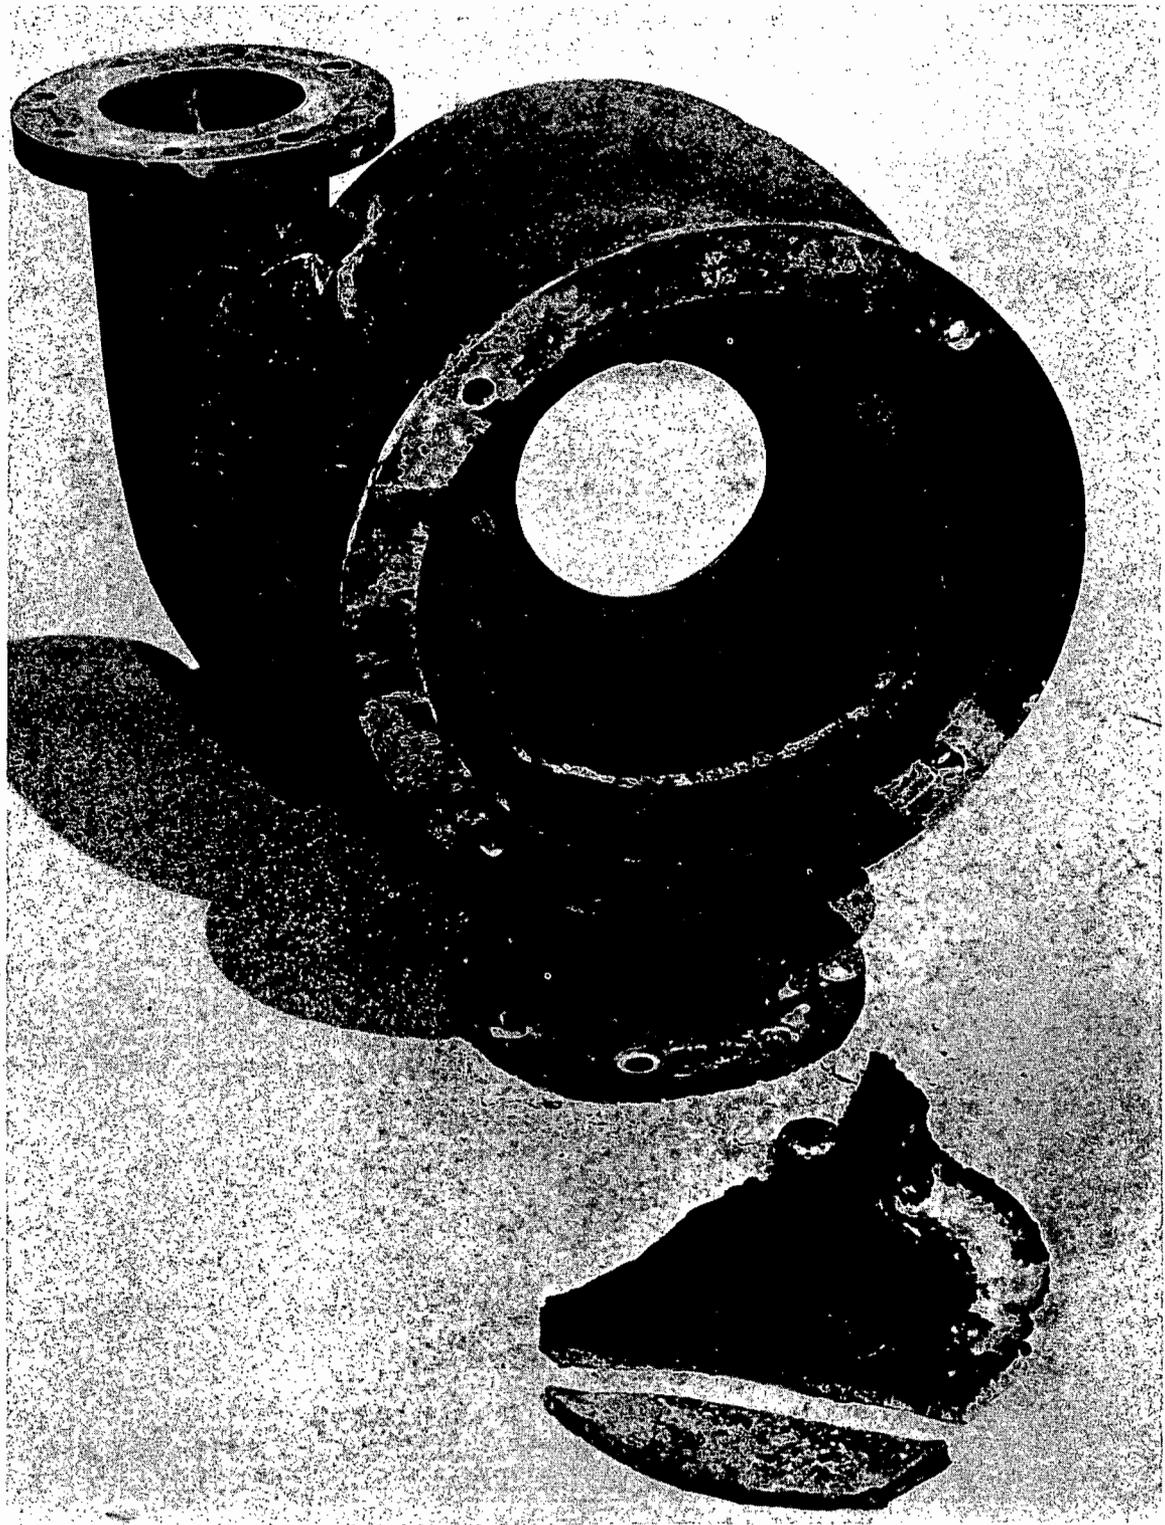
The failure occurred in the bottom of the pump in its suction stage. (See figures 12a, 12b, and 12c.) The Safety Board's metallurgist concluded that since the pump had been tested successfully to 150 psig in 1950 and had been operating about 18 psig until 1976 with no known operational problems up to that time, the failure must have been caused by additional stresses and damage imposed on the pump after 1976.

Figure 12A.--Pump case as received for examination.
The pieces in the foreground broke from the bottom of the case.

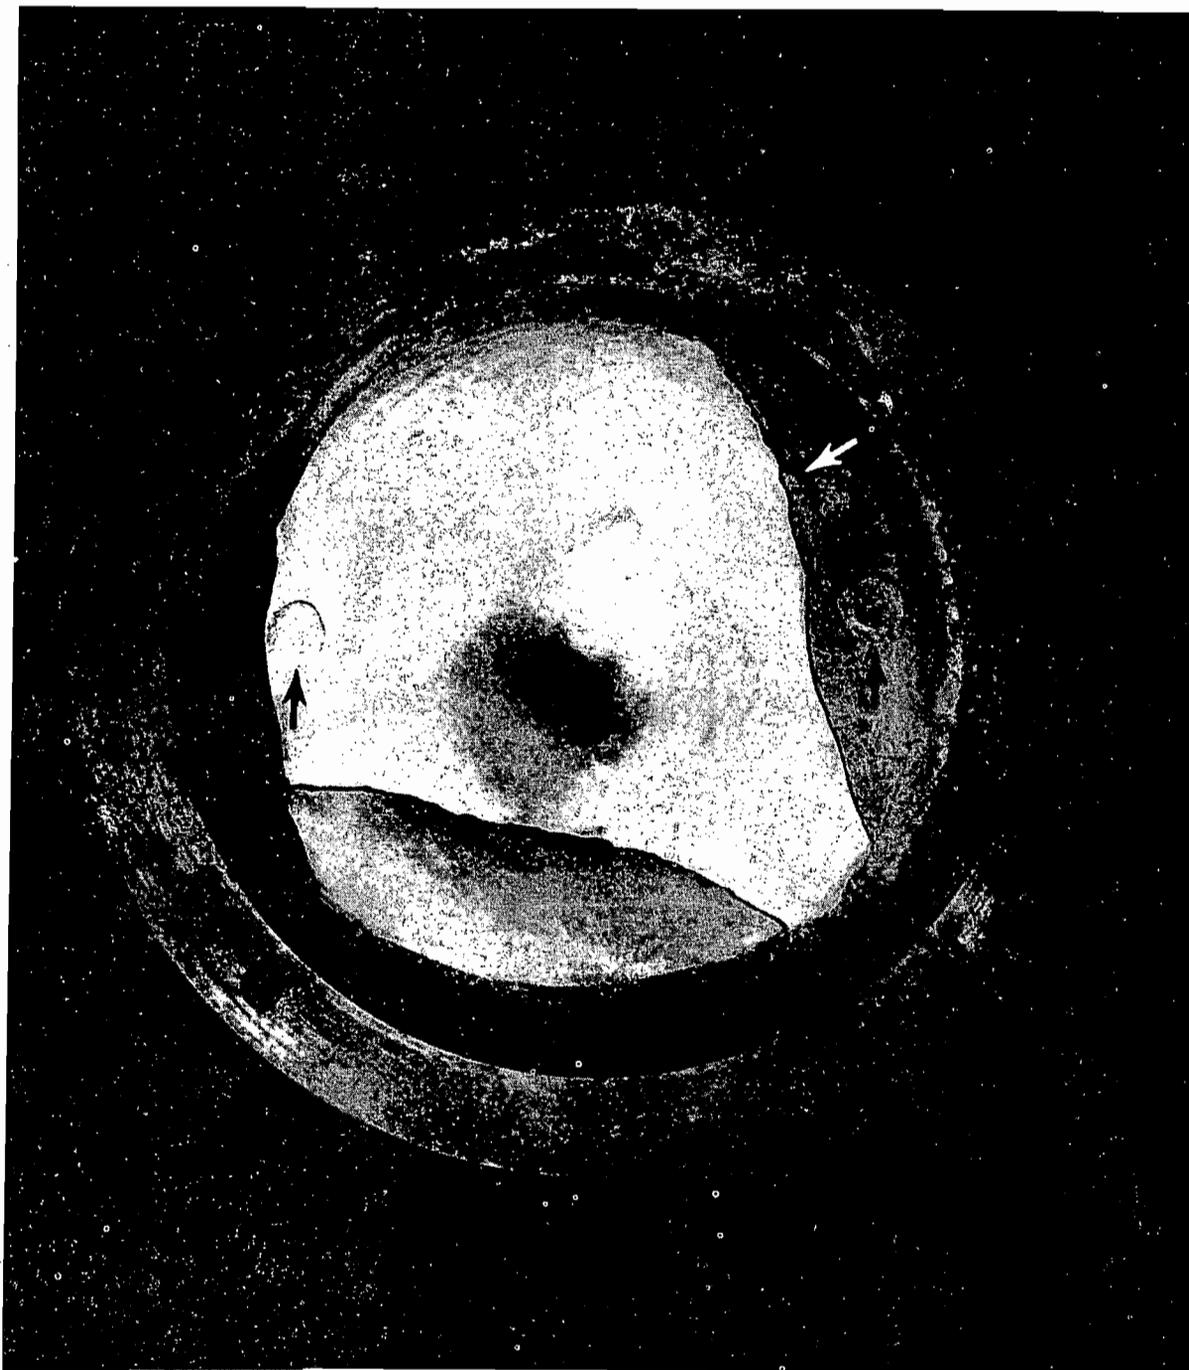
1. The wall thickness of the casting at the measured positions in the fracture varied from a low of 0.350 inch to a high of 0.533 inch. The chaplet size indicates that the design wall thickness of the casting was to be 0.500 inch. ^{3/}

2. Some evidence of porosity (voids in the metal casting) was detected on the casting radiographs and on the sections taken through the fracture area. This porosity may have been caused by free sand in the interior of the mold when the metal was poured.

4. The fracture either initiated at, or progressed through an existing repair made to the casting. The repair had been made by drilling through the leaking area, tapping the drilled hole with threads, and sealing the hole by the insertion of an appropriate size bolt which was then trimmed flush with the casting bottom.

Figure 12B.--Bottom of case with broken pieces in place.
The black arrows indicate what appeared to be chaplets,
the white arrow an apparent repair.

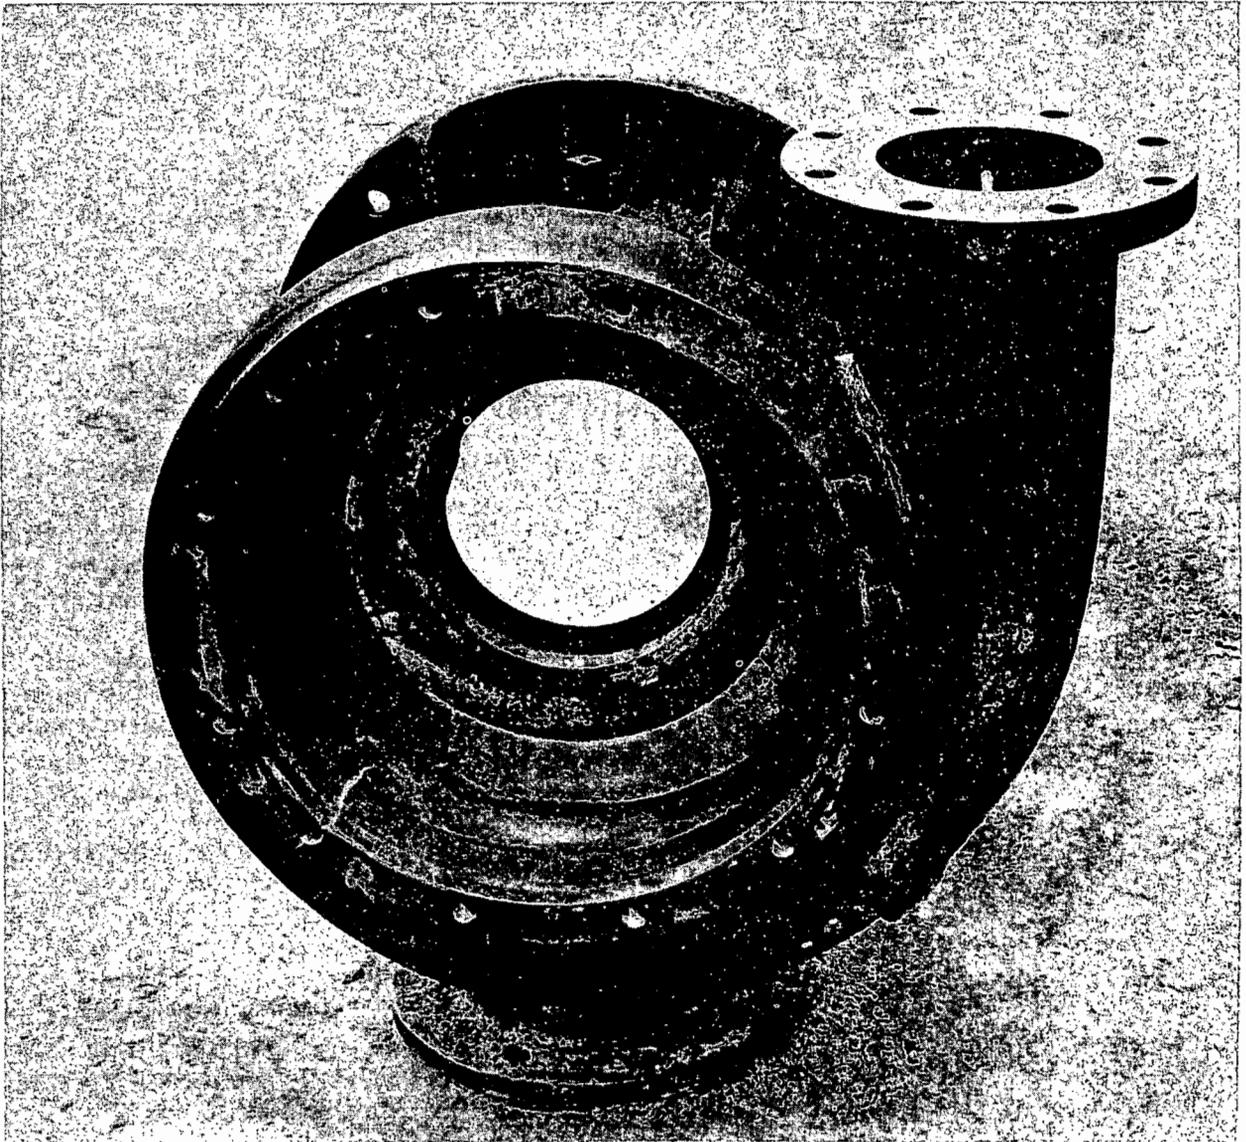
5. Some additional cracks were detected around the bolt holes in the top of the pump case where the motor bolted to the pump. It was not possible to determine whether or not these cracks had occurred when the pump bolts had been damaged before the accident or whether they occurred after the accident as a result of the intense fire.

Figure 12C.--Pump case from top. The arrow indicates magnetic particle indications of a crack.
