Overpressurization of Natural Gas Distribution System,
Explosions, and Fires in
Merrimack Valley, Massachusetts
September 13, 2018

Accident Report

NTSB/PAR-19/02
PB2019-101365

Pipeline Accident Report

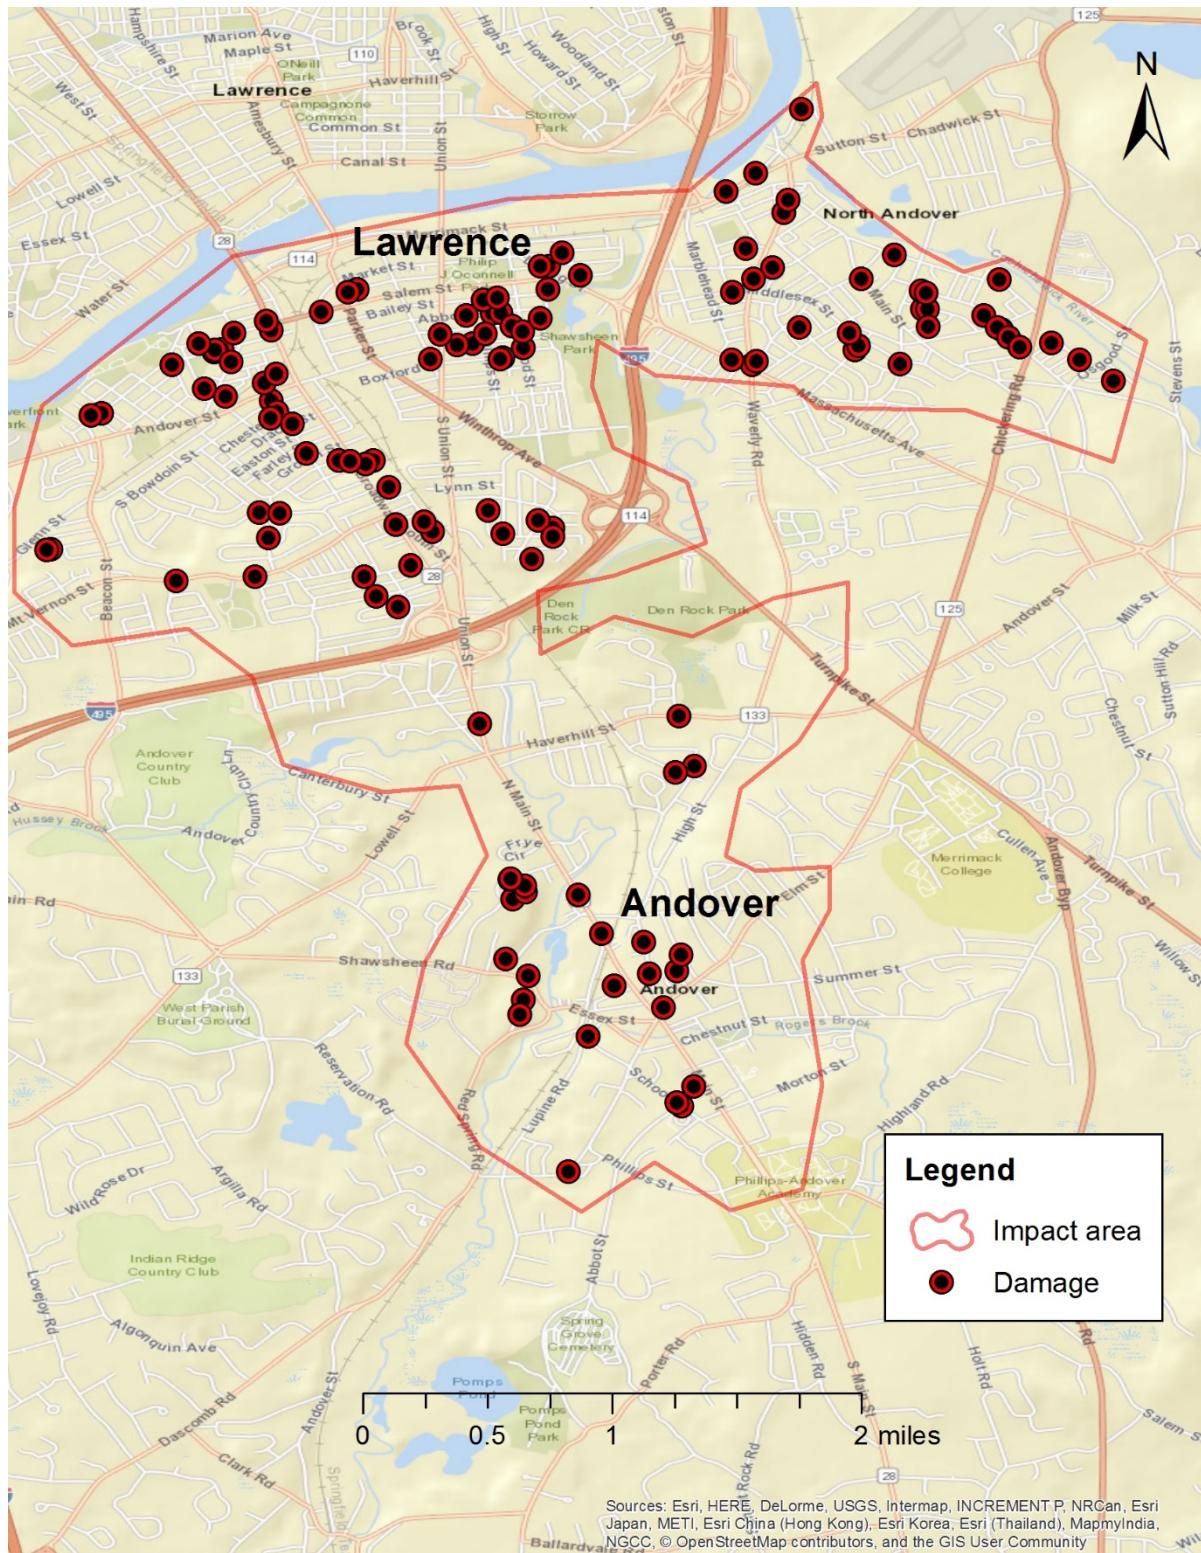
Figure 1. Map of the damaged structures in the area impacted by the overpressurization.

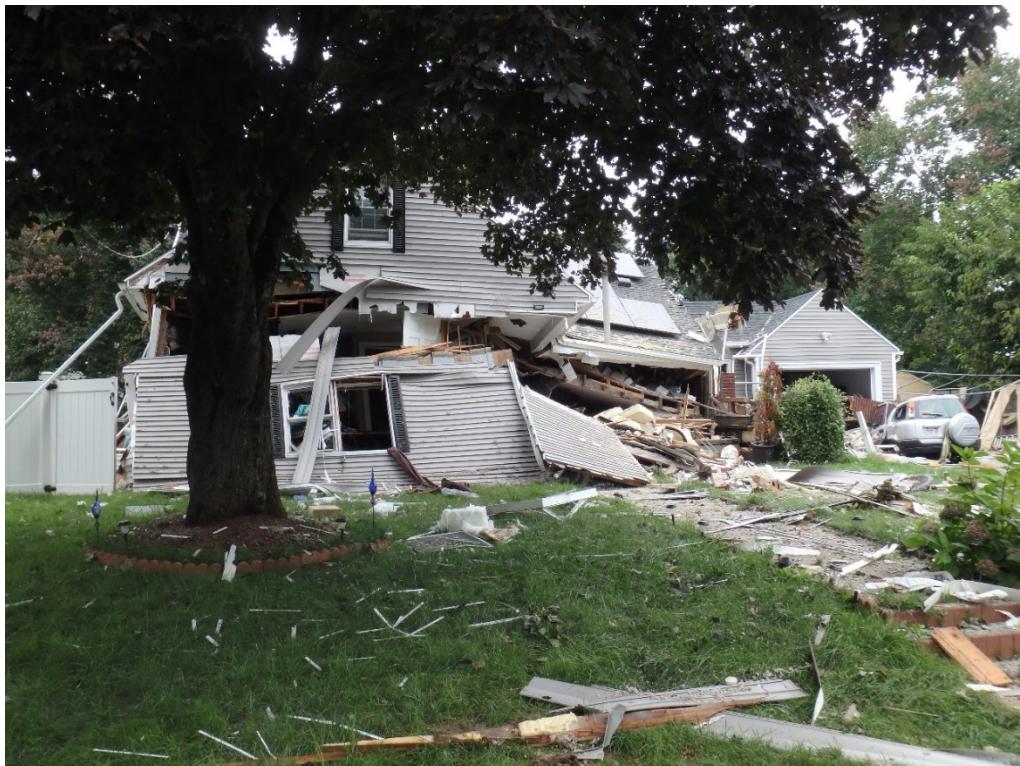
An 18-year-old male was killed when a home exploded, and the chimney fell onto the vehicle where he was sitting. (See figure 2.) Another person in the vehicle at the time of the

Figure 2. Remnants of house where the fatality and two severe injuries occurred.

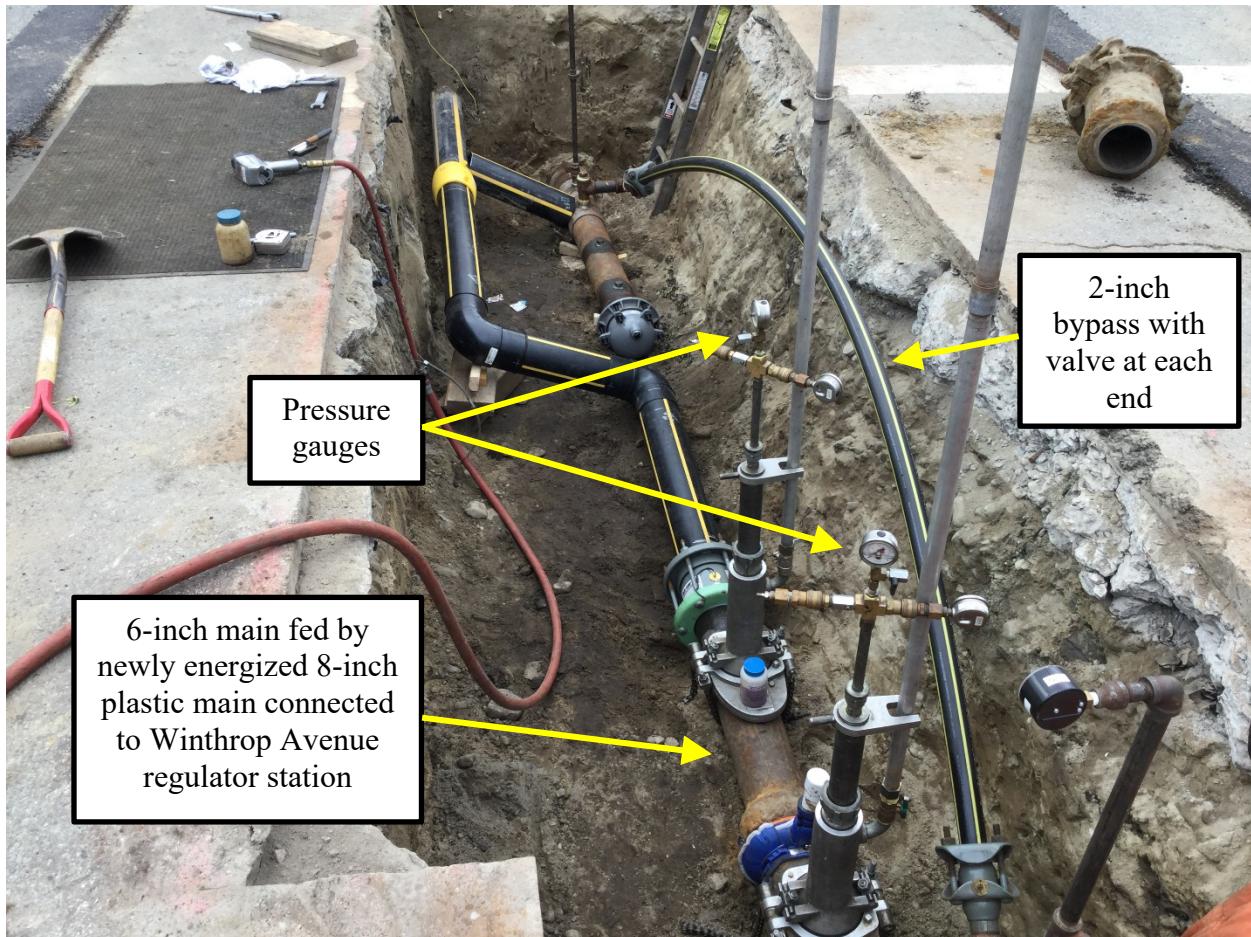
valves on a 2-inch plastic bypass pipe between the cast iron and polyethylene mains.⁸ The crew then cut the bypass pipe to abandon the cast iron main. (See figure 5.) In postaccident interviews, crewmembers said that within minutes of closing the valves and cutting the bypass, they observed the pressure gauge on the polyethylene main exceed the expected readings.⁹ Furthermore, a fitting on the polyethylene natural gas main blew off into the hand of one of the workers. The crewmembers said that they responded quickly to plug the blowing natural gas, and they heard emergency vehicles in the neighborhood and observed smoke plumes in multiple directions within minutes.

Figure 5. Salem Street tie-in for the South Union Street project (looking west). Photograph courtesy of Feeney Brothers.

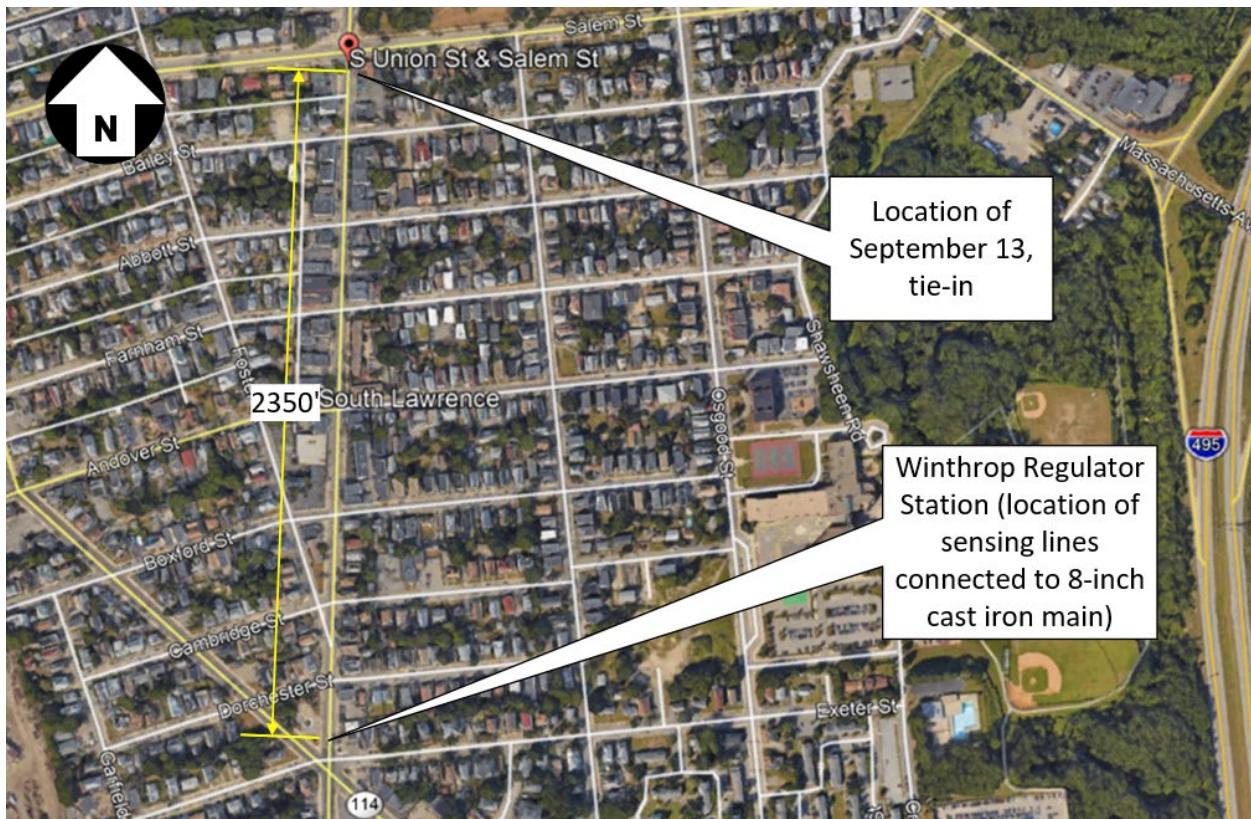
At the Winthrop Avenue regulator station, about 0.5 mile south of the work area, the abandoned cast iron main was still connected to the regulator sensing lines providing input to the two pressure regulators used to control the system pressure.¹⁰ (See figure 6.) Once the contractor

crew isolated the cast iron main, the natural gas pressure began to drop in the cast iron main and in the regulator sensing lines. As the pressure dropped, the pressure regulators responded by opening further, increasing pressure in the natural gas distribution system. Since the Winthrop Avenue regulators no longer sensed system pressure, they fully opened, allowing high-pressure natural gas to be released into the low-pressure natural gas distribution system.

Figure 6. Location of September 13, 2018, tie-in and the Winthrop Avenue regulator station.

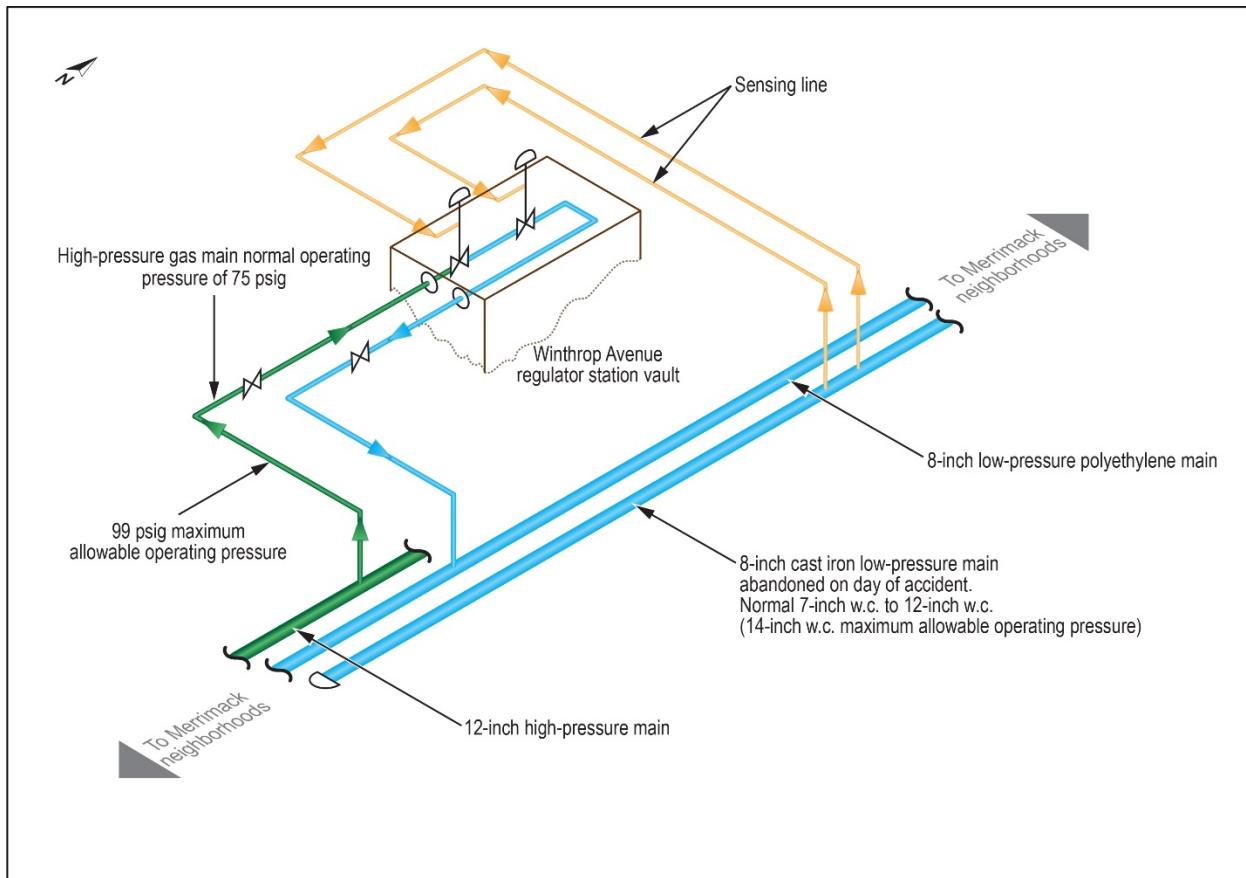
The first stage of the project involved the installation of the polyethylene main, which was completed in late 2016. The regulator sensing lines at the Winthrop Avenue regulator station remained attached to the cast iron main, where they controlled natural gas flow through the Winthrop Avenue regulator station into both the cast iron and polyethylene mains, which were connected in the low-pressure natural gas distribution system. (See figure 8.)

began in 2018 and involved installing the tie-ins to the polyethylene main and abandonment of the cast iron main. On the day of the accident, the sensing lines were still connected to the cast iron main and were functionally disconnected from the distribution system when the cast iron main was abandoned.

Figure 8. The Winthrop Avenue regulator station.
