# PIPELINE ACCIDENT REPORT

LOW-PRESSURE NATURAL GAS  
DISTRIBUTION SYSTEM  
GARY, INDIANA  
JUNE 3, 1969

NATIONAL TRANSPORTATION SAFETY BOARD  
Bureau of Surface Transportation Safety  
Washington, D. C. 20591

**ADOPTED: DECEMBER 4, 1969**

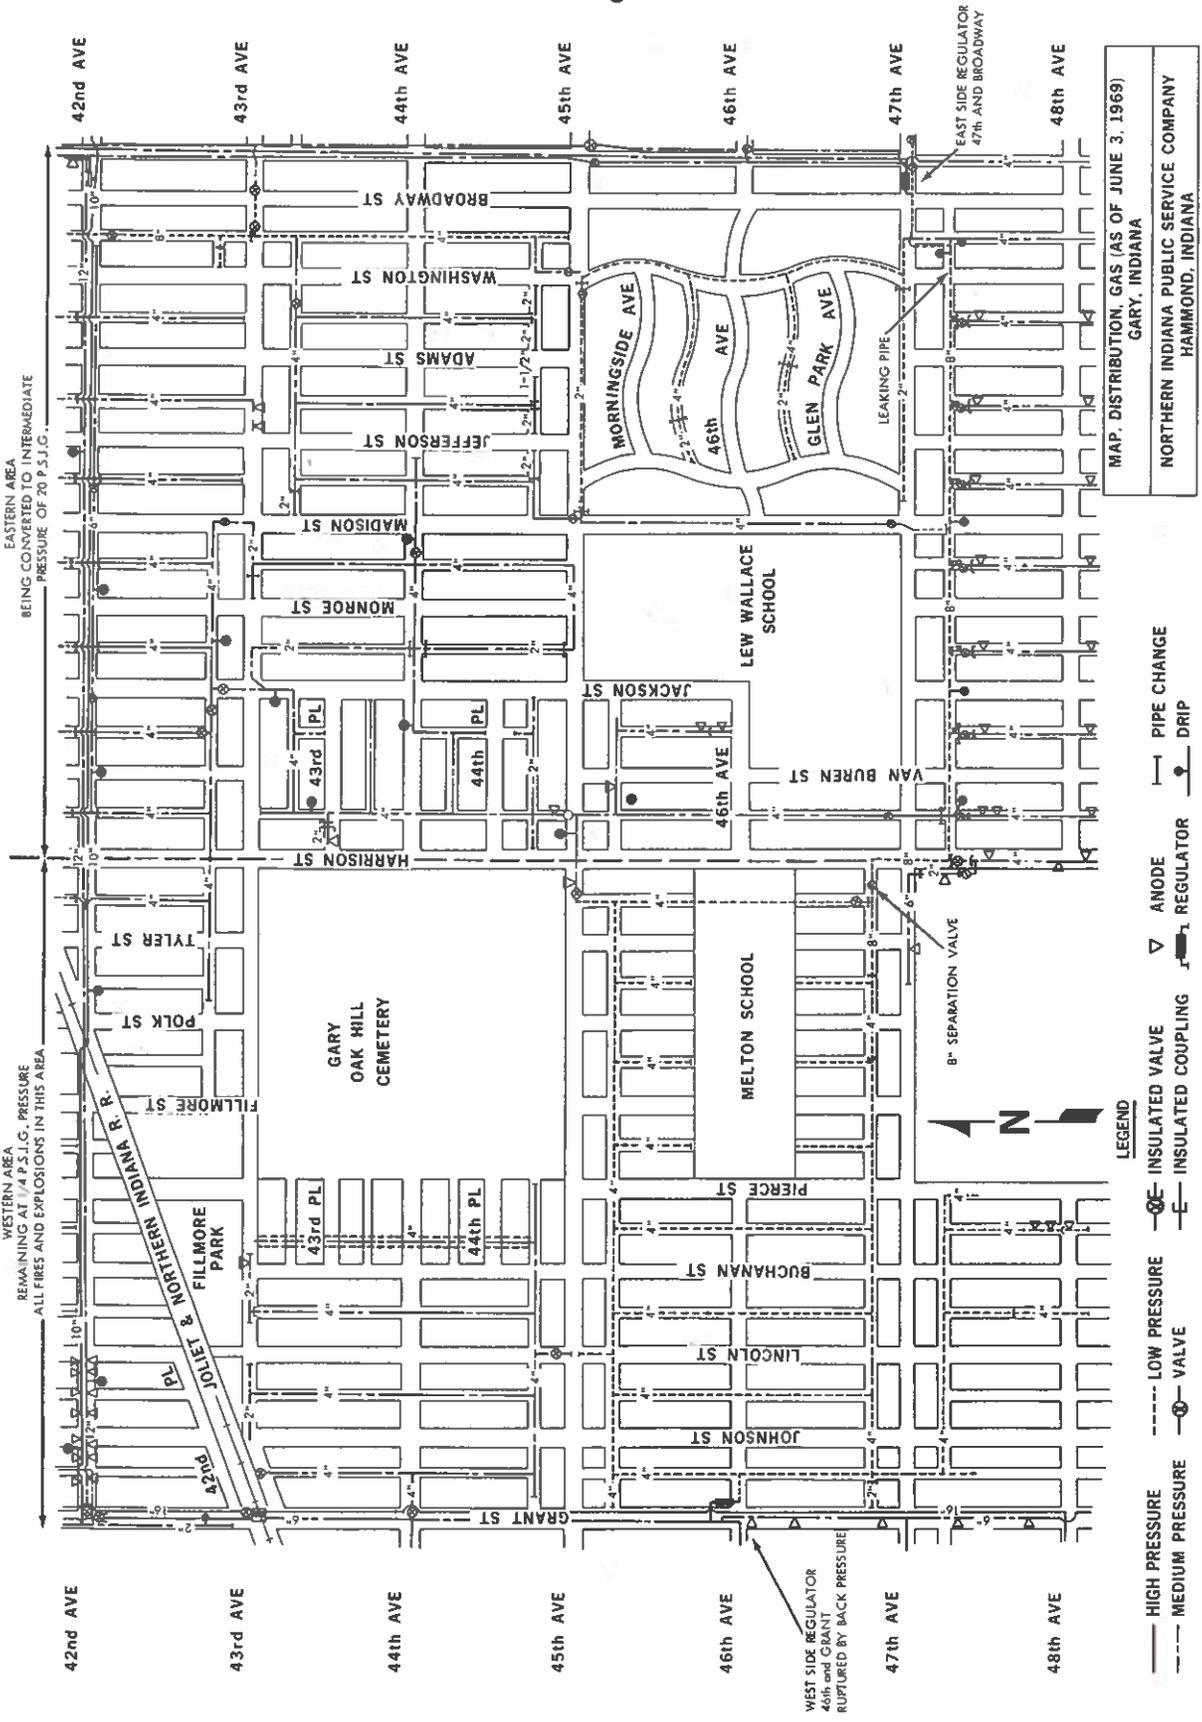
EASTERN AREA  
BEING CONVERTED TO INTERMEDIATE  
PRESSURE OF 70 P.S.I.G.

WESTERN AREA  
REMAINING AT 70 P.S.I.G. PRESSURE  
ALL PIPES AND EXPLOSIONS IN THIS AREA

WEST SIDE REGULATOR  
46th and GRANT  
RUPTURED BY BACK PRESSURE

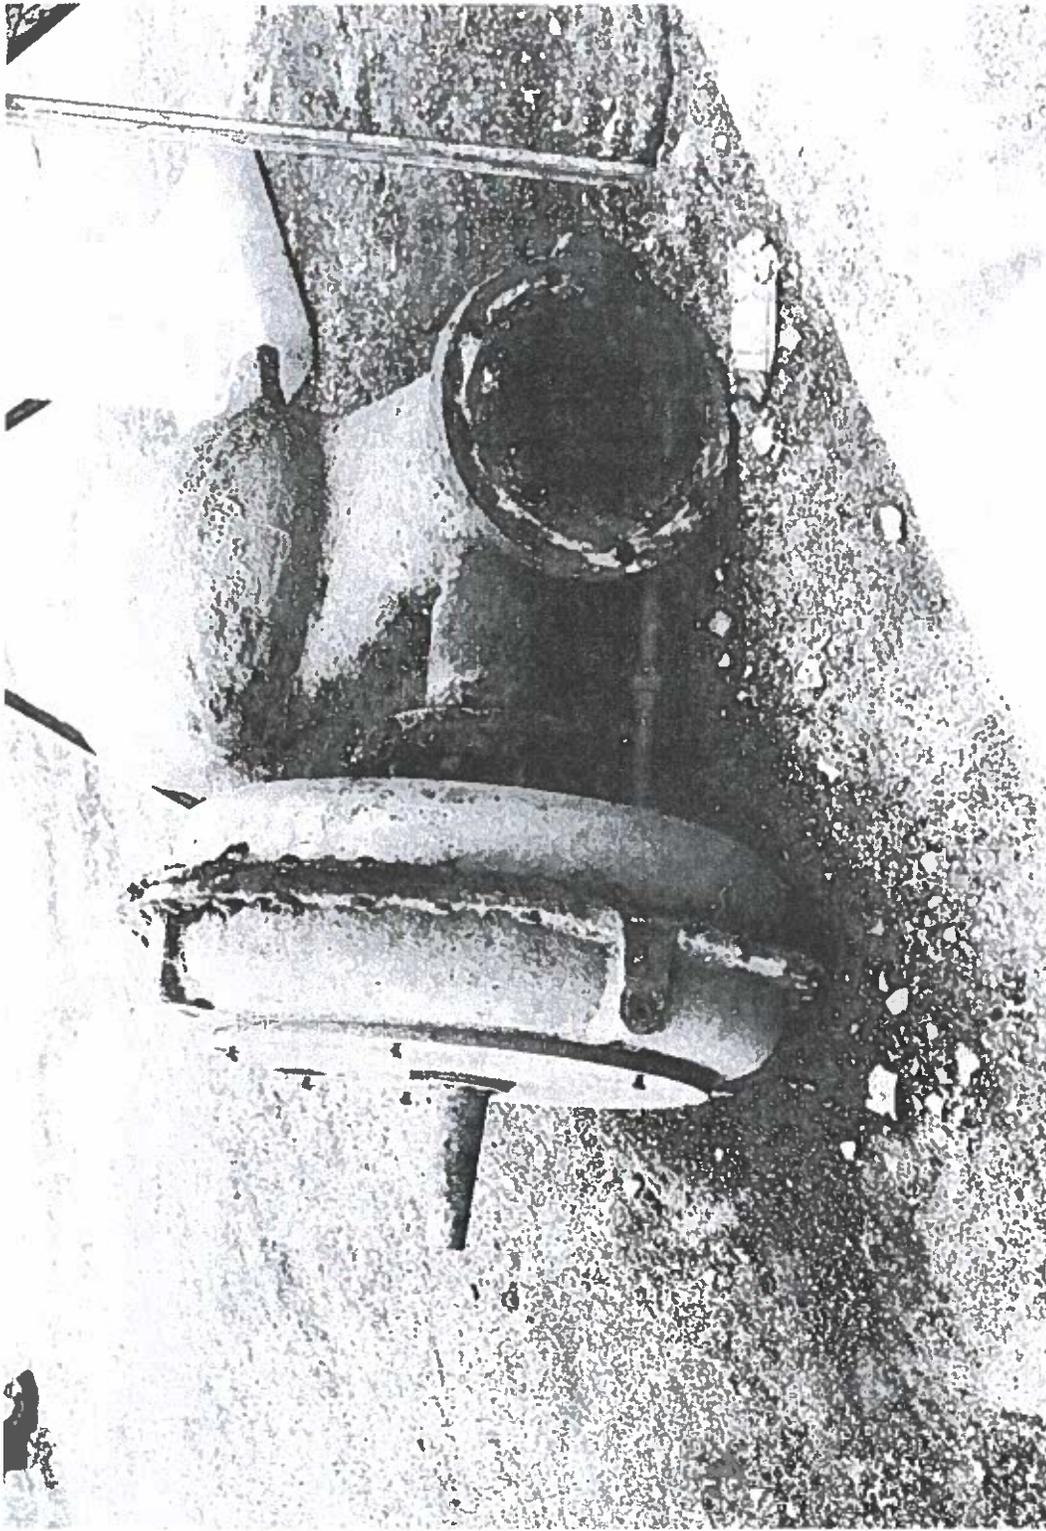
FIGURE 2

REGULATOR REMOVED FROM PIT AT 47th AVENUE AND BROADWAY  
STREET IN EASTERN SECTOR OF GLEN PARK. IT IS SIMILAR TO  
REGULATOR WHICH FAILED AT 46th AVENUE AND GRANT STREET IN  
WESTERN SECTOR

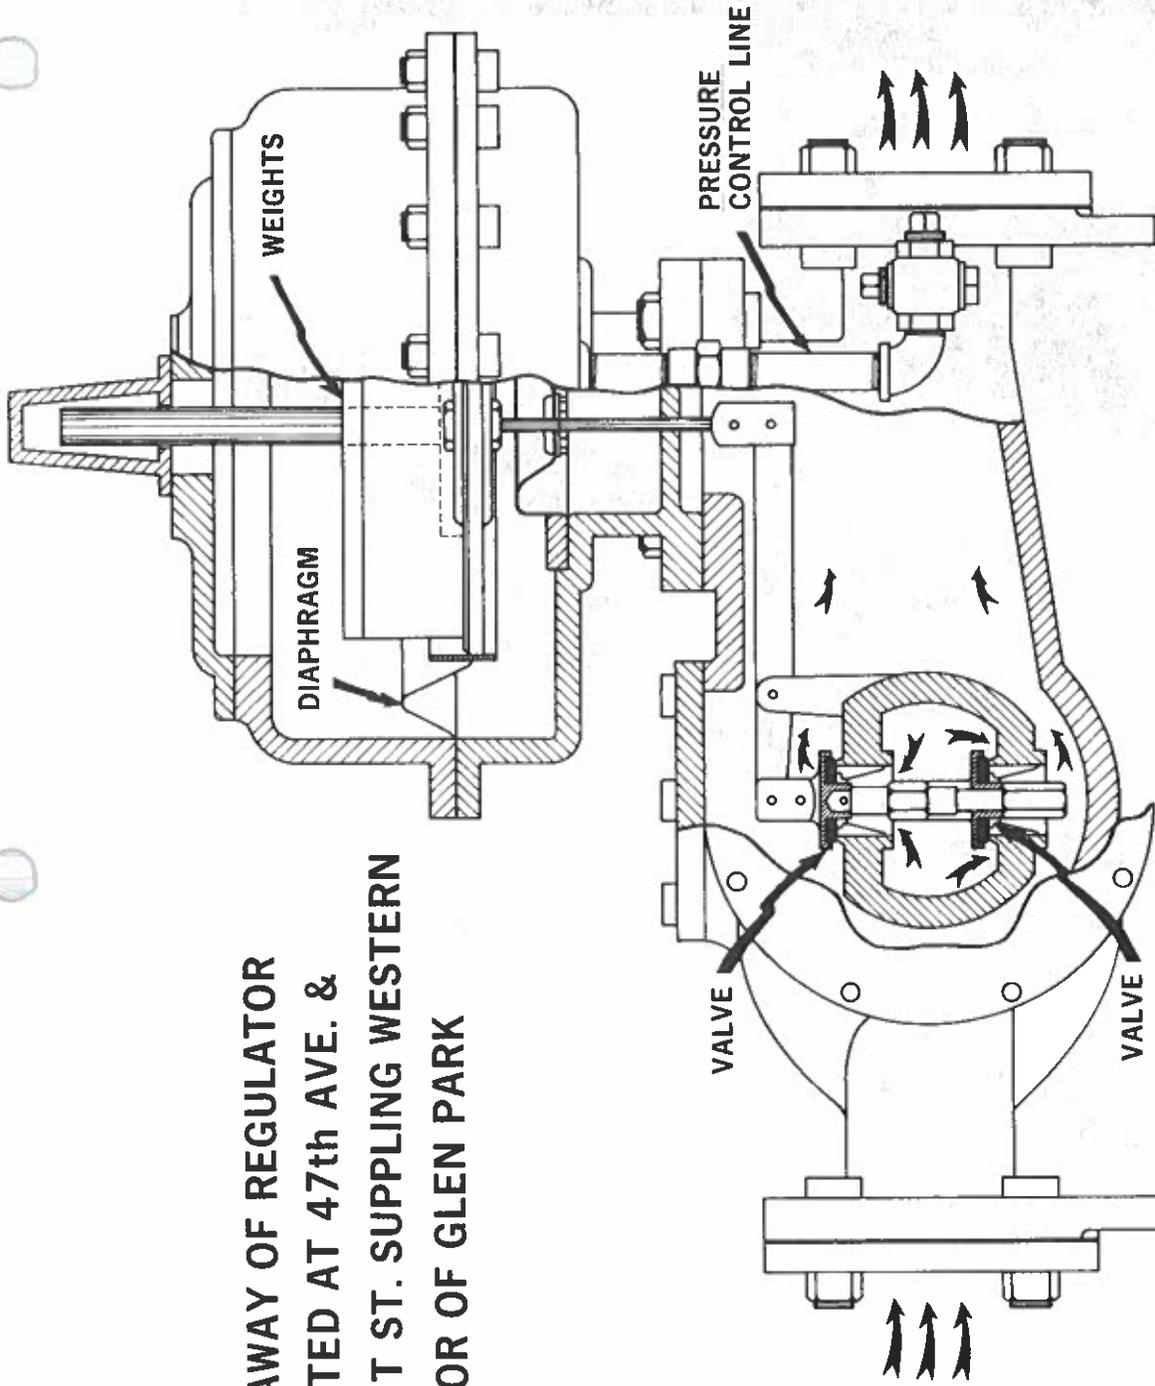
**FIGURE 3**

CUT AWAY OF REGULATOR  
LOCATED AT 47th AVE. &  
GRANT ST. SUPPLYING WESTERN  
SECTOR OF GLEN PARK

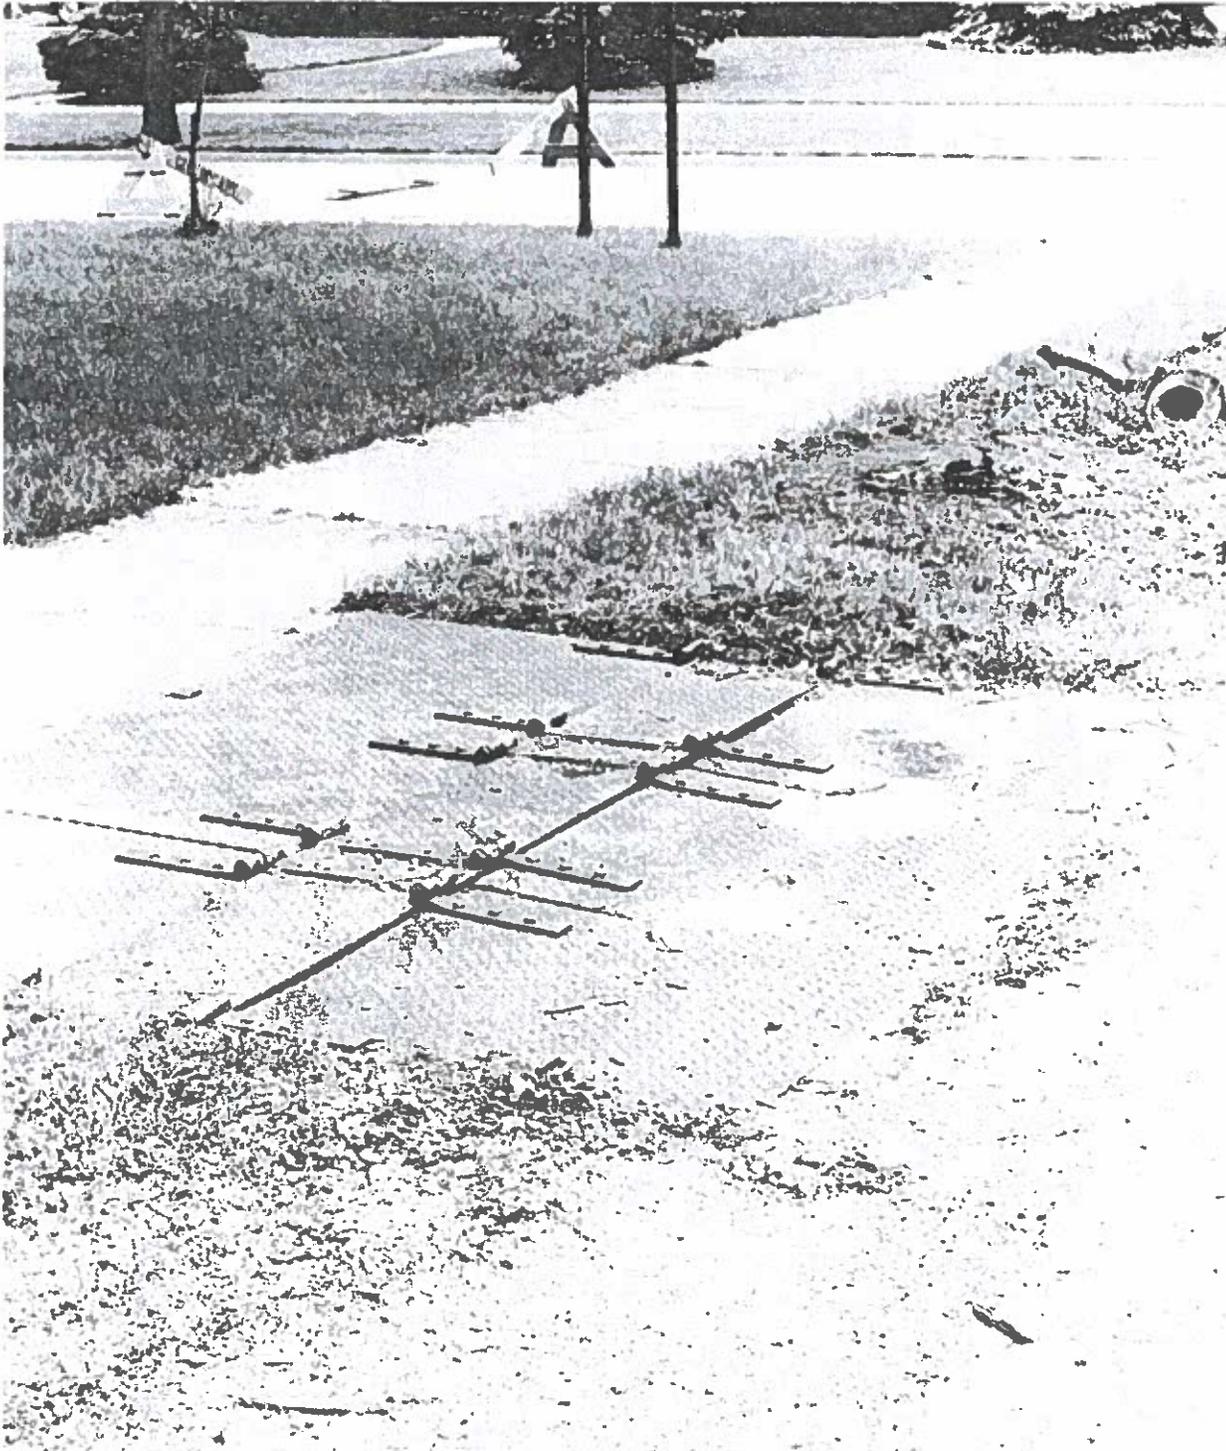
FIGURE 4

STEEL COVER ON REGULATOR PIT  
AT 46TH AVENUE AND GRANT STREET  
COVER WAS CHAINED AND LOCKED AT TIME OF ACCIDENT

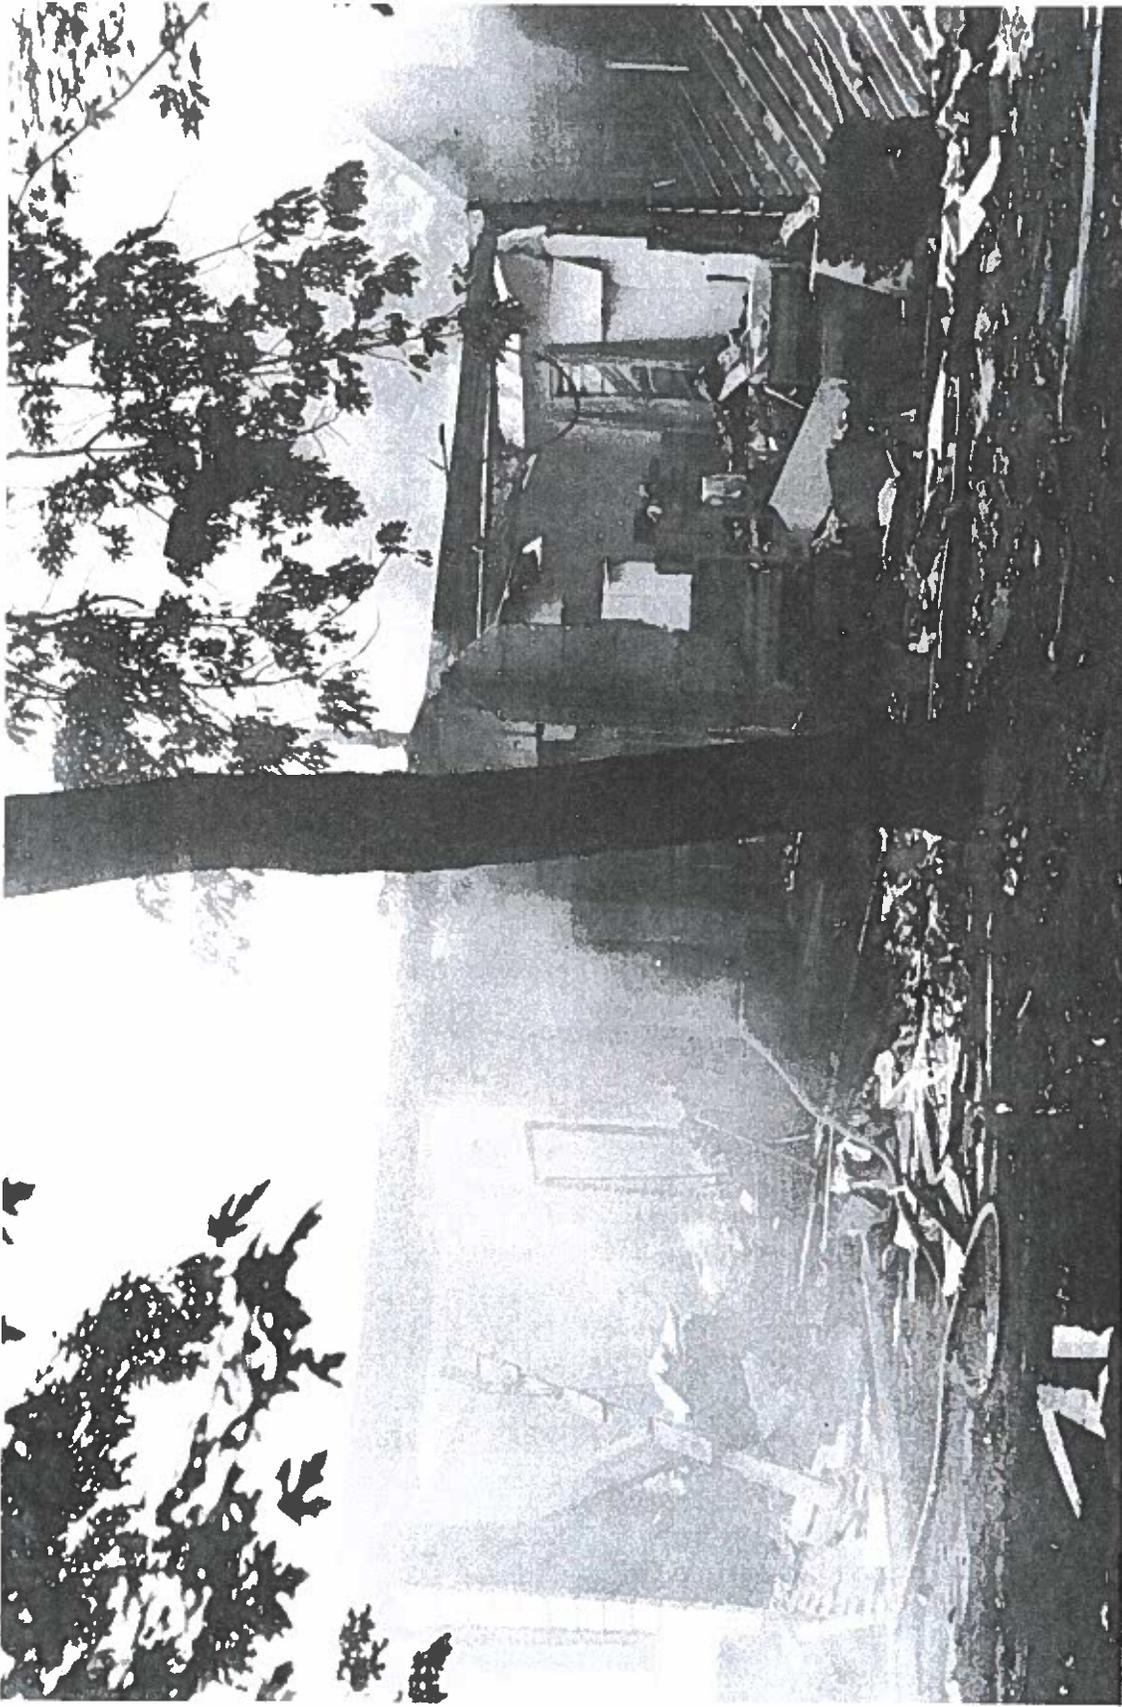
FIGURE 5  
RESIDENCE AT 4586 LINCOLN STREET  
SHOWING DAMAGE CAUSED BY EXPLOSION

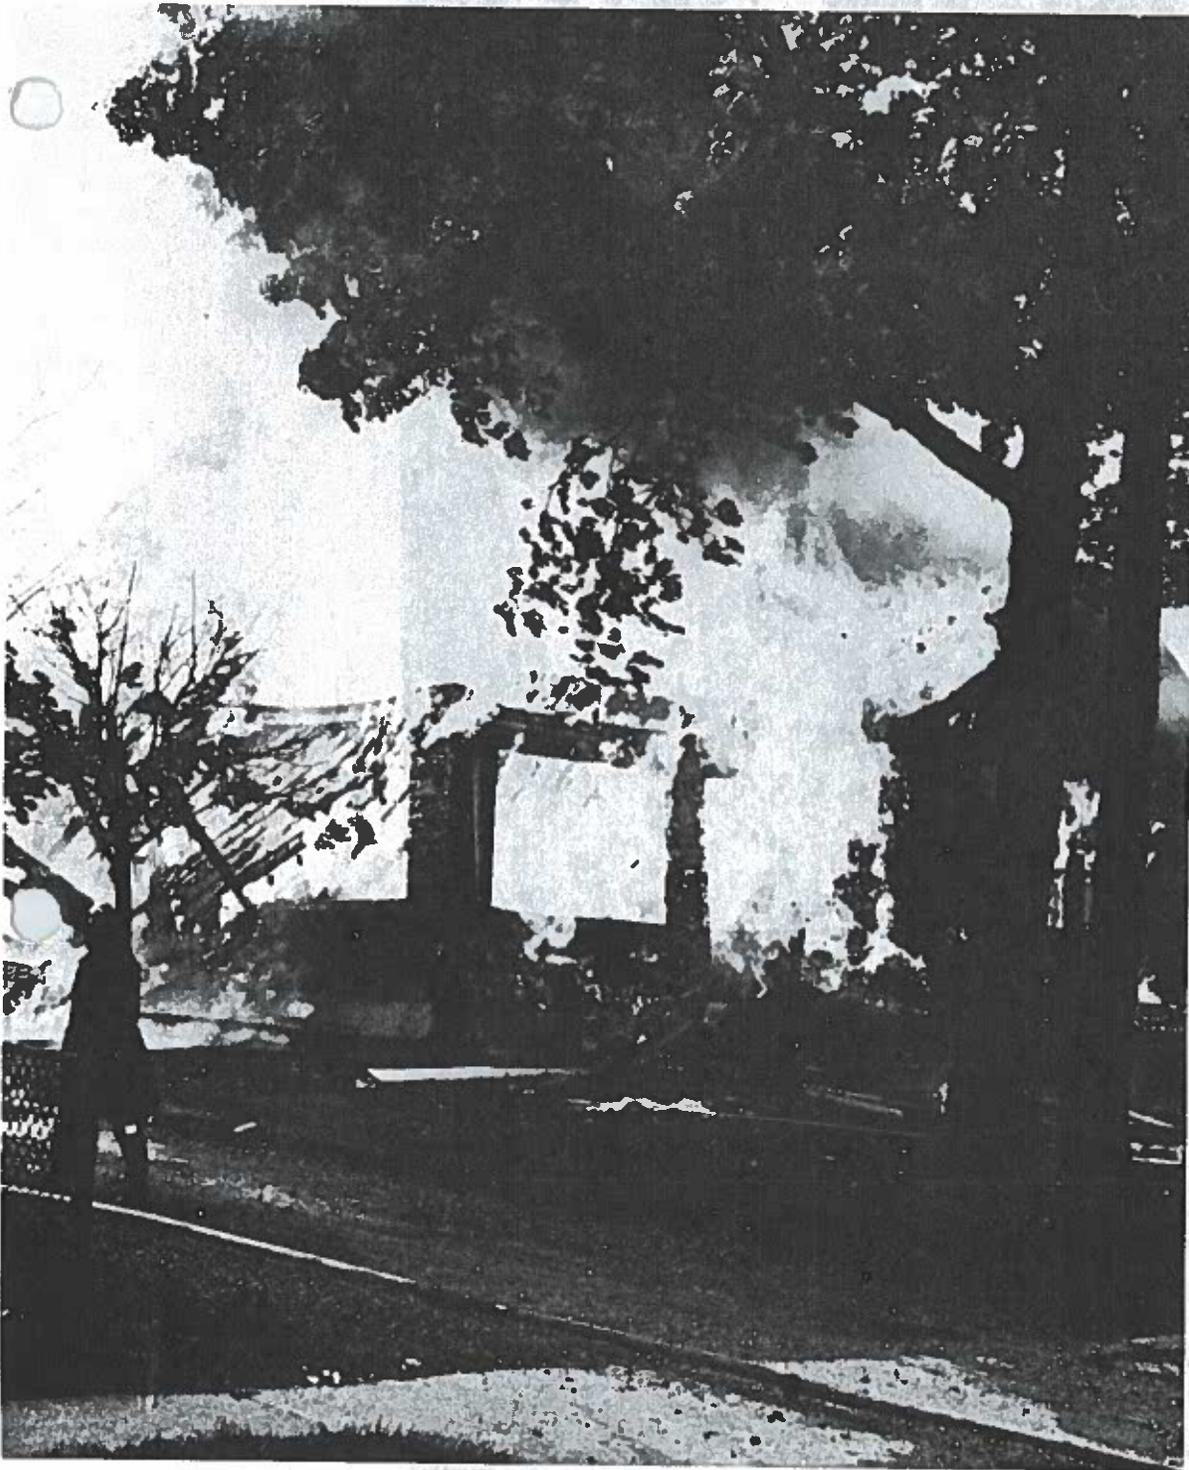
FIGURE 6

RESIDENCE AT 4666 LINCOLN STREET DURING HEIGHT OF FIRE

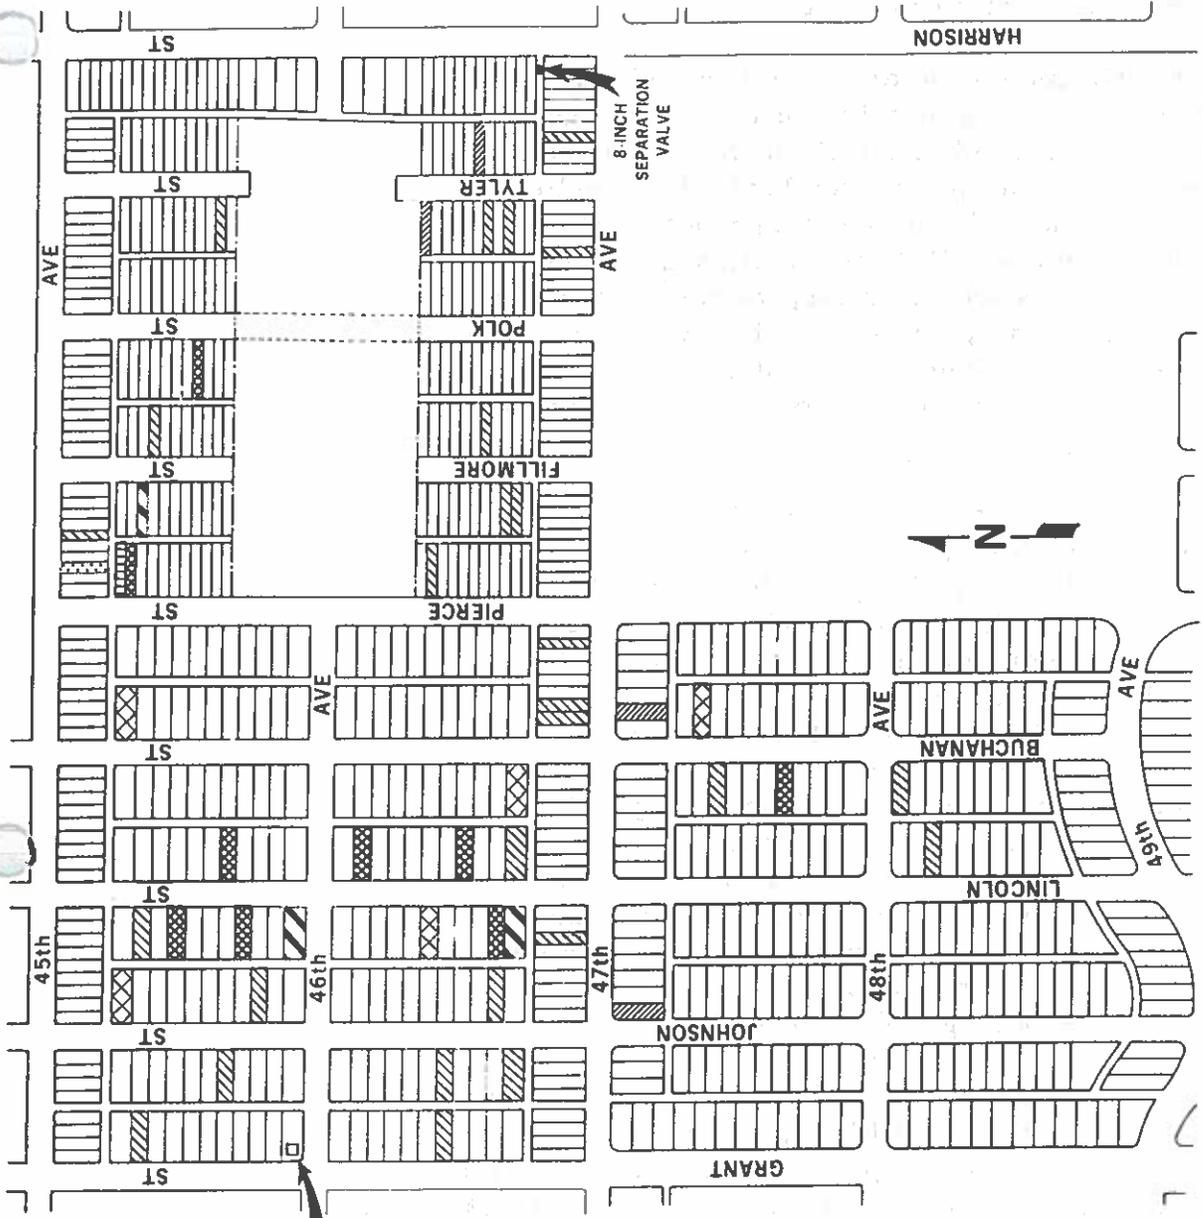
DAMAGE MAP OF WESTERN  
SECTOR OF GLEN PARK,  
CITY OF GARY, INDIANA,  
RESULTING FROM FIRES AND  
EXPLOSIONS ON JUNE 3, 1969

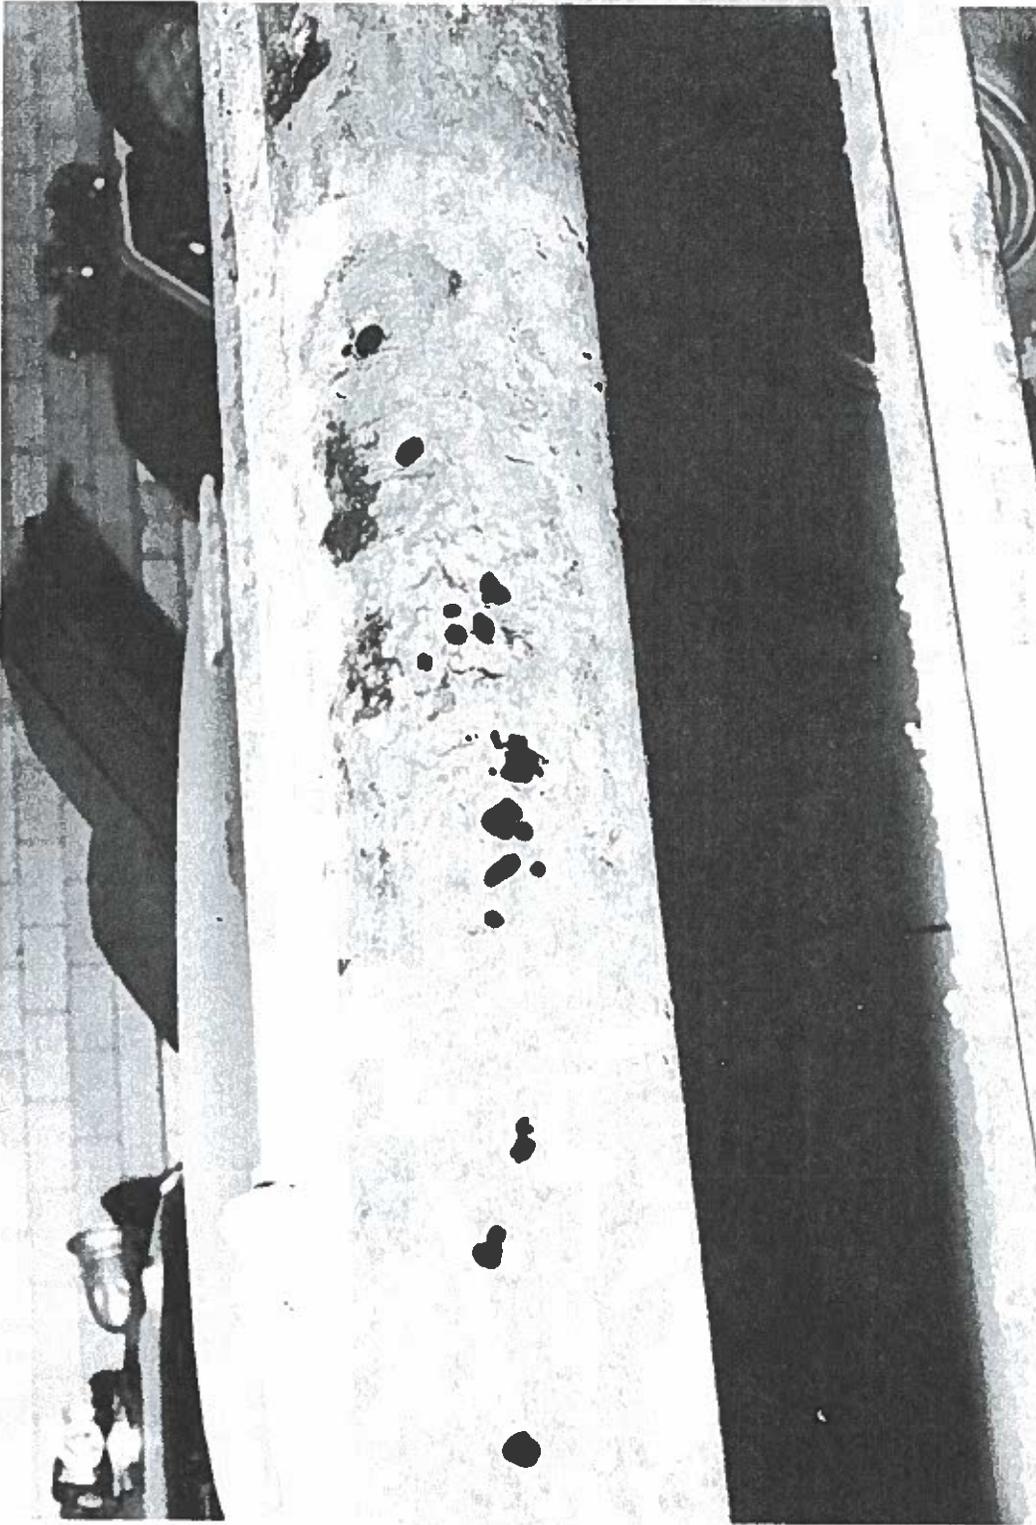
FIGURE 9

As noted in the photographs, one 35-foot length of 8-inch pipe contained 54 holes from corrosion. Another portion of 8-inch pipe contained nine holes in a 29-foot length; the holes varied in size from about 1/4 inch in diameter to 1 1/4 inch in diameter. When the aforementioned pipe was exposed at 47th Avenue and Washington Street, there were no leak clamps over the holes. Leak clamps were installed during attempts to make repairs at that location.

BADLY CORRODED 8-INCH PIPE  
REMOVED FROM 47TH AVENUE AND WASHINGTON STREET  
IN EASTERN SECTOR OF GLEN PARK

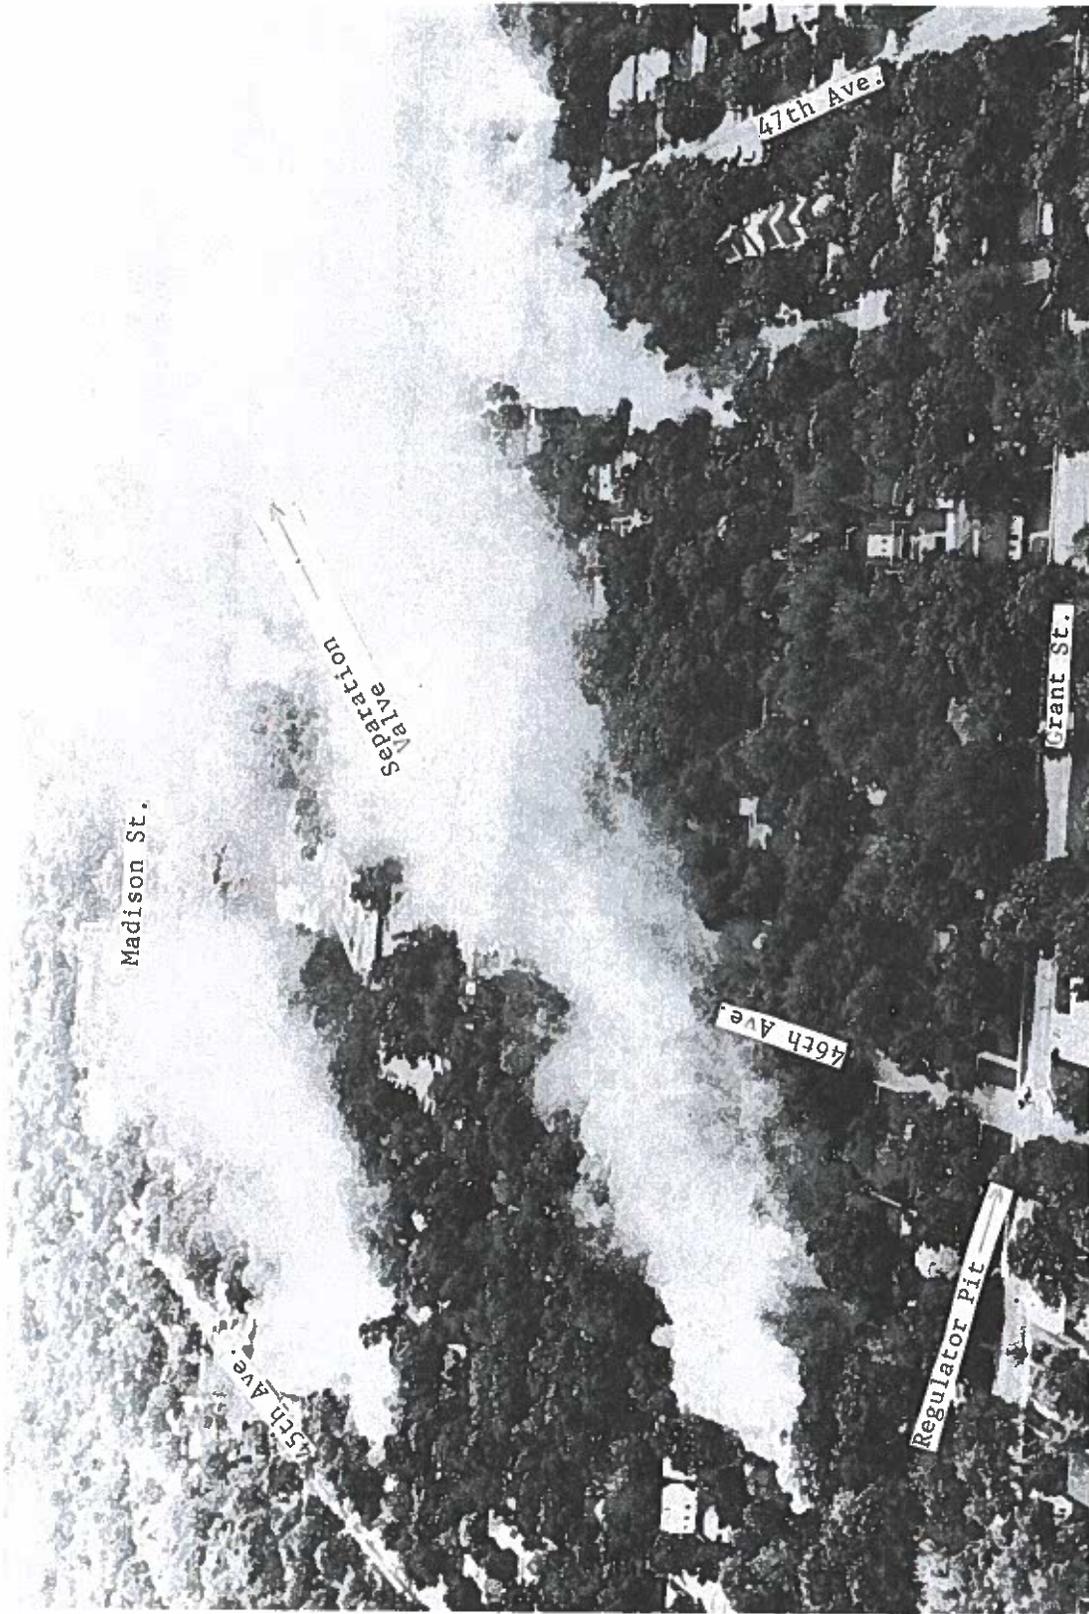
FIGURE 10  
AERIAL VIEW LOOKING EAST  
WESTERN SECTOR OF GLEN PARK DURING ACCIDENT
