NATIONAL TRANSPORTATION SAFETY BOARD

# PIPELINE ACCIDENT REPORT

LOW-PRESSURE NATURAL GAS  
DISTRIBUTION SYSTEM

BURLINGTON, IOWA

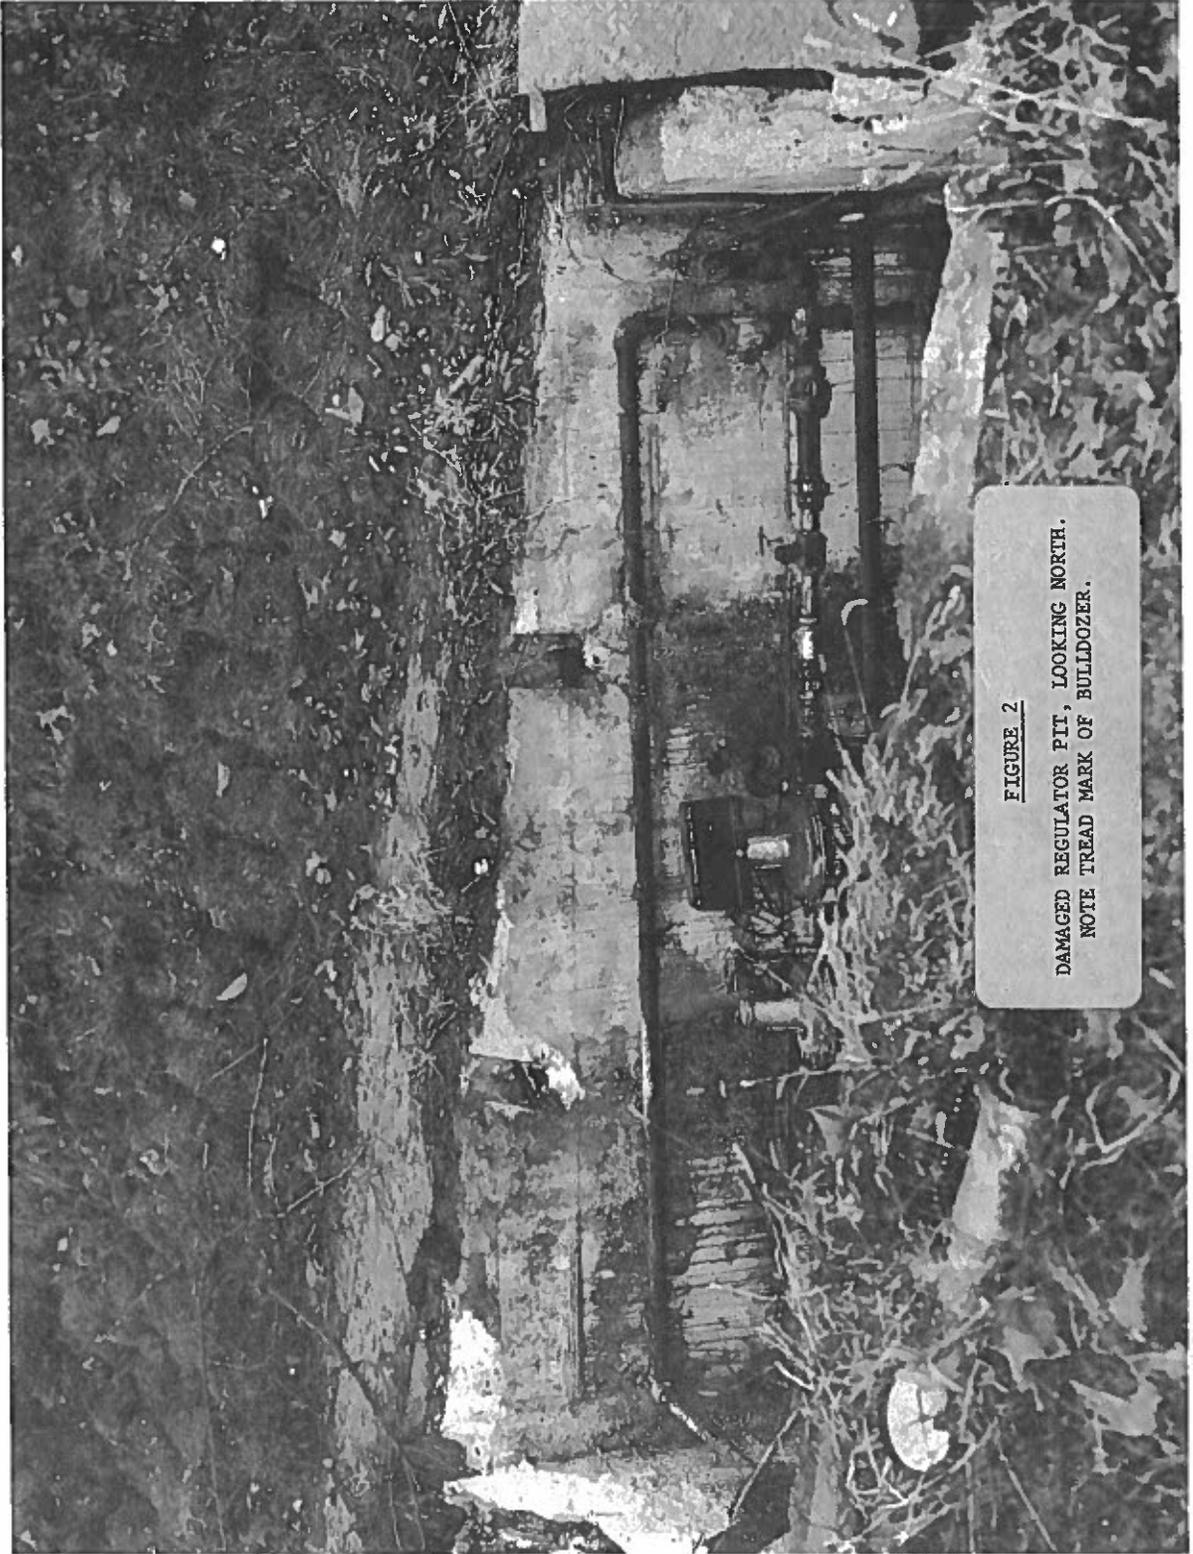
FIGURE 2

DAMAGED REGULATOR PIT, LOOKING NORTH.  
NOTE TREAD MARK OF BULLDOZER.

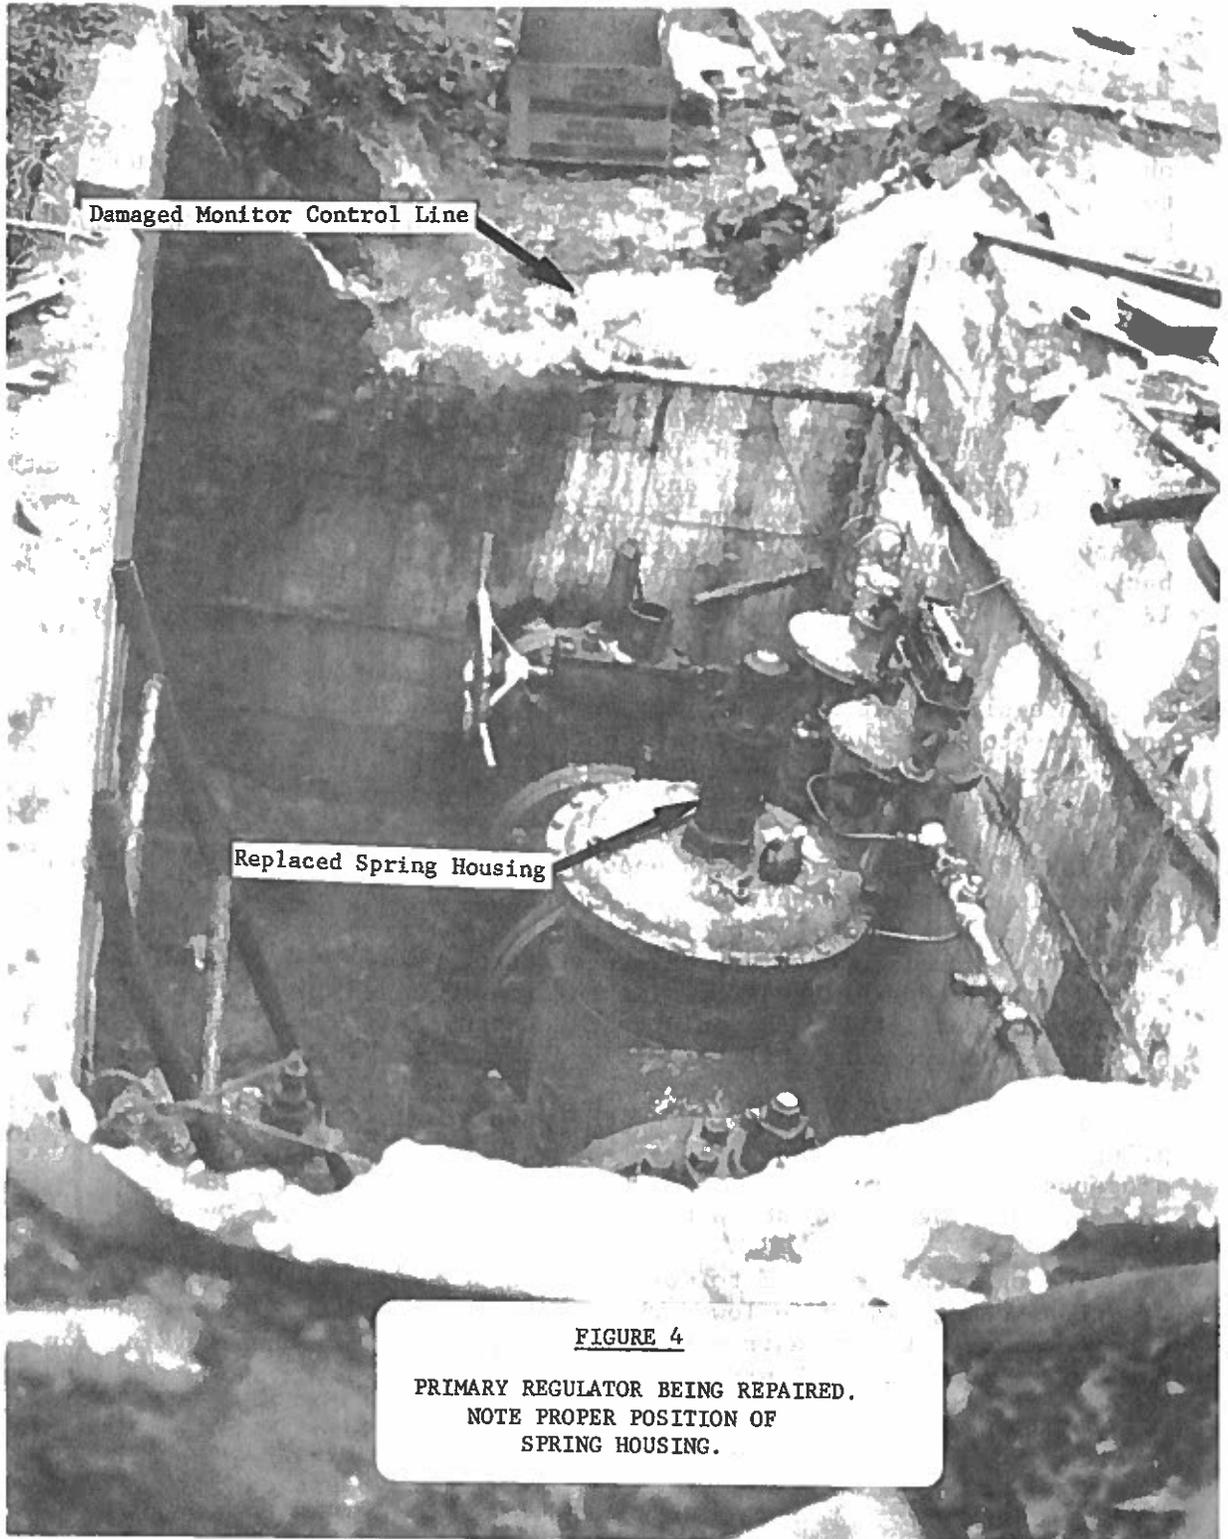
FIGURE 4

PRIMARY REGULATOR BEING REPAIRED.  
NOTE PROPER POSITION OF  
SPRING HOUSING.

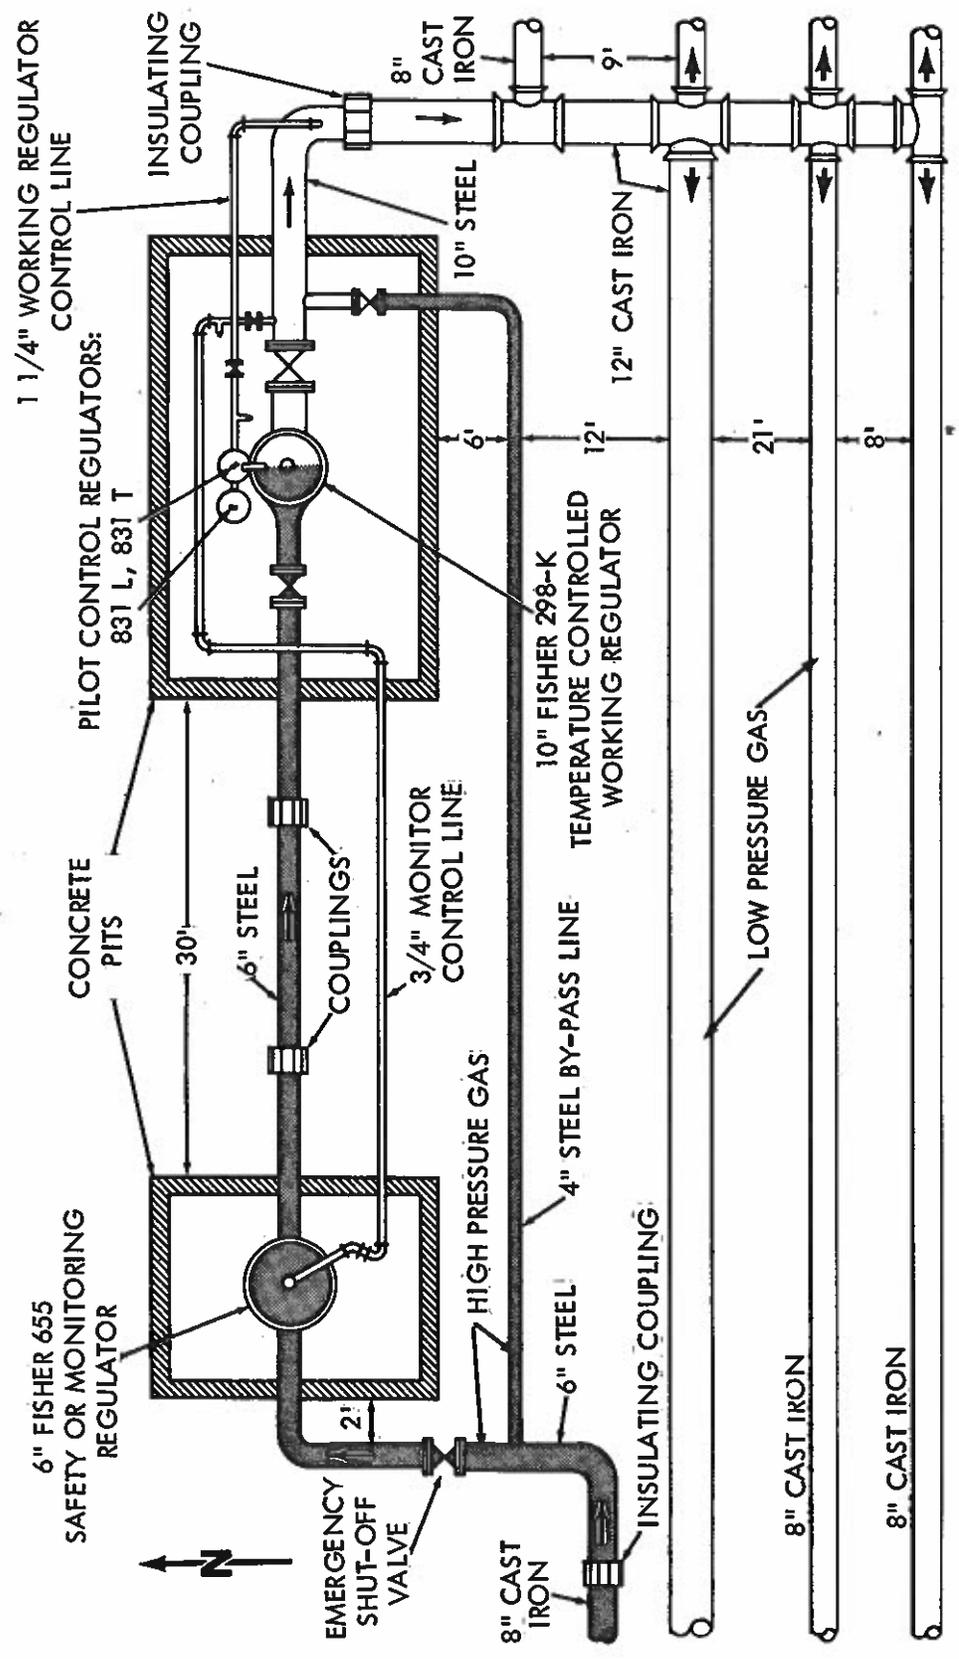
FIGURE 8  
REGULATOR STATION R-5  
HIGH STREET AND 4th STREET  
BURLINGTON, IOWA

The district regulator station R-5, which was damaged in the accident, consisted of a 10-inch Model 298-K pilot-controlled working regulator and a 6-inch Model 655-A monitoring or safety regulator. The pilot control on the Model 298 working regulator included a small type 831-T temperature loading regulator. The 831-T automatically adjusted the outlet pressure of the working regulator in relation to the atmospheric temperature changes. This allows more gas to flow into the low-pressure system when the temperature drops to meet increasing requirements of gas consumers. A type 831-L maximum boost limit regulator is also included to allow only a predetermined boost in the outlet pressure by the temperature loading pilot regulator. (See Figure 8 page 17 .) The regulators and pilots were manufactured by the Fisher Governor Company of Marshalltown, Iowa. The station was supplied with 60 p.s.i.g. gas from an 8-inch main, and fed gas reduced to 1/4 p.s.i.g. to three 8-inch mains and one 12-inch main for distribution to gas consumers.

The station was designed so that if the working regulator should fail open, the monitoring safety regulator would activate and maintain the pressure at a slightly higher level. However, after the working regulator was damaged in the accident, the safety regulator was activated to control at a pressure of about 1/2 p.s.i.g., but did not control the 55 p.s.i.g. inlet pressure at the 1/2 p.s.i.g. level. It is estimated by ISU that the pressure in the system reached 1 to 1 1/4 p.s.i.g., preceding the fires. This amounts to about a four fold to a five fold increase over normal operating pressure.

The safety regulator was essentially a nonworking monitor because it remains in a wide-open position upstream from the working regulator, sensing the pressure reduced by the working regulator via a control line. When the pressure surged through the damaged working regulator, it was sensed by the monitor regulator which started to close down as intended. However, it did not work to reduce the pressure to 1/2 p.s.i.g. as designed.
