PIPELINE ACCIDENT REPORT

COLONIAL PIPELINE COMPANY
PETROLEUM PRODUCTS DIVISION
JACKSONVILLE, MARYLAND
SEPTEMBER 3, 1970

REPORT NUMBER: NTSB-PAR-71-2

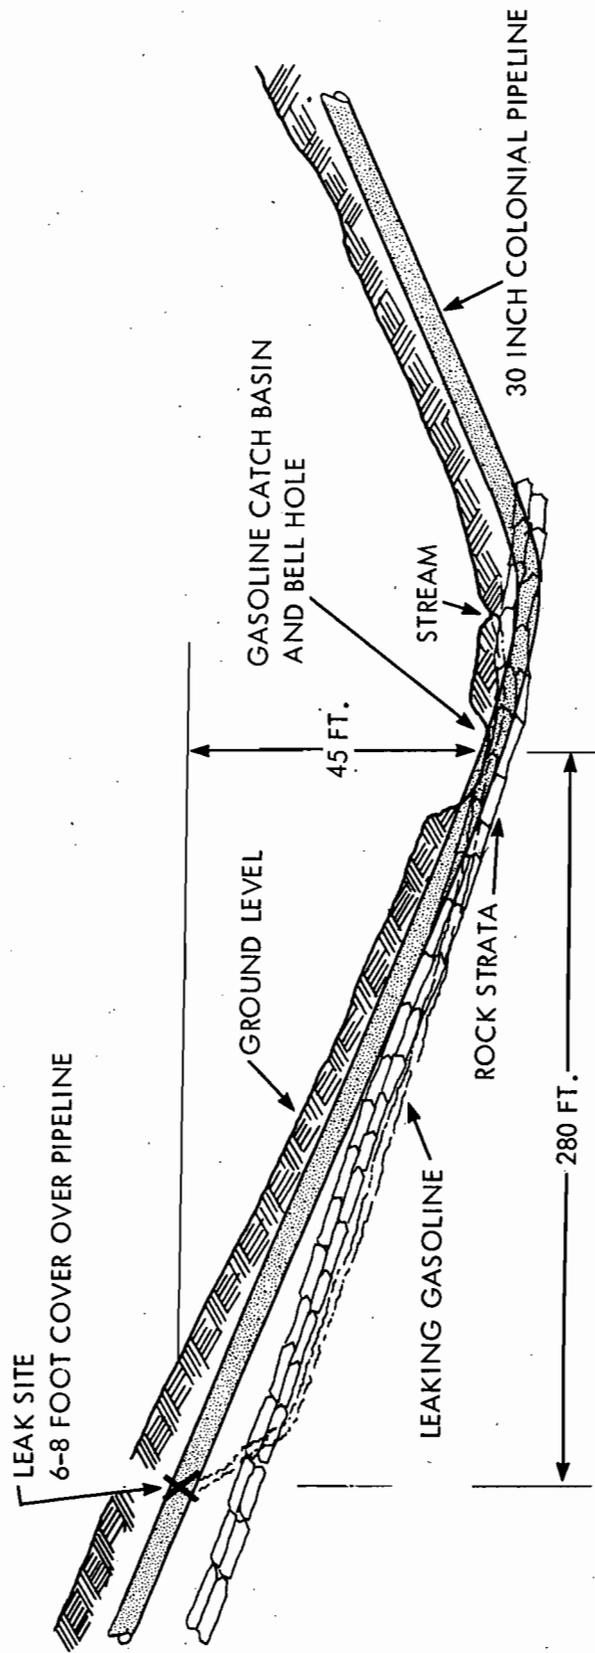
FIGURE 2

SECTION A-A OF FIGURE 1
 SITE OF JACKSONVILLE, MARYLAND
 PIPELINE ACCIDENT OF
 SEPTEMBER 3, 1970

few feet away from the leak had not been dampened by the kerosene; the leaking product had been disappearing in the arid dirt. A rock strata, underneath the pipeline at the leak, ran downhill almost parallel to the ground contour above, but was closer to the surface as it neared the creek at the bottom of the hill. The leak location was 45 feet above the excavation at the accident site and gasoline had formed an underground column 280 feet long with a 45-foot head (approximately 14 p.s.i.g.) pressing down on this area. (See Figure 2.)

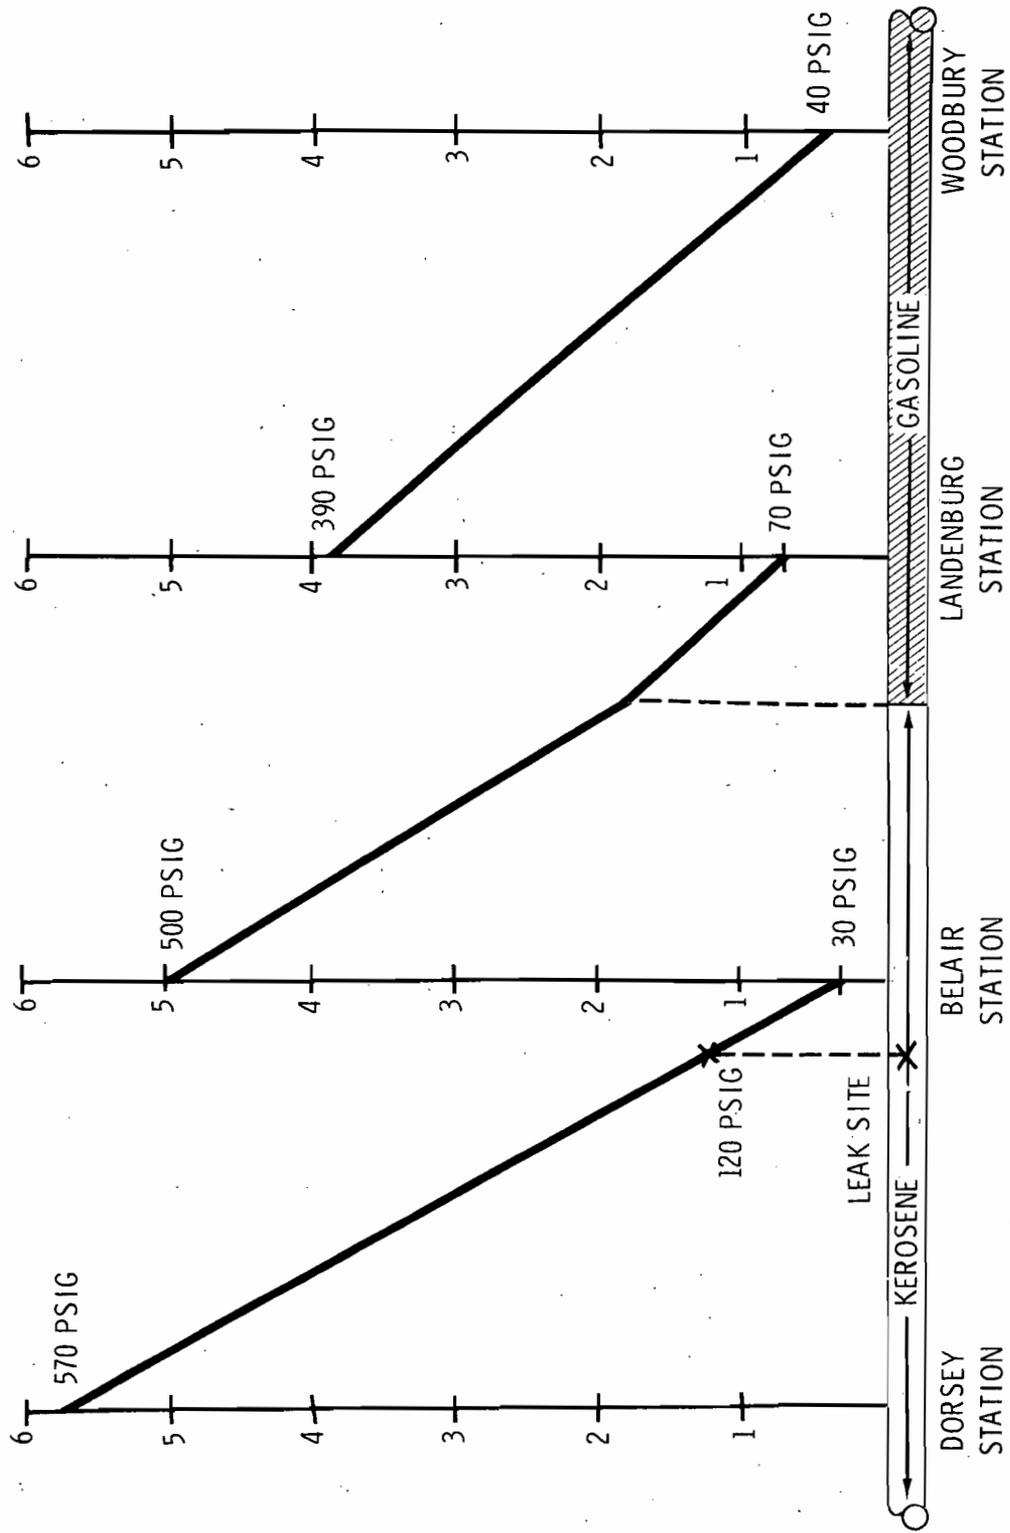
FIGURE 4

COLONIAL PIPELINE PRESSURE GRADIENT
IN THE ACCIDENT AREA

e.d.t., when the leak was reported, kerosene had displaced the gasoline well beyond the leak. The upstream station, Dorsey, was pumping at 570 p.s.i.g. which exerted a resultant pressure of 120 p.s.i.g. on the pipe at the leak site. (See Figure 4.)

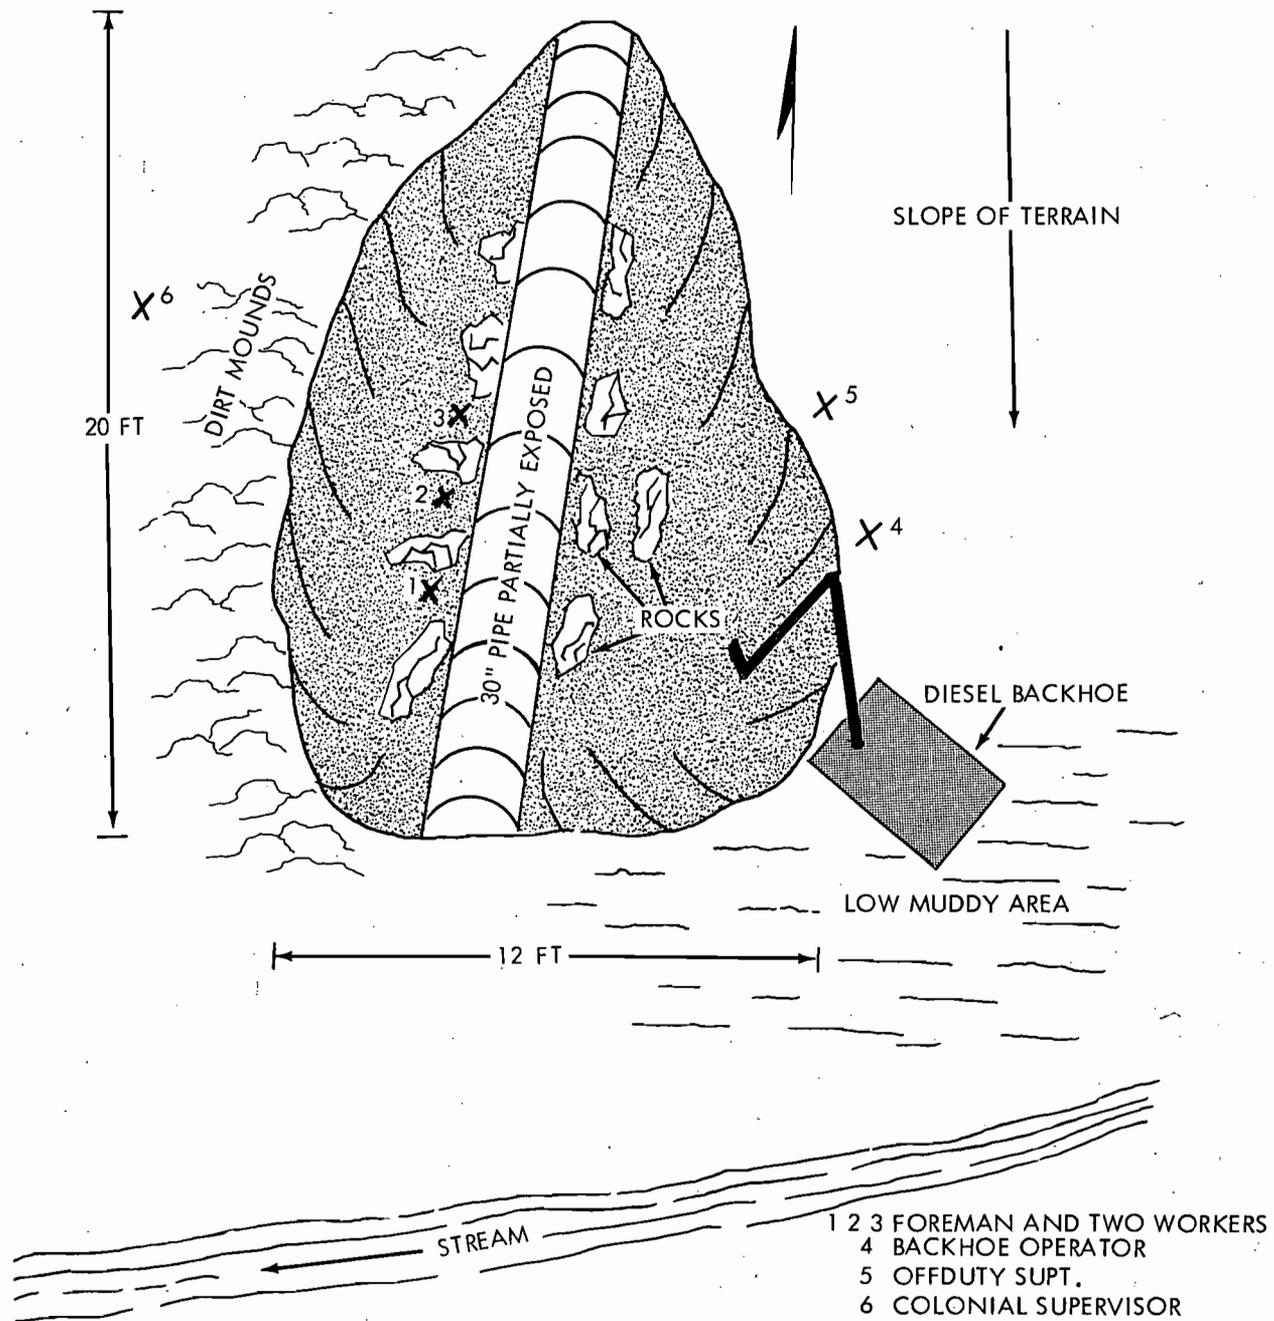
FIGURE 8
 SCENE OF ACCIDENT SHOWING
 LOCATION OF INJURED PARTIES
 SEPTEMBER 3, 1970
