**PIPELINE ACCIDENT REPORT
PHILLIPS PIPE LINE COMPANY
PROPANE GAS EXPLOSION
FRANKLIN COUNTY, MISSOURI
DECEMBER 9, 1970**

**NATIONAL TRANSPORTATION SAFETY BOARD
Washington, D. C. 20591
REPORT NUMBER NTSB-PAR-72-1**

FRANKLIN COUNTY, MISSOURI

DECEMBER 9, 1970

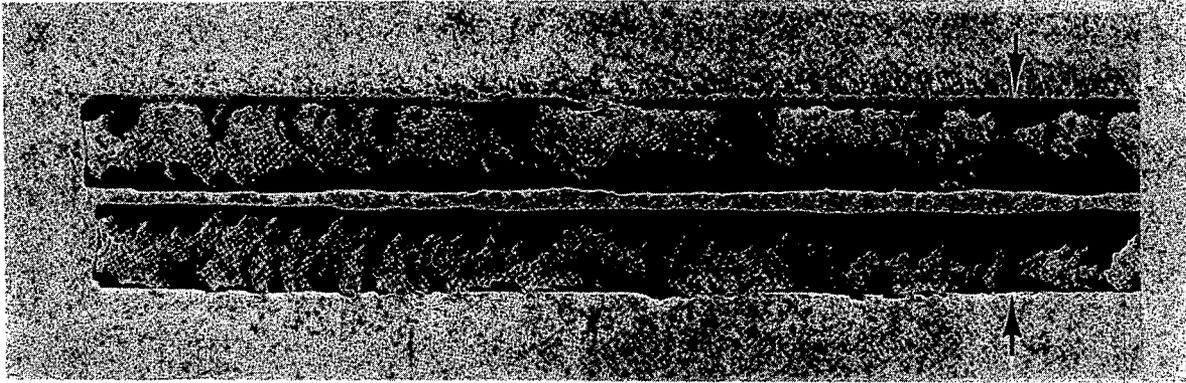
Figure 2 Ruptured Pipe Section Showing Cold-Stitched Longitudinal Weld

contain oxide pockets in the voids. The phenomena is caused by inadequate heat or pressure at the time the pipe edges are pushed together and welded, and results in the entrapment of oxides which prevents good fusion and causes a weak bond at frequent intervals all along the longitudinal weld. The cold-stitched weld derives its name from the uniformly interrupted, symmetrically patterned appearance of the imperfectly fused metal. (See Figure 2.)

Fracture faces of the electric resistance weld broken open by bending and the inside edges matched together. Specimen was located several inches beyond the east end of the split. Note the stitch pattern which has been accentuated by entrapped oxides and corrosion at the black areas. Also note entrapped oxides extending in from outside at spots. One of these spots is indicated by the arrows and is shown in greater detail below.

Detail of matched fracture faces at location indicated by arrows where entrapped oxides and corrosion extend practically across the wall.

Phillips sent the failed section of pipe to a metallurgical laboratory for analysis, and also conducted their own tests on this pipe (See Figure 9). The rupture was 77 inches long with a 4-inch maximum opening near the middle of the split. Examination showed that the longitudinal weld was defective at the time it was manufactured at the pipe mill. Inadequate heat and pressure had trapped oxides within the weld area, resulting in weak bonding of the

pipe at frequent intervals rather than a universally strong, continuous, longitudinal weld. Internal corrosion had further weakened this weld by sharply reducing the pipe weld thickness along the weld line. Failure resulted when the pipe was subjected to higher than normal operating pressures. A test section of this failed pipe, cut out from beyond the end of the split, was broken open at the weld to check for defects. Although this test piece was back of the rupture and the weld was still intact, the black oxide spots, the corrosion, the stitch pattern and the variations in weld soundness were all apparent.³

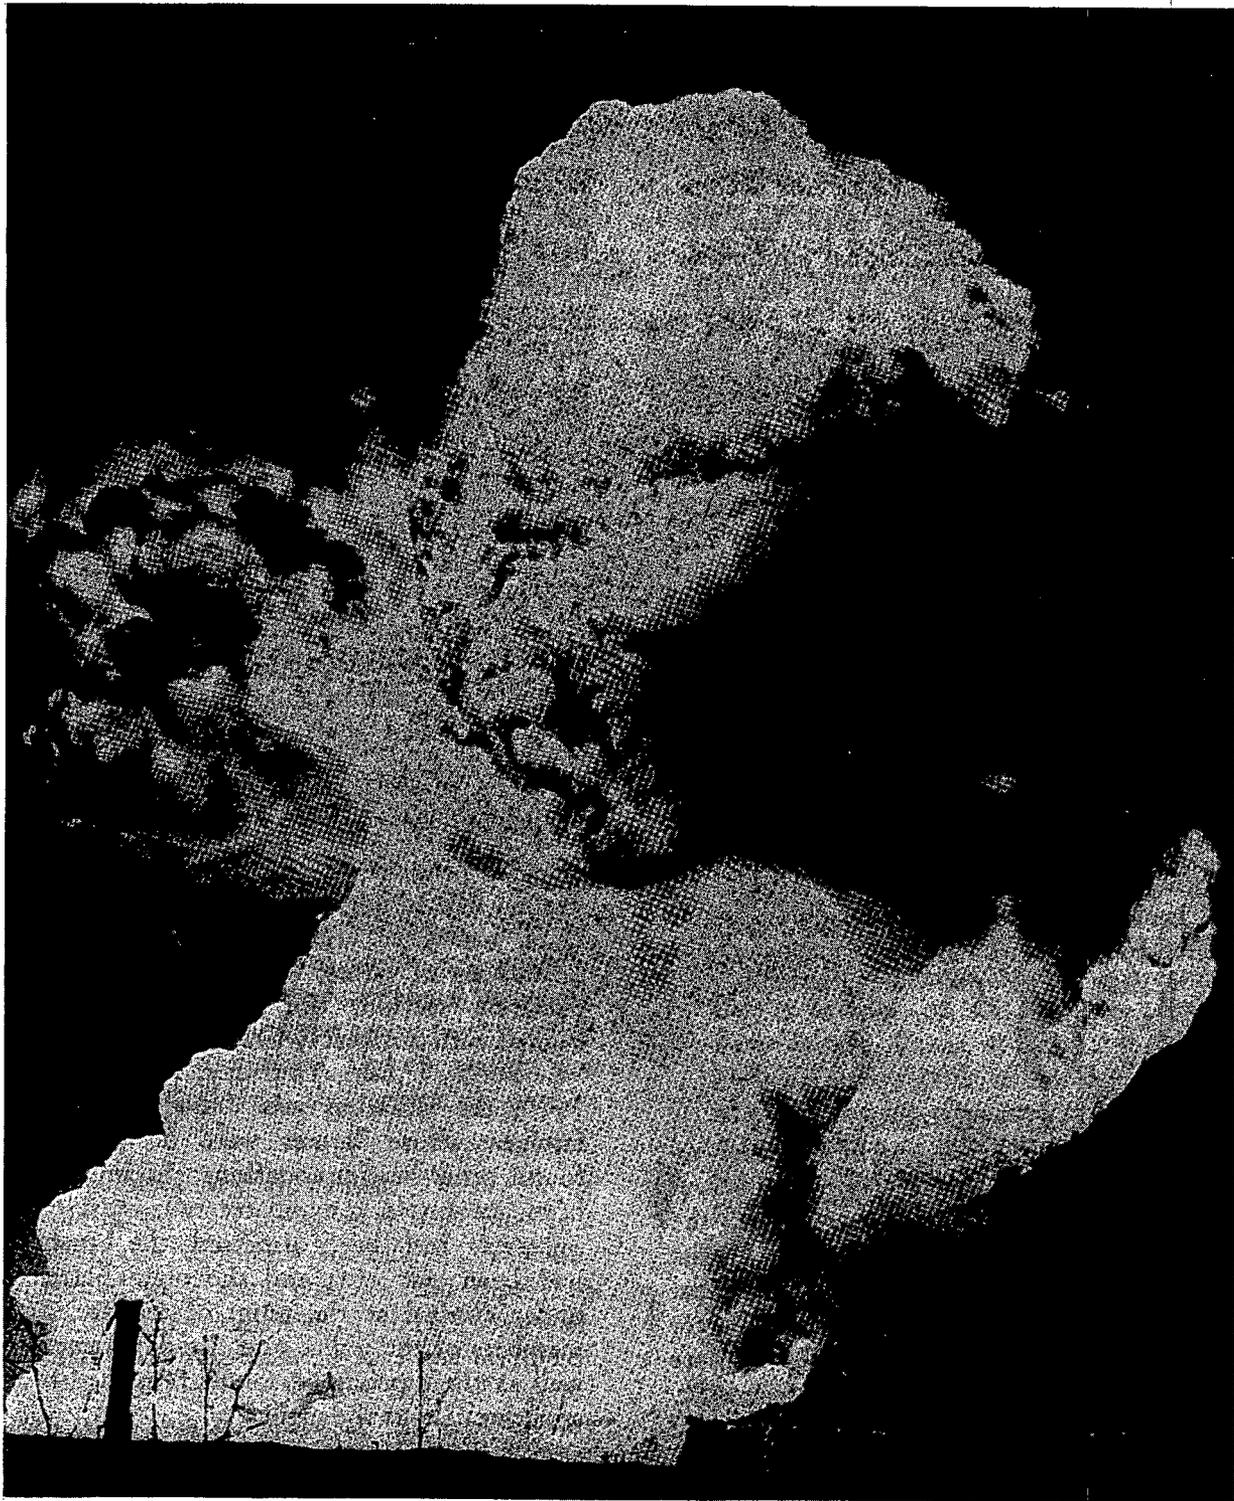
Figure 7 Propane Burning at Rupture Site

at a home along the way to telephone the fire department, but the telephone poles had been snapped off and broken and the lines were down. The ball of flame then subsided; it left one large conflagration which still roared at the pipe rupture and dozens of smaller blazes which dotted the entire valley. (See Figure 7.)

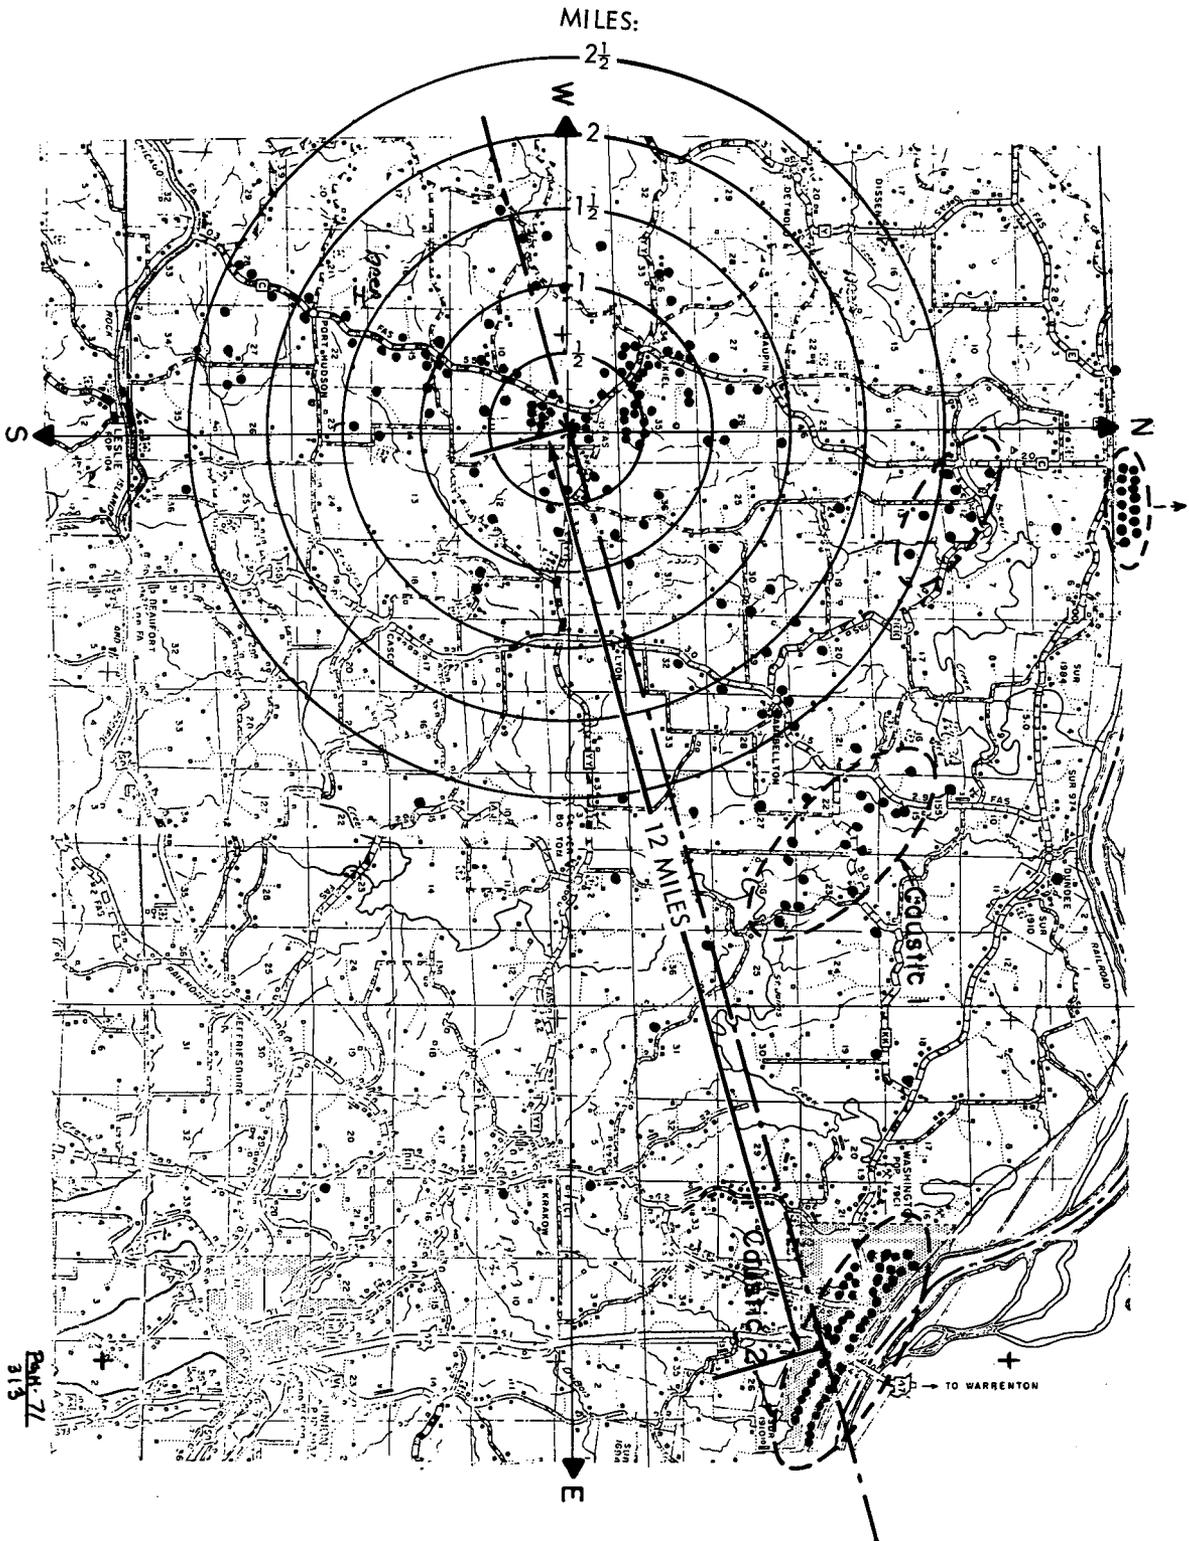
Figure 10 Topographic Map Showing Extent of Blast Damage

On the day following the explosion and fire, evaluation of the damage began. Incredibly there were no fatalities; however, ten people had been treated for injuries. Within a 2-mile radius of the blast, major structural damage occurred to 14 houses, minor structural damage affected an additional 14 houses and windows were damaged in a total of 37 dwellings. Within a 7-mile radius, excluding the initial 2-mile section, some 17 houses sustained minor structural damage and 124 houses and other buildings had window damage. Within a 12-mile radius, which included the city of Washington, Missouri, 12 commercial buildings had windows blown out and 87 houses had broken windows (See Figure 10). The city of St. Louis, Missouri, 55 miles away, felt the detonation and a reading of 3.5 was recorded on a seismograph located there.
