PIPELINE ACCIDENT REPORT. COLUMBUS
GAS OF WEST VIRGINIA, INCORPORATED,
CHARLESTON, WEST VIRGINIA, DECEMBER 2,
1973

PIPELINE ACCIDENT REPORT

**COLUMBIA GAS
OF WEST VIRGINIA, INC.
CHARLESTON, WEST VIRGINIA**

DECEMBER 2, 1973

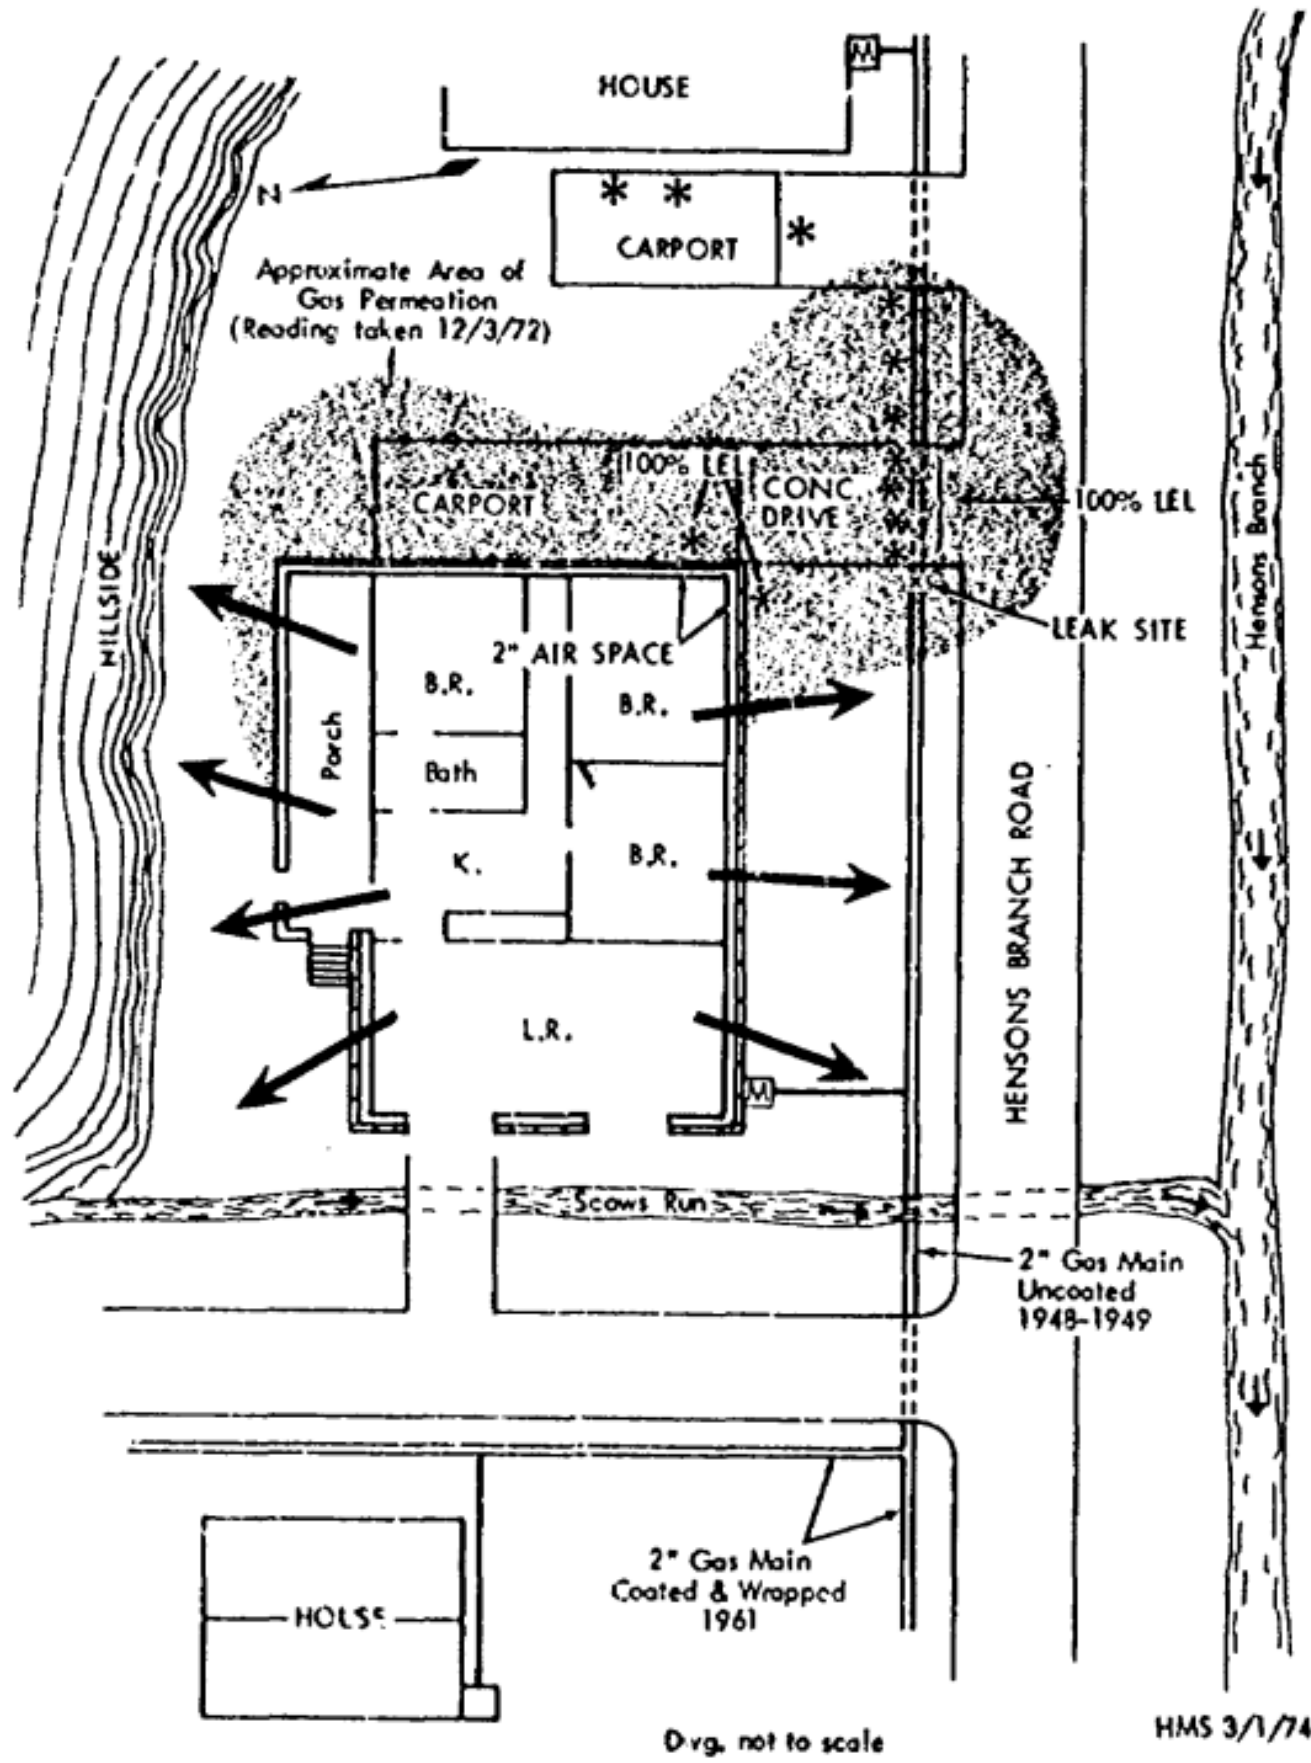
Figure 2. Accident site.
