NATIONAL TRANSPORTATION SAFETY BOARD

PIPELINE ACCIDENT REPORT

**CONSOLIDATED EDISON COMPANY
EXPLOSION AT
305 EAST 45TH STREET
NEW YORK, NEW YORK**

REPORT NUMBER: NTSB-PAR-76-2

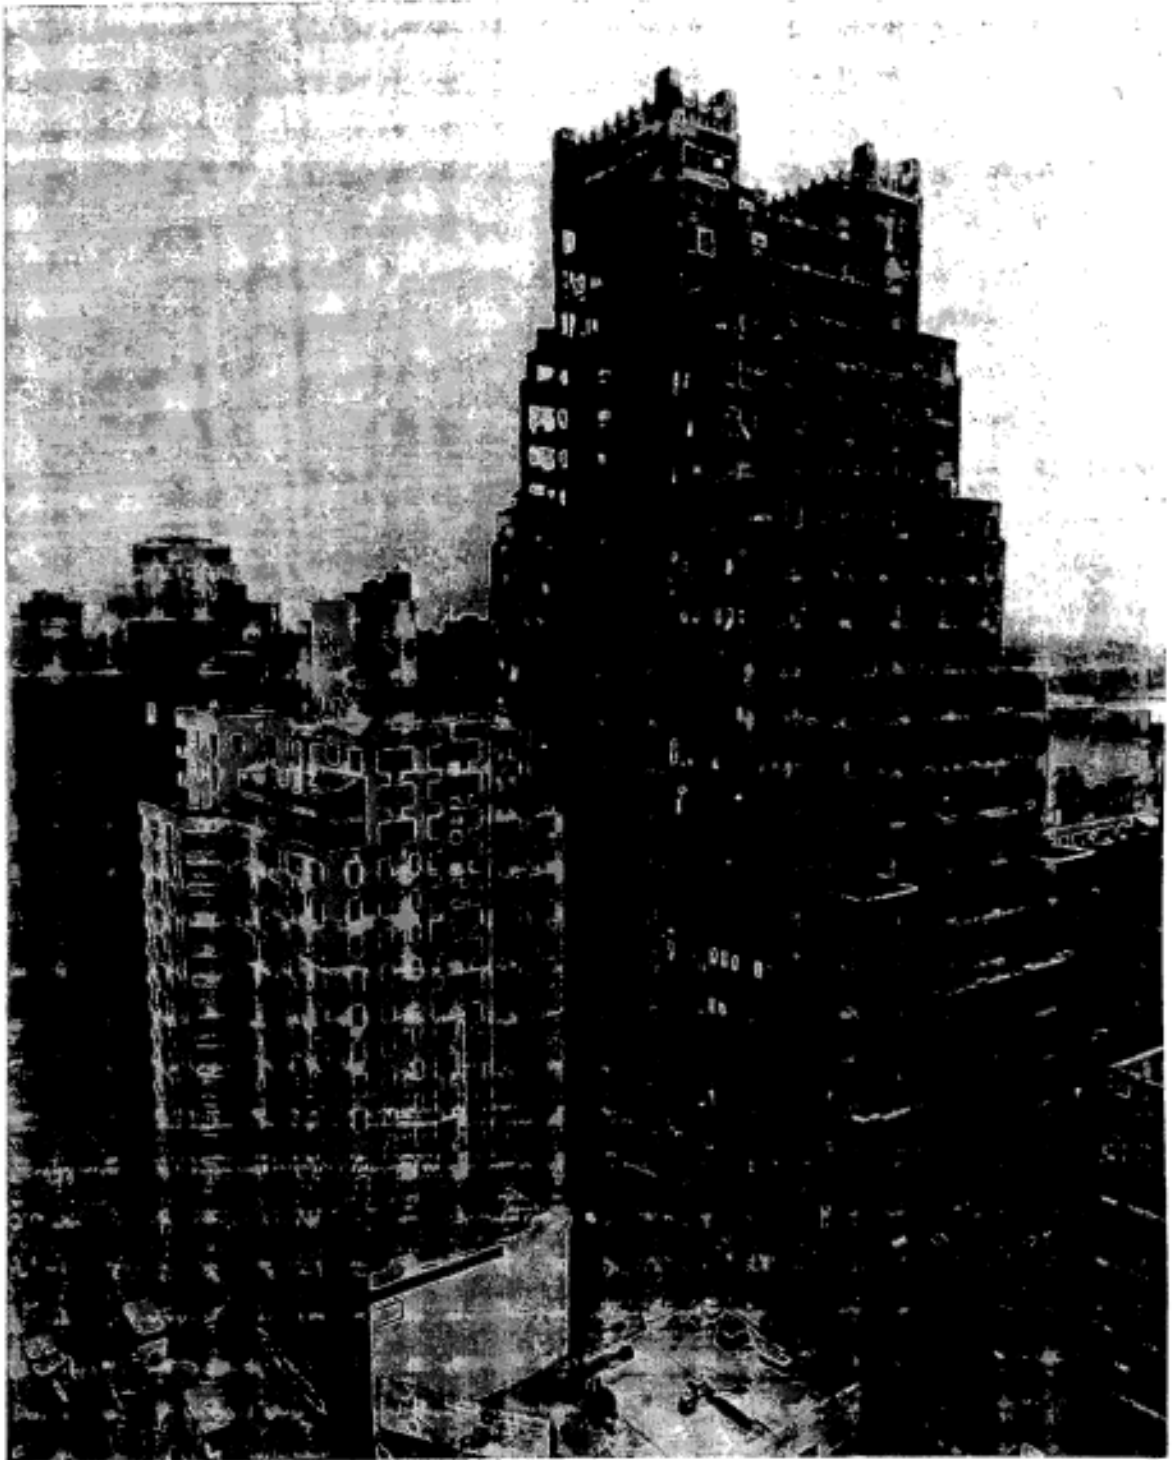
The accumulated natural gas began to ignite in the basement and rapidly propagated up the elevator shafts to the second story from the top. The explosion blew out the west wall and the windows on all four sides of the building. It also smashed the windows, blasted in the walls, scattered debris on all floors, and caved in the roof of a restaurant in the adjacent apartment building. Windows in other buildings were smashed and broken glass showered into the street.

Although there were no fatalities, about 70 persons were injured by the blast, the flying debris, and the broken glass. Most of the persons injured in the explosion were in the apartment house. (See Figures 1 and 2.)

Figure 1. Accident site at 305 East 45th Street, New York City.

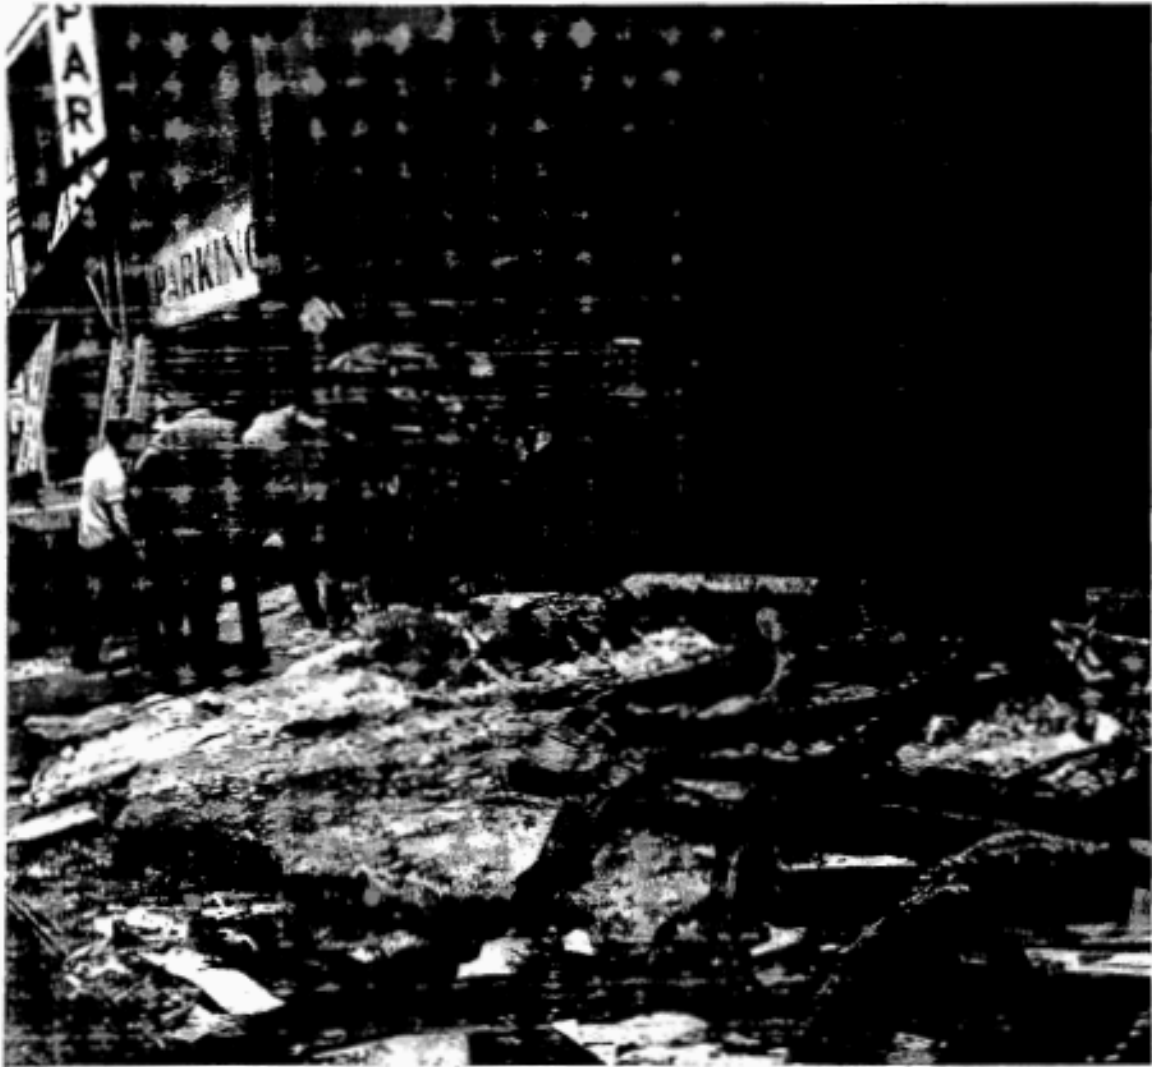
Figure 2. Building entrance after explosion.

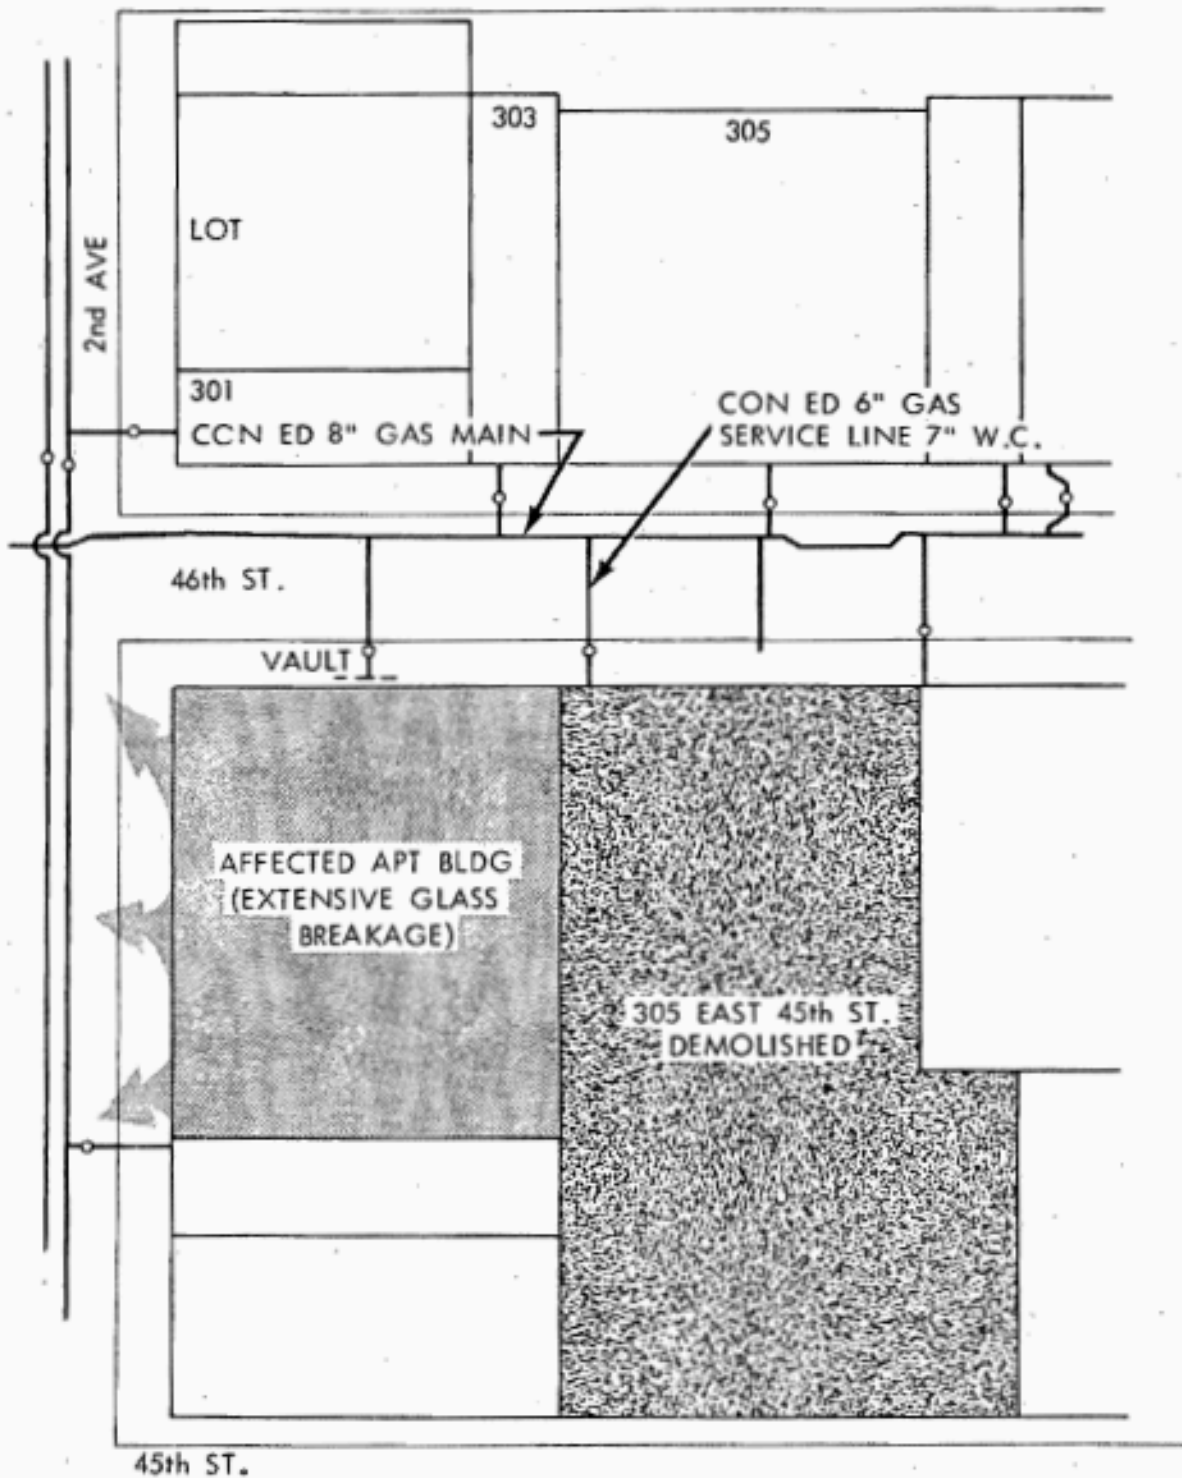
Figure 5. Service line connection from main to building.

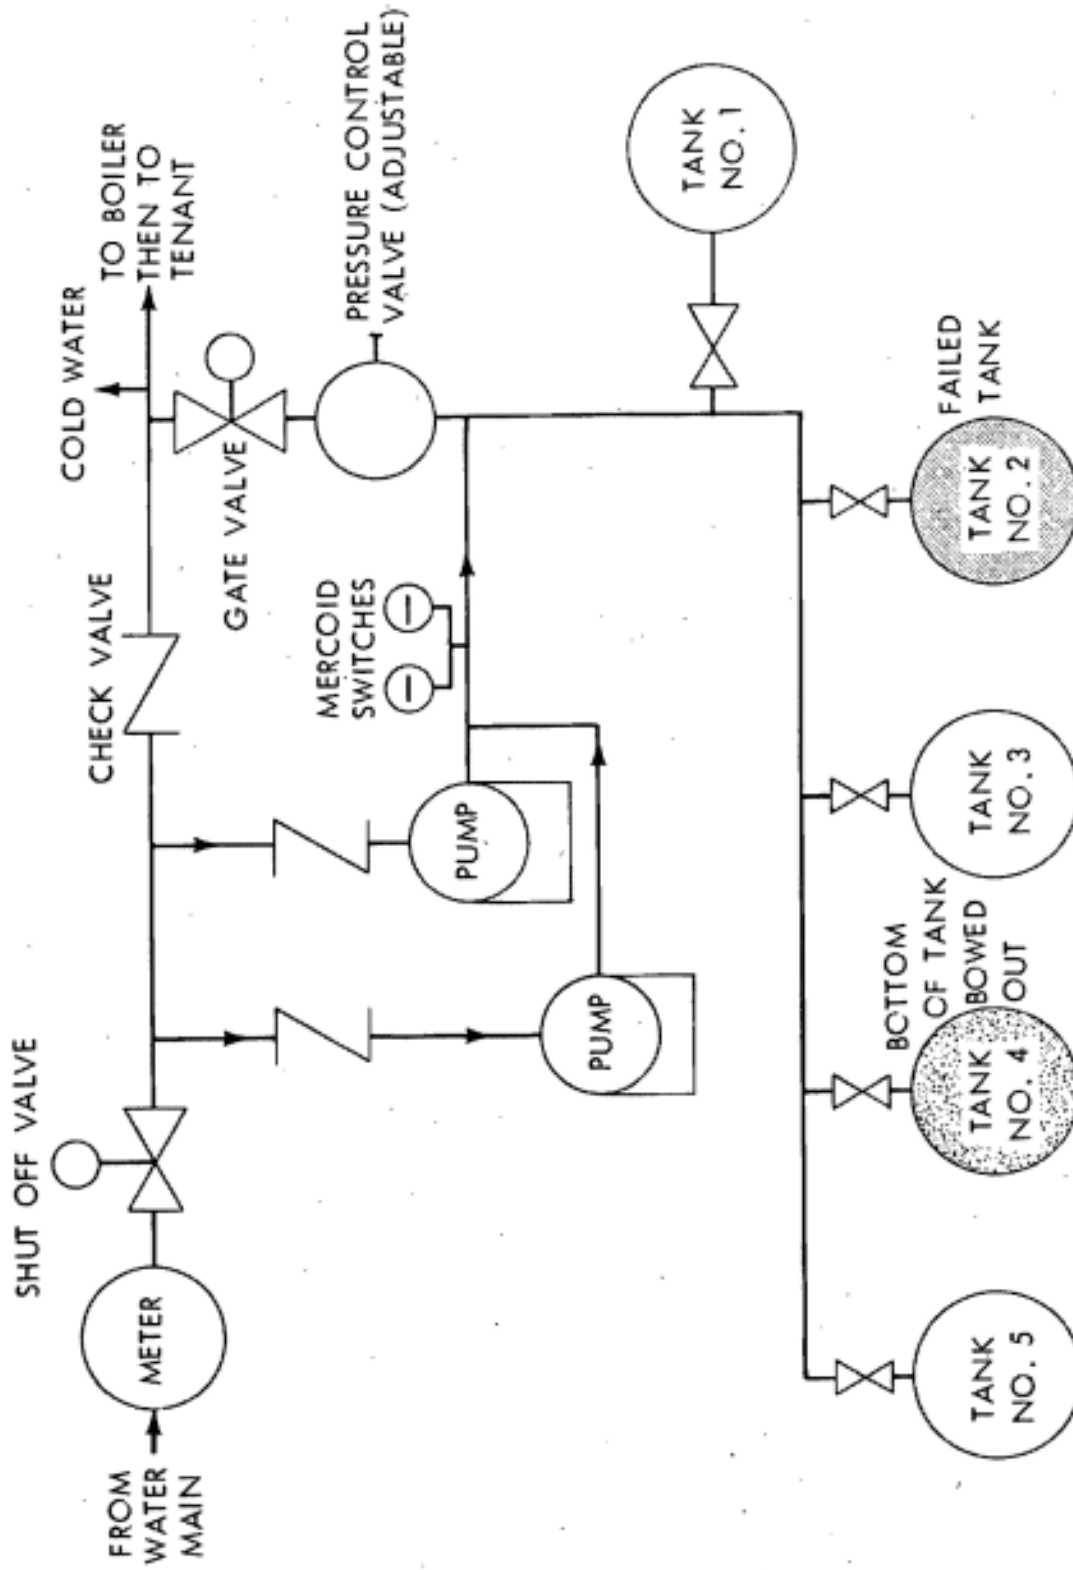
The pressure was still unsatisfactory. It fluctuated between 60 psig and 40 psig rather than remaining steady. As a result of many letters and telephone calls complaining about this problem, the firm on April 20, 1974, installed a pressure-regulating valve to maintain a constant pressure on the discharge side of the pumps. It is not known whether the system was pressure-tested or test-operated after the modifications were made that day. After the explosion, the pump was examined and found to have an impellor capable of producing 125 psig against a closed valve. (See Figure 7.)

Figure 7. Schematic plan showing arrangements of hydropneumatic tanks and controls in the basement at 305 East 45th Street.

The location of the hydropneumatic pressure tanks directly under the gas service line was a critical factor in this accident. The tanks should have been located at some other point in the basement where potential danger to existing facilities would be at a minimum. Currently, there is no Federal agency with authority to deal with this problem of piping location within buildings. Plumbing codes, which include gas piping, are set up on a State, county, and city basis, but there is no Federal code. There are three basic plumbing codes from which, in whole or in part, the States, counties, and cities have derived their own codes. The trade groups that developed these codes are the International Association of Plumbers and Mechanics Officials, the Southern Building Code Congress, and the Building Officials and Code Administration International, Inc. Some uniformly accepted guidance in this area of plumbing location is needed.
