PIPELINE ACCIDENT REPORT

NEBRASKA NATURAL GAS COMPANY
PATHFINDER HOTEL EXPLOSION
AND FIRE

FREMONT, NEBRASKA

REPORT NUMBER: NTSB-PAR-76-6

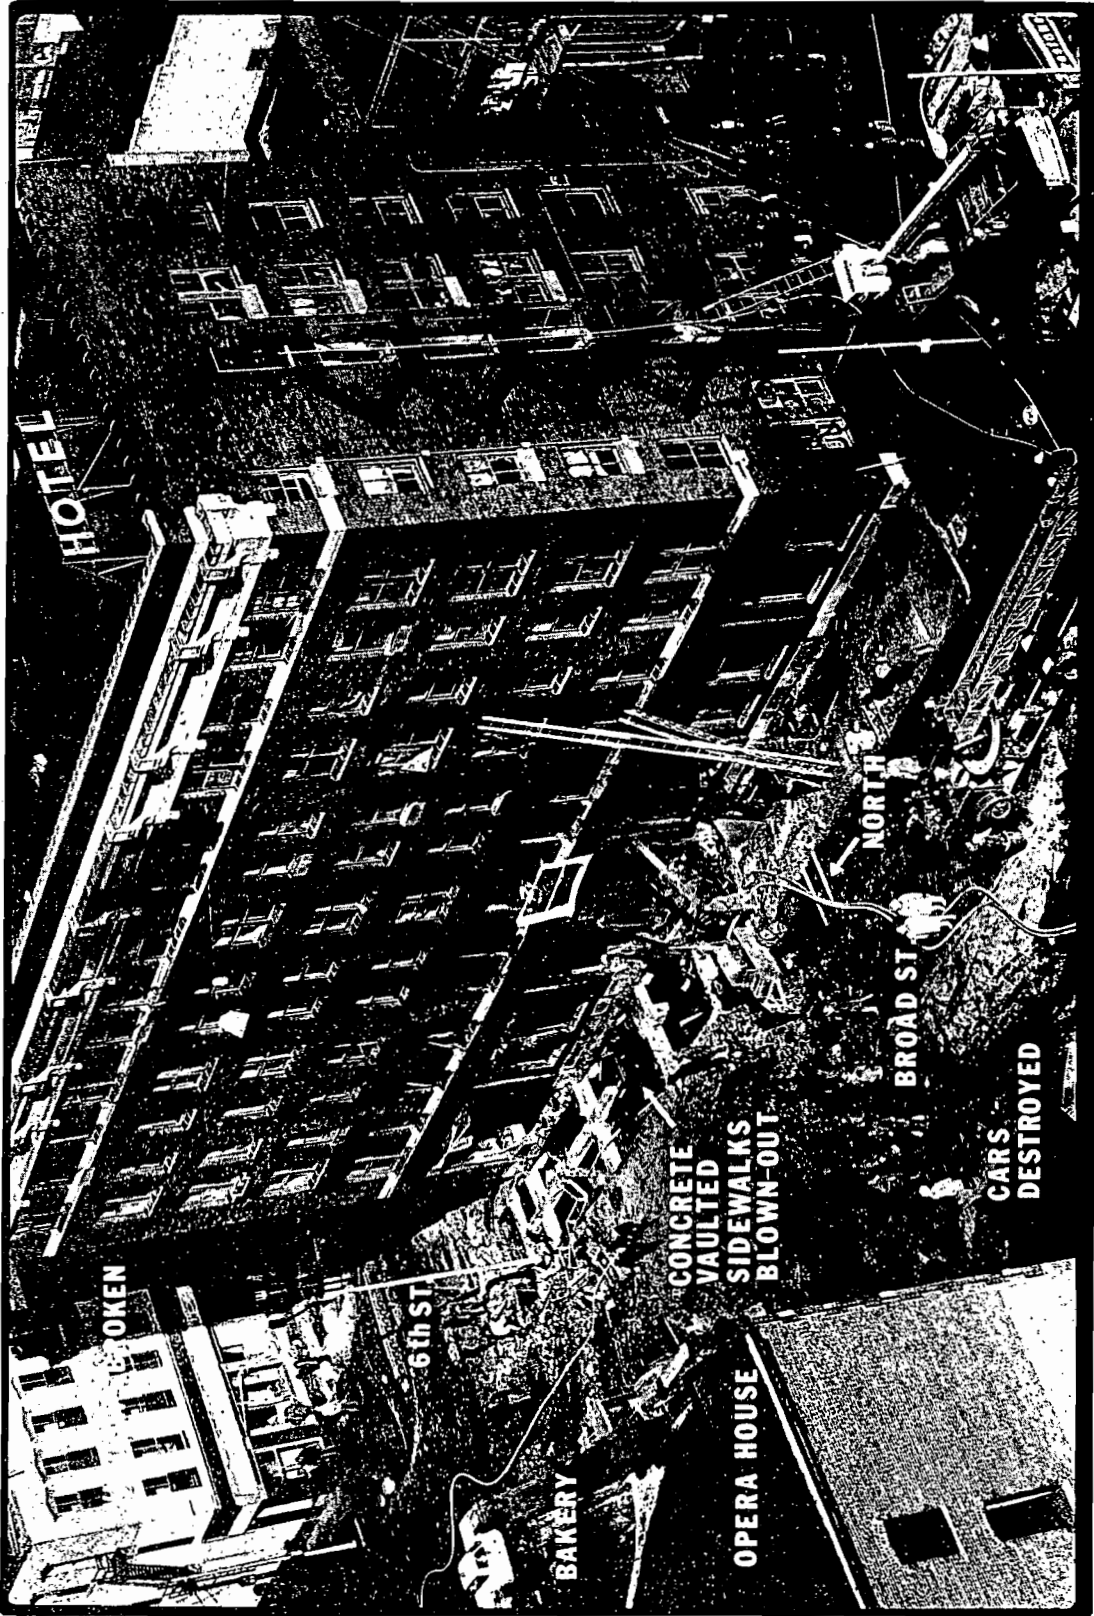
The Fremont fire department and fire departments from nearby communities responded to the fire, which began on the northwest corner of the hotel. As the firemen were fighting the blaze, several firemen saw fire burning in the street about 12 feet from the northwest corner of the hotel. The firemen extinguished the fires by early afternoon. (See Figure 1.)

Figure 1. South and West sides of Pathfinder Hotel.

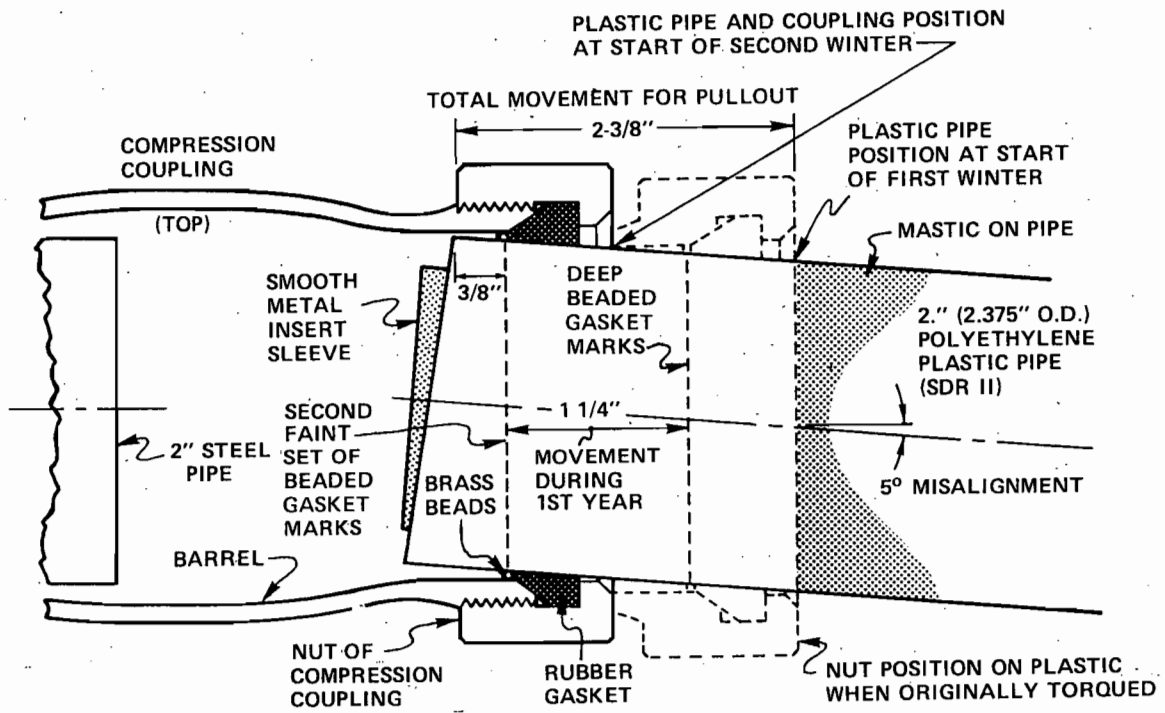
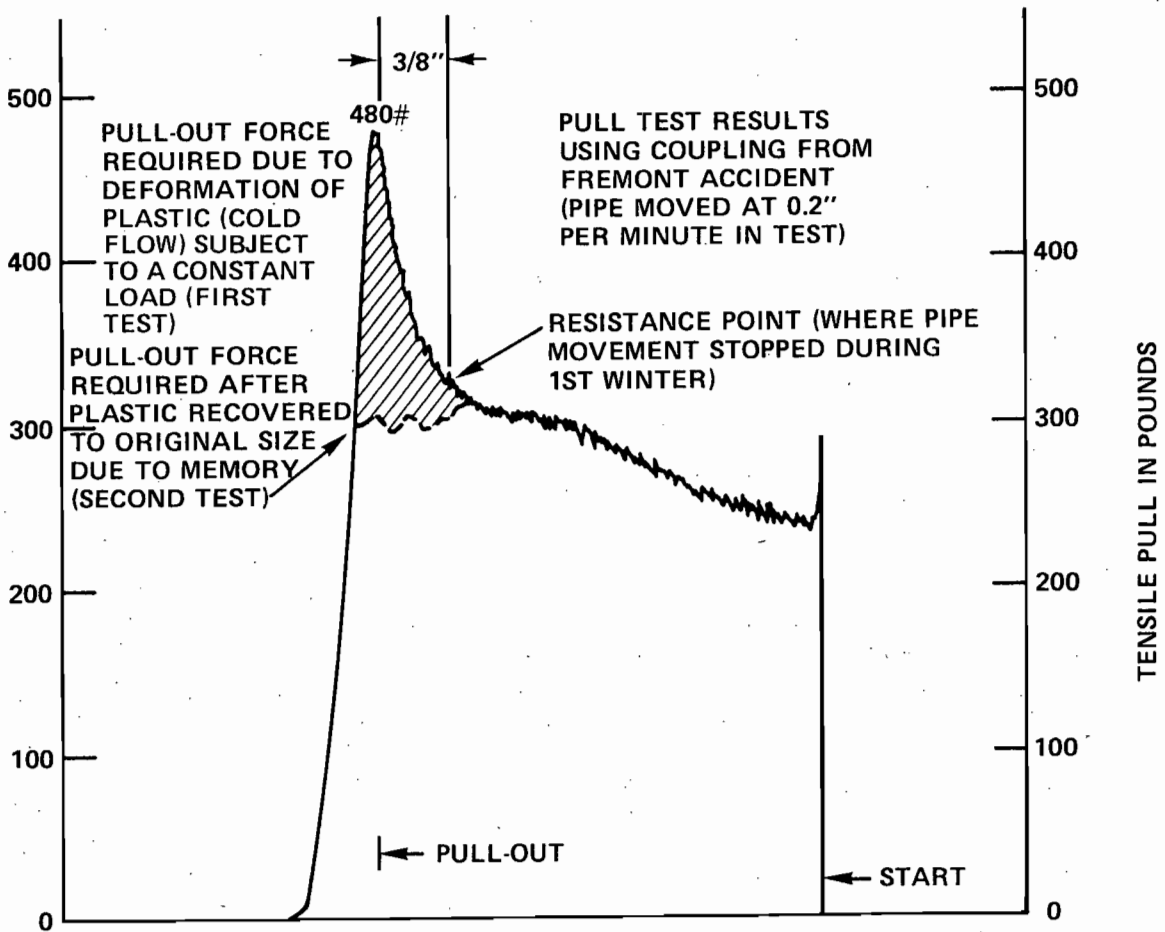
Figure 4. Cross-section of plastic pipe within compression coupling, and force diagram.

When the pipe was installed, the compression nut was tightened with a 24-inch wrench, which would provide an average torque of 150 foot-pounds. The brass-beaded rubber gasket made deep marks on the pipe, which indicated that the pipe remained in its original position for about 6 months. (See Figure 4.)

During the first winter after installation, the ground temperature at the pipe depth did not get as low as it did during the second winter because the ground was insulated by a blanket of snow the first year. Thermal contraction created a pullout force of about 300 pounds. Because of a property of plastic which is known as cold flow, ^{5/} this force was not enough to pull the pipe completely out of the gasket.

As the pipe slowly pulled out of the gasket, the forces created by the compression gasket caused the plastic to cold flow toward the end of the pipe, inside the gasket. This bunching of the plastic made the outer diameter (OD) of the pipe larger. When the plastic wave reached 3/8 inch from the end of the pipe, it could not move further, and the plastic started to ball up inside of the gasket. It then would have required 480 pounds of force to pull the pipe out of the gasket because of the plastic wave. Since only about 300 pounds of force were available, the forces created by thermal contraction and by the compression gasket equalized and the plastic pipe stopped moving.

Since there was no insulating layer of snow during the second winter, cold temperatures penetrated the ground. The temperature differential of the pipe between the day that it was installed and the day that the hotel exploded was at least 24°F, but it probably was closer to 30°F. Given this temperature range, the force which was caused by thermal contraction would have been between 500 and 623 pounds. (See Appendix B.) The test with the partially inserted pipe indicates that with only 3/8 inch of pipe inserted in the coupling, there is not enough plastic material inside the gasket to cause a wave to build up and, therefore, only 300 pounds of force are required to pull the pipe out of the coupling.
