**CONSOLIDATED GAS SUPPLY CORPORATION  
PROPANE PIPELINE RUPTURE AND FIRE**

**RUFF CREEK, PENNSYLVANIA**

**JULY 20, 1977**

**REPORT NUMBER: NTSB-PAR-78-1**

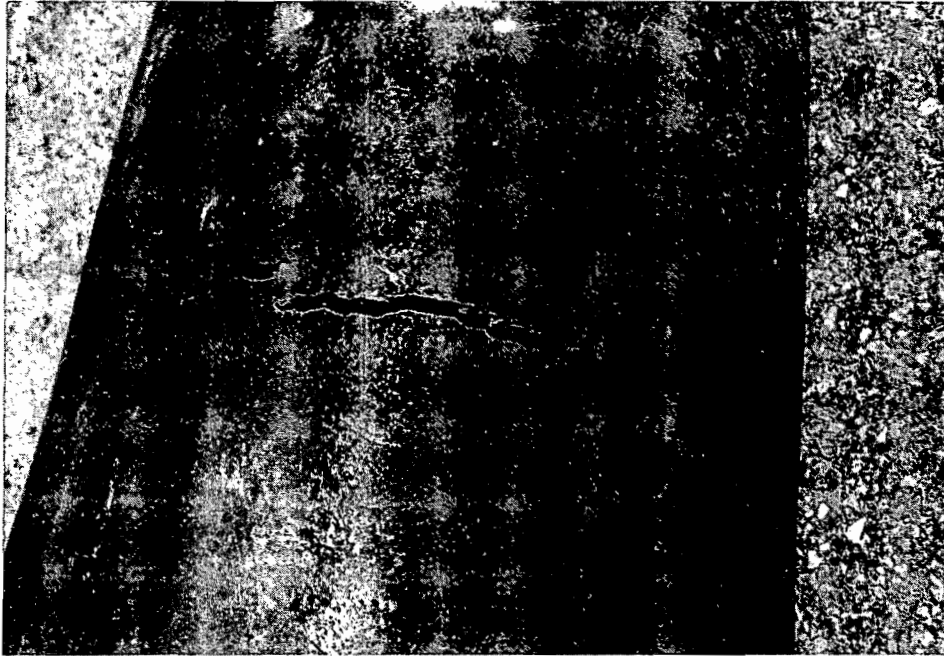
A segment of 12-inch pipe, approximately 33 feet long, that contained a 13° overbend which had been made in the field during construction was removed for examination. The pipe had a 10-inch-long fracture which had opened 1/8 to 1/4 inch (See figure 5.) The fracture was approximately in the center of the convex side of the curved region and was oriented transversely to the longitudinal axis of the pipe. Approximately 1,800 barrels (75,600 gallons) of liquid propane were vaporized and burned by the fire.

Figure 5. Ten-inch-long crack in 12 3/4-inch outside diameter, bare steel pipe.

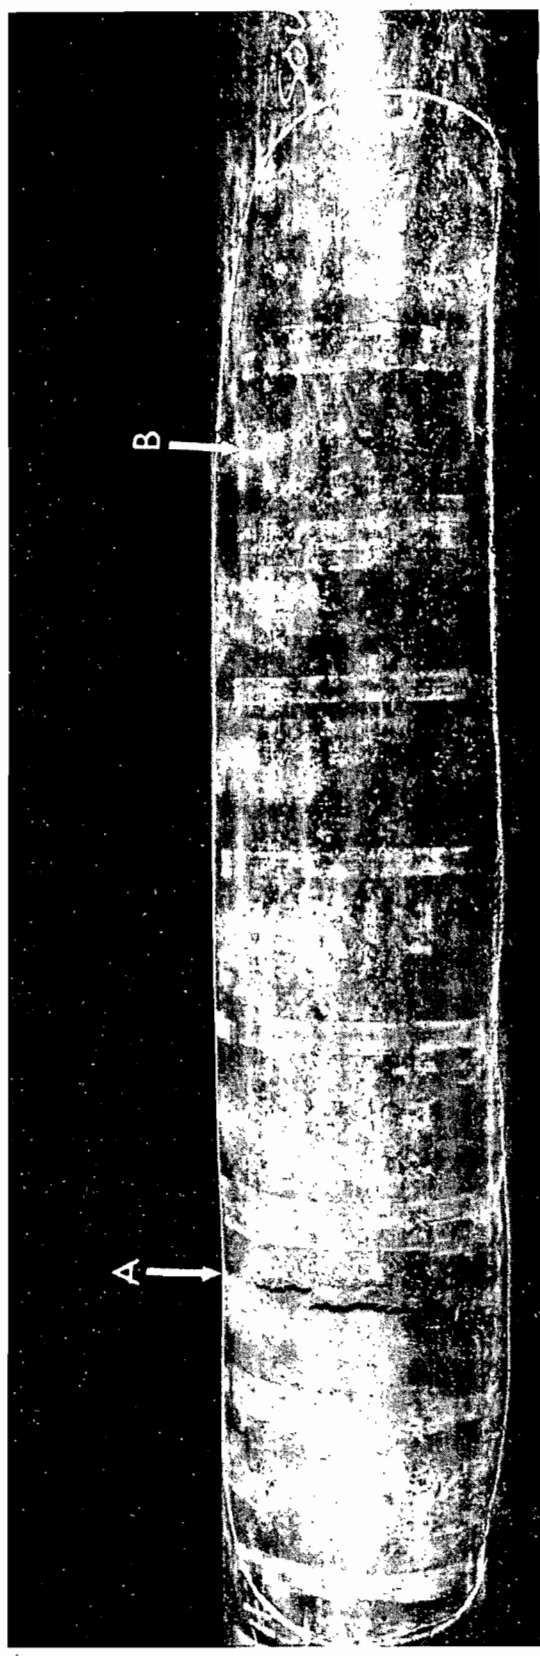
Figure 7. Area of stress-corrosion cracking on top of overbend.

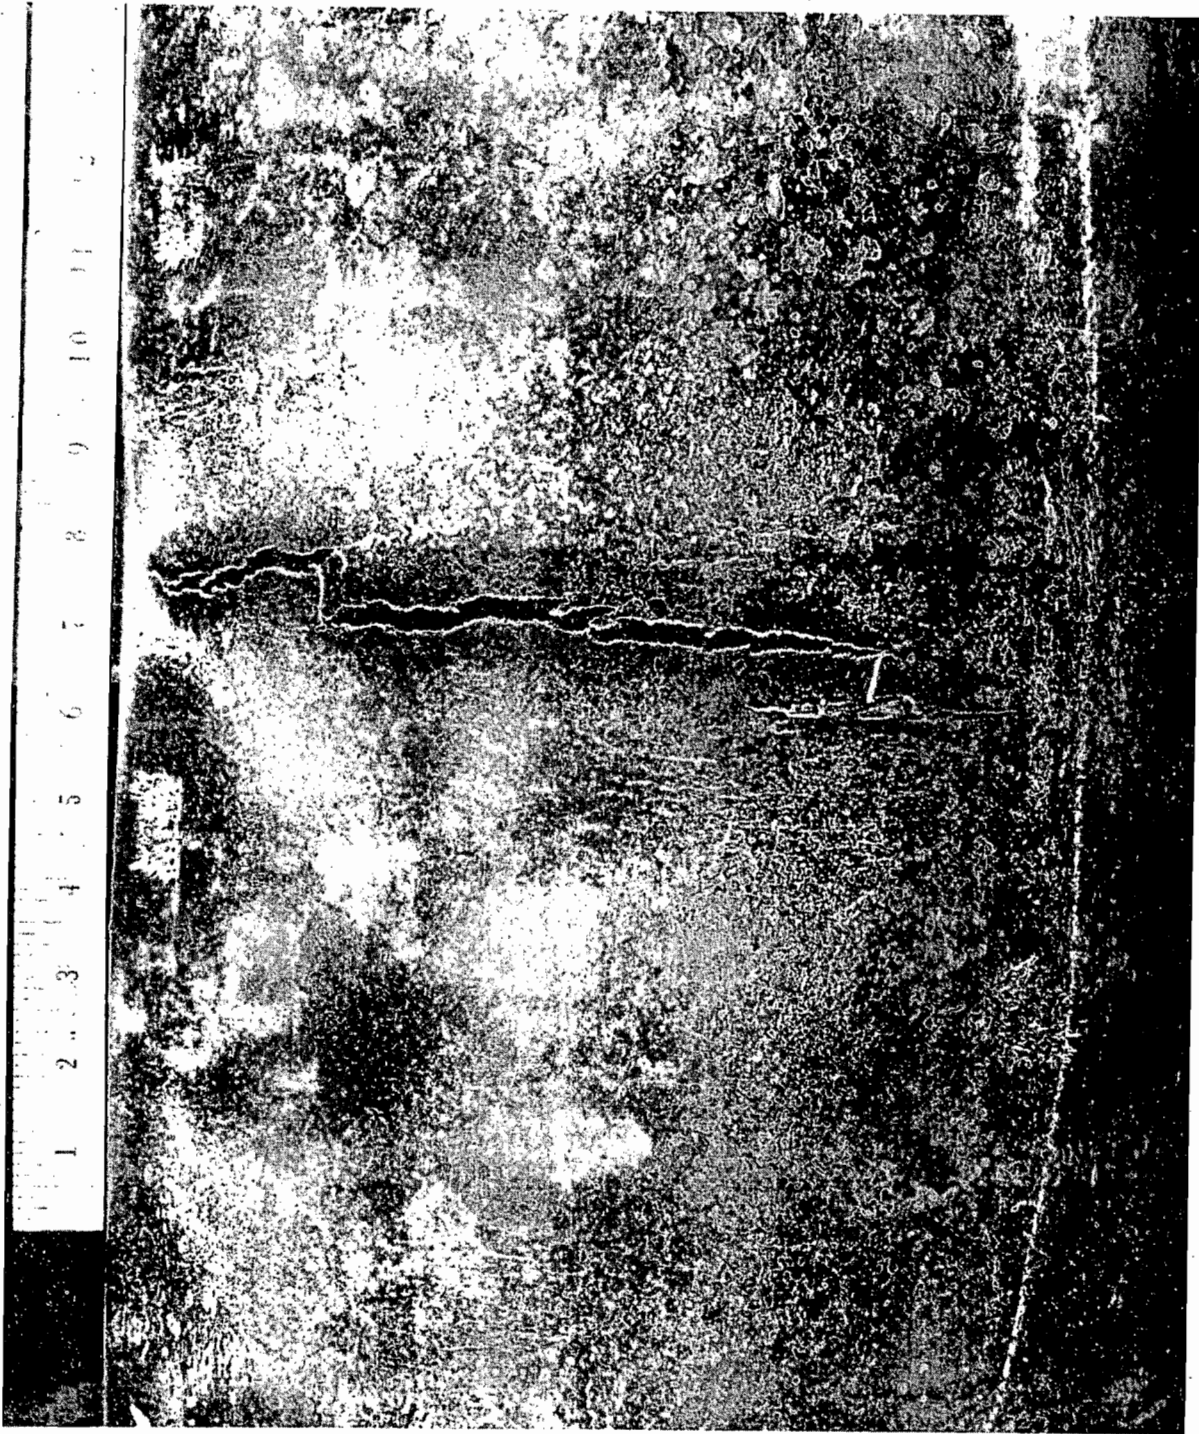
Figure 8. Higher magnification view of the secondary cracks around the primary fracture in area A (see figure 7) on the outside surface of the pipe. About 50 percent of the cracks in area A are shown.

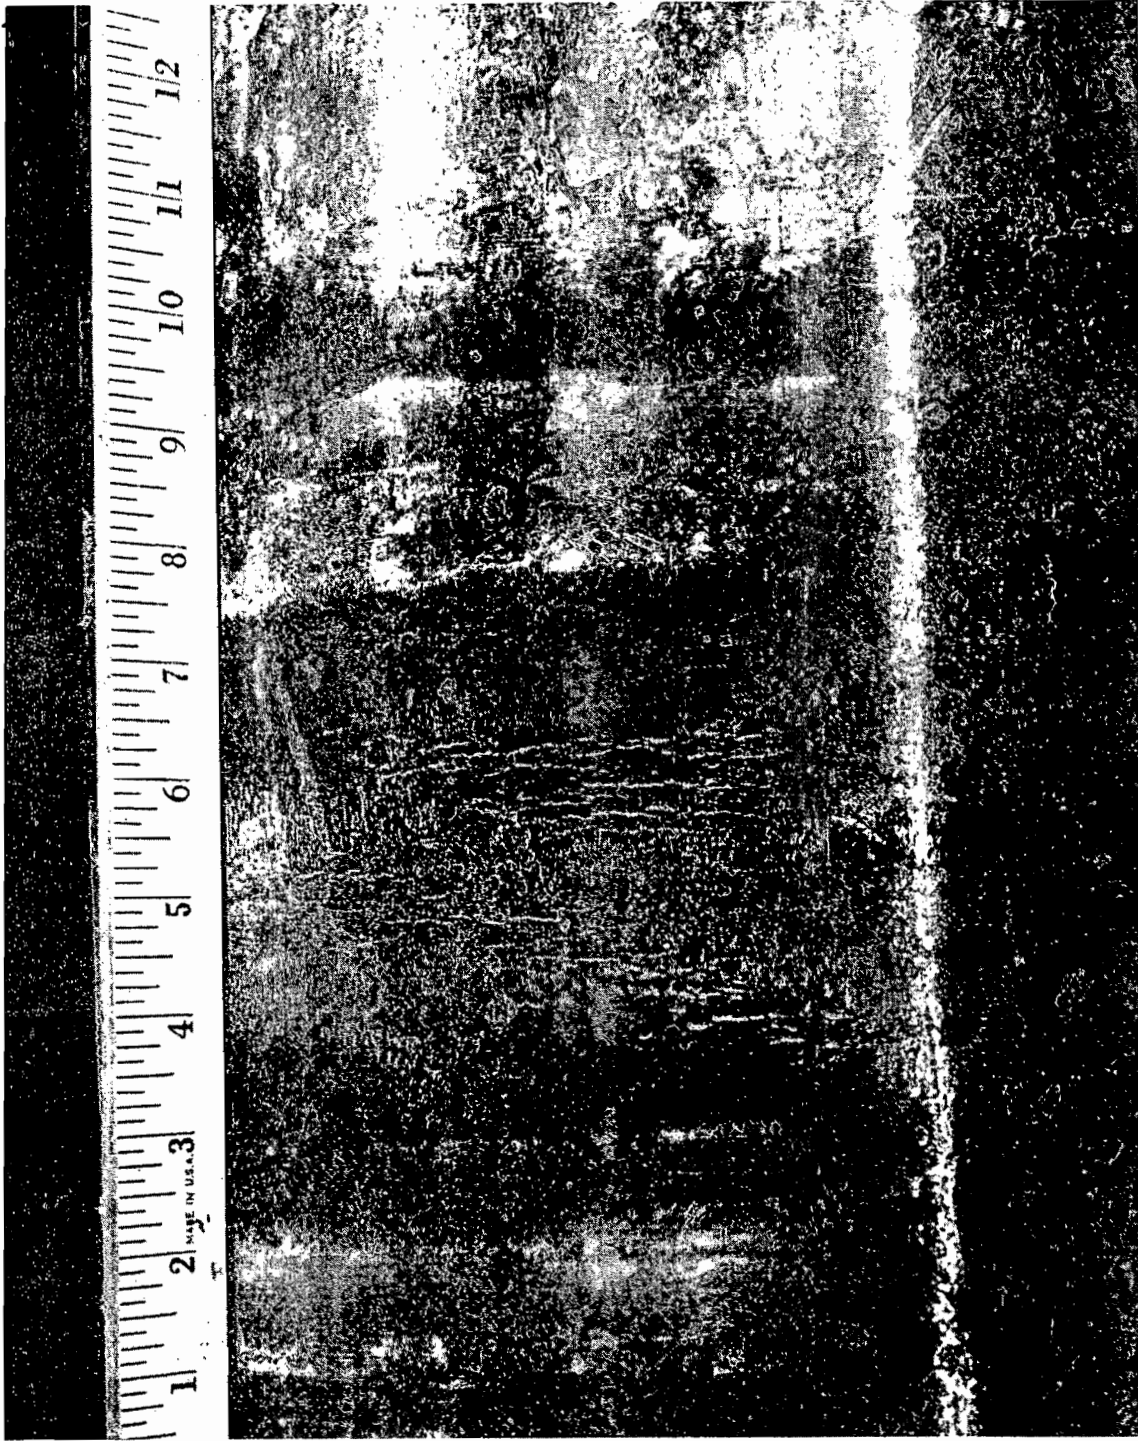
To more closely assess the surface condition of the pipe, the surfaces were examined for other cracks by a magnetic-particle-inspection technique. No cracks were found parallel to the longitudinal axis of the pipe on the outside surface. However, cracks were found transverse to the axis of the pipe (parallel to the primary fracture). Cracking occurred within a band about 56 inches long and about 13 inches wide on the convex side of the bend in the pipe. (See figure 7.) The cracks occurred in clusters and were revealed by the magnetic particles. Secondary cracks were found near the primary fracture and up to 13 inches to the north. (See figure 8.) There was a second cluster of secondary cracks about 43 inches south of the primary fracture near the beginning of the overbend curvature. (See figure 9.)

Figure 9. Higher magnification view of the secondary cracks on the outside surface of the pipe in area B (see figure 7). About 50 percent of the cracks in area B are shown.

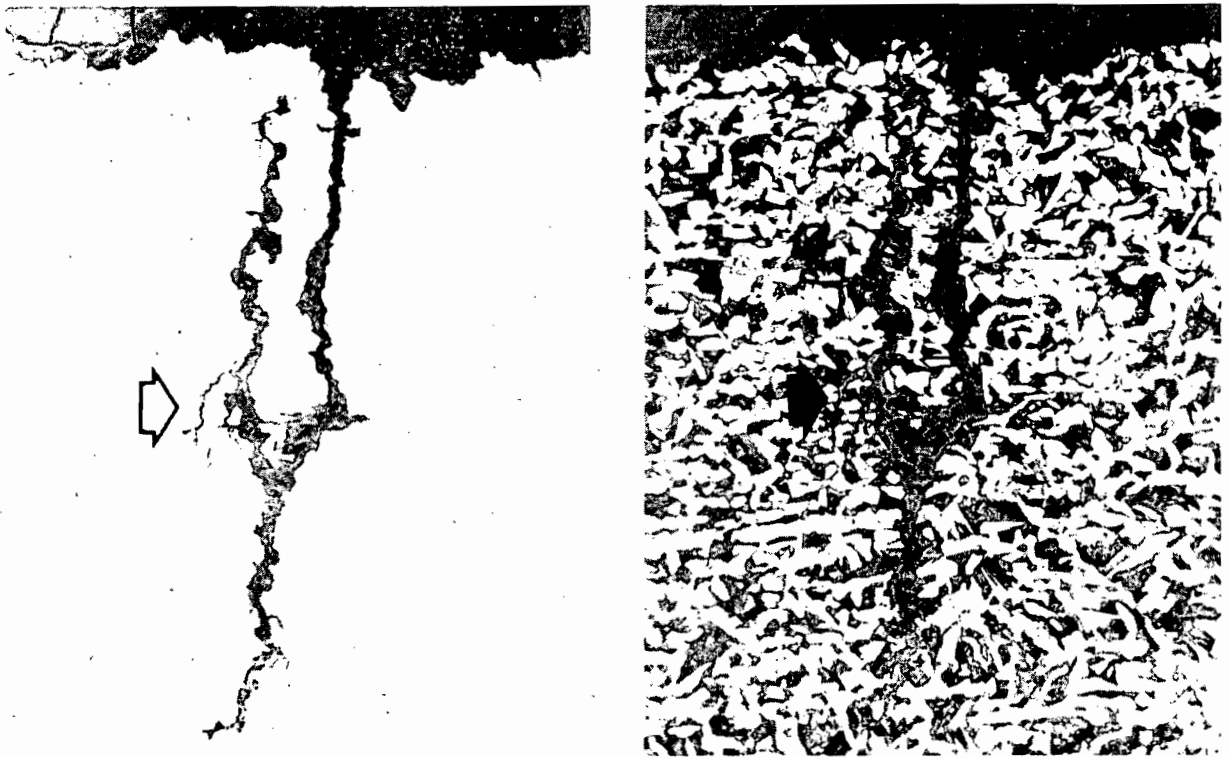
Figure 11. Longitudinal metallographic section through a secondary crack at higher magnification. Left photograph shows crack as polished. Right photograph shows same area etched.

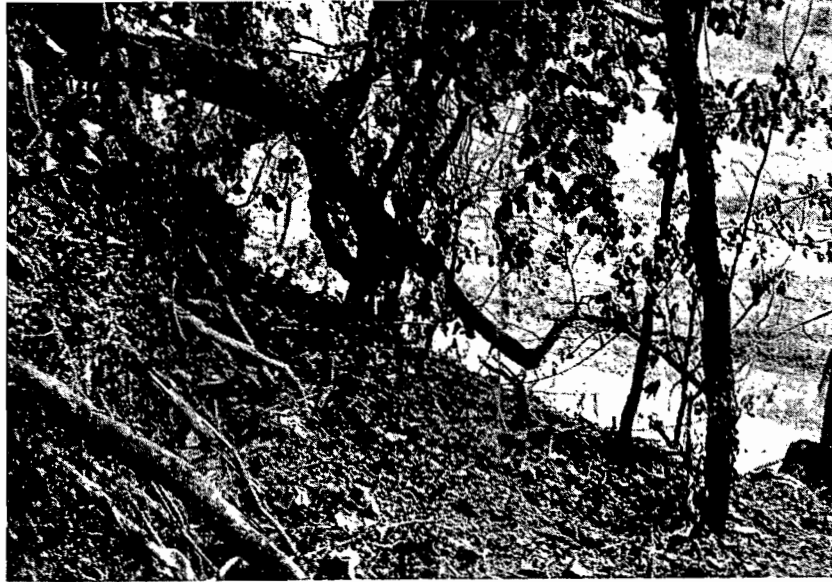
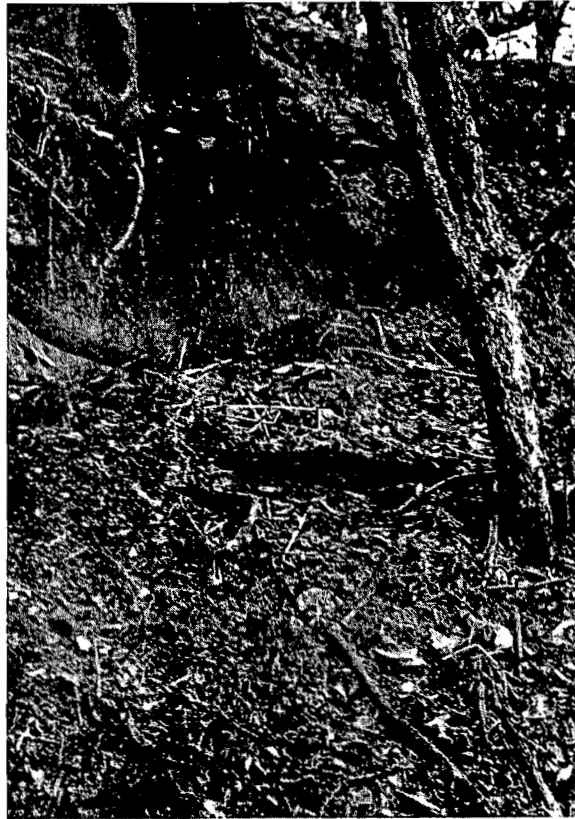
Often the ground surface is affected by the pulling of pillars, especially if there are no other coal seams or rock formations over the mined-out area to bridge the underground void. In this particular case, there is evidence of extensive ground subsidence. Approximately 200 feet southwest of the pipeline rupture, there was a 6-foot drop in the side of a hill due to underground subsidence. (See figure 12.)

Figure 12. Earth subsidence in burn area west of Township Roads T-550 & T-552.
