# **NATIONAL TRANSPORTATION SAFETY BOARD**

## **PIPELINE ACCIDENT REPORT**

**KANSAS PUBLIC SERVICE COMPANY, INC.  
EXPLOSION AND FIRE  
LAWRENCE, KANSAS  
DECEMBER 15, 1977**

**REPORT NUMBER: NTSB-PAR-78-4**

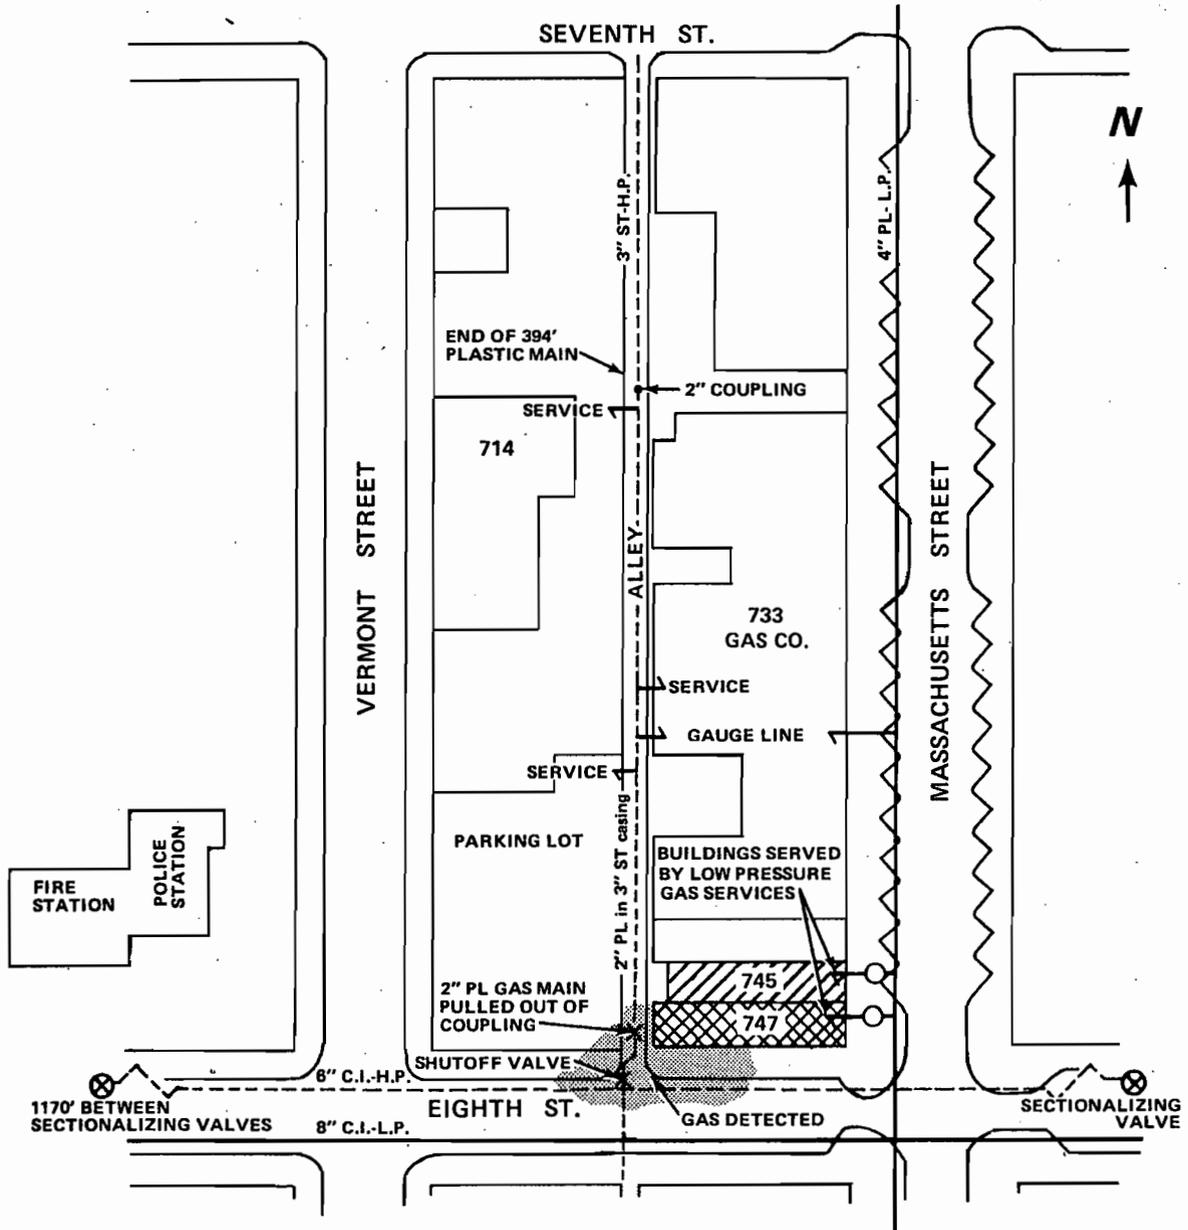
Figure 2. Plan of accident site.

of the possibility of other explosions. The gas company did not have a written procedure to guide their emergency response personnel as to what their responses to this type of emergency should be, or what liaison activities should be carried out with the fire department. The atmosphere of the buildings were not checked with CGI's until later in the day when the company's regular day crews reported for work. The gasmen also shut off the low-pressure gas supply to the burning buildings at curb boxes in Massachusetts Street. The two buildings that were destroyed by the high-pressure gas leak were not served by the high-pressure gas main in the alley. (See figure 2.)

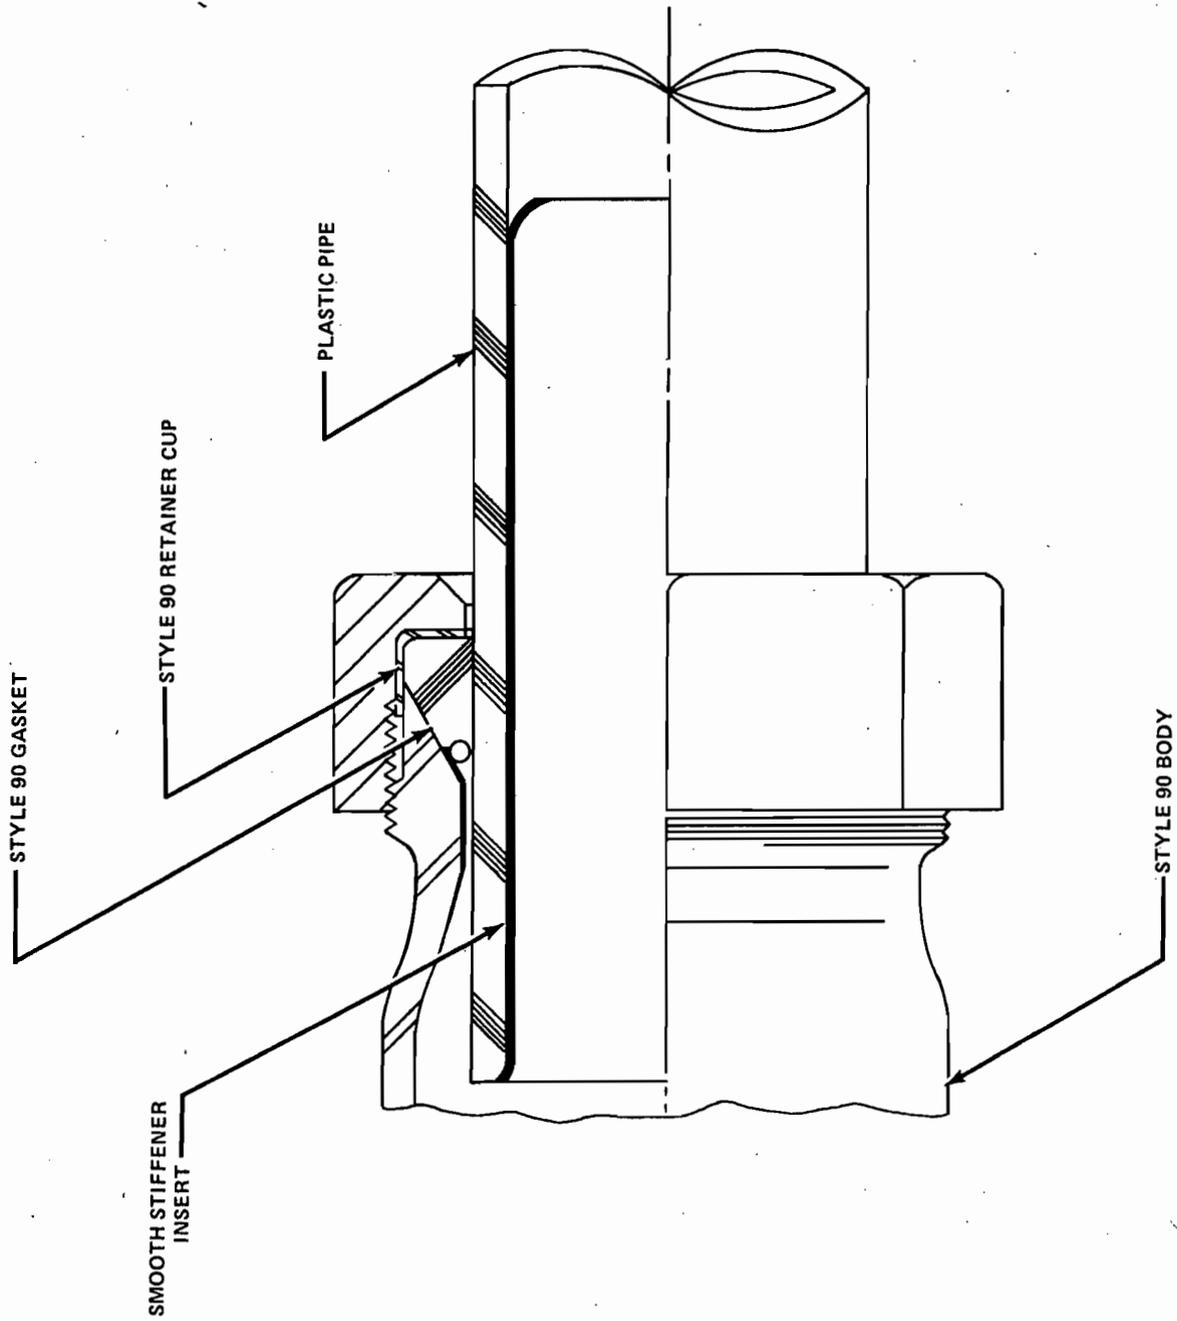
Figure 5. Dresser Style 90 coupling with smooth stiffener insert.

Since the accident, the gas company has been excavating locations where standard compression couplings might have been used to join inserted plastic pipe to steel pipe. The standard compression couplings found are replaced with the POSI-HOLD couplings.

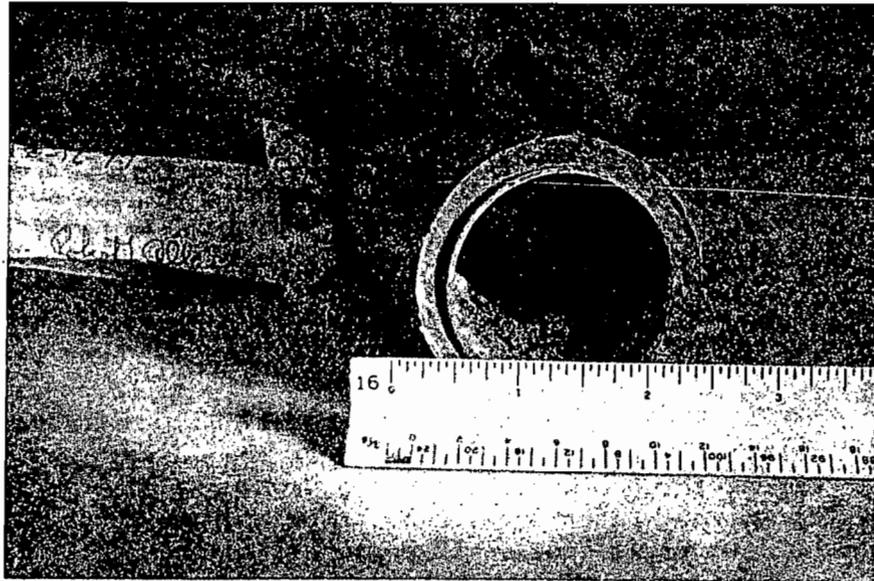
The test sections of plastic were cut into lengths of 18 inches each. The test sections were each bowed about 0.3 inch because the pipe had been coiled during manufacture, and had retained some of this initial "set." (See figure 6.)

The pipe wall thickness averaged about 0.23 inch, which was within the allowable dimensional tolerances specified in ASTM D 2513. In addition to being bowed, all of the sections of pipe were somewhat flattened and out-of-round; however, the average values were sufficient to indicate that the pipe probably met the required nominal dimension of 2.375 inches at the time of manufacture. For "roundable" plastic pipe, the specific tolerances for out-of-round are required to be met only at the point of manufacture. This variation in the pipe diameter was attributable in part to the fact that it had been coiled.

Figure 6. End view of plastic pipe showing bow, bias cut, and metal stiffener.

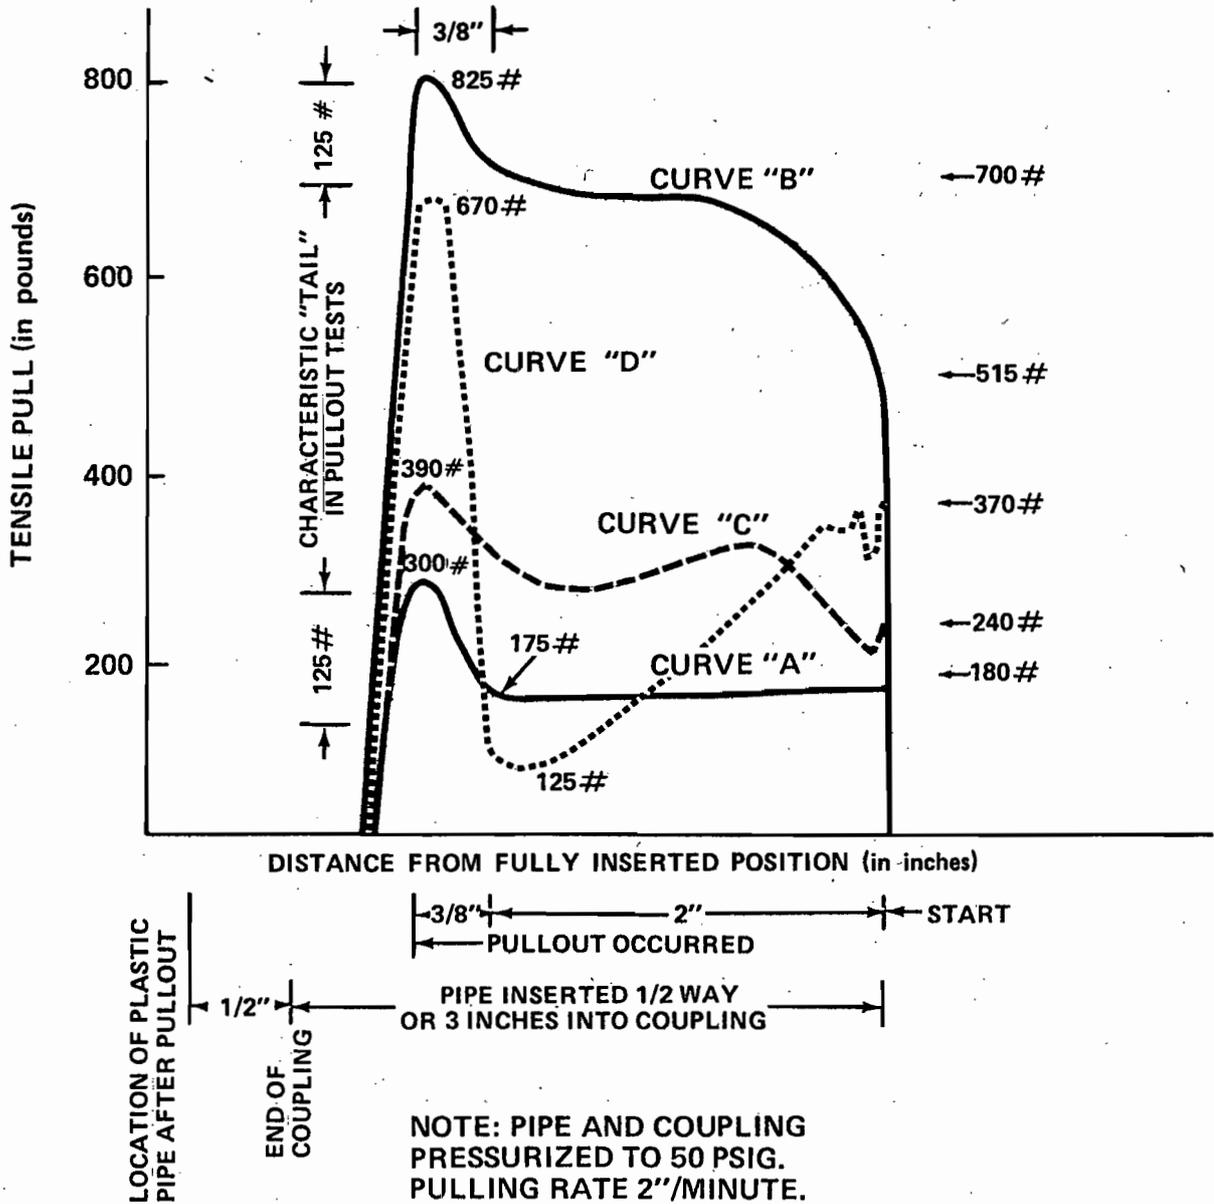
In one of the tensile tests simulating actual field conditions, the nut on the coupling was torqued to 150 ft-lbs; however, the nut was not retorqued after 15 minutes as in the other tests and the coupling was immediately pressurized to 50 psig instead. In this test, using a new gasket in a coupling similar to the one from the accident site, the torque relaxed 46.7 percent--down to 80 ft-lbs--after 15 minutes. The pipe started to move with 515 pounds of force and it required 700 pounds of axial loading to keep the pipe moving at 2 in./min. After 1 minute, the pipe had moved 2 inches to the point where the gasket was near the end of the pipe. In the next 3/8 inch of movement, the load required for pullout increased 125 pounds--from 700 pounds to 825 pounds--and the pipe pulled out. (See curve B, figure 7.)

Figure 7. Diagram showing tensile forces at various pipe locations within couplings. Curve B--uncompressed pipe in new gasket. Curve A--previously compressed pipe and old gasket from accident site. Curve C--uncompressed pipe and old gasket in coupling from accident site. Curve D--previously compressed pipe and coupling from accident site with new gasket.

length, exhibited evidence of permanent compressive deformation on its outer circumference at approximately 0.19 to 0.25 inch from the outer face, i.e., in the area where the gasket appeared to have been in contact with the outer rim of the coupling barrel. The first test using the 2 1/2-year-old coupling and gasket with a piece of previously uncompressed plastic pipe indicated that the tensile forces necessary to keep the pipe moving at 2 in./min ranged between 220 and 390 pounds. There was no torque relaxation from 150 ft-lbs in this test either. (See curve C, figure 7.)

(curve B in figure 7). This was probably because the gasket had taken a permanent set in the 2 1/2 years that it had been installed and did not adequately transfer the gasket loading pressure from the compression nut to the plastic pipe. Based on the tests conducted by Dresser on Style 38 bolted couplings on 4-inch polyethylene plastic pipe, a gasket relaxation of 26 percent occurred in a little over 1 year. It was thought that machining and design differences between the boltless and the bolted style couplings could account for some of the above differences. However, it should be noted that the Dresser tests were on gasket relaxation, but the NBS tests were on pullout resistance --two different tests.

Referring to curve B of figure 7 and the calculations for a 30° F temperature differential which simulates the installation conditions, the pipe would have pulled partly out of the coupling, shortly after installation or during the first winter and then stopped because only 611 pounds of tensile force was generated by the thermal stress (plus 47 pounds of pullout force created by the 30-psig gas pressure). From the marks on the plastic pipe it is believed that more movement took place the following winter. In the 1976-1977 winter the pipe pulled until the end of the pipe approached the armored gasket and then stopped when the characteristic 125 pounds of additional pullout resistance was encountered.

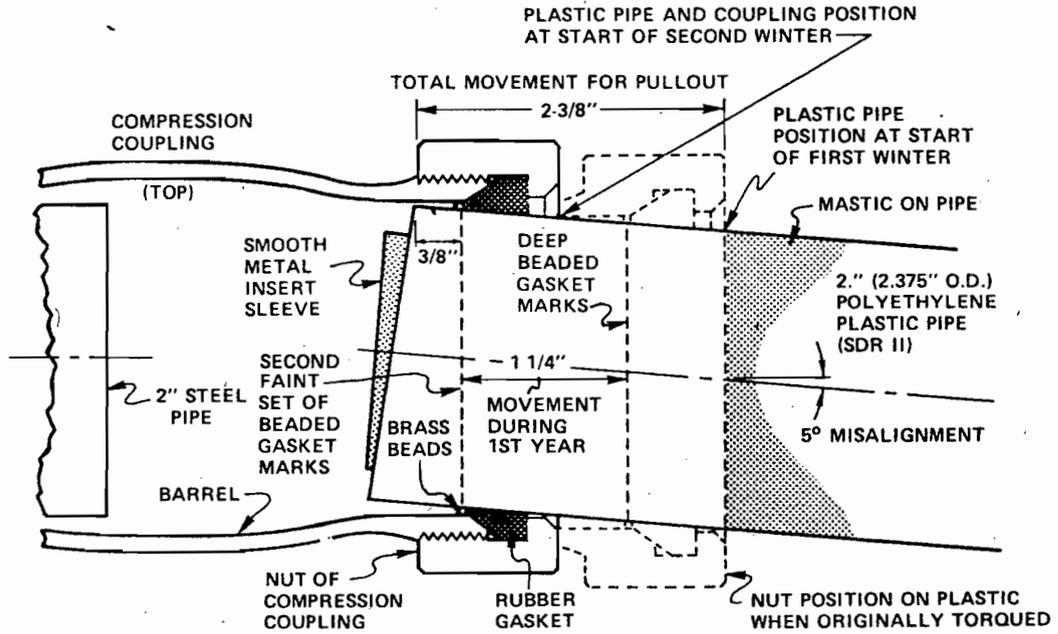
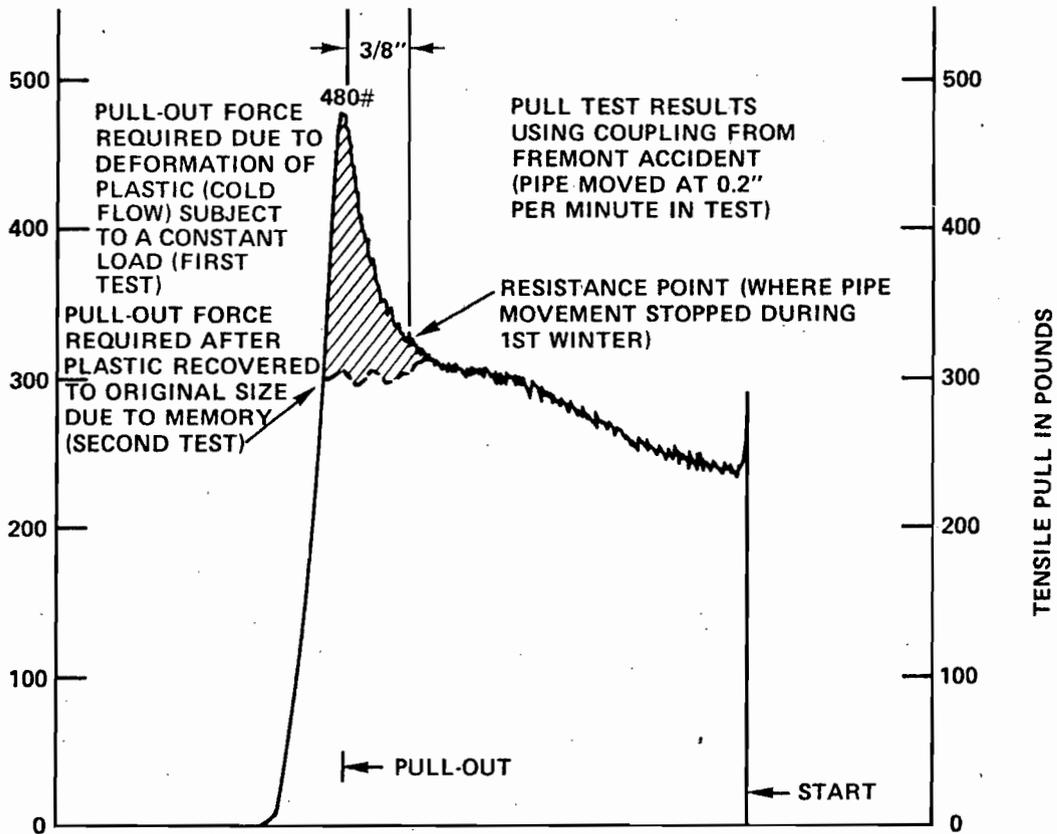
APPENDIX E

Cross-section of plastic pipe, from Fremont, Nebraska, accident, within compression coupling, and force diagram.
