PIPELINE ACCIDENT REPORT

**GAS SERVICE CO.
EXPLOSION AND FIRE
LONDON, KENTUCKY
JANUARY 16, 1979**

NTSB-PAR-79-2

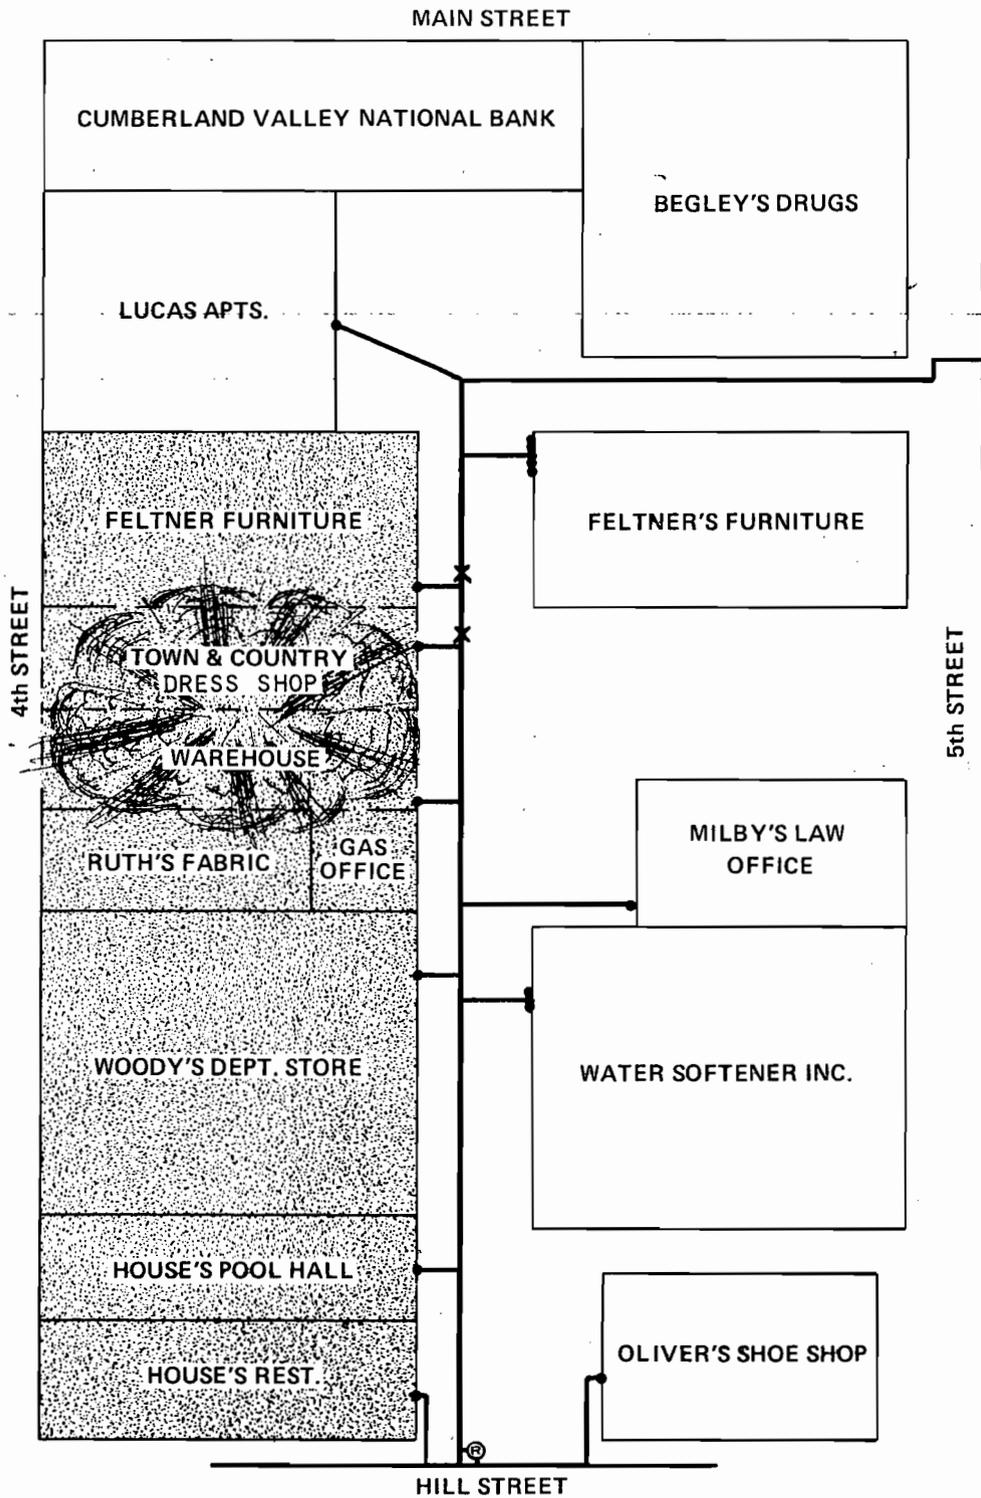
Gas company personnel commenced work at Hill Street where the 7-inch gas main was connected through a regulator to a 3-inch main to provide a loop in the low-pressure system. (See figure 1.)

On Friday, January 12, 1979, gas company personnel turned off the valves at the newly installed regulators and then increased the pressure on the 7-inch bare steel gas main from 4 ounces to 17 psig. The workers then returned to each regulator, replaced the previously removed orifice, and began relighting procedures ^{2/} inside each building served by gas. One worker walked over the area to check for leaks. He did not use a combustible gas indicator (CGI) but relied upon his nose to detect the odor of gas. Although he did not check any sewer manholes, he detected two leaks: one at the corner of 5th and Main Streets -- gas was seen bubbling through standing water -- and a smaller one in the alley behind 5th Street. (See figure 1.)

Figure 1. Plan of the accident site.
