# **NATIONAL TRANSPORTATION SAFETY BOARD**

## **PIPELINE ACCIDENT REPORT**

**PHILADELPHIA GAS WORKS  
NATURAL GAS PIPELINE RUPTURE,  
EXPLOSION, AND FIRE  
PHILADELPHIA, PENNSYLVANIA  
MAY 11, 1979**

**NTSB-PAR-79-3**

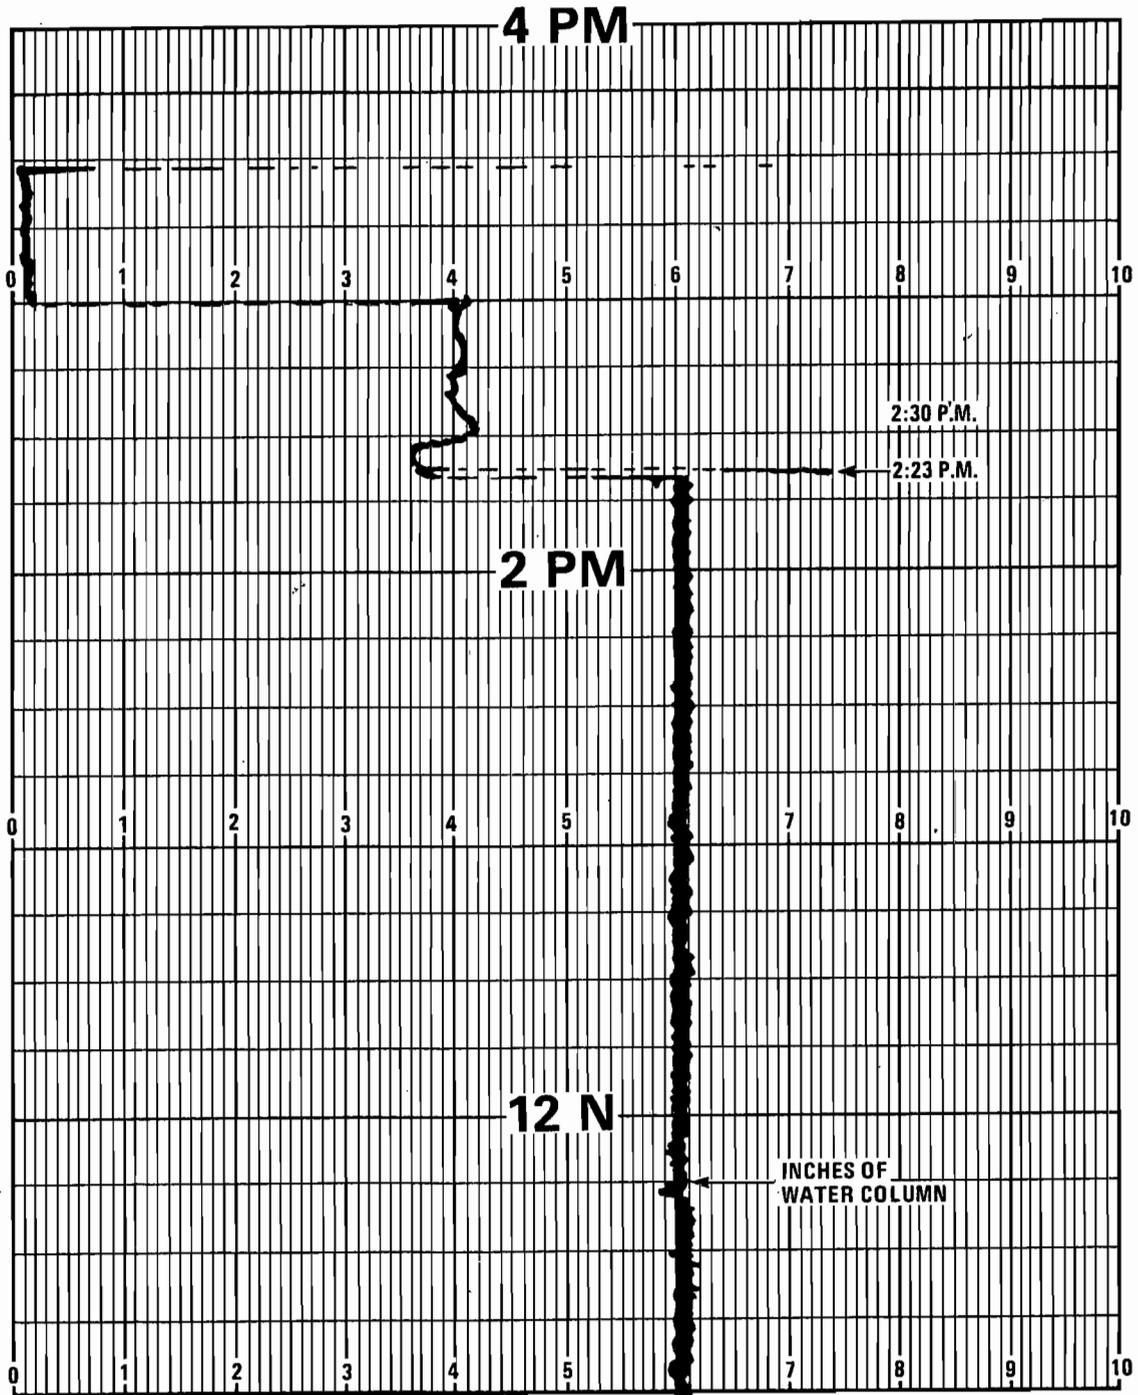
Figure 2. Pressure-recording strip chart.

At 2:30 p.m., a gas pressure recorder which was connected to the gas system that ran under Margaret Street, and located 1 1/2 blocks from the intersection, indicated that the pressure had dropped from 6 to 3.6 inches of water column. (See figure 2.) This information was telemetered into the PGW distribution department dispatcher office where an alarm sounded. A pressure specialist was dispatched to the location 1 1/2 blocks from the accident site. He checked the pressure chart which indicated a failure somewhere on the gas main. The chart showed the pressure drop in inches of water column and the time of the drop in pressure. The pressure-recording chart was found to be 7 minutes slow, which meant that the indicated 2:23 p.m. pressure drop actually occurred at 2:30 p.m. While the specialist was checking out the equipment, the explosion occurred.

been noticed, and the pressure-recording chart 1 1/2 blocks away had been constant in the recent past. Therefore, the Safety Board concludes that the gas main collapsed at 2:30 p.m. on May 11, 1979, as indicated by the rapid drop from 6 to 3.6 inches water column shown on the pressure-recording chart.

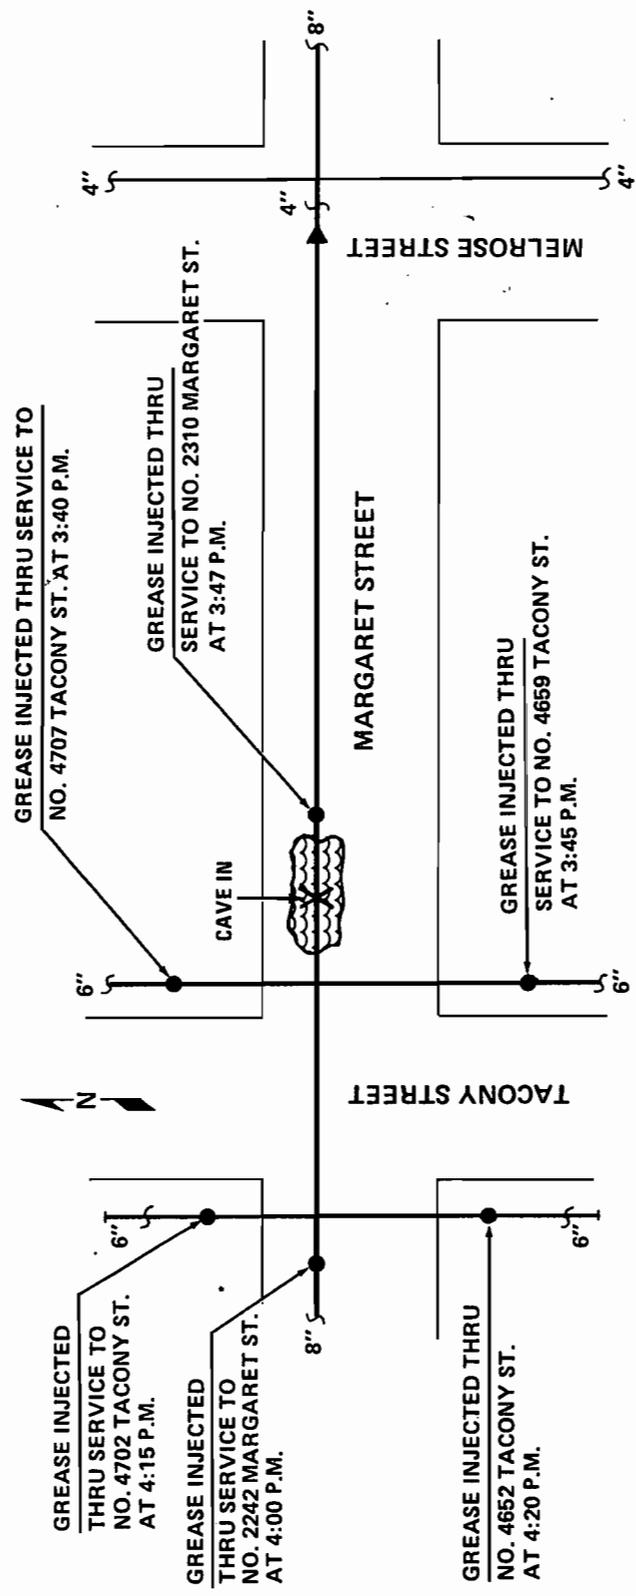
Figure 4. Grease injection locations.

At 7:30 p.m., while the search for survivors continued, PGW customer service crews continued the gas odor survey of all houses near the accident site. At 9:45 p.m., the PGW distribution crew completed cutting and capping all natural gas mains leading to the intersection. Six "greased off" locations were capped. (See figure 4.)

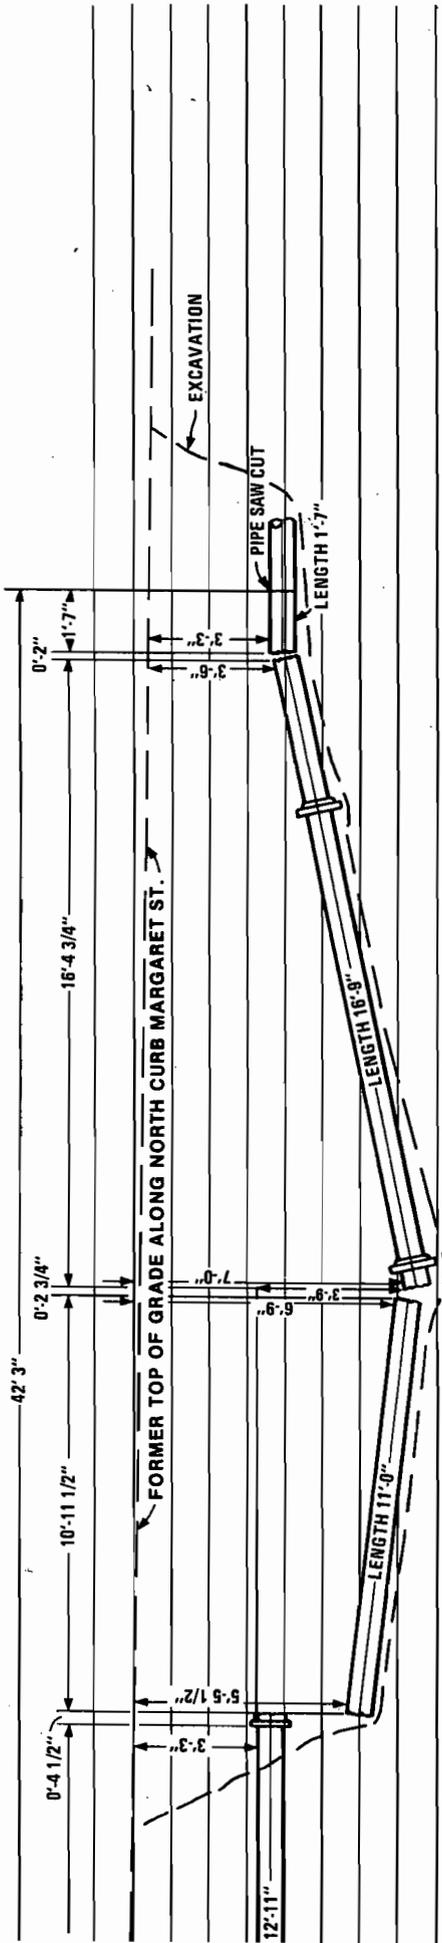
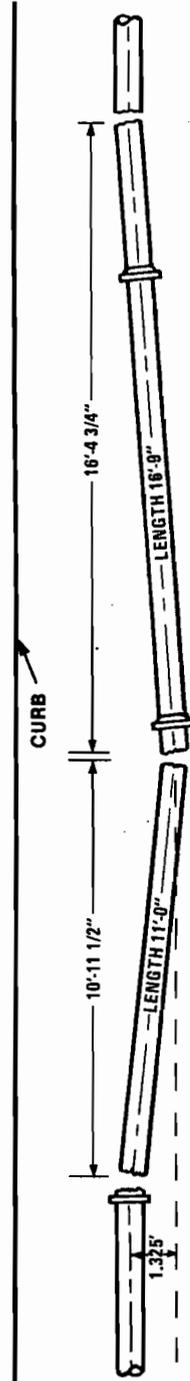
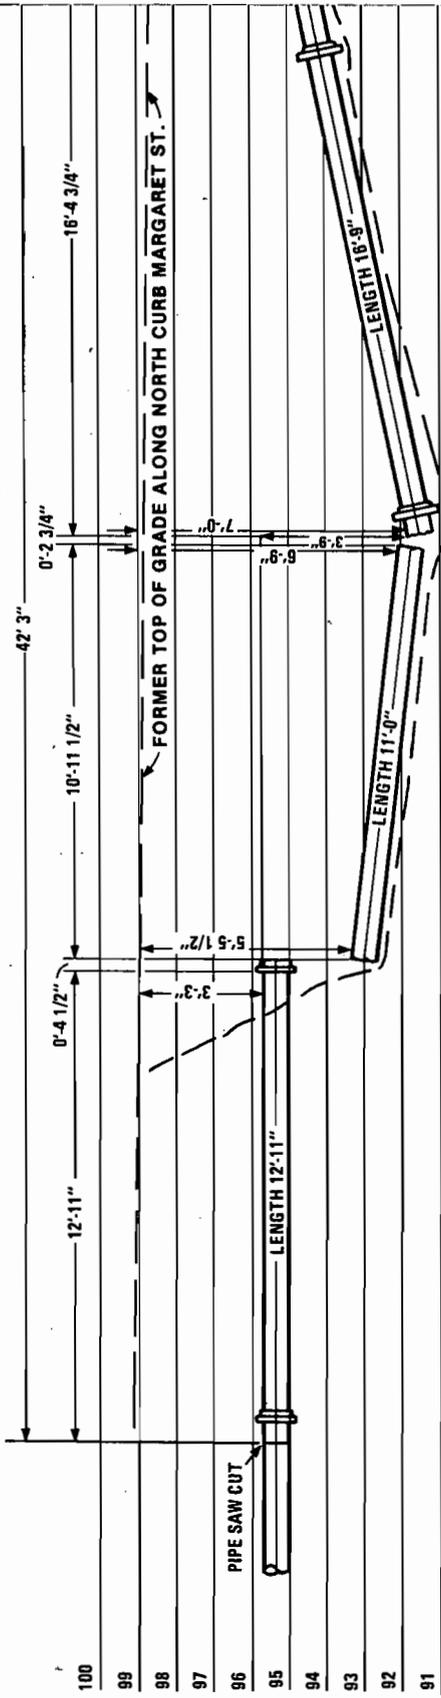
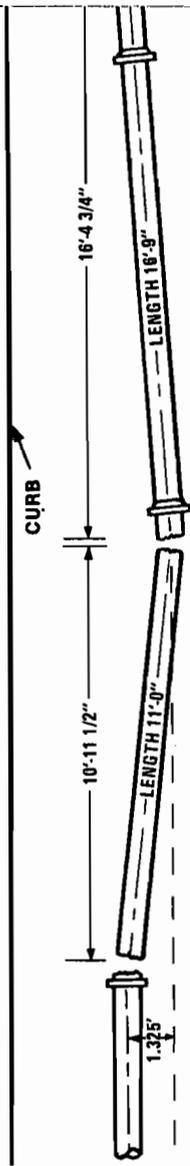
**FIGURE 5.**  
**PROFILE VIEW LOOKING NORTH 8" CAST IRON GAS MAIN**  
**ELEVATIONS TAKEN 5-12-79**

When the hole was cleared of debris and the water was pumped out, investigators found that the 8-inch, cast-iron gas main below the street was broken in three places. (See figure 5—Profile.)

When the gas main was uncovered, the pipe to the east was lying at a slight angle from the horizontal. Excavation to the west exposed two breaks in the line, one end of this broken section was 3 feet 9 inches below its former horizontal position. (See figure 5—Profile.) Further excavation to the west revealed a third break about 11 feet west of the second break. The gas main had shifted laterally a total of 1.325 feet from its original position. (See figure 5—Plan View.) The broken main ends and segments of the water main were cut off and visually examined by a Safety Board metallurgist. The pipe was also sent to the National Bureau of Standards for further metallurgical examination.

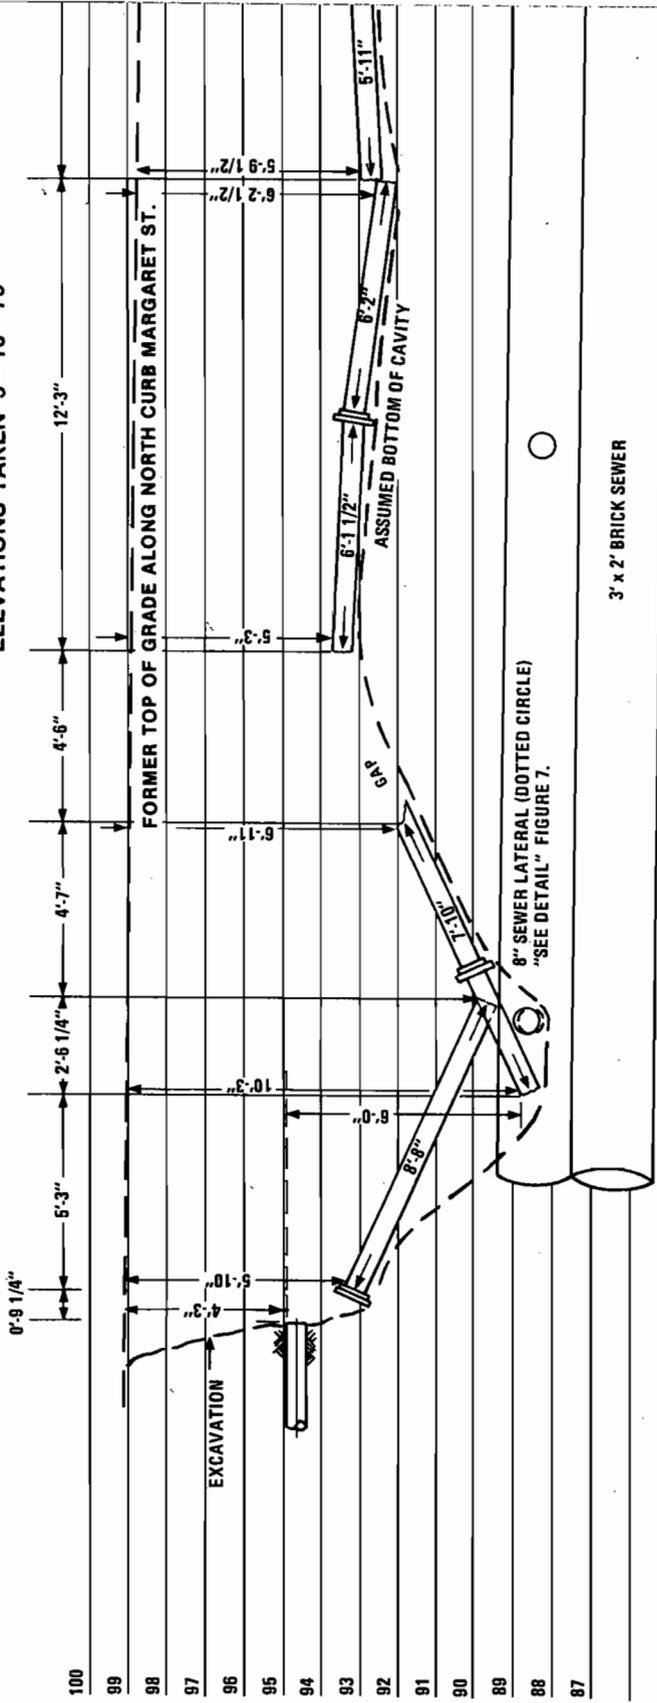
FIGURE 6.

A 6-inch, cast-iron water main in the hole was broken in five places. (See figure 6.) The water main had been installed in 1941 with 4 feet 3 inches of cover. The deepest break in the water main occurred where the main crossed above an 8-inch sewer lateral from a rowhouse. At this point one end of the broken main had dropped 6 feet below its original horizontal position, and had severed the 8-inch sewer lateral connection with the sewer main. (See figures 6 and 7.) The oval-shaped, 3-foot by 2-foot brick sewer was very old, but was found to be intact in the

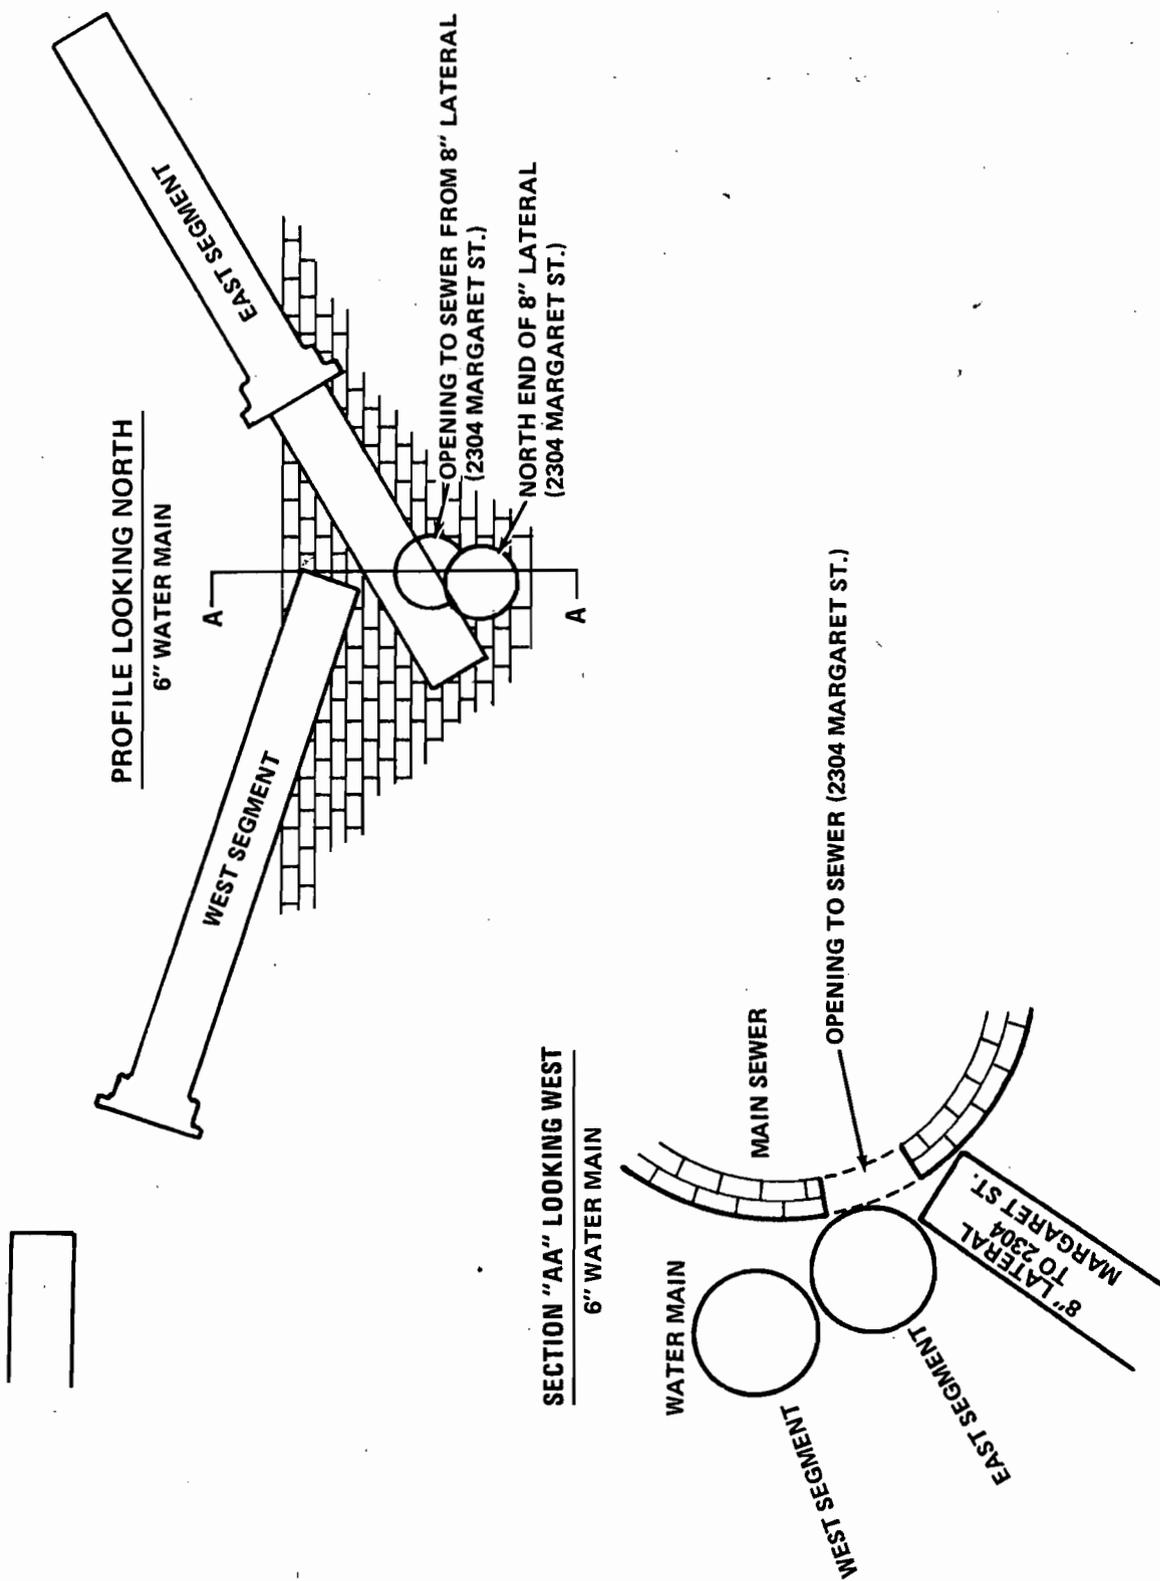
Figure 7. Detailed profile view of water main section.

1. The three fracture faces submitted were covered with corrosion products. The fractures were cleaned ultrasonically with a detergent followed by ultrasonic cleaning with buffered hydrochloric acid. Some of the corrosion product adhered tightly to the fracture face, and much of it remained on the surface after the cleaning process.

2. Because of the difficulty in removing the corrosion product from the fracture and because of the corrosive attack of the fracture features, it appeared that the pipe had been fractured for some time.

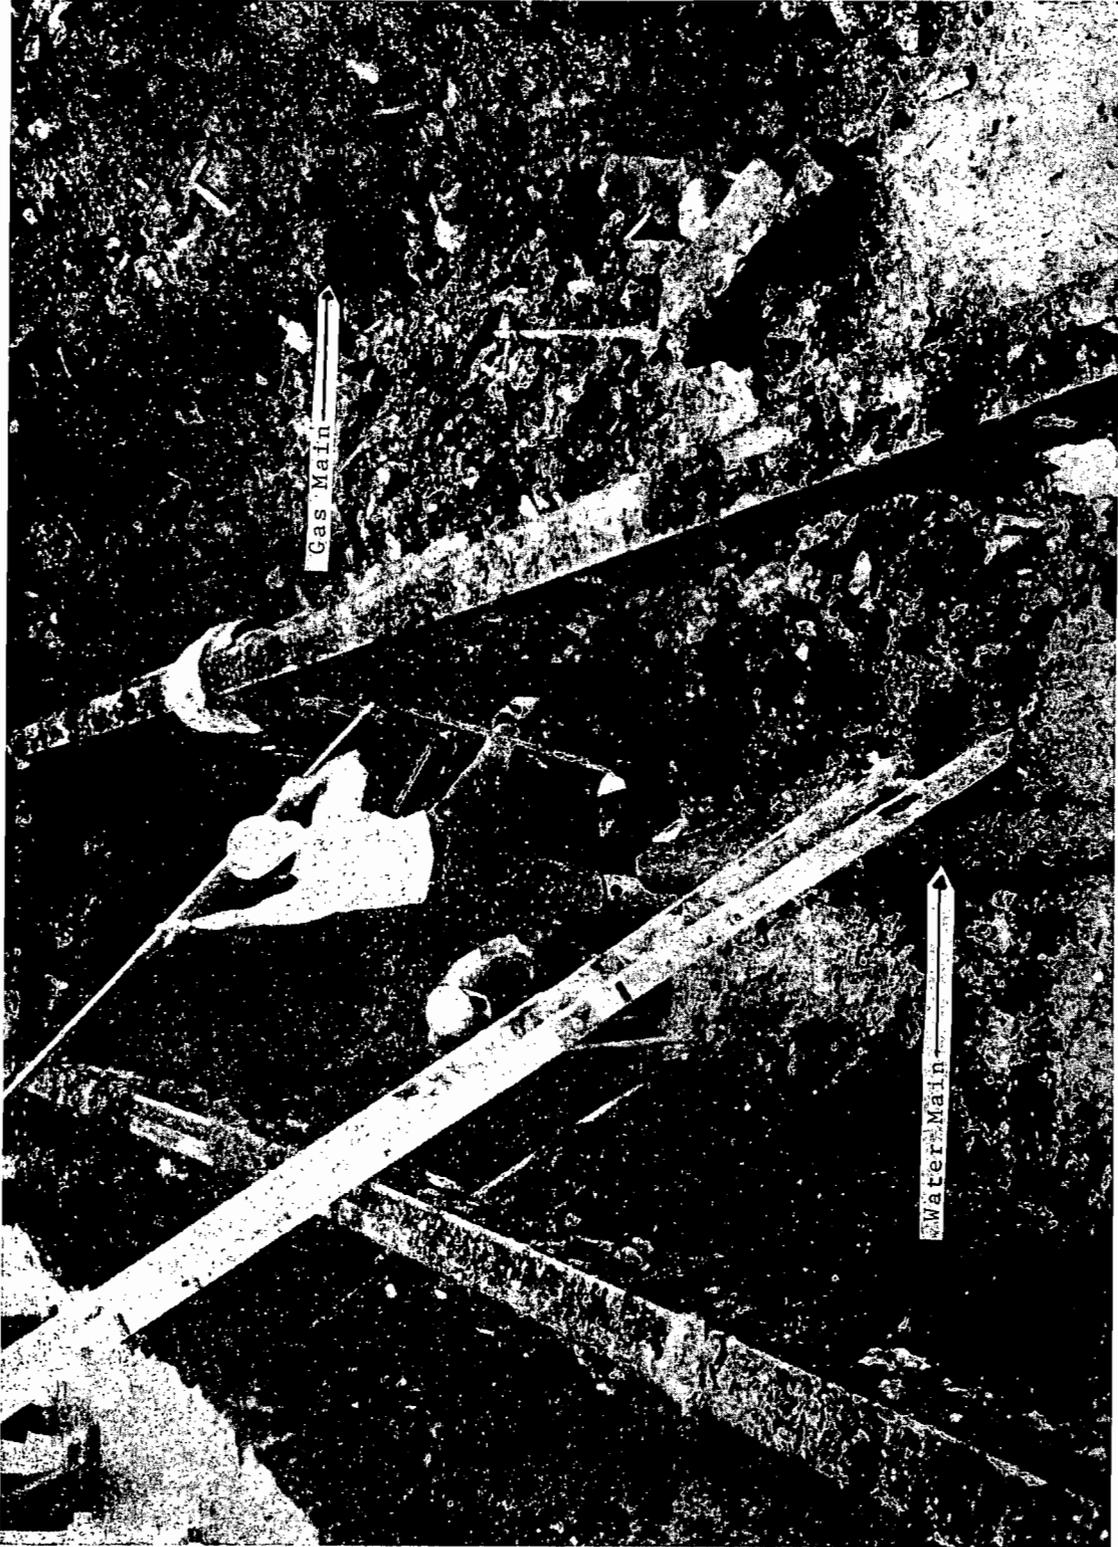
3. The cavity beneath the road appeared to have been in existence for a considerable time before the road collapsed. The trolley track apparently had supported the road surface and all the vehicular traffic on the road up to the time of the cave-in. (See figure 8.)

Figure 8. Partial view of cavern over which trolley track had supported pavement.

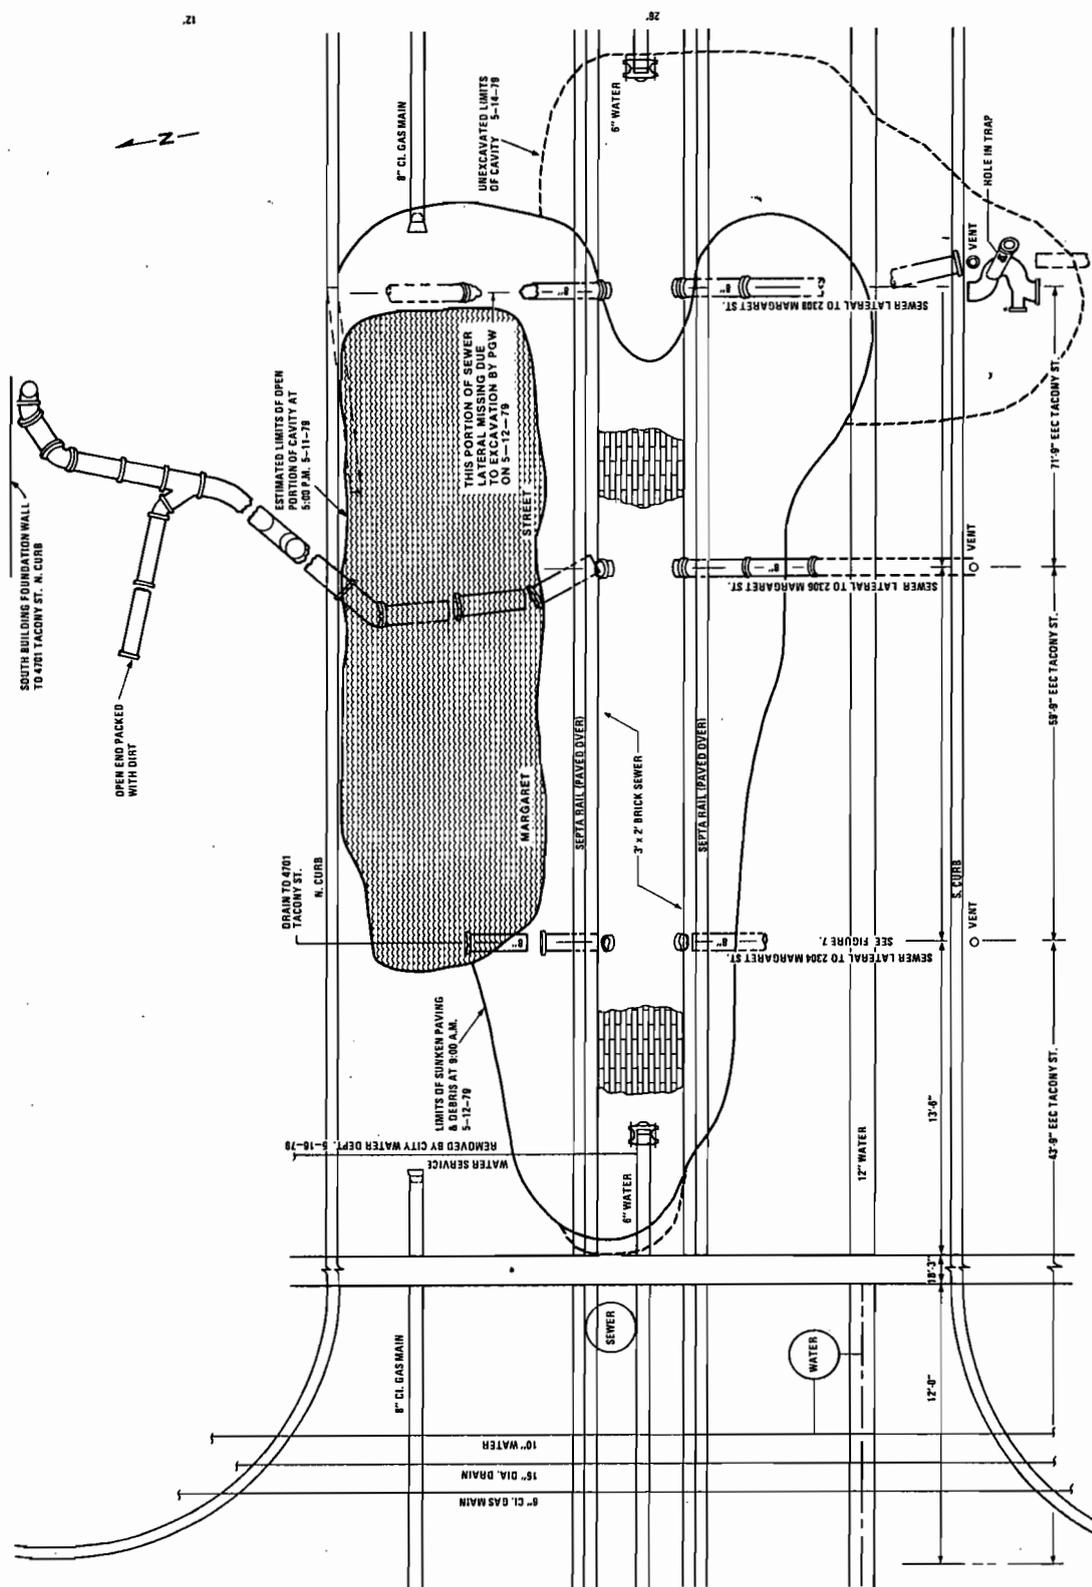
5. The condition of the sewer main was good with no breaks or leakage in the area excavated.
6. Six sanitary sewer laterals were excavated and examined. These laterals served the rowhouses and tavern adjacent to the cave-in. In general, the laterals were not in good condition; three of them appeared to have been disconnected from the sewer main for some time. (See figure 9). The ground around these laterals contained sewer sludge.

Figure 9. Plan view of initial cave-in with adjacent damaged sanitary sewer laterals.

The examination of the cave-in revealed that the large cavern had been in existence for a long time and had been created by a slow erosion process. The poor condition of the three sewer laterals and of the soil around them leads the Safety Board to conclude that seepage from these laterals contributed to the erosion that created the cavern. The openings in the sewer main caused by the broken laterals, allowed sewer backup during periods of heavy rain to escape and erode the immediate area. Water escaping from the fracture in the water main, which tests indicated had existed for some time, also probably contributed to the erosion. The break in the water line was not complete; it was probably more of a fissure which let water escape under pressure and helped to erode the cavity. Had the water pipe broken completely, water pressure to the area would have been disrupted, residents would have complained of no water or low water pressure, and the break would have been detected and repaired within a few hours.

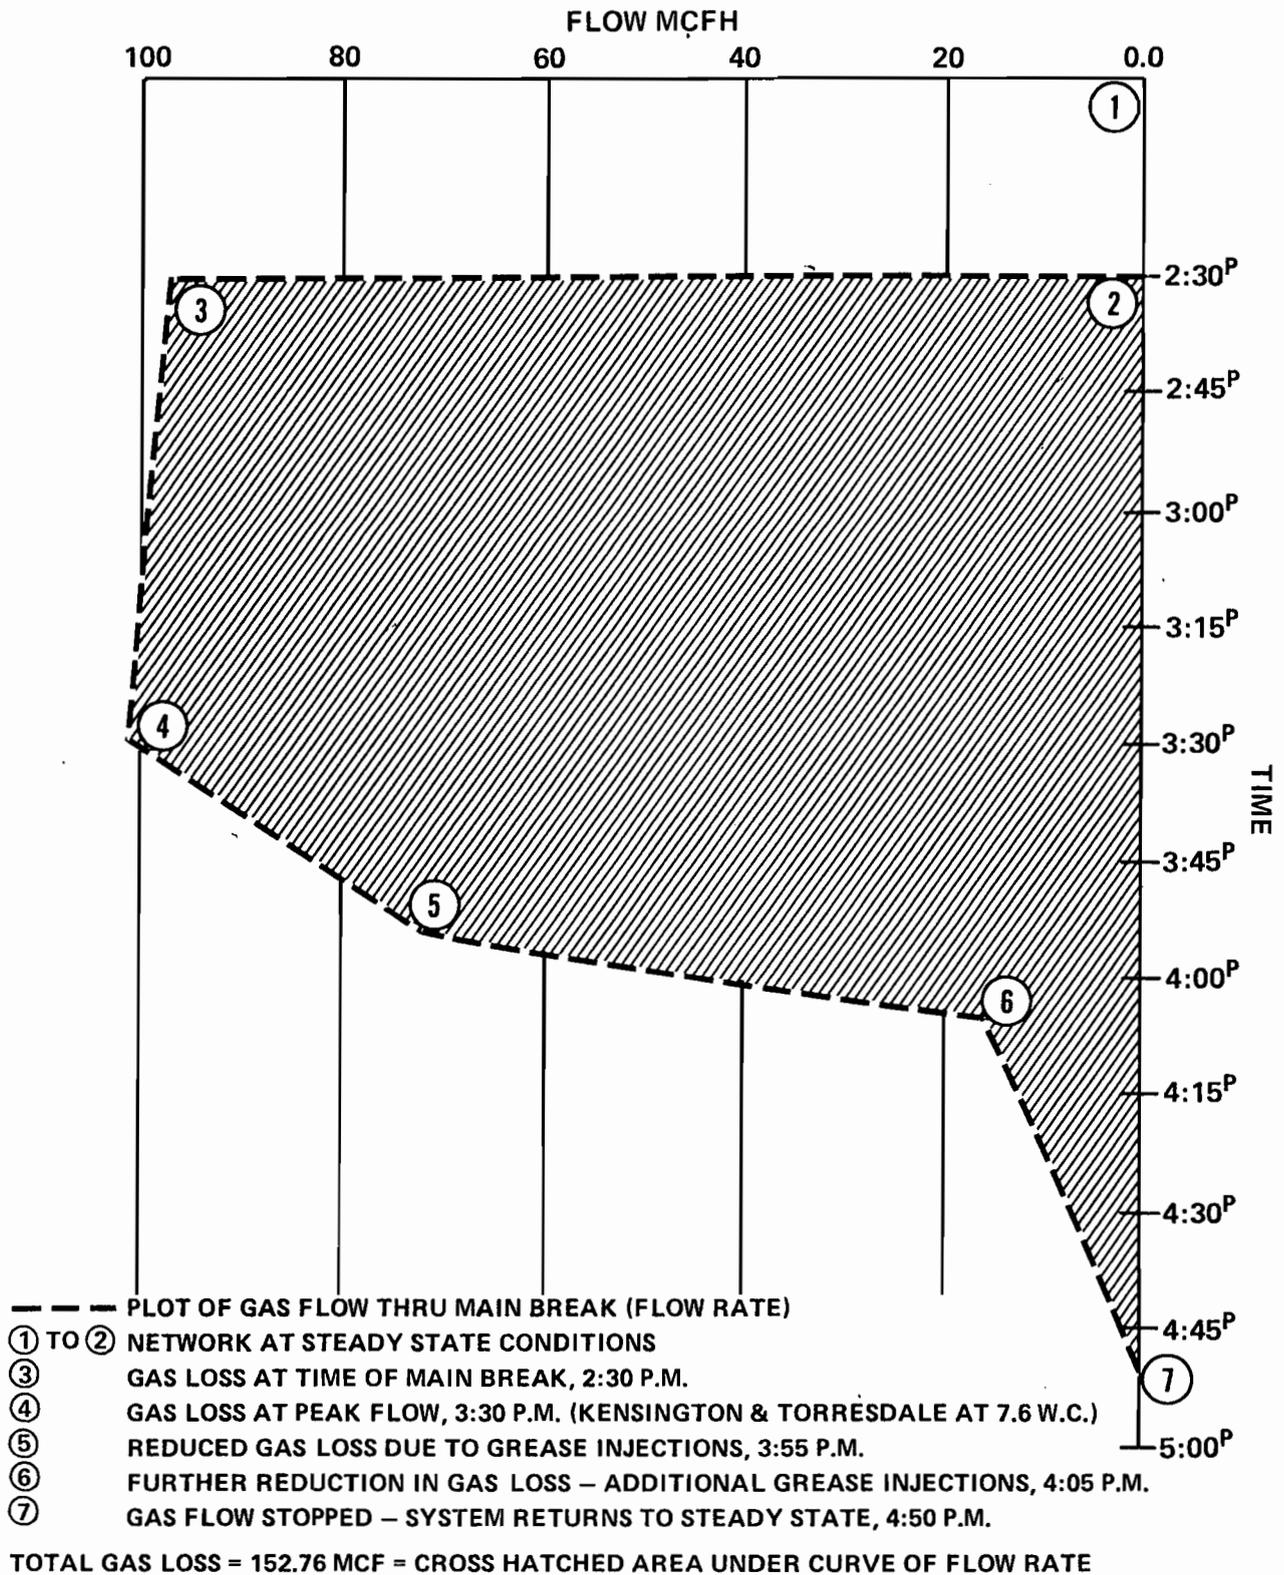
Figure 10. Time-flow plot of gas loss.

Calculations of gas loss. — Computerized calculation of gas flow showed a total of 152.76 MCF <sup>2/</sup> of gas lost from 2:30 p.m. to 4:50 p.m. (See appendix B.) From 2:30 p.m., the time of the failure, until 3:05 p.m., the time of the explosion, a total of 50 MCF of gas entered the cavity beneath the street. It took approximately 3 minutes to fill the estimated 4,780-cubic-foot cavern at a rate of 1,619 cubic feet per minute.
