# **NATIONAL TRANSPORTATION SAFETY BOARD**

## **PIPELINE ACCIDENT REPORT**

**PACIFIC GAS & ELECTRIC COMPANY  
NATURAL GAS PIPELINE PUNCTURE  
SAN FRANCISCO, CALIFORNIA  
AUGUST 25, 1981**

**NTSB-PAR-82-1**

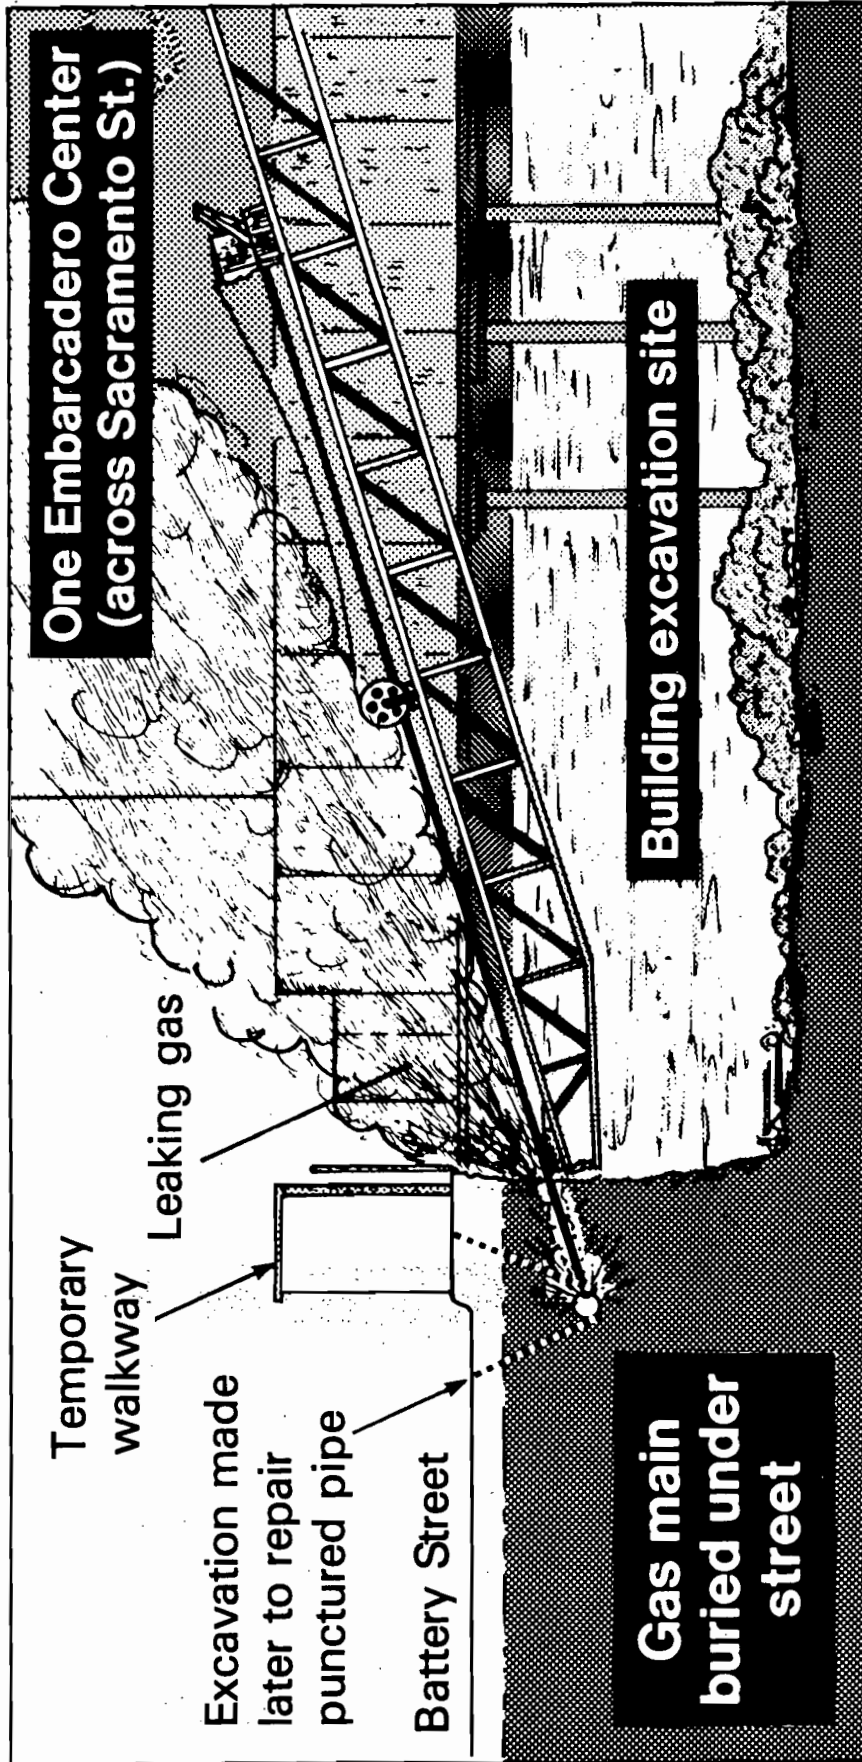
Turner Construction Company (Turner) had contracted to build a high-rise office building at a site bounded by Halleck, Battery, and Sacramento Streets in downtown San Francisco, California. (See figure 1.) On August 25, 1981, a construction crew of J. H. Pomeroy, Inc. (Pomeroy), a subcontractor for Turner, was excavating for the foundation of the proposed building. The crew had driven steel sheet piles into the ground around the periphery of the site. Before the crew could continue to deepen the excavation in the area encompassed by the sheet piles, it was necessary to drill holes through the piles extending below the adjacent street to set anchors or tiebacks which would later be attached to the sheet piles to hold them in place when excavation resumed (see figure 2). The 8-inch holes were to be drilled at a 30-degree angle with the horizontal pavement.

Figure 2.—Illustration of tieback drill puncturing gas main.

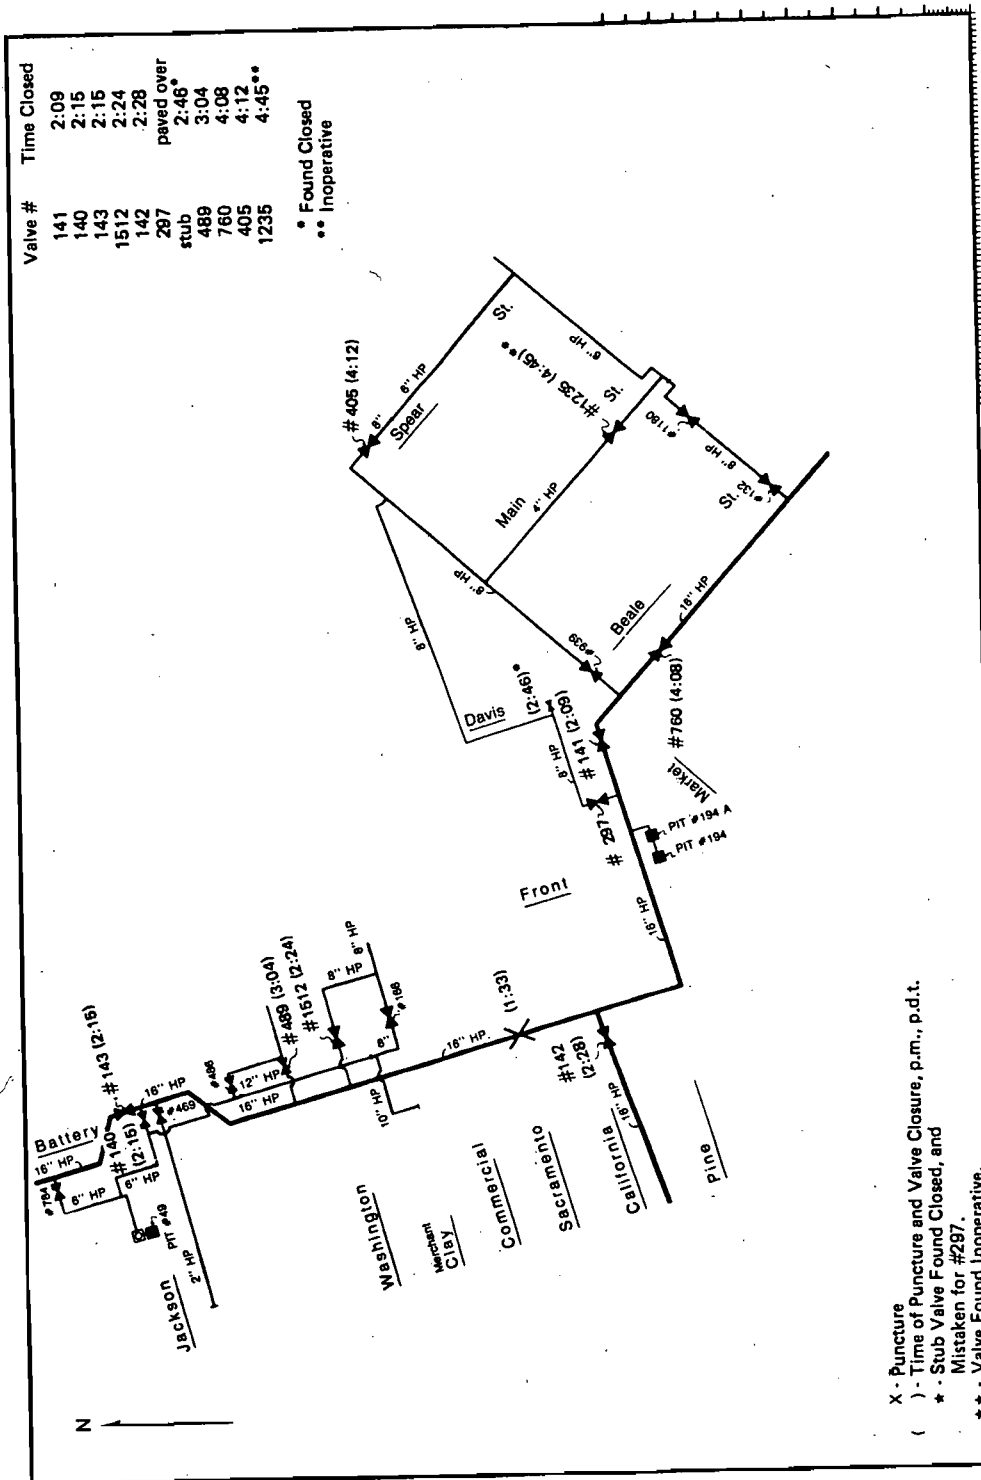
Figure 3.—Schematic diagram of shutdown valves.

Although the valve crew had successfully closed these five valves by 2:28 p.m., gas continued to escape from the break.

Believing that valve 141 was leaking, EOR personnel checked ESD 6B to determine which additional valves to close for isolating the break. It was then determined that valve 297 was a part of an 8-inch loop (rather than a one-way tie-in as shown on ESD 224) and was connected into the 16-inch main in a manner that bypassed valve 141, allowing gas to be fed to the section of the 16-inch main containing the break. (Valve 297 was not listed on ESD 224 as an emergency isolation valve, but was so noted on ESD 6B.) The valve crew was then directed to close valve 297. The valve crew located a valve thought to be valve 297 and found it in the closed position. This was reported to the EOR as well as the fact that there was no identification tag on the valve. Gas continued to escape under pressure from the break, and the valve crew was again directed to check valve 297. At 2:46 p.m., the valve crew verified to the EOR that valve 297 was closed. (About 2 days after the accident, PG & E discovered that access to valve 297 had been paved over in 1978 and that the PG & E valve crew had checked a stub valve that was located about 35 feet east of valve 297 and which had no effect in controlling the flow of gas in the 8-inch loop.)

EOR personnel again checked Emergency Diagram 224 and found an additional feed into the 16-inch main north of the break. This feed could be controlled by either valve 489 or valve 486, neither of which was listed as a valve to be closed for controlling gas into the main section that included the break. Valve 489 was ordered closed which was accomplished at 3:04 p.m. However, gas continued to escape under pressure from the break.

EOR personnel concluded that either valve 297 (which they believed to be closed) or valve 141 was leaking. Therefore, the valve crew was directed to close three second line valves that were listed on ESD 6A in an attempt to stop the flow of gas from the east, even though this meant interrupting gas service to a larger number of customers. The valve crew closed valve 760 and valve 405 at 4:08 p.m. and 4:12 p.m., respectively. At 4:45 p.m., the valve crew attempted to close valve 1235, the third valve, but was unable to turn the valve stem. (PG & E maintenance records showed that the annual inspection of valve 1235 was made on August 10, 1981, 15 days before the accident.)

A third factor which diminished the ability of the EOR personnel to isolate the section of main which included the puncture was the result of deficiencies in PG & E's maintenance operations for emergency isolation valves. Not only was valve 297 not shown on ESD 224 as an isolation valve, it also was not listed on the annual inspection list which is the means PG & E used to assure that emergency valves were inspected, greased, and partially operated at least once each year. This deficiency allowed valve 297 to be paved over in 1978 without PG & E instituting any action to assure that this valve remain accessible. The fact that PG & E was not aware that the valve was inaccessible contributed to the valve crew checking a valve 35 feet from valve 297 and reporting to the EOR personnel that valve 297 was closed when, in fact, valve 297 was open. Had the EOR personnel directed that a positive identification be made of valve 297 (the valve located by the valve crew as 297 had no valve identification tag to enable positive identification), the inaccessibility of valve 297 would have been known promptly to EOR personnel and they would have recognized earlier that a greater area would have to be isolated to stop the flow of gas to the break. While the EOR personnel soon did expand the area of isolation, this attempt was thwarted because valve 1235 could not be operated. The failure of EOR personnel's actions to isolate the section of main containing the break in combination with the urgency to stop the flow of gas then entraining PCB laden oil apparently influenced PG & E to attempt repair of the break without first isolating the gas main thereby accepting a somewhat higher hazard to its employees.

Train and equip company personnel who respond to emergency conditions in the operation of emergency shutdown valves. (Class II, Priority Action) (P-82-1)

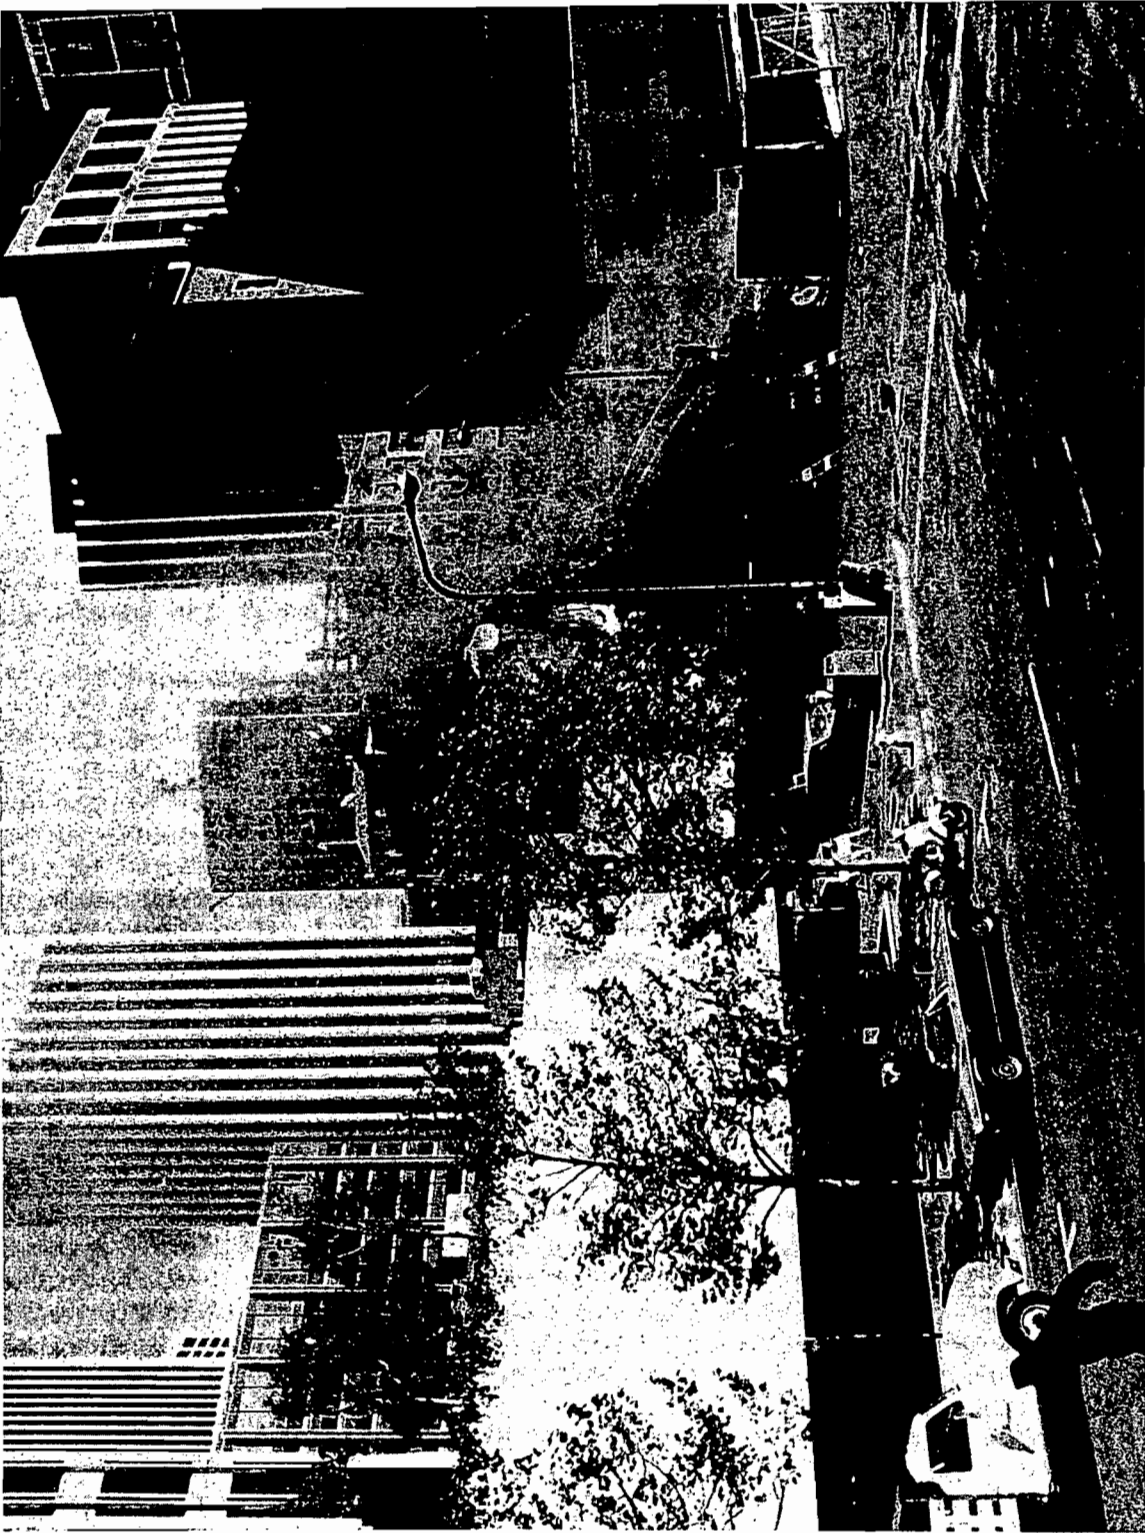
At approximately 2:46 p.m., a little more than 1 hour after the main was punctured, a heavy, dark, oil mist began to appear with the escaping gas and coated buildings, automobiles, shrubbery, and persons in its path. (See figure 4.) At 2:47 p.m., immediately upon being notified of the appearance of the oil mist, PG & E's division engineer went to the accident site to obtain a sample. PG & E was concerned about the oil report because of its possible PCB content. (PCB had been introduced into its gas transmission system in

Figure 4.--Photograph of blowing gas.

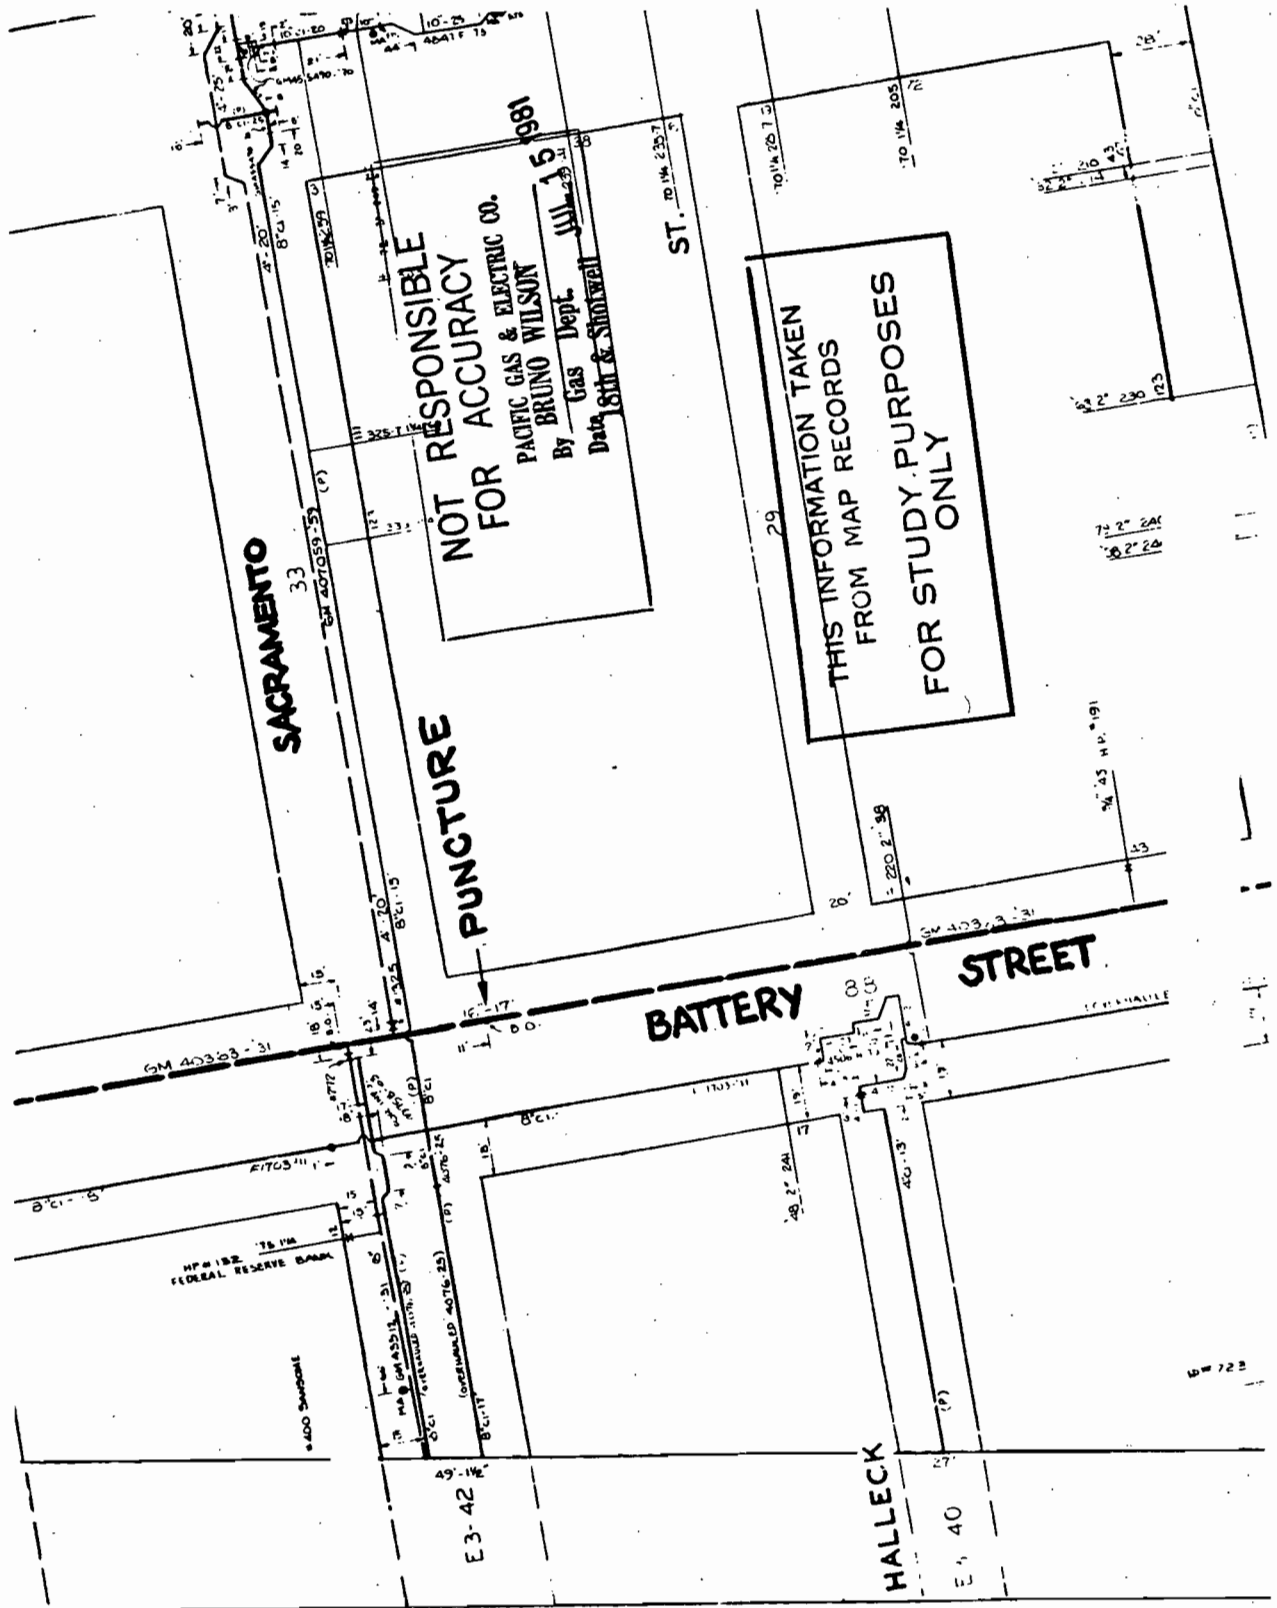
On April 23, 1981, Turner made a telephonic request to PG & E for maps showing the location of underground facilities in the area of Battery Street, from Sacramento to Halleck Streets. The maps mailed to Turner by PG & E were clearly stamped "NOT RESPONSIBLE FOR ACCURACY" and "FOR STUDY PURPOSES ONLY," and were similar to the maps Tronoff had been furnished by PG & E and which Tronoff used in preparing the topographic and utility survey. (See figure 5.)

Figure 5.--PG & E utility location map (representative copy).

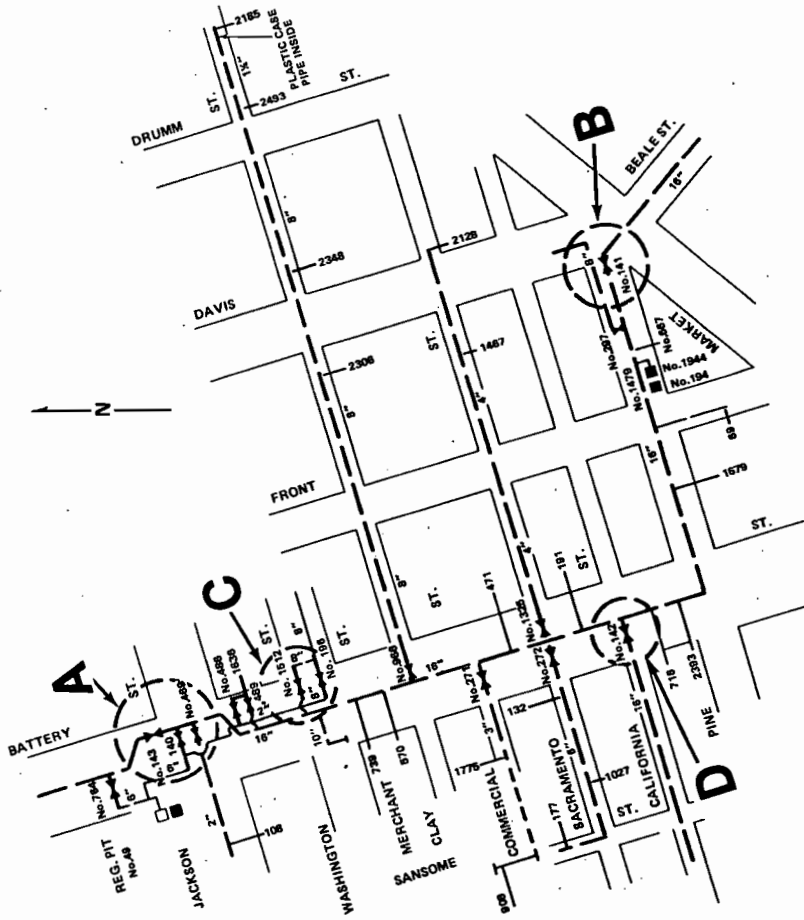
Among other provisions, the emergency shutdown procedures for the PG & E high-pressure gas distribution system provided for the establishment of an EOR to direct company emergency responses and for sectionalizing the system to isolate a break. The essentials of this plan included the designation of emergency valves to effect the shutdown and the specification of district regulators and services which would be affected. This information was listed and shown on an Emergency Shutdown Diagram for each of the shutdown sections. (See figure 7 for ESD 224, a typical diagram.)

The Engineering Department of PG & E is responsible for developing the ESD's which are used for identifying valves necessary for isolating a section of main. The ESD for each isolation section provides a map of the section showing the location of mains and valves, provides a listing of valves to be operated to isolate the section, and provides positive location information for each emergency valve. Valve 297 was installed in 1968 when a one-way flow 8-inch main extension was installed from the 16-inch main. Later, three extensions of this 8-inch main were made beyond valve 297 with the last extension being tied into an 8-inch main at Market Street. This tie-in created an 8-inch loop rather than a simple extension. Each of the extensions and the final tie-in were required to be reviewed by the Engineering Department for purposes which included the identification of necessary changes to the ESD's. Prior to the accident, ESD 224 did not show valve 297 as an emergency isolation valve nor did it show the two-way feed that resulted from the extensions in the 8-inch main; however, ESD 6B did list valve 297 as an emergency isolation valve and showed the 8-inch main as being a loop.

Figure 7.—Emergency Shutdown Diagram.
