PIPELINE ACCIDENT REPORT

MISSOURI POWER AND LIGHT COMPANY
NATURAL GAS FIRES
CENTRALIA, MISSOURI
JANUARY 28, 1982

NTSB-PAR-82-3

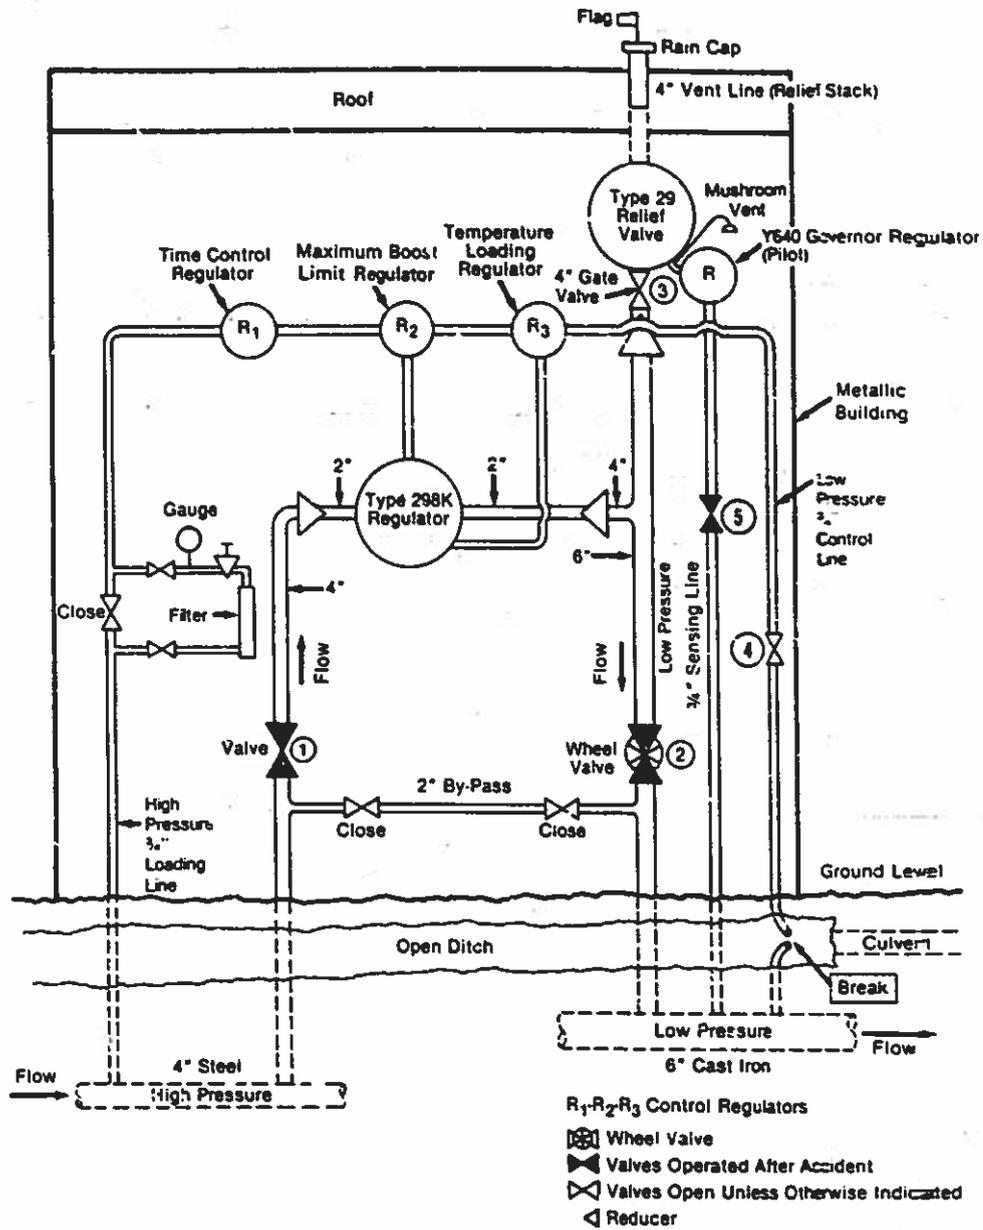
Figure 8.--Schematic of district regulator station No. 1.

The in-place test results indicated that the relief valve was in good working order. However to operate properly, a relief valve must have the valves open on the inlet side (valve No. 3) and on the sensing line (valve No. 5). Since the valve failed to operate following the rupture of the control line, either the gate valve (valve No. 3) under the relief valve or the plug valve (valve No. 5) in the sensing line must have been closed.

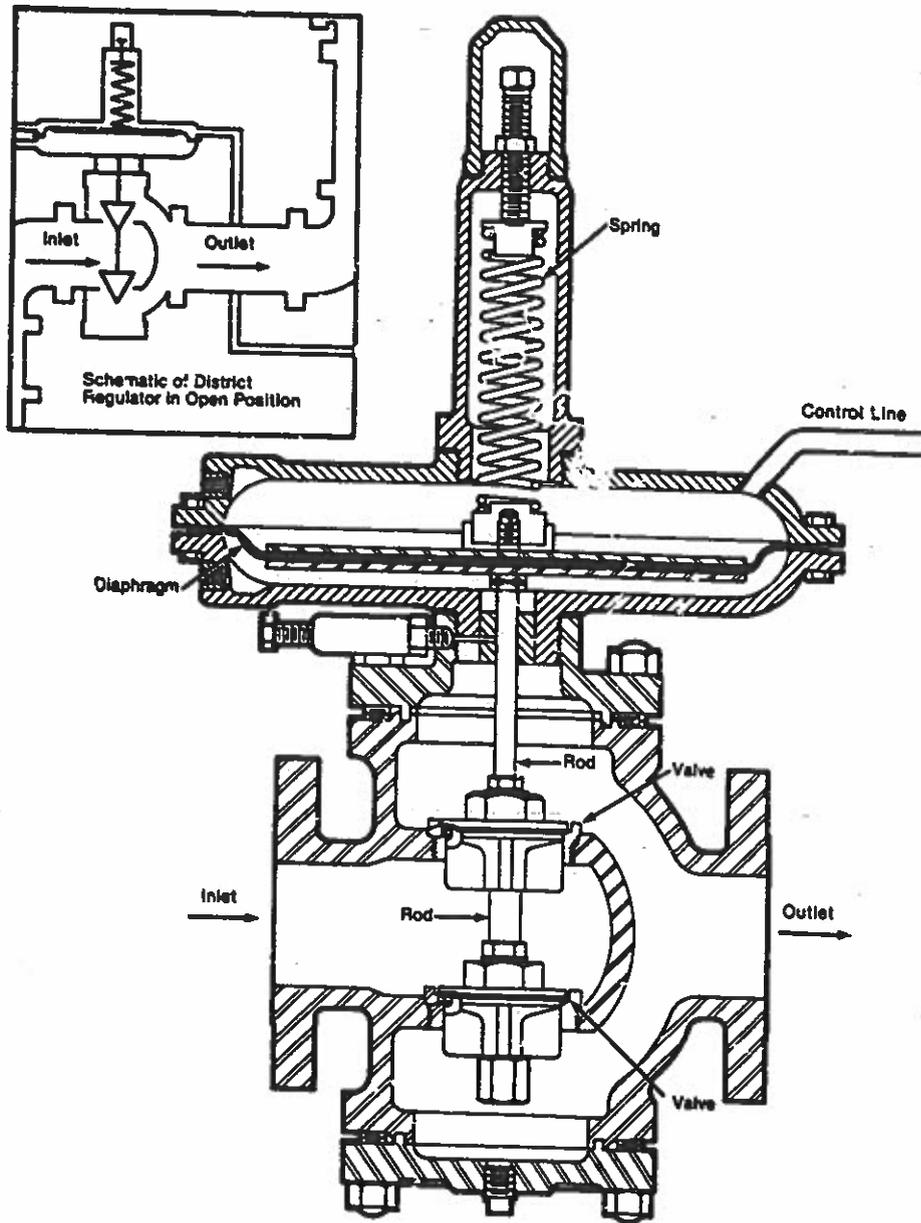
Figure 9.--Fisher controls type 298K, 2-inch double V-port gas regulator in closed position.

When the backhoe bucket snagged and broke the pressure regulator control line, the regulator, in an attempt to hold the 11 inch W.C. (0.40 psig) and satisfy what the regulator sensed to be a demand for additional gas, opened wide. The wide open position of the regulator allowed gas at 47 psig to enter the low pressure system and overpressure the system. When the overpressure occurred, some pilot lights were blown out, permitting gas at high pressure to fill buildings. In other buildings where the pilot lights did not go out or furnaces or stoves were in use, the gas flames intensified and burned flammable building materials within the structures.

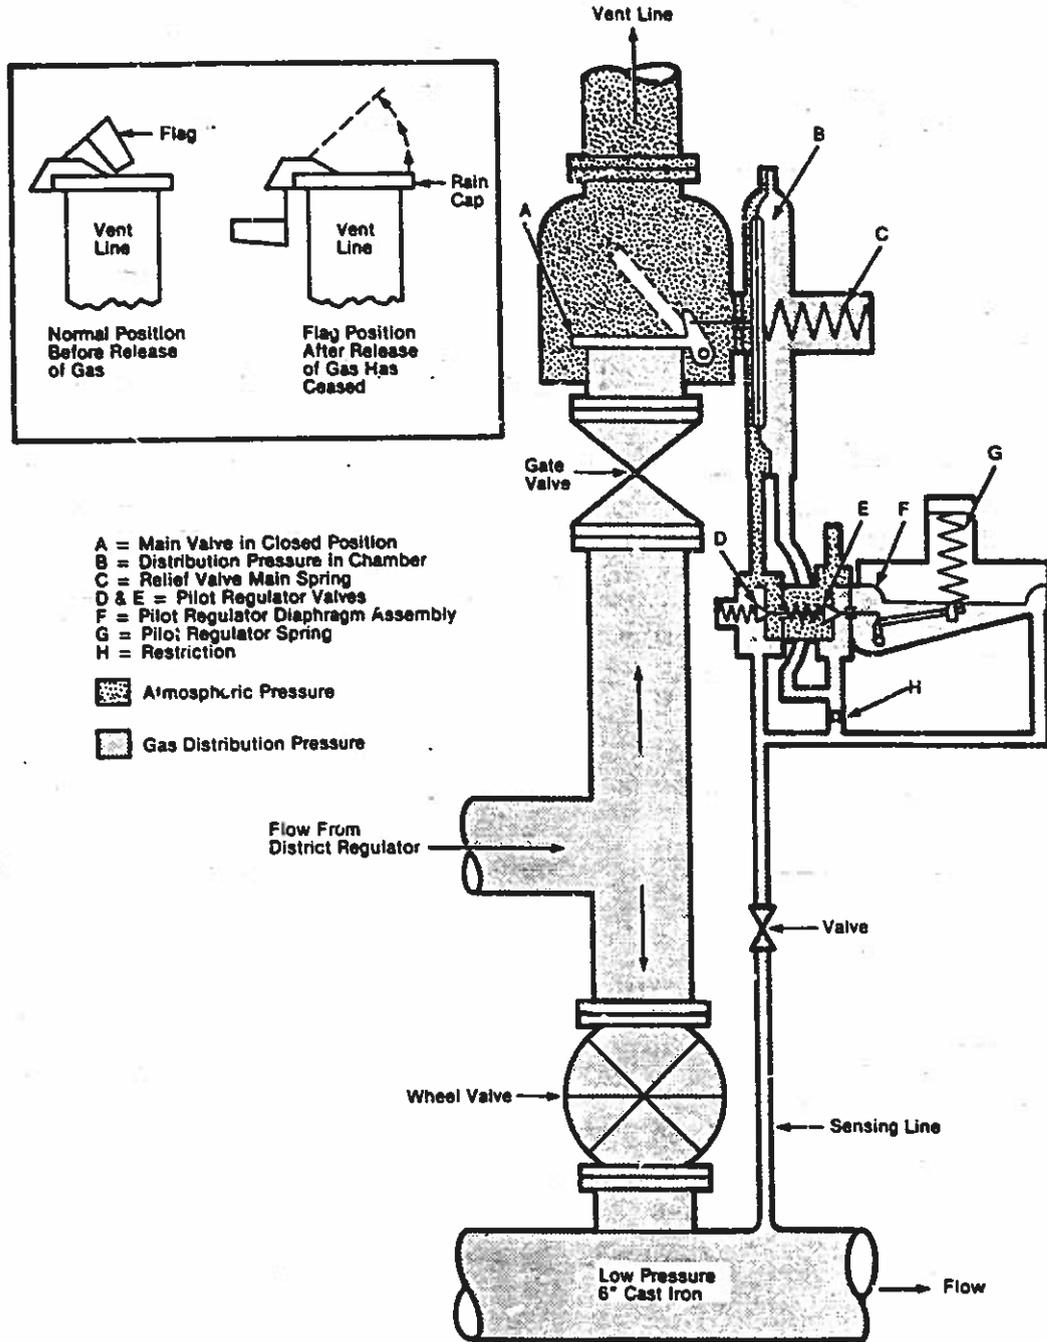
Figure 10.--Schematic of Fisher controls type 29, 4-inch pilot controlled relief valve in closed position.

From the in-place test, the Safety Board determined that the relief valve's governor regulator was set at 9 inches W.C. (0.33 psig) pressure at the time of the accident. The pressure on the low pressure system was about 11.5 inches of W.C. (0.41 psig). These conditions would have resulted in the continuous release of gas through the relief valve if it were operational and would serve to explain why the valve had been isolated.
