NATIONAL TRANSPORTATION SAFETY BOARD

PIPELINE ACCIDENT REPORT

**THE GAS COMPANY OF NEW MEXICO
NATURAL GAS EXPLOSION AND FIRE
PORTALES, NEW MEXICO
JUNE 28, 1982**

NTSB-PAR-83-1

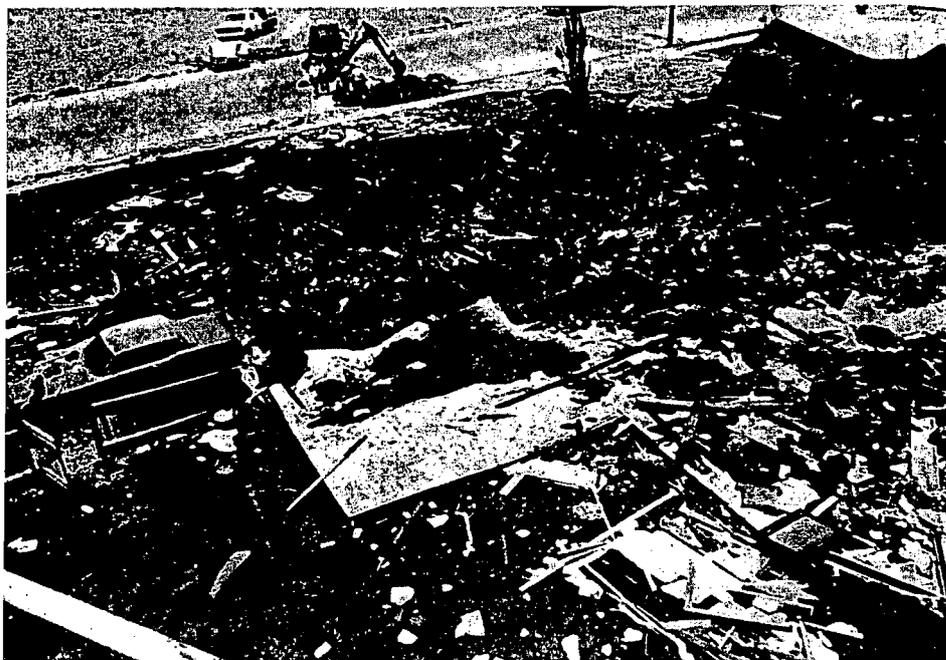
At 3:30 a.m., m.d.t., on June 28, 1982, an explosion followed by an intense, gas-fed fire destroyed the house at 827 West 18th Street. The sides of the house were blown outward and the front wall was blown into and across the street by the blast. The roof was blown upward and portions of the roof landed in the front and back yard. (See figure 2.) Of the six persons inside the house at the time of the explosion, five died as a result of the explosion or fire and one was critically injured.

Figure 2.--Destroyed house at 827 West 18th Street.

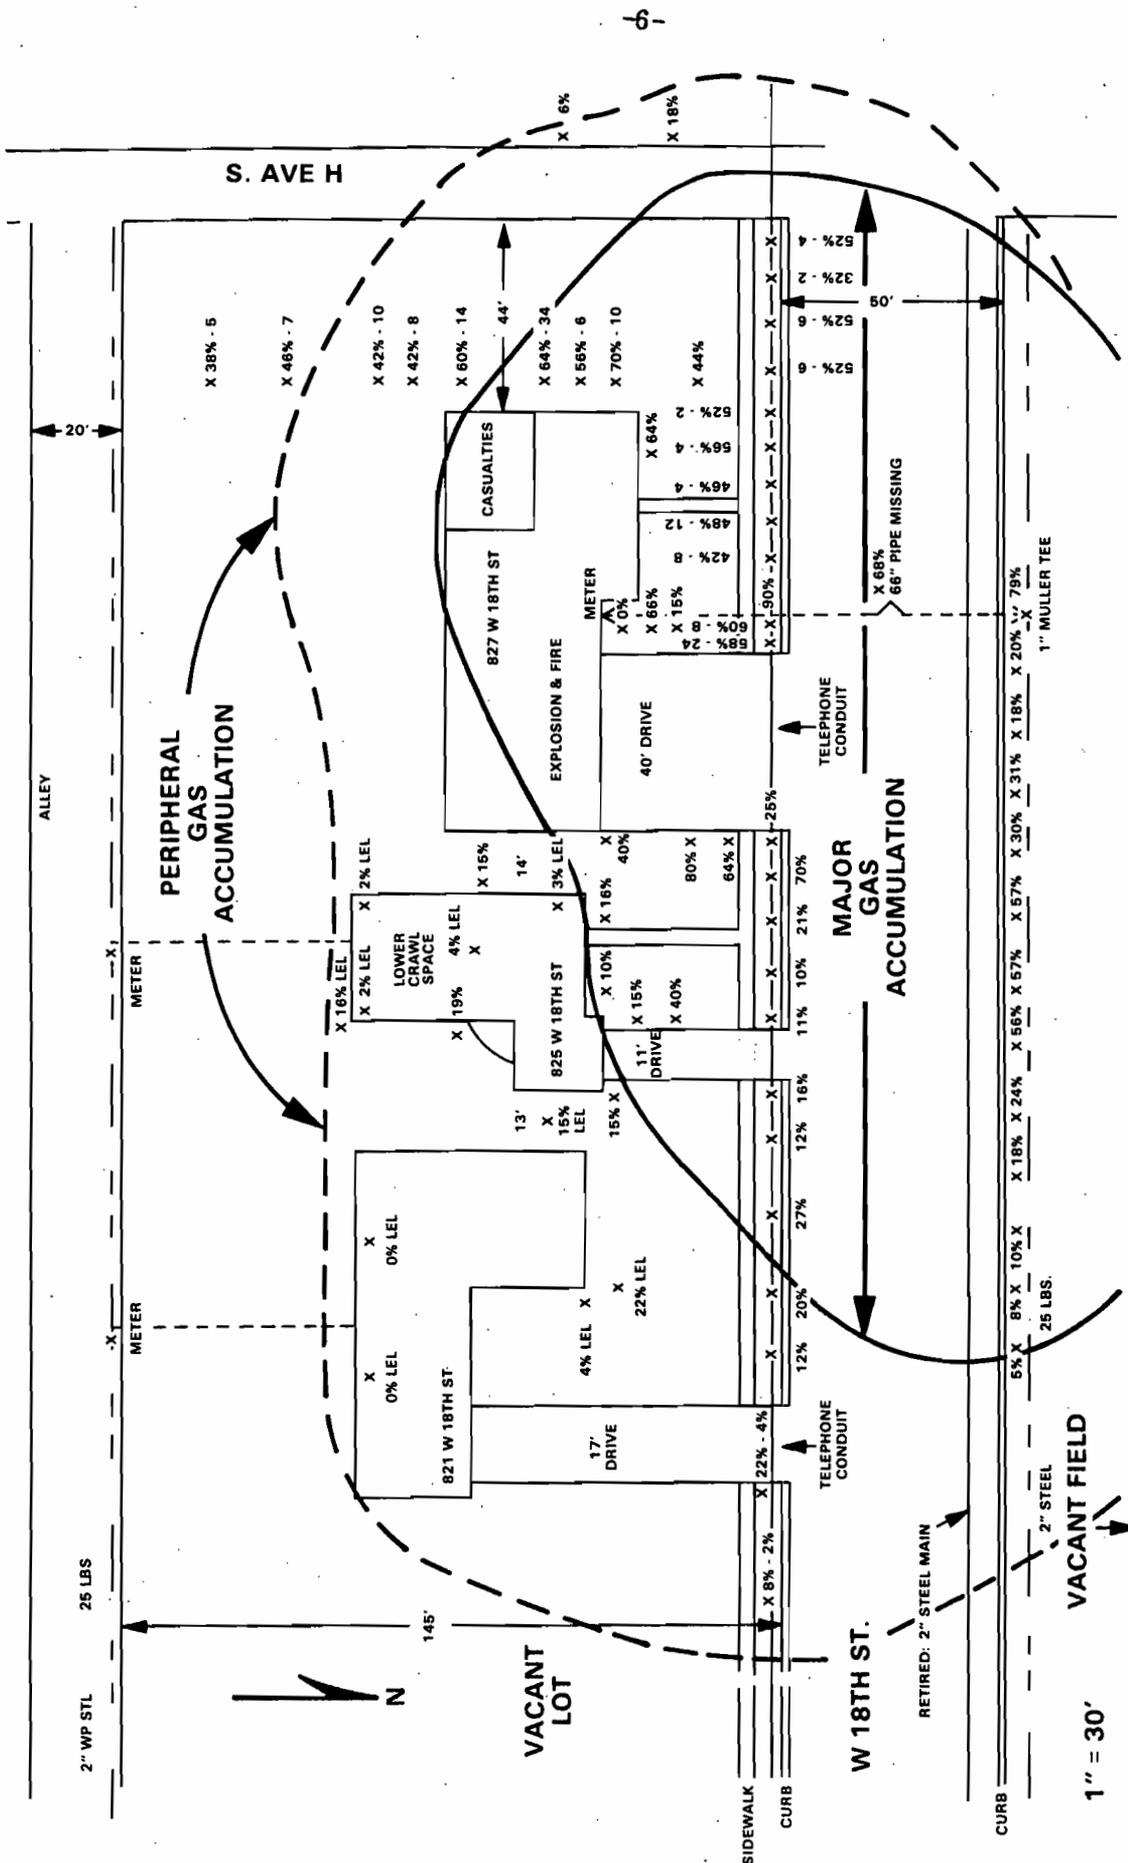
After the fire was extinguished, gas company employees tested for gas in the ground around the houses at 821, 825, and 827 West 18th Street and along the gas main and the telephone conduit. A high CGI reading of 79-percent gas was obtained over the gas service line's connection with the gas main, and a high CGI reading of 90-percent gas was obtained at the south curb over the service line. Varying CGI readings were obtained around the houses, in the yards, over the gas main, and over the telephone conduit. (See figure 3.) The gas company excavated by the sides of the houses at 821, 825, and 827 West 18th Street to allow any accumulated gas to escape. (Gas company employees continued CGI tests for gas accumulation in the accident area until July 5, 1982. When these tests indicated only a minimal amount of gas remaining in the ground, testing was ended.)

Figure 3.--Gas saturation measured at accident site.

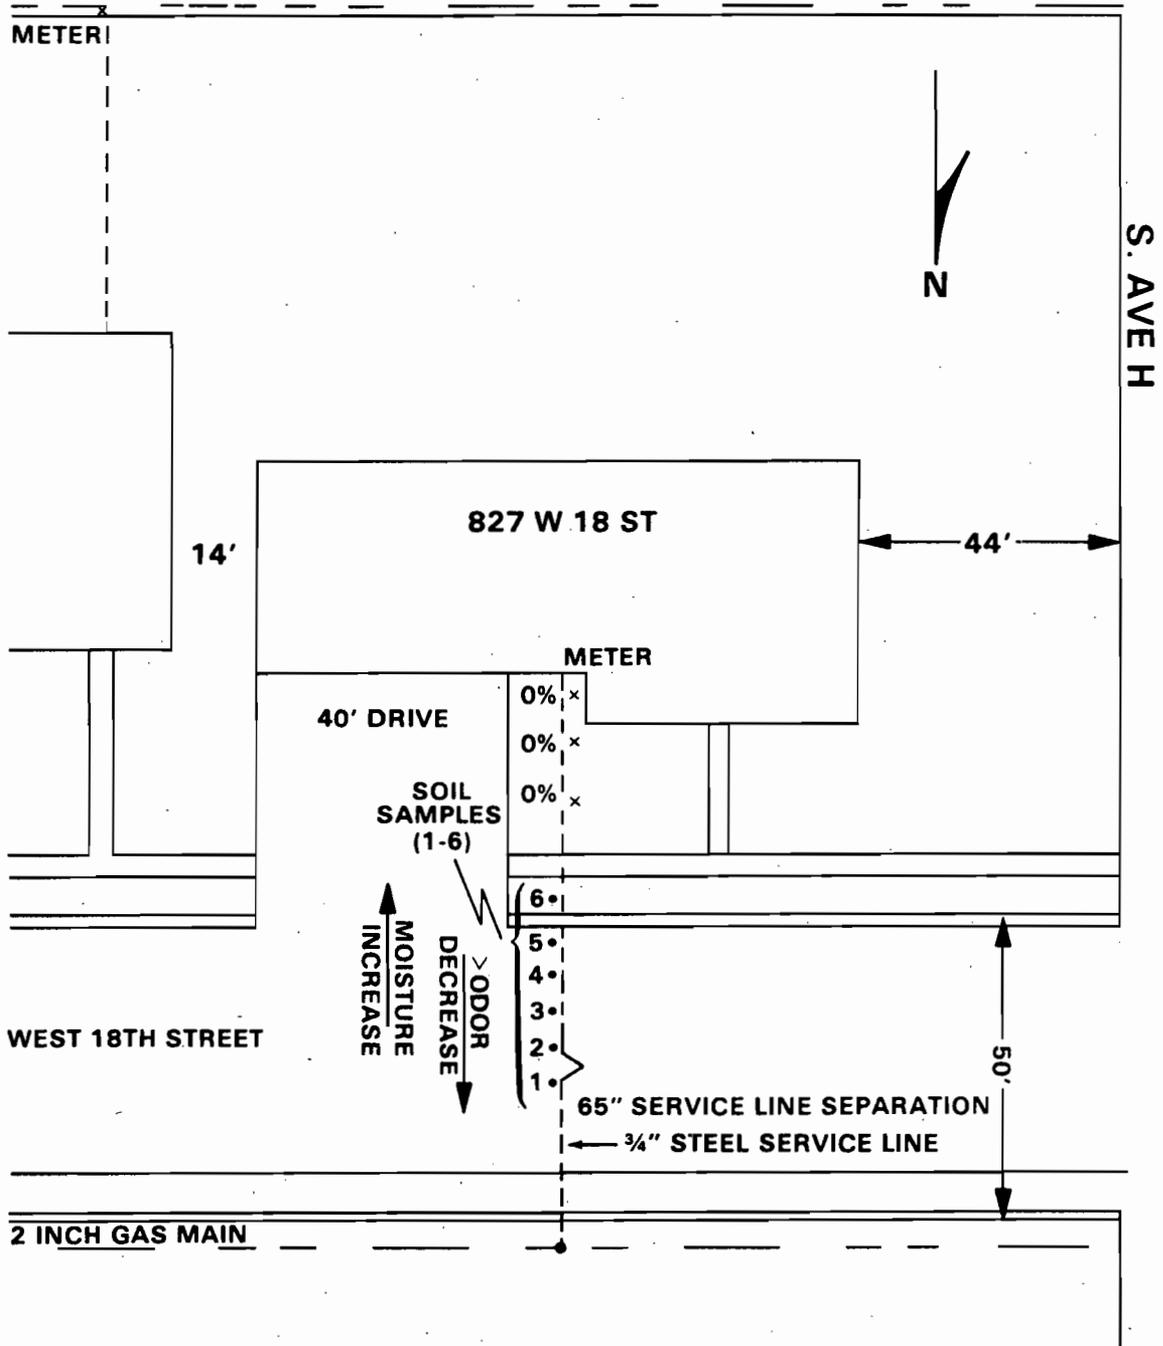
After the accident, an independent testing laboratory was retained to collect and to test the soil along the 3/4-inch gas service line from the 65-inch separation under West 18th Street up to the sidewalk in front of 827 West 18th Street. Six soil samples, averaging 250 cubic centimeters per sample, were taken from the side and just below the depth of the service line at 6-foot intervals. (See figure 6.) Samples 1, 2, and 3 contained little or no moisture (these were directly under the paved road) and had a recognizable odor similar to that added to gas. Samples 4, 5, and 6 "contained moisture in relative amounts that increased with distance from the center of the road. It was necessary to heat sample 4 to detect the odor of gas and even with heat, the odor was slight. No odor was detected when samples 5 and 6 were heated." (See appendix C.)

Figure 6.--Soil samples taken at accident site.

Between May 1 and June 20, 1982, the Portales area had received 1.17 inches of rain. The Safety Board concludes that the odorant compounds added to the gas by the gas company were adsorbed by the surrounding soil when the gas leaked from the service line. Soil samples taken at the side of the gas service line from its pullout in the middle of West 18th Street in 6-foot intervals up to the curb showed that the gas odor in the samples went from strong at the pullout to nonexistent at the curb line and that the moisture content of the soil samples taken were dry at the pullout to wet at the curb line.

Samples 1 through 3 contained little or no moisture. It was not necessary to heat portions of these samples in order to detect the contaminants; the "signature" of the natural gas was immediately noted when the jars containing these samples were opened. Samples 4 through 6 contained moisture in relative amounts that increased with increased distance from the gap (see figure 6). It was necessary to heat portions of sample 4 to detect only a slight odor of the contaminants. No odor was detected when portions of samples 5 and 6 were heated.
