# **NATIONAL TRANSPORTATION SAFETY BOARD**

## **PIPELINE ACCIDENT REPORT**

**PIEDMONT NATURAL GAS COMPANY  
NATURAL GAS EXPLOSION AND FIRE  
WINSTON-SALEM, NORTH CAROLINA  
JANUARY 18, 1988**

NTSB/PAR-88/01

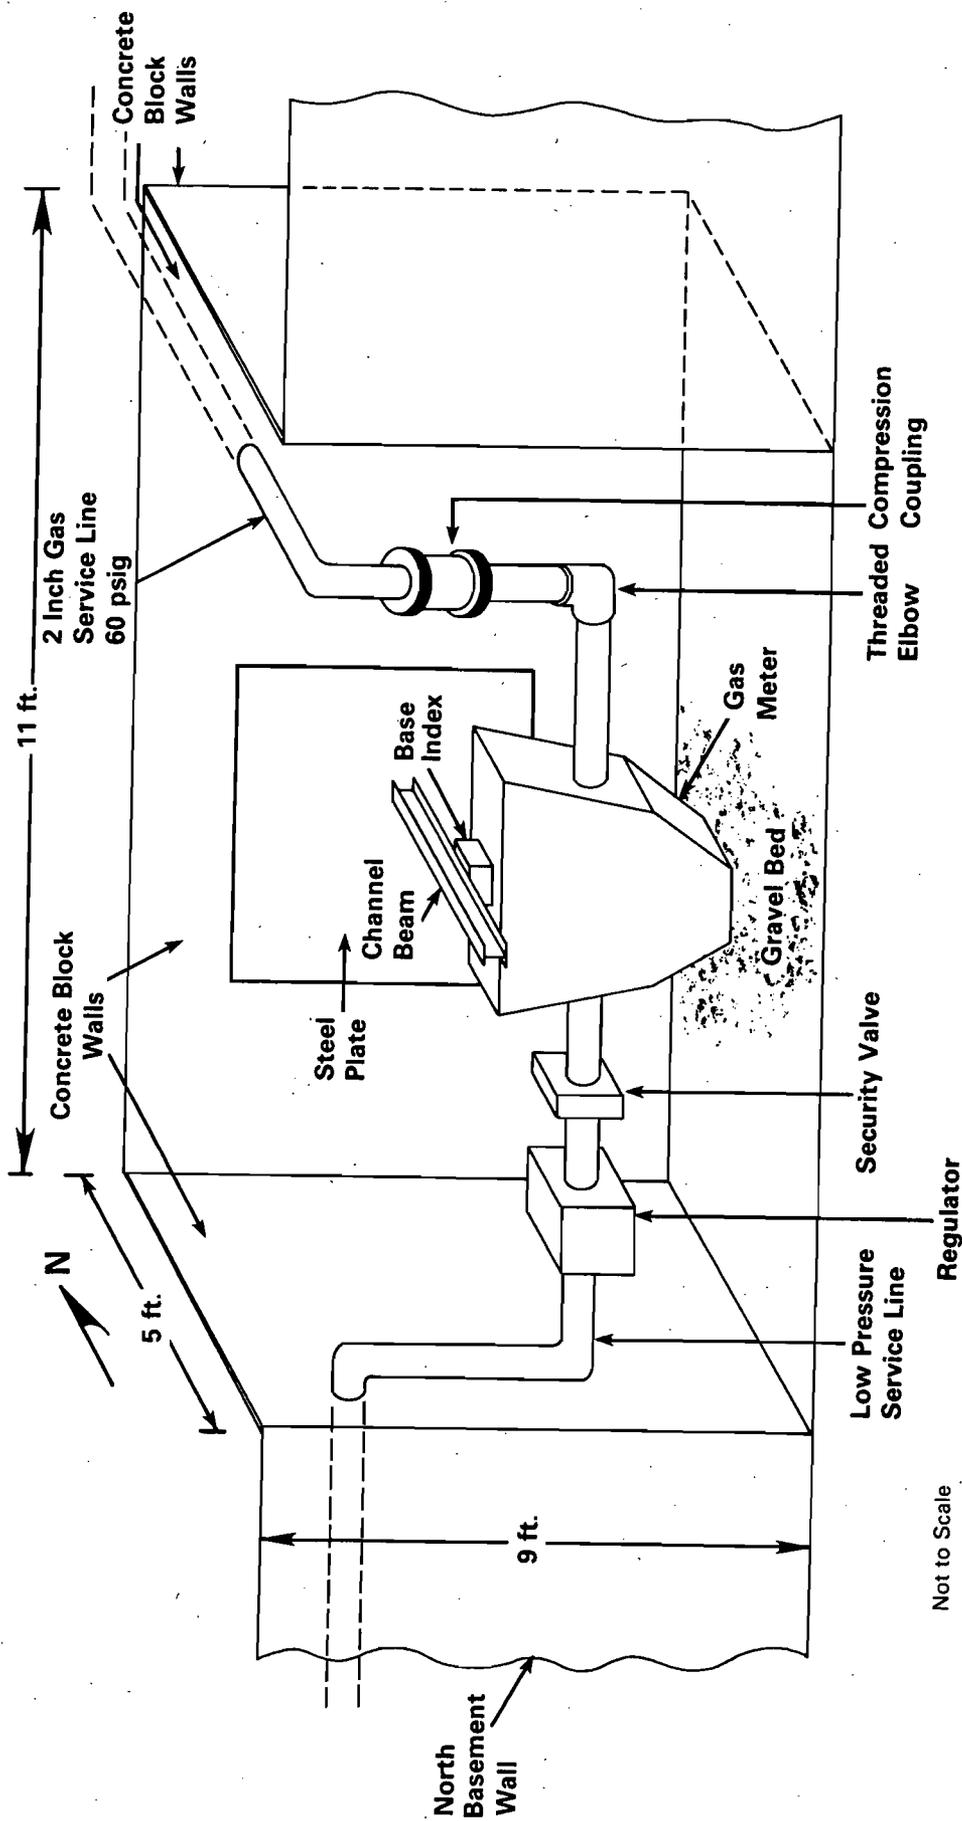
On January 21, Piedmont recovered the gas meter, the security valve, the regulator, and piping from the pit. (See figure 4.) The fitting on the inlet side of the gas meter was damaged. The security valve was still connected to the gas meter but had been separated from the downstream piping. The security valve, which is designed to close if the gas pressure in the customer's piping exceeds the set pressure of the valve, was found in the open position. The regulator piping was separated at both ends, and the regulator valve body was fractured. The piping from the threaded elbow to the inlet side of the gas meter was not recovered. The fire department took custody of the gas meter, the security valve, the regulator, and sections of gas piping recovered from the pit.

Figure 4.--Gas meter installation in pit.

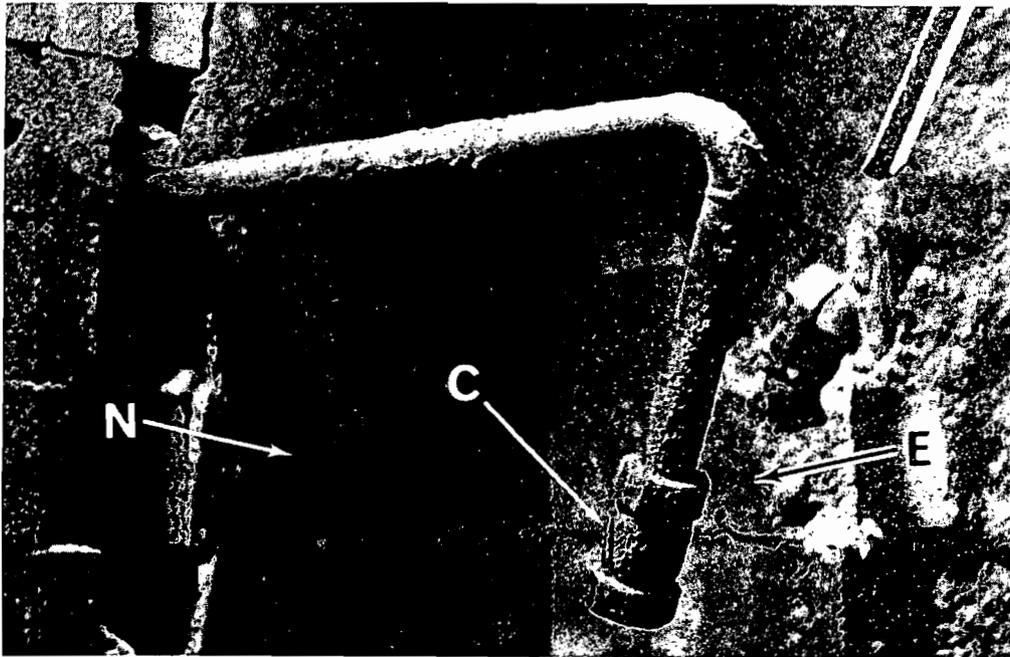
On February 1, a representative for Travco discovered that the 2-inch gas service line was corroded and cracked near the point where the service line entered the pit through the north wall. (See figures 5 and 6.) The area of corrosion was along an uncoated length of the service line extending about 2 inches into the concrete wall of the pit. The circumferential crack was located approximately 1 1/2 inches inside the concrete wall. The crack extended around the west half of the pipe, from the 10:30 o'clock position clockwise to the 6:30 o'clock when viewed from upstream. From the pit wall, the service line extended horizontally into the pit to a 90° welded elbow and then extended vertically downward. The downstream end of the vertical pipe section was connected to a Dresser Industries (Dresser) Series-90 compression coupling. The 2-inch pipe section that had been connected to the downstream end of the coupling was found separated from the coupling. The cracked service line section with the coupling was removed from the pit and placed in the custody of the fire department.

Figure 5.--View of the gas service line after the explosion at its entry point into the pit through the north wall (arrow "N"). The east wall of the pit (arrow "E") and the disengaged compression coupling (arrow "C") also are shown.

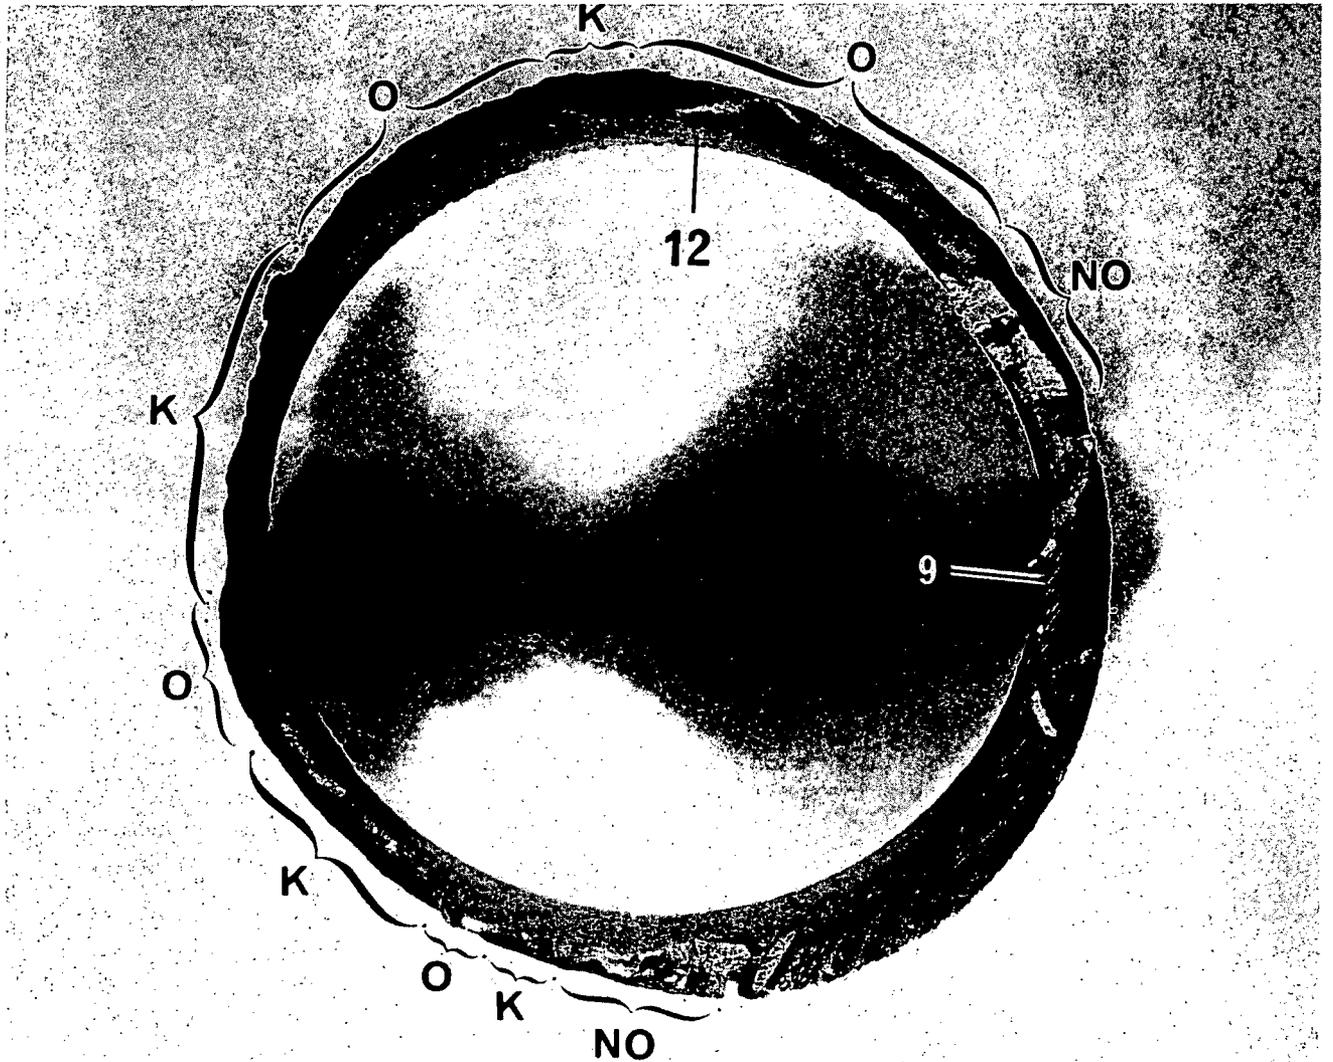
Severe corrosion damage to the outer surface of item A extended about 0.75 inch on both sides of the crack and had significantly reduced the pipe wall thickness. The intact area of the pipe between the crack ends exhibited only minor corrosion attack. Measurements at three positions on the crack face established that corrosion had reduced the thickness of the pipe wall by 0.06 to 0.14 inch, from a nominal wall thickness of 0.151 inch. Corrosion had thinned the pipe wall at four locations along the crack face to a knife edge. (See figure B-1.) The combined length of these four locations was approximately 50 percent of the total crack length. The remaining crack length, other than the ends of the crack, were heavily corroded and contained characteristics of tensile shear overstress. The crack ends also exhibited tensile shear overstress characteristics but were only lightly corroded.

Figure B-1.--Photograph at 2X of the upstream crack face. Corrosion thinned knife edges denoted by bracket "K." Heavily corroded overstress fracture areas at bracket "O" and highly corroded overstress at bracket "NO."
