PIPELINE ACCIDENT REPORT

LIQUID PROPANE PIPELINE RUPTURE AND FIRE
TEXAS EASTERN PRODUCTS PIPELINE COMPANY
NORTH BLENHEIM, NEW YORK
MARCH 13, 1990

ADOPTED: JUNE 11, 1991

NOTATION 5319A

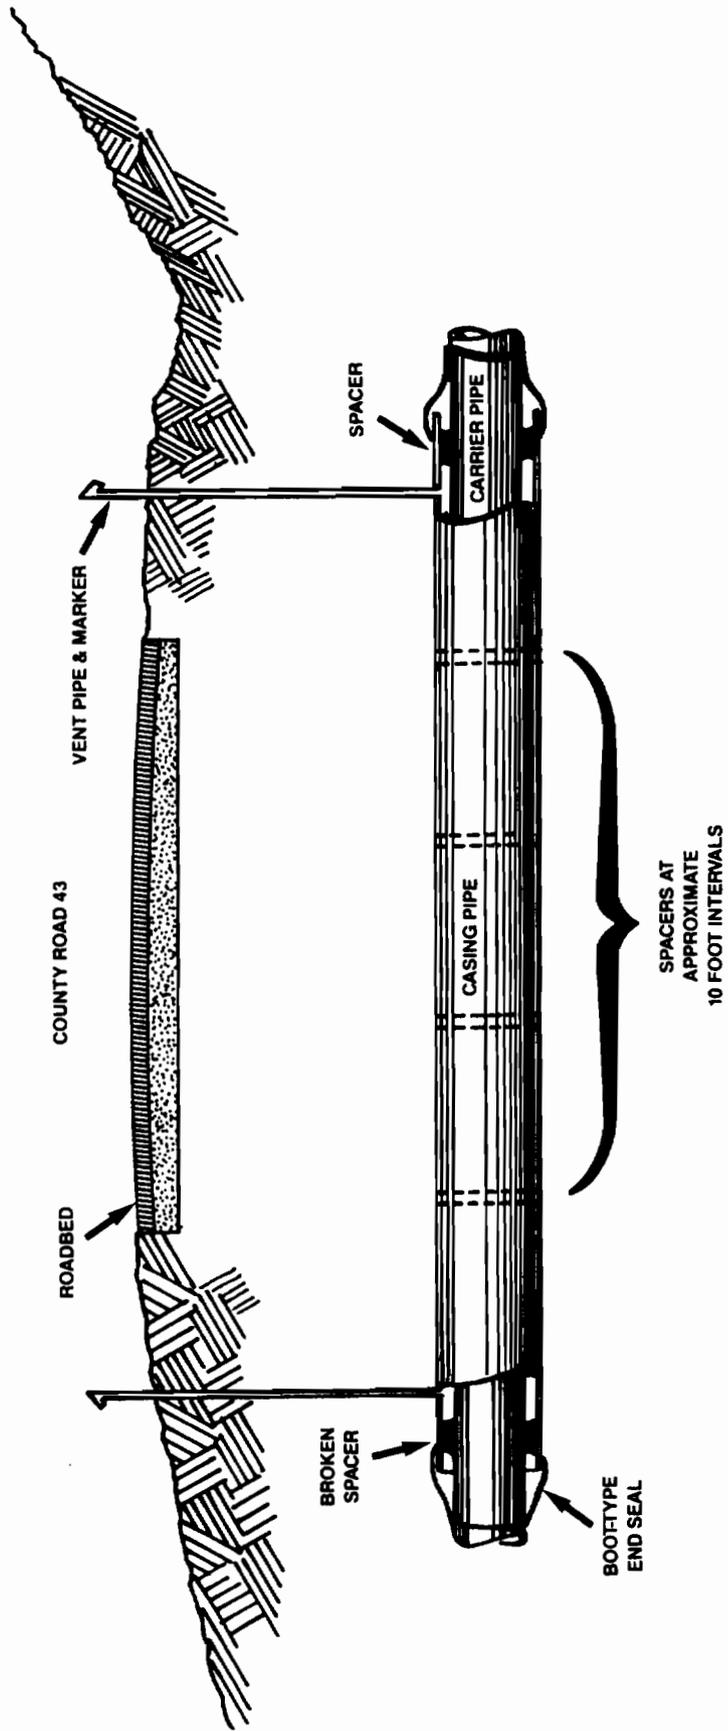
Figure 4.--Cross sections sketch of pipe crossing CR 43, looking North.

On the east side of CR 43, an approximate eight-degree bend upward had been made in the pipe as it exited the casing, about 8 feet of soil covered the casing, and the earth cover over the pipe 30 feet east of the casing was about 6 feet deep. The ground on the east side was higher than the road, and it sloped down to the road at an approximate 14-degree angle. The pipe was found centered within the casing, and a casing insulator was near the end of the casing. A synthetic rubber end seal had not been damaged by the fire, but it had been moved 2 to 3 inches from the casing; its stainless steel straps appeared in sufficiently tightened to hold the seal in place.

On the west side of CR 43, the casing was about a foot lower than on the east side, making the slope of the casing about one degree downward to the west. The ground west of the casing was lower than the road, and it sloped

downward at a four-degree angle. The pipe had no bends as it exited the casing and was buried about 6 feet below the surface. It exited the casing to the west at a downward angle about 3 1/2 degrees relative to the casing. (See figure 6.) Other than fire and rupture damage, no other damage was visible. At the point where the pipe exited the casing, it was in contact with the bottom of the casing. The link seal, installed in February, was found about 3 feet from the end of the casing, and one of the links was broken. No evidence was present of select backfill (such as sand), sand bags, or other support for the carrier pipe except for the single, wooden skid that had been installed on February 21, 1990.

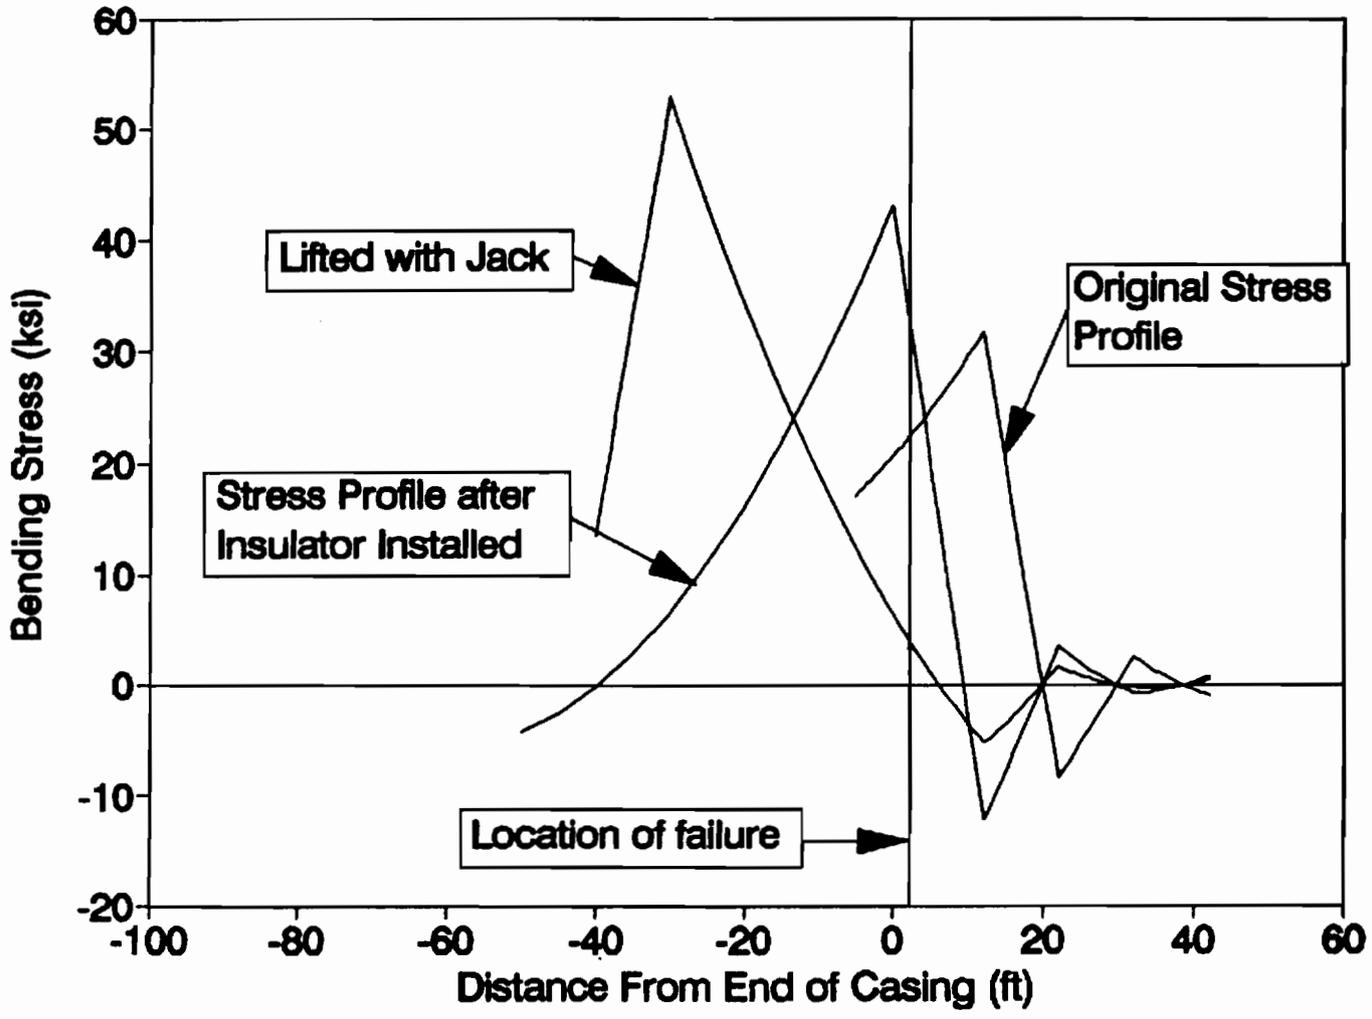
Figure 7.--Battelle's bending stress profiles showing the stresses before, during, and after repair.

Stress Analysis.--Battelle performed a series of two-dimensional finite-element analyses to estimate the magnitude of the bending stresses in the pipe before, during, and after the repair work. Assumptions had to be made about the original pipe's raised positions and soil conditions. The analyses considered only bending stress. The calculations did not take into account any values for residual stress or axial stress from pressurization; these would have to be added. The analyses indicated that when the pipe was initially raised to remove the broken casing spacer, the maximum bending stress on the pipe increased from about 32,000 psi to about 53,000 psi. In addition, the point of the maximum stress moved from a few feet within the casing to about 30 feet west of the casing, where the jack lifted the pipe. After the link seal was installed in the annulus and the pipe lowered, the maximum bending stress was reduced to 43,000 psi at the end of the casing. At the point of failure, the bending stress was less than the maximum stress. (See figure 7.) The Battelle analyses indicated that the bending stress at the point of failure decreased from about 22,000 psi to 4,000 psi when the pipe was initially raised and increased to about 32,000 psi after the repair work. The net effect of the repair work performed on February 21, 1990,
