**PB92-916501
NTSB/PAR-92/01**

PIPELINE ACCIDENT REPORT

**NATURAL GAS EXPLOSION AND FIRE
DEPARTMENT OF DEFENSE/ARMY
FORT BENJAMIN HARRISON
INDIANAPOLIS, INDIANA
DECEMBER 9, 1990**

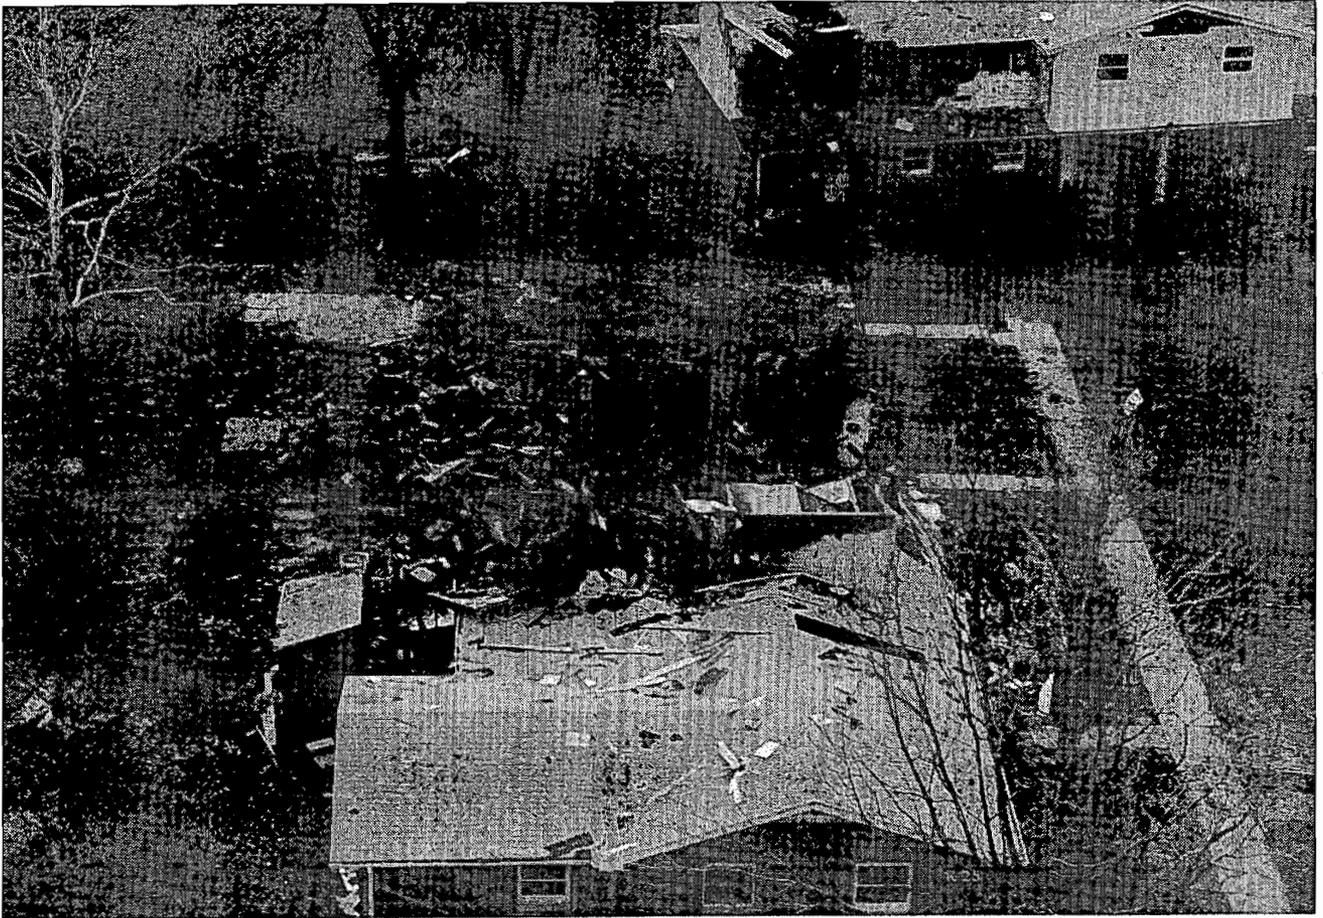
Figure 2.--View of the destroyed and damaged buildings.

The Army Corps of Engineers (Corps) estimated the explosion and fire damages to buildings 1023 and 1024 at \$3,800 and \$48,500, respectively. Building 1025 was destroyed, and the estimated loss was \$300,000. Total building damage was approximately \$352,000. After the accident, the gas company replaced the entire village gas distribution system at a cost of \$147,000 to the Army. Also, flexible gas fuel piping and vent pipes within the village were replaced at a cost of \$73,000.

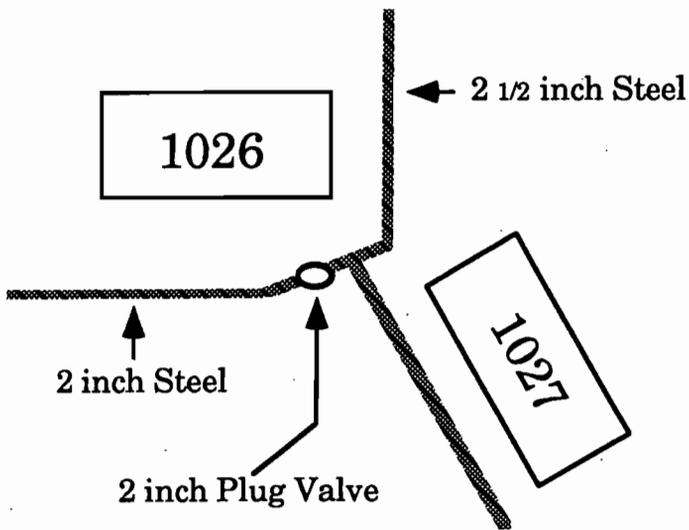
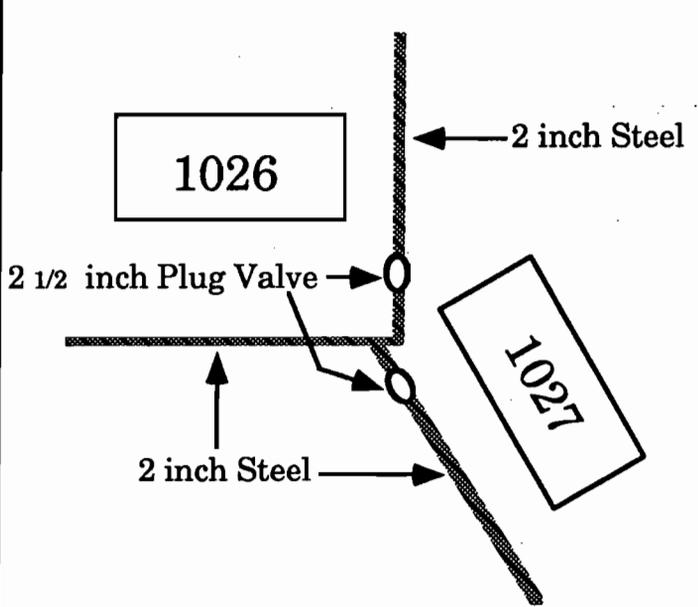
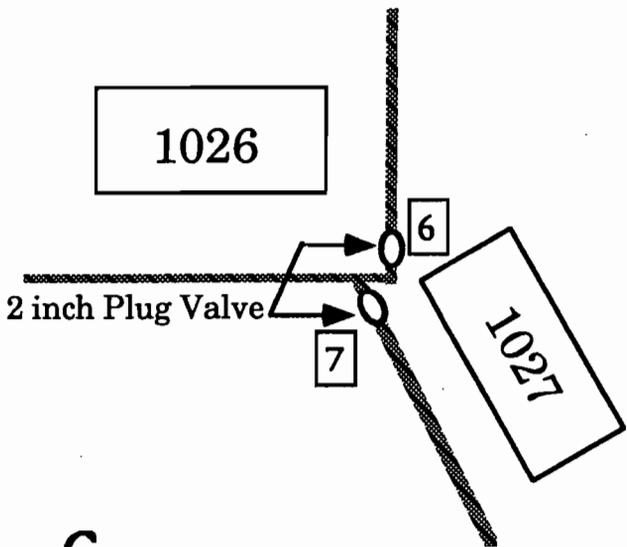
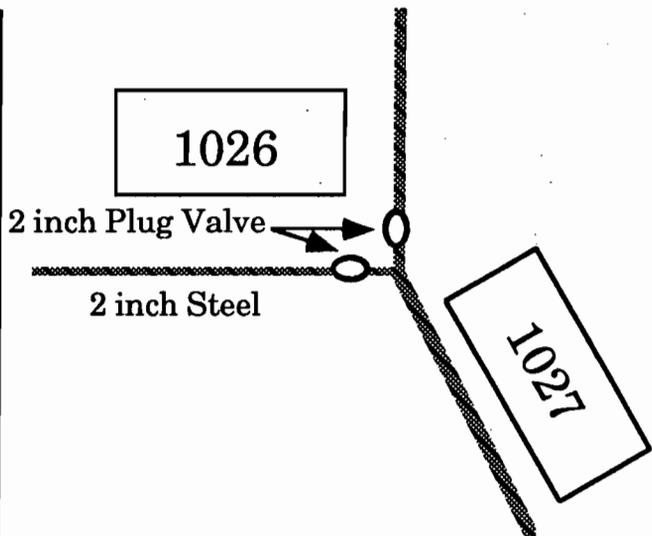
An approved-for-construction drawing dated 1971 did not show the valve behind building 1027 but did show the valves beside and behind building 1026. (See figure 4D.) This drawing also did not show the distance between the buildings and the gas mains.

Figure 4.--Valve arrangement between buildings 1026 and 1027 as shown on various Fort documents.

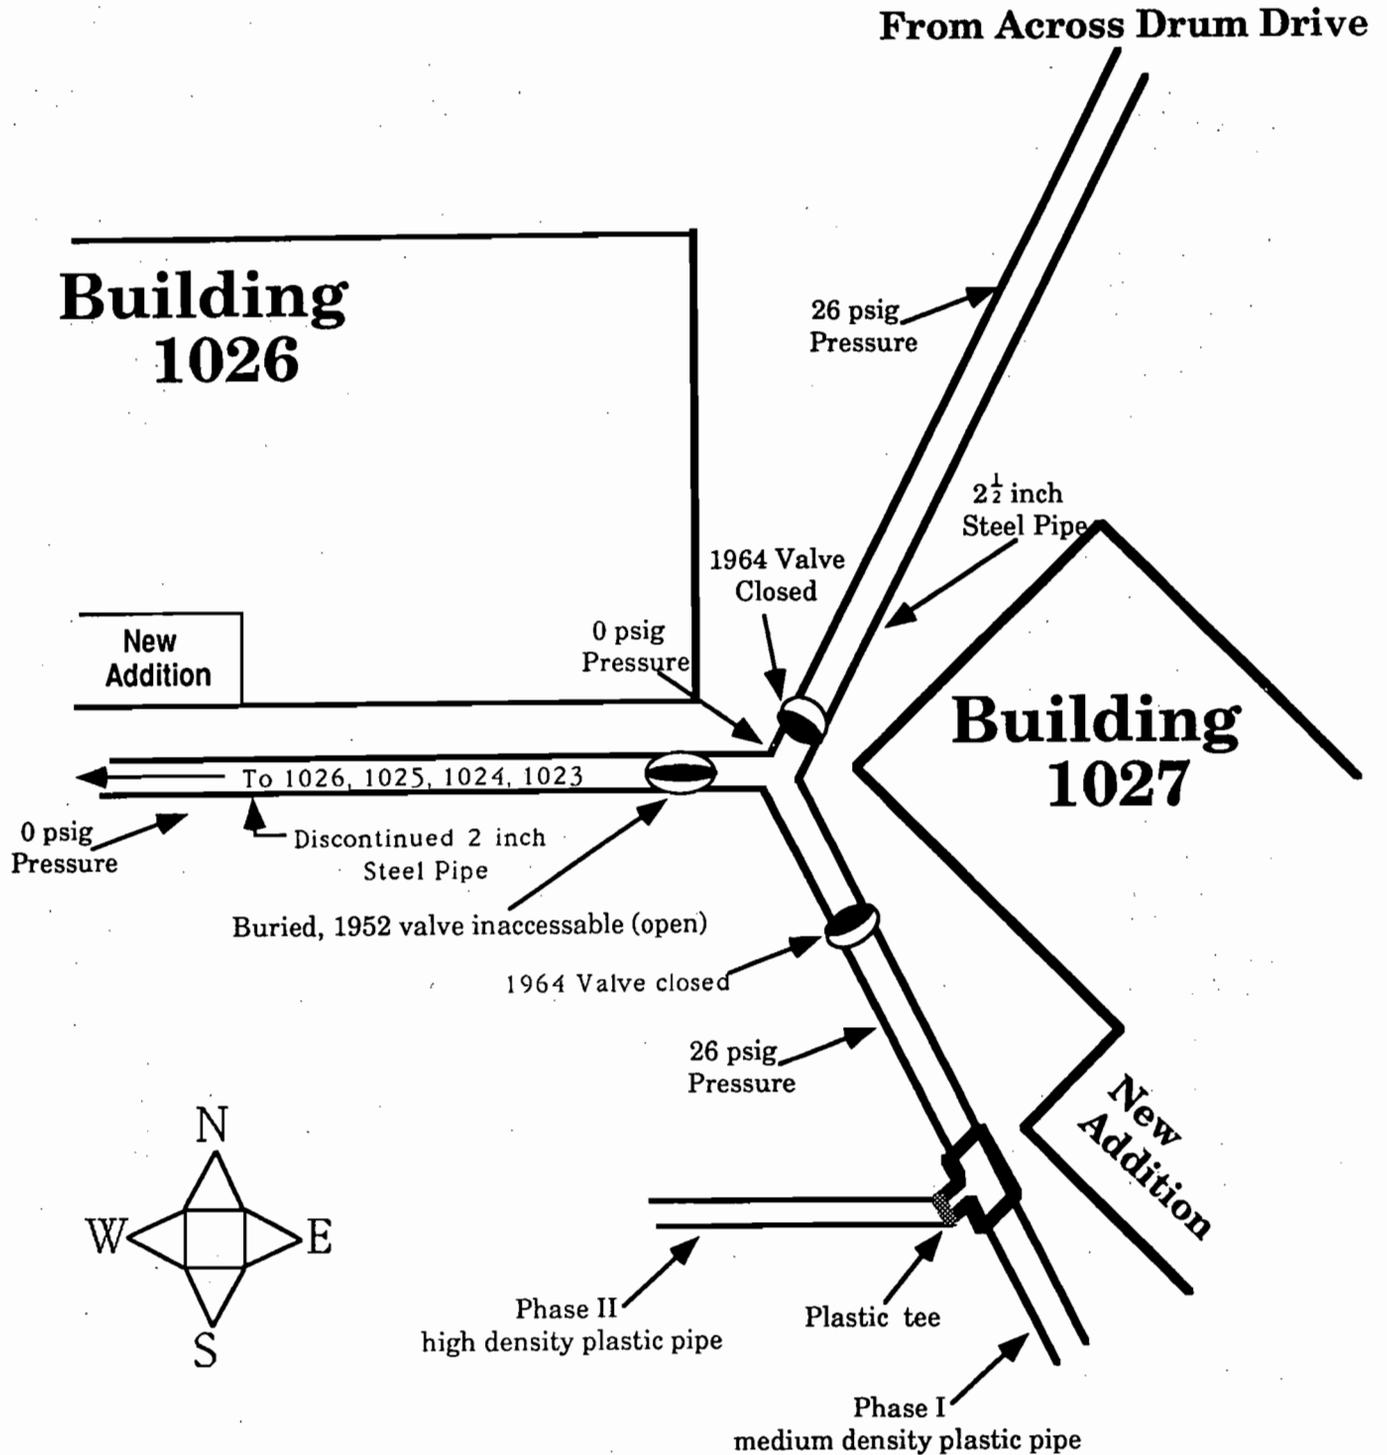
The contractor's as-built drawing showed that some of the old steel piping loop between buildings 1027 and 1035 remained. The drawing also indicated that two new valves had been installed during Phase II to replace valves abandoned between buildings 1027 and 1028 and between buildings 1033 and 1034 in that nine-building loop. The steel piping not replaced in the loop was not pressure tested or otherwise checked for leaks, and its corrosion protection system was not tested to determine whether the anodes had remained in electrical contact during the construction and whether the electrical protection was adequate to prevent corrosion.

Figure 5.--Schematic showing the gas pipes and valves near buildings 1026 and 1027 as found after the accident.
