NATIONAL TRANSPORTATION SAFETY BOARD

PIPELINE ACCIDENT REPORT

UGI UTILITIES, INC., NATURAL GAS DISTRIBUTION
PIPELINE EXPLOSION AND FIRE
ALLENTOWN, PENNSYLVANIA
JUNE 9, 1994

**Adopted: February 26, 1996
Notation 6652**

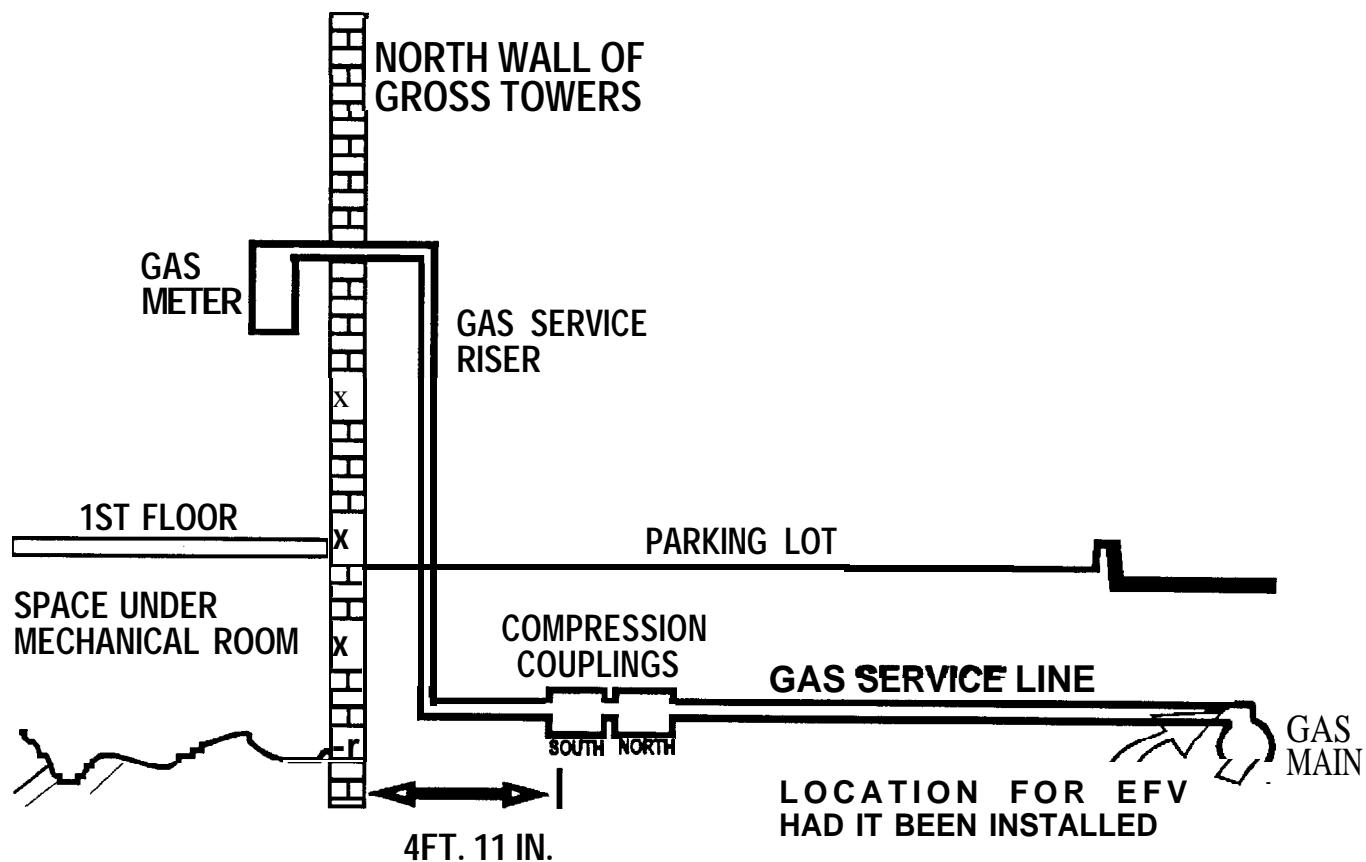
Figure 2. Schematic of Gas Service Line

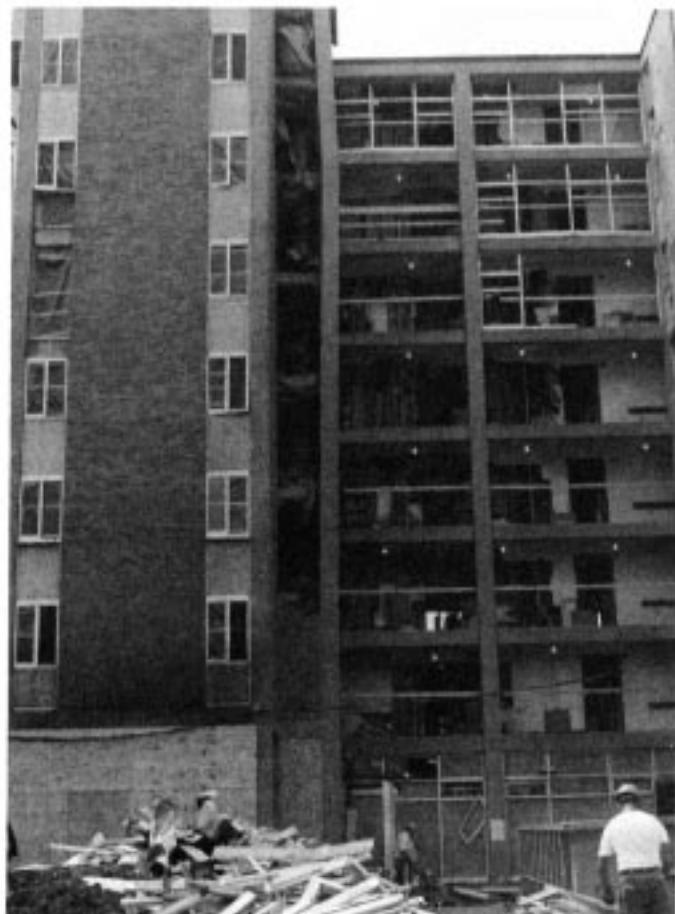
Figure 3. Back of Gross Towers after Accident

Gross Towers was severely damaged. Its walls, both exterior and interior, and its windows were damaged, and the first floor concrete slab over the crawl space was pushed

upward. The majority of the damage was in the north portion of the building, with the worst damage occurring on the first and seventh floors. The apartments next to the tower that housed the trash chute and boiler stacks were heavily damaged by overpressure, and the cinder block wall enclosing the tower was blown outward, fragmenting the adjacent exterior walls. The exhaust ducting on at least two boilers was pushed outward. Towers East sustained minor damage, primarily broken windows. According to the insurance carrier for the housing authority, the damage was \$4.3 million. The explosion also caused moderate damage to other area buildings, including a sports bar, automobile dealership, and tire dealership. Total damages exceeded \$5 million.

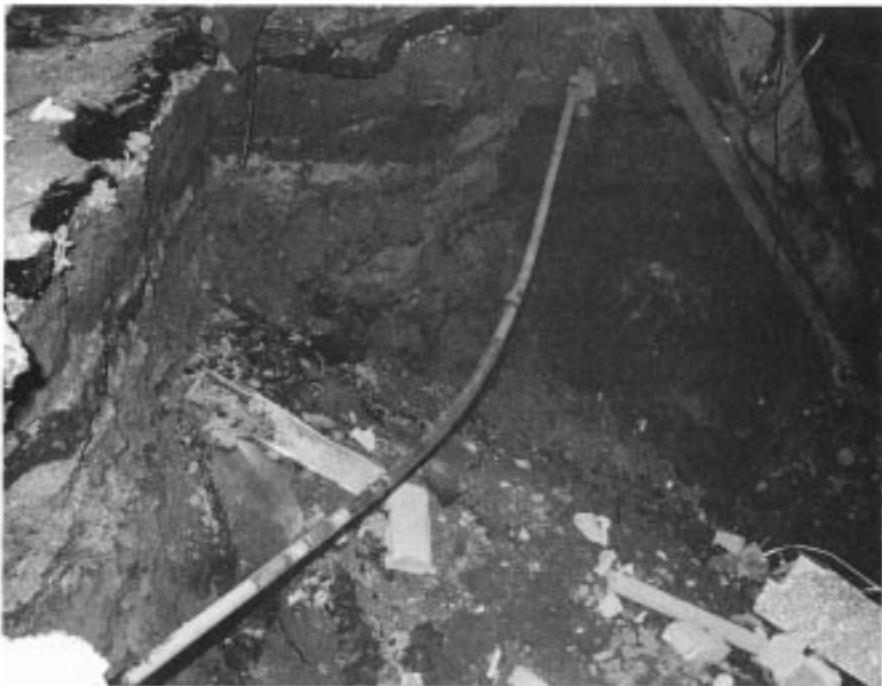
While an Allentown fire inspector was inspecting the EPAI's work, he saw the excavation's west sidewall slide into the excavation, exposing the gas line, which was about 3

to 4 feet⁶ west of the tank. The collapsed sidewall removed the soil support from about 30 feet of the gas line, causing it to sag. (See figure 4.)

Figure 4. Gas Service Line after Explosion

The plastic coating of the suspended pipe segment, predominately on the top half, had numerous gouges and cuts. The damage appeared to be recent, as corrosion was not evident on the exposed metal. The configuration and orientation of the damage were typical of the kind made by such mechanized excavation equipment as a backhoe. (See *Postaccident Tests and Inspections*.)

On the day after the accident, the pipe was surveyed to determine its location and alignment. According to the survey, the pipe sagged a maximum of 1.6 feet and was moved horizontally to the west a maximum of 1.2 feet.

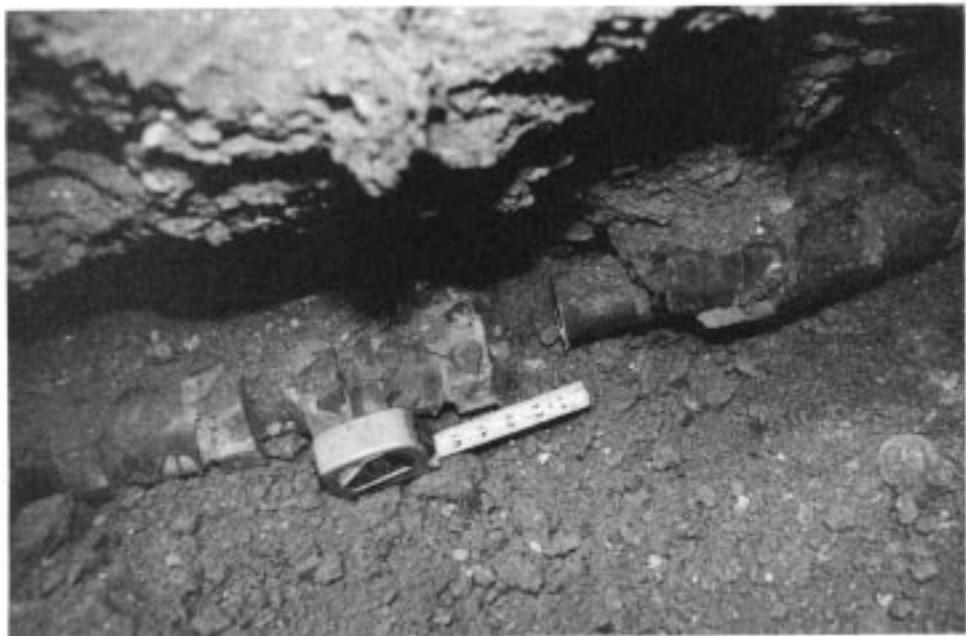
The soil next to and west of the service line was excavated by machine to pipe depth and then excavated horizontally by hand tools until the pipe's location was revealed. Next, the soil around the pipe was removed by hand. When fully exposed, two compression couplings were found in the service line about 5 feet north of the building wall. The service riser assembly pipe was separated about 2 5/8 inches from the south end of the south coupling. While there was no other separation, the pipe in the north end of the south coupling had been pulled out about 1/4-inch, and the pipe in the south end of the north coupling had been pulled

Figure 5. Service Line Separation from the Compression Coupling

out about 1/8-inch. (See figure 5.) The end of the service riser pipe that had separated was misaligned with the coupling by 13/16-inch to the east and 5/8-inch upward. The initial insert depth of the pulled-out pipe end was 2 5/16 inches. Using the measured distance of 1/4-inch between the outside edge of the compression nut and the outer edge of the compression ring, the movement of the service line pipe was calculated to be 4 15/16 inches to the north.
