Pipeline Investigation Report: NTSB/PIR-22/02

Enbridge Inc. Natural Gas Transmission Pipeline Rupture and Fire

Danville, Kentucky
August 1, 2019

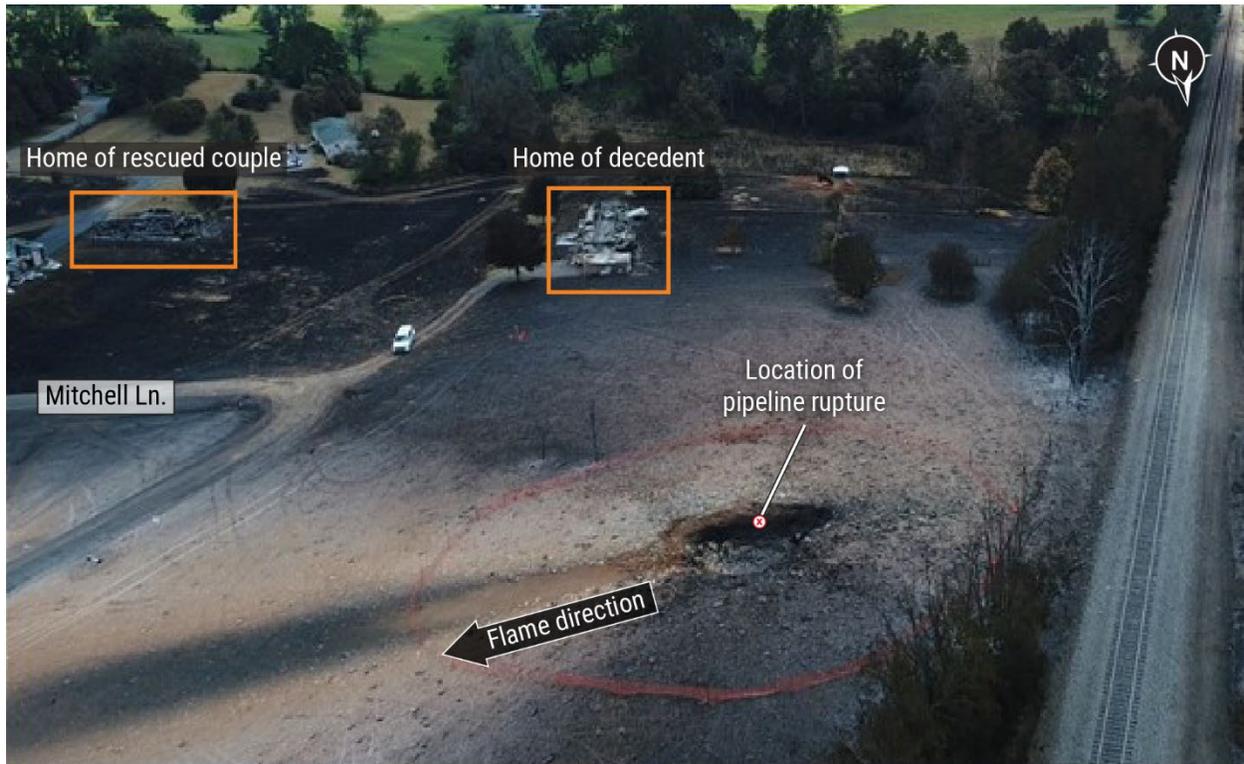
Five residences were destroyed by resulting structure fires. Fourteen other residences suffered property damage to various degrees; some were 1,100 feet from the rupture crater. The gas flame direction, as shown by the darkened area of soil indicated with a black arrow in figure 3, was oriented along a true bearing of about 80°, or just north of due east. This flame direction was consistent with the direction of the pipeline at the rupture location.

Figure 3. Homes of decedent and rescued couple, rupture location, and gas flame direction.

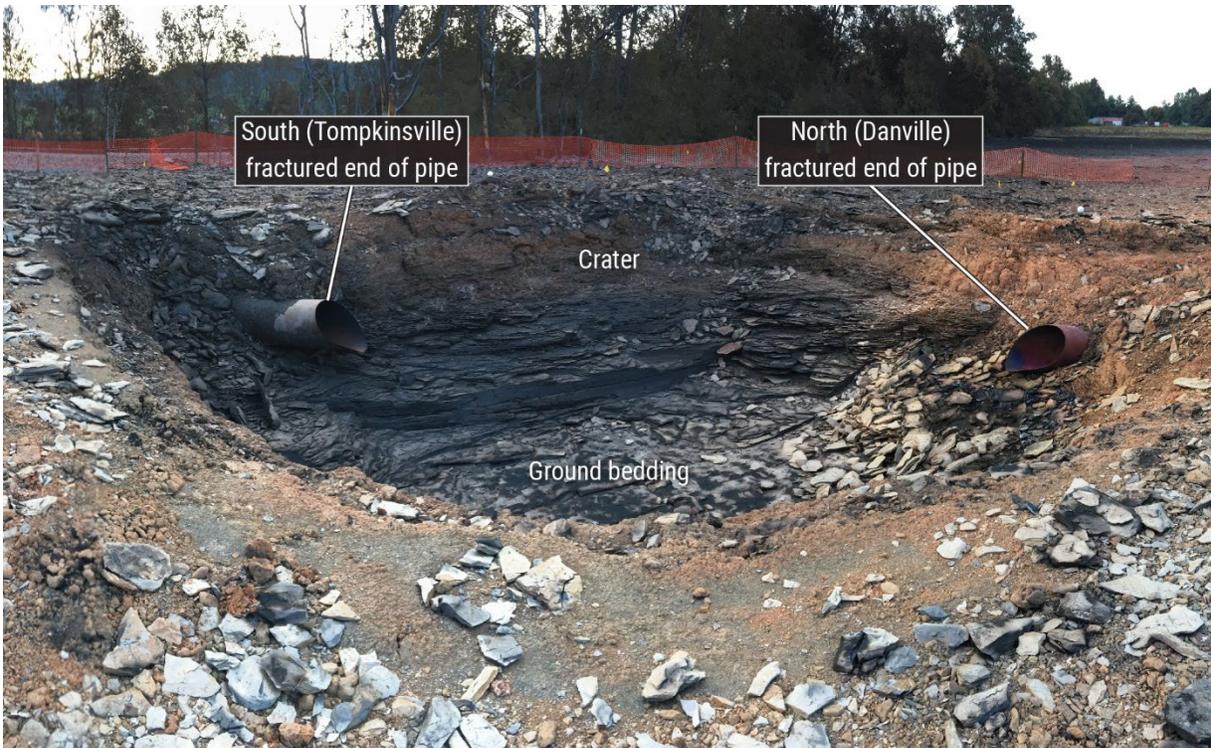
A crater was located in the area of the rupture; the crater and ground bedding under the pipe consisted of soil and broken pieces of shale. (See figure 4.)

Figure 4. Crater and ground bedding at rupture site.

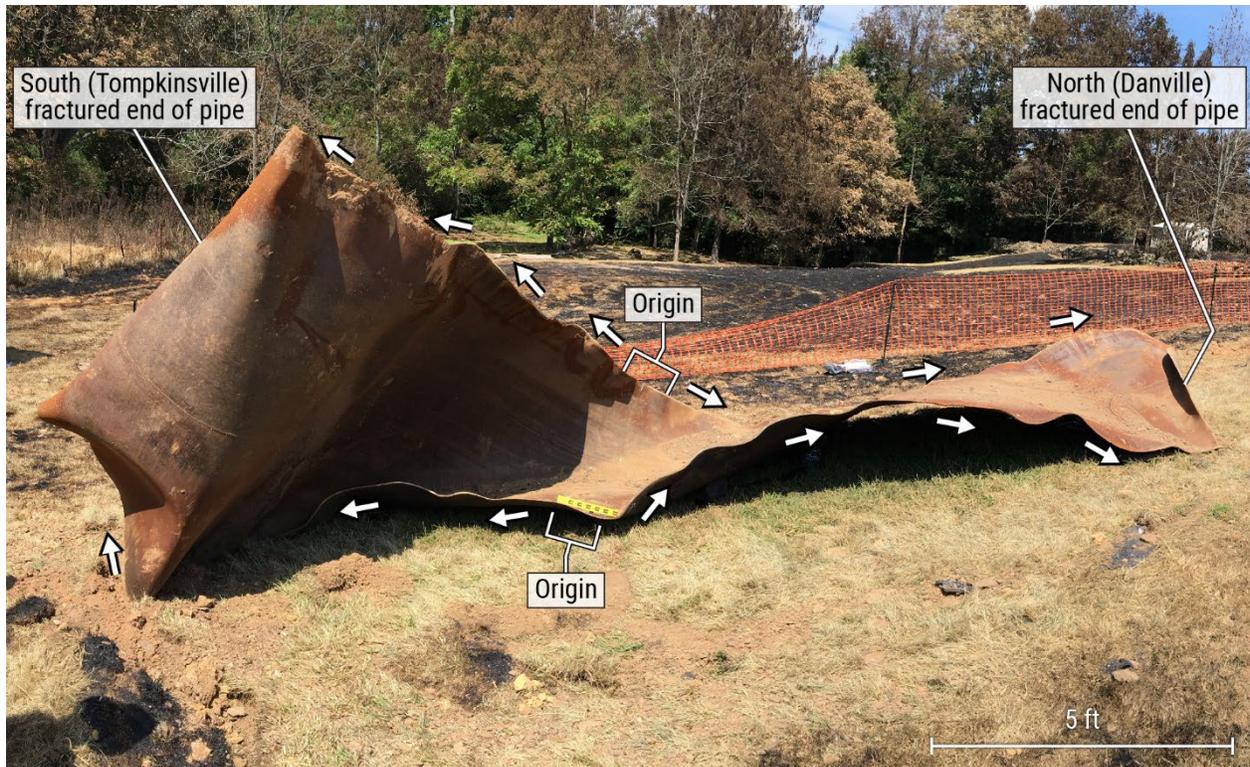
The NTSB's on-scene examination of the ejected pipeline segment revealed that most of the external coal tar coating was consumed by fire, leaving large regions of the external pipe surface bare. The fracture face of the ejected segment exhibited chevron fracture features, helping investigators locate the origin of the fracture.⁹ Figure 5 shows the origin of the fracture as indicated by the brackets; the arrows indicate the general direction of fracture propagation.

Figure 5. Ejected pipeline segment.

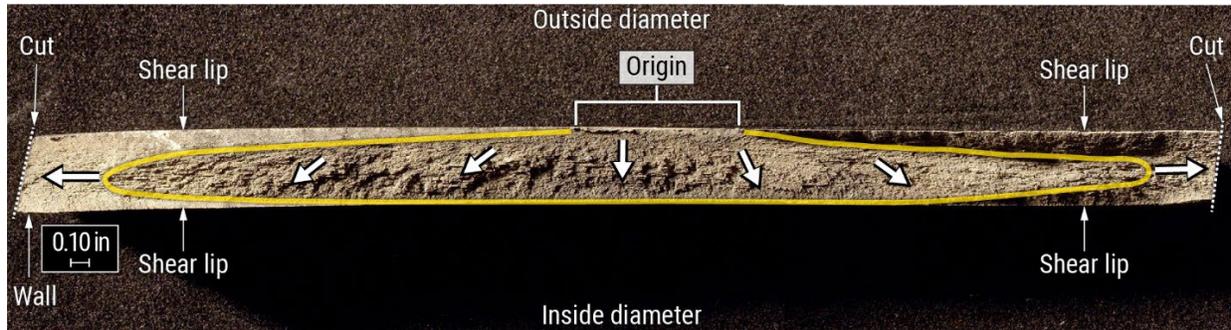
The NTSB Materials Laboratory examination of the fracture faces from the ejected pipe revealed that the fracture originated at the outer surface, as indicated in figure 6. The origin of the fracture and an area extending below it contained a flat region with a rough texture, shown enclosed by a yellow line. Fracture propagation was in the general direction indicated by the arrows.¹⁰ The origin of the fracture showed no evidence of a gouge or dent and did not originate from a weld. The length of the origin at the outer surface measured about 0.8 inches, and shear lips extended from both ends.¹¹ The fracture face at the inner surface (opposite the

fracture origin) contained a minor shear lip, indicating the fracture did not start at the inner surface of the pipe. The fracture areas located outside of the north and south ends of the flat region were on a slant plane and contained a chevron pattern, consistent with overstress separation.

Figure 6. East face of the fracture origin.

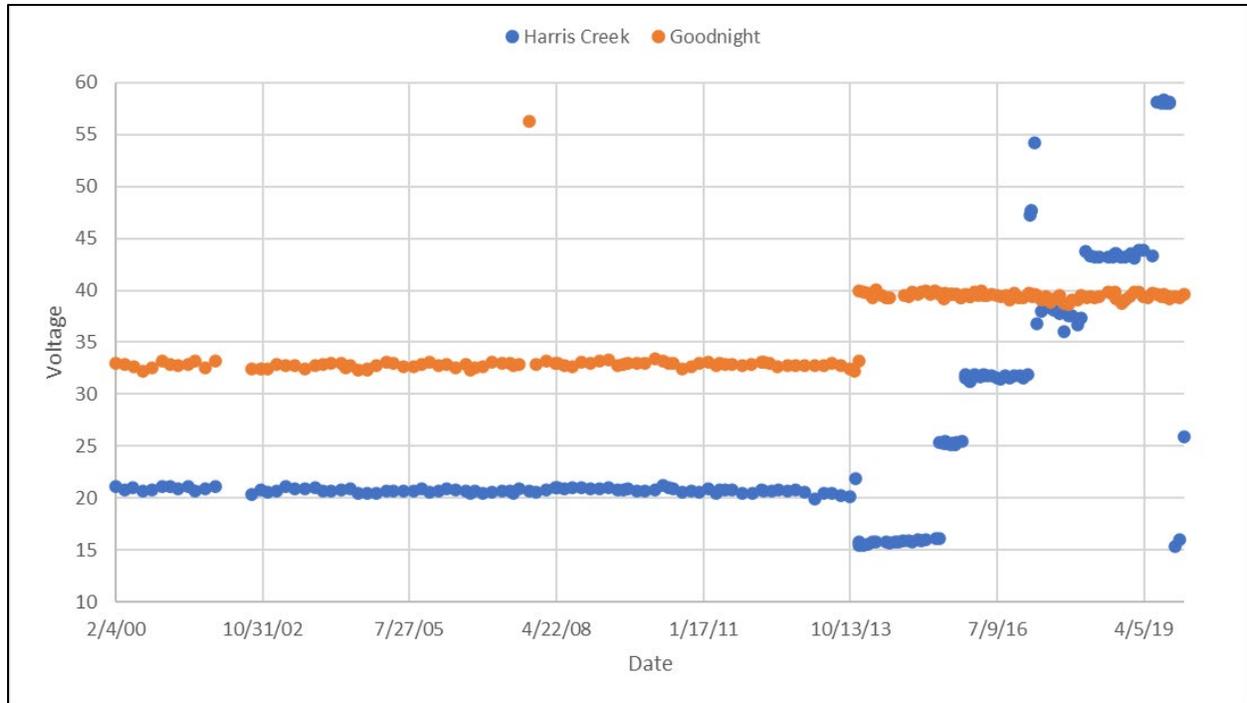
Investigators examined 10 years of maintenance activities related to cathodic protection at Goodnight and Harris Creek. In 2017 and 2019, the output from the Harris Creek rectifier was increased to address dropping potential readings.²⁸ These dropping potentials began in early 2014 after the flow reversal project was completed. Before the flow reversal, cathodic protection voltages were regular and consistent; after the flow reversal, technicians were unable to stabilize readings; at Harris Creek, voltages were increased by 18 percent, and the voltages at Goodnight increased by 58 percent. (See figure 9.) The plot in figure 9 shows the steady potentials up to 2013; after that, they became unstable. In 2018, a new anode was installed at Harris Creek, but it did not successfully raise potentials.

Figure 9. Voltage outputs at Goodnight and Harris Creek rectifiers.
