Pipeline Investigation Report: PIR-22/01

Enbridge Inc. Natural Gas Pipeline Rupture

Hillsboro, Kentucky
May 4, 2020

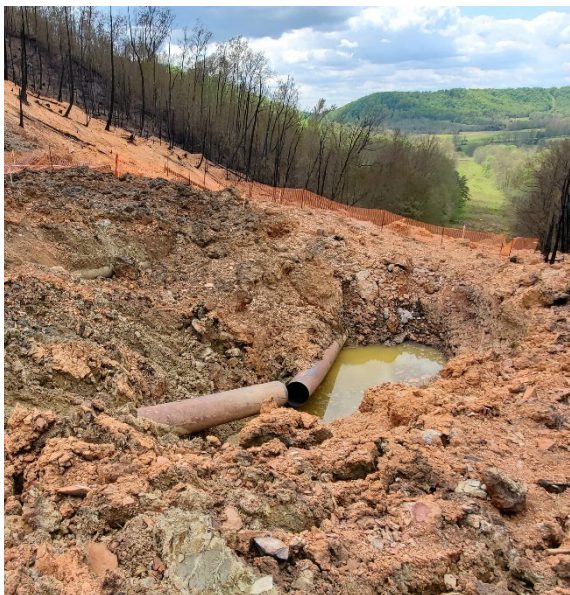
Figure 1. Ruptured pipeline.
(Source: BGC Engineering USA, Inc.)

On May 4, 2020, about 4:36 p.m. local time, a 30-inch diameter interstate natural gas transmission pipeline owned and operated by Enbridge Inc. (Enbridge) ruptured about 3 miles east-northeast of Hillsboro, Kentucky, resulting in a fire.¹ (See figure 1.) The rupture occurred on Line 10 at a hillside location that was previously identified by Enbridge for geotechnical monitoring because of an active landslide.²

at a girth weld at an elevation of about 923 feet.⁴ There were no fatalities or injuries, and Enbridge estimated the cost of property damage and emergency response at \$11.7 million.

Other contractors directed by the NTSB evaluated the ruptured girth weld, removed and evaluated exemplar girth welds, and estimated the tensile strain demand and capacity. Two incomplete penetration and lack of root fusion defects were identified on the fracture face of the ruptured girth weld.⁸ One defect was about 7 inches long and 0.13 inches deep. The other defect was about 4.9 inches long and 0.10 inches deep.

The National Transportation Safety Board determines that the probable cause of the pipeline rupture was Enbridge Inc.'s analysis of an active landslide that did not fully address uncertainties associated with pipeline defects, landslide movement, and corresponding pipeline response.
