Enbridge Inc. Natural Gas Pipeline Rupture

Hillsboro, Kentucky
May 4, 2020

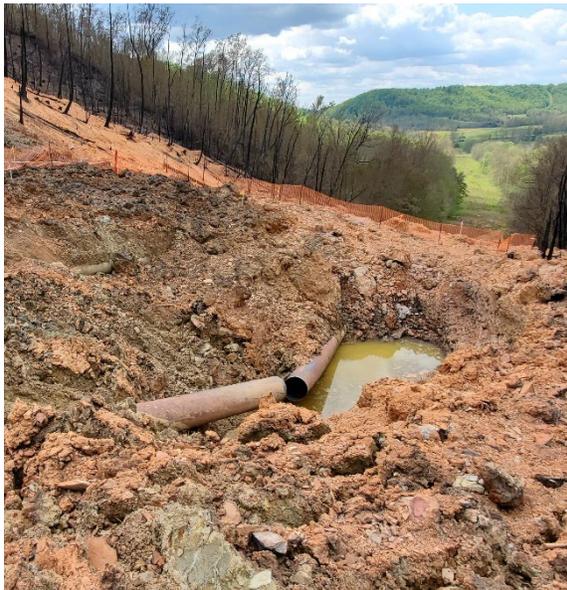
Figure 1. Ruptured pipeline. (Source: BGC Engineering USA, Inc.)

On May 4, 2020, about 4:36 p.m. local time, a 30-inch diameter interstate natural gas transmission pipeline owned and operated by Enbridge Inc. (Enbridge) ruptured about 3 miles east-northeast of Hillsboro, Kentucky, resulting in a fire.¹ (See figure 1.) The rupture occurred on Line 10 at a hillside location that was previously identified by Enbridge for geotechnical monitoring because of an active landslide.²

Other contractors directed by the NTSB evaluated the ruptured girth weld, removed and evaluated exemplar girth welds, and estimated the tensile strain demand and capacity. Two incomplete penetration and lack of root fusion defects were identified on the fracture face of the ruptured girth weld.⁸ One defect was about 7 inches long and 0.13 inches deep. The other defect was about 4.9 inches long and 0.10 inches deep.

The National Transportation Safety Board determines that the probable cause of the pipeline rupture was Enbridge Inc.'s analysis of an active landslide that did not fully address uncertainties associated with pipeline defects, landslide movement, and corresponding pipeline response.

Enbridge issued several new procedures for managing geohazards, including for estimating tensile strain capacity, conducting multidisciplinary reviews, and determining appropriate response actions. Enbridge reported that the new procedures would result in a reduced tensile strain capacity threshold (0.5 percent) on Line 10 in the area where the rupture occurred, which, given the information available before the incident, would trigger a high-priority response action.⁹ Additionally, Enbridge acknowledged that the pre-rupture strain demand methodology may have underestimated the actual strain demand. Enbridge indicated that it would continue to work with its contractors to determine whether a different method with an appropriate level of conservatism should be applied.
