Atmos Energy Corporation Natural Gas–Fueled Explosion During Routine Maintenance

Farmersville, Texas
June 28, 2021

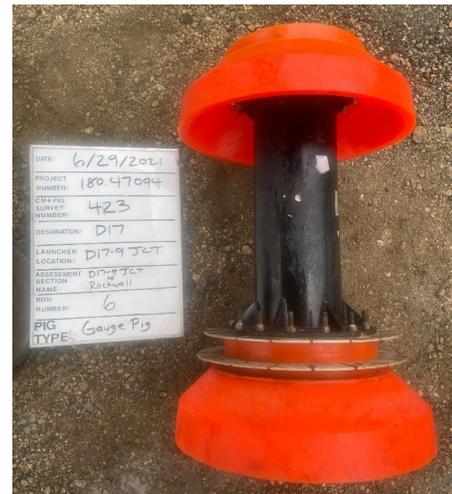
On June 28, 2021, about 3:35 p.m. local time, a natural gas explosion occurred during routine maintenance activities at an Atmos Energy Corporation (Atmos) facility near Farmersville, Texas.¹ The natural gas ignited and exploded after workers inserted an in-line tool (or *pig*) into a launcher.² (See figure 1.) Seven workers from Atmos, FESCO, Ltd. (FESCO), and Bobcat Contracting, L.L.C. (Bobcat) were on-site at the time of the accident and performing work for

Figure 1. Pig before the explosion. (Courtesy of Bobcat Contracting.)

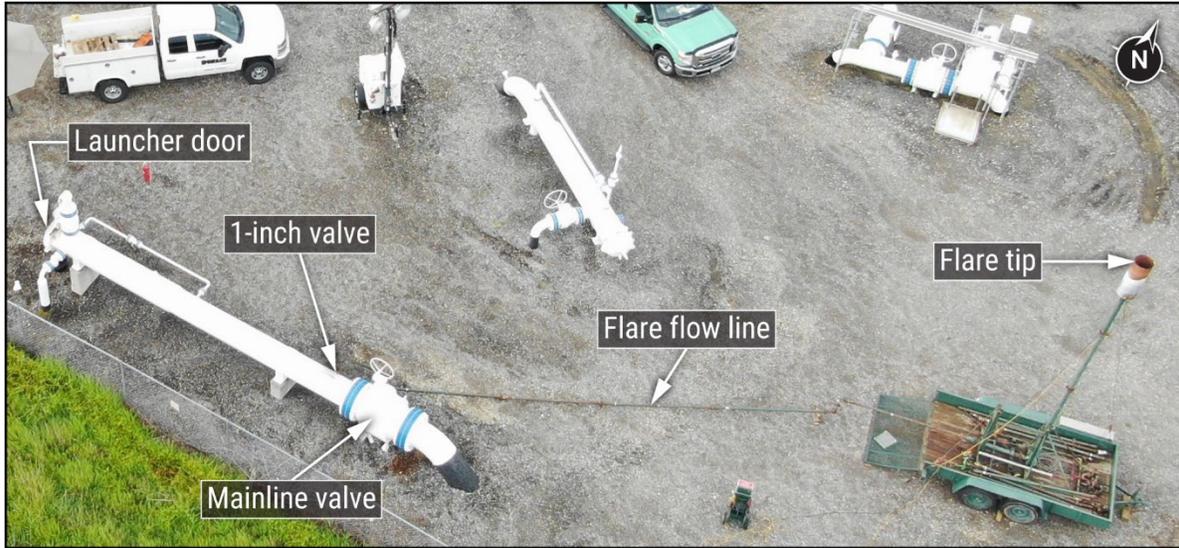
Atmos.³ The explosion occurred while the workers were removing the pig insertion tool during the sixth of a series of in-line inspections.⁴ The explosion was directed through the open launcher door, ejecting the pig from the launcher, injuring two of the workers and killing two more. At the time of the accident, the weather was 75°F with light to heavy rain showers. No cloud-to-ground lightning strikes were reported within 15 miles of the accident site. Atmos estimated property damage at the site to be about \$580,000.

Figure 2. Accident site. (Courtesy of Wylie Fire Department.)

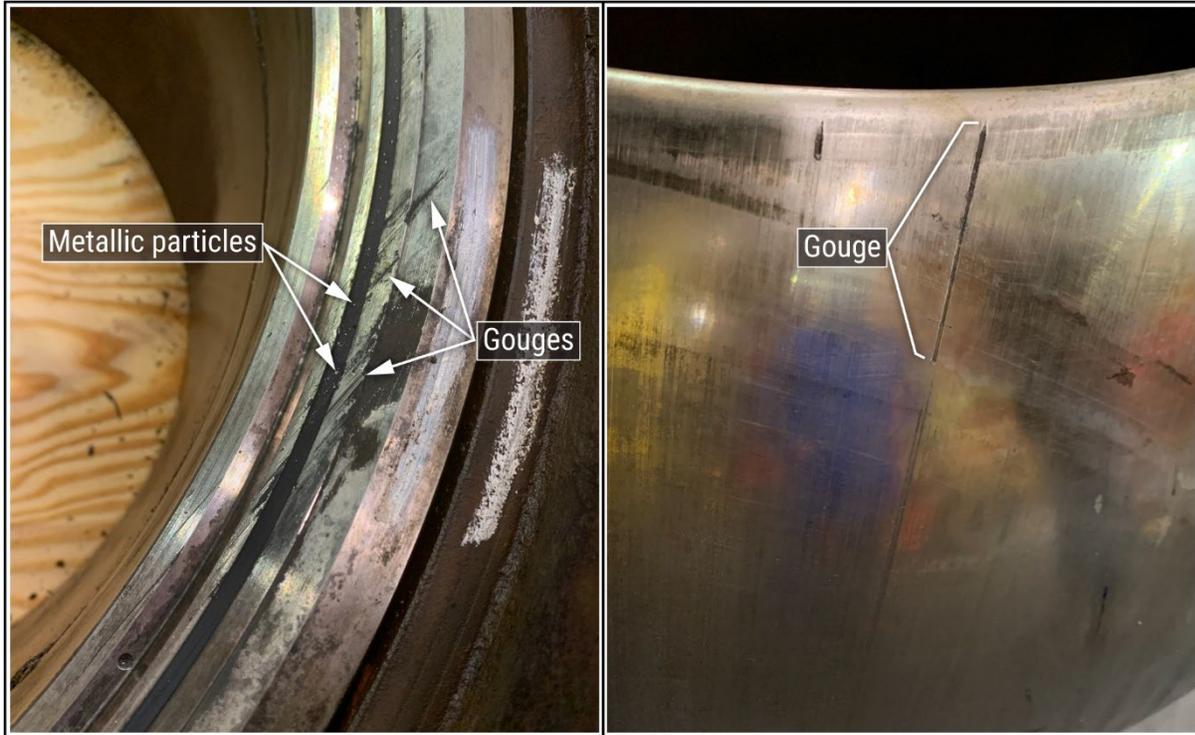
Investigators tested and examined the mainline valve, which was a 24-inch-diameter side-entry ball valve. Pressure testing revealed that the mainline valve was leaking, and examinations found that its sealing surfaces were scratched and gouged. (See figure 3.) This damage created leak paths along the sealing surfaces. The damage was consistent with foreign debris (such as metallic particles) entering the valve from an external source, and the scratches' and gouges' orientations were consistent with wear incurred during normal valve operation. The mainline valve seals were adequately lubricated at the time of the explosion and no abnormal wear was reported. No issues were found with the materials or the process for manufacturing the valve.

Figure 3. Damaged mainline valve sealing surfaces visible after disassembly into ring (left) and ball (right) components.

The National Transportation Safety Board determines that the probable cause of the June 28, 2021, explosion was a leaking mainline valve that allowed natural gas to enter the launcher where it mixed with air, creating a flammable gas-air mixture that was ignited by an undetermined source. Contributing to the explosion and its severity were Atmos Energy Corporation's procedures and training practices that did not prepare workers to recognize and safely respond to abnormal operating conditions.

Atmos suspended all pigging operations on in-service pipelines immediately following the accident and initiated a review of its related processes and procedures. Atmos revised their pigging procedure, established a new covered task for pigging operations, and developed associated training. The revised procedure standardizes launcher designs, requiring additional ports for venting, pressure gauge measurements, and gas monitoring; a grounding lug; and double block and bleed valving for valves that connect launchers to their natural gas transmission system.¹⁸ The revised procedure also requires a site-specific valve sequencing plan, job safety analyses, oversight by a third-party inspector, purging natural gas from the launcher with nitrogen, mandatory stabilization periods, criteria for stopping work if pressure and gas concentration levels rise beyond a defined threshold, and delineation of hazard zones in proximity to launchers and receivers. Additional specifications for on-site tools and grounding requirements were also included to further reduce the risk of inadvertent ignition.

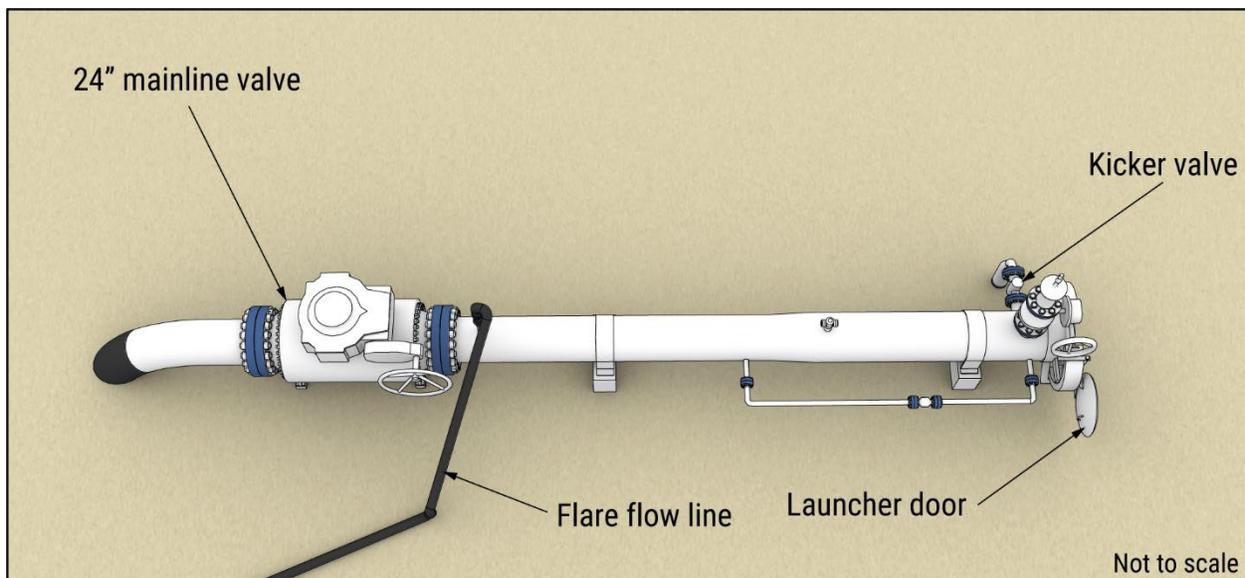
Insertion of the pig was modeled as a complete blockage within the launcher barrel.¹⁶ When the pig fully obstructs the launcher barrel, the *equalizer piping* (a valved pipe that allows equalization of pressure within the launcher on both sides of the pig) is the only way for gas to move between the launcher barrel sections on either side of the pig. (See figure 4.) Modeling that included the leak from the mainline valve showed that once the blockage was introduced, the concentration of natural gas in the launcher between the pig and open launcher door would have decreased while the concentration between the pig and mainline valve would have increased.

Figure 4. Diagram of pig launcher.

Opening the launcher door did allow natural gas to vent to atmosphere, decreasing the concentration within the launcher. However, the mainline valve was leaking, which allowed additional natural gas to enter the launcher while workers were loading the pig. After the pig was loaded into the launcher, the pig obstructed the pipe between the mainline valve and launcher door. This obstruction and the leaking mainline valve caused natural gas concentrations between the pig and mainline valve to rise to an explosive concentration. The workers were not using any means of detecting or measuring gas that could have alerted them to the hazardous condition. The gas ignited, causing an explosion.

Although the NTSB did not determine the ignition source, two possible ignition scenarios were identified: (1) an ignition source was present between the pig and mainline valve, or (2) a flammable gas-air mixture and an ignition source were present between the pig and open launcher door which flashed back to the other side of the pig. As a result of the explosion, Atmos revised their pigging procedure to include gas monitoring for hazardous atmosphere and purging the launcher with nitrogen to expel natural gas before opening the launcher door during pigging operations.
