Pipeline Investigation Report PIR-25-01

UGI Corporation Natural Gas-Fueled Explosion and Fire

West Reading, Pennsylvania
March 24, 2023

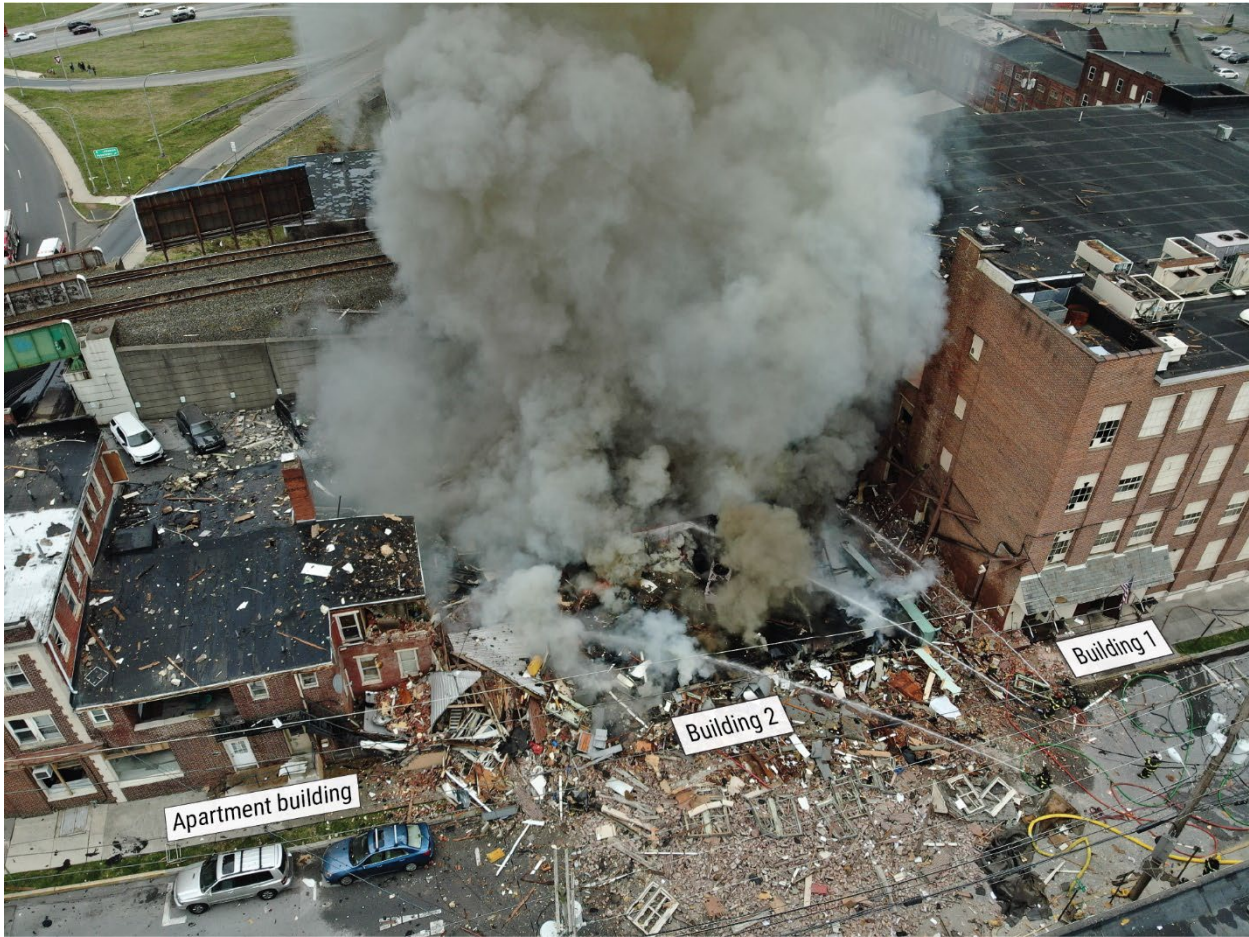
Figure 1. Overhead image of the accident. (Source: Western Berks Fire Department.)

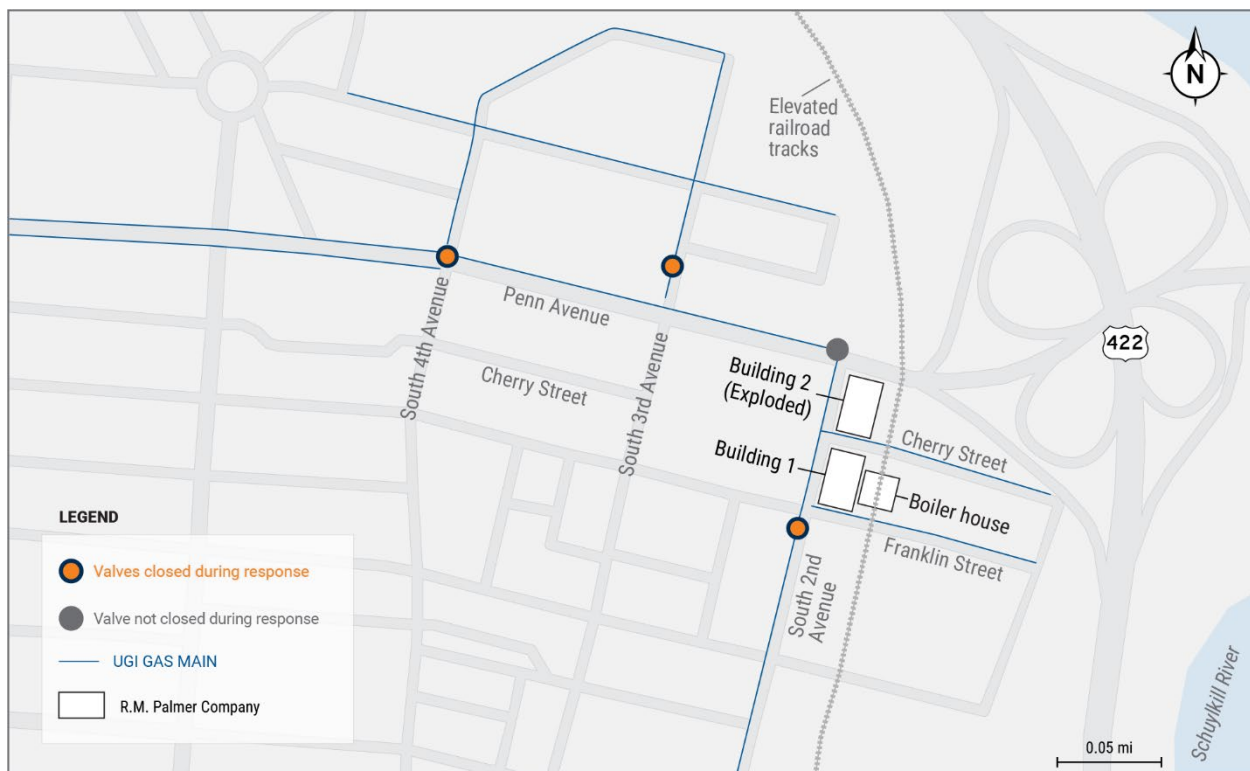
UGI added that upon encountering this issue, the UGI mechanic used geographic information system (GIS)-based maps and records to identify the next-closest valve needed to isolate the main segment; this valve was located at South 3rd Avenue and Penn Avenue. The UGI mechanic subsequently closed the South 3rd Avenue and Penn Avenue valve about 5:50 p.m., shutting off gas flowing north to south. He then moved to the final valve at South 4th Avenue and Penn Avenue that, when closed, shut off gas flowing west to east and completed the isolation of the gas system in the affected area.

Figure 6. Underground gas main valves involved in response to the March 24 incident.

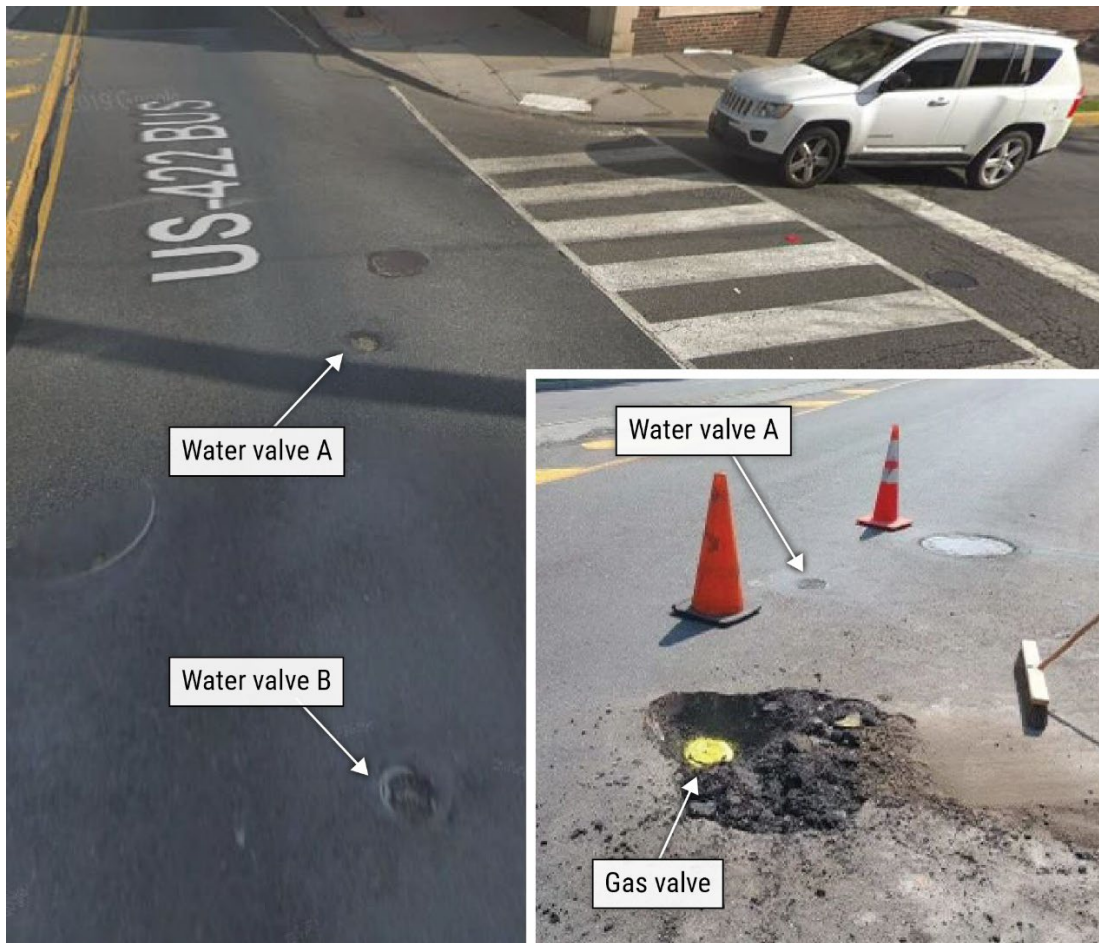
The gas valve at South 2nd Avenue and Penn Avenue was not positively identified by UGI's mechanic during the emergency response; he was unable to verify the gas valve's identification number to confirm that it was the valve he intended to shut off. In July 2024, at the NTSB's request, UGI excavated the site and found the gas valve under a layer of asphalt near two water valves (water valves A and B).

A 2018 photograph provided by UGI of South 2nd Avenue and Penn Avenue is shown in figure 8 along with an inset image of the uncovered gas valve and water valve A from UGI's 2024 excavation. The gas valve is not visible in the 2018 image. A UGI representative stated that during the 2021 inspection, UGI personnel likely located a nearby water valve that had a gas cover (water valve A) and that they had likely inspected that valve.³³ He further stated that the appearance of and the mechanism used to operate the types of water and gas valves found at that location were nearly identical.

Figure 8. South 2nd Avenue and Penn Avenue intersection in 2018 (*main image*) and during an excavation in 2024 (*inset*); water valve A had a gas cover. (Source: Google Street view via UGI.)

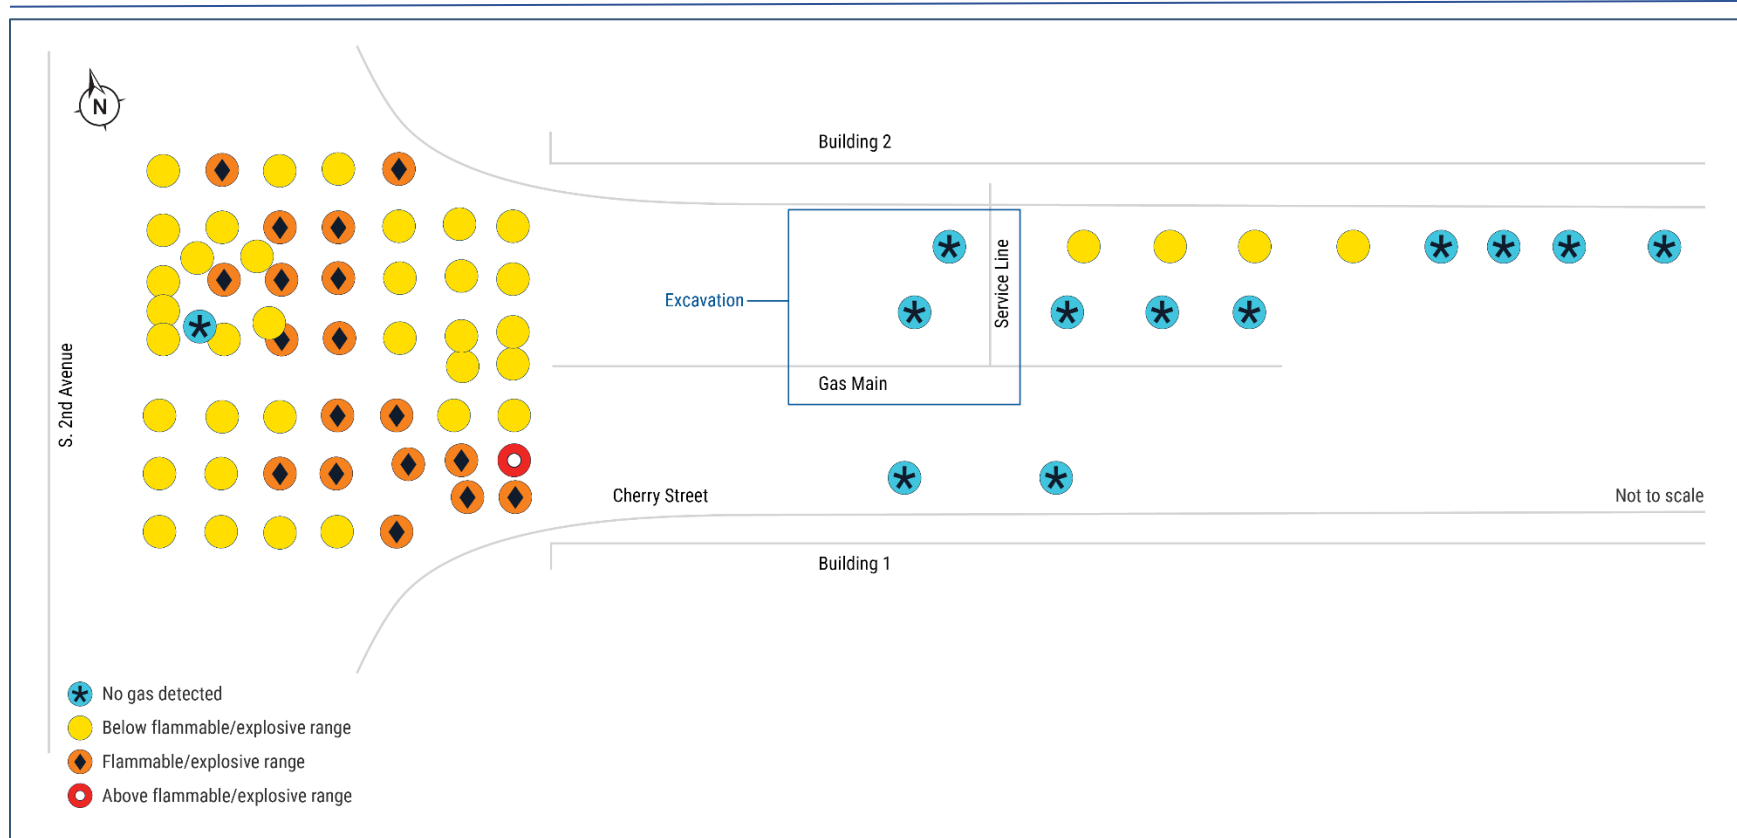
Figure 9. Bar hole test readings conducted in March 2023 (*left side of image*) and April 2023 (*right side of image*).

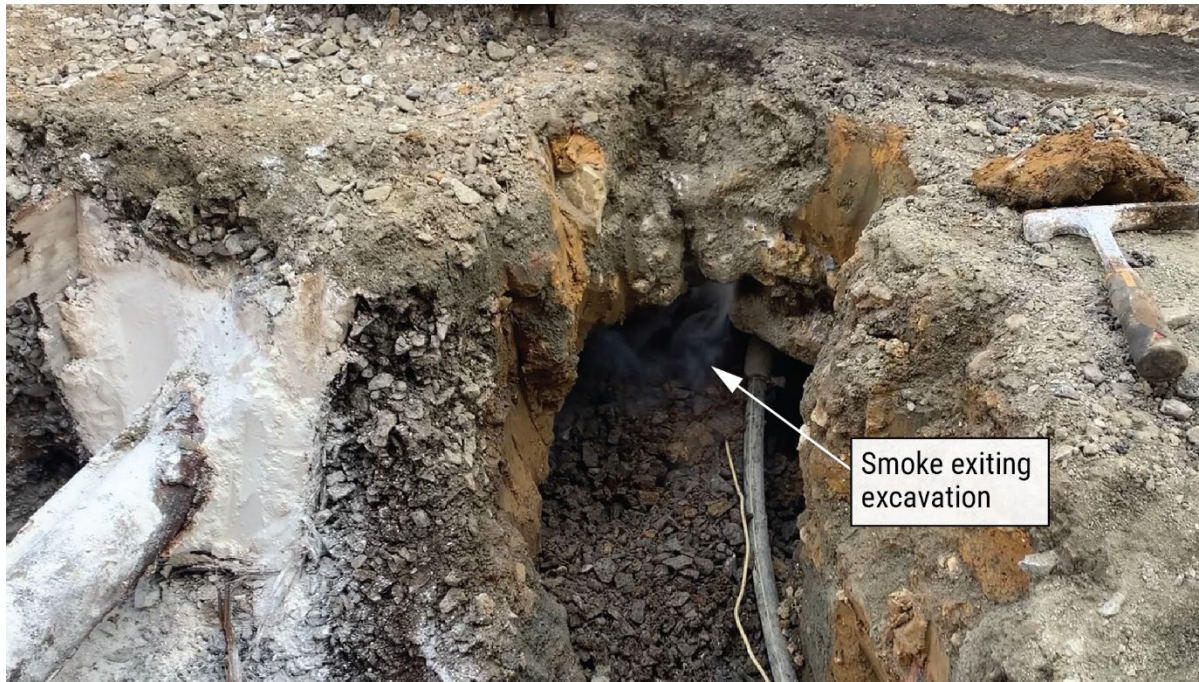
To further test the interaction between the chocolate pipe conduits and the ground around the gas pipelines, the NTSB used rags to block the spaces in the conduit opening around the chocolate pipes in the Building 1 basement. When the smoke generator was restarted in the Building 2 basement, smoke emanated from the ground near the Building 2 foundation and the gas service line. (See figure 10.)

Figure 10. Smoke from conduit visible near gas service line to Building 2.

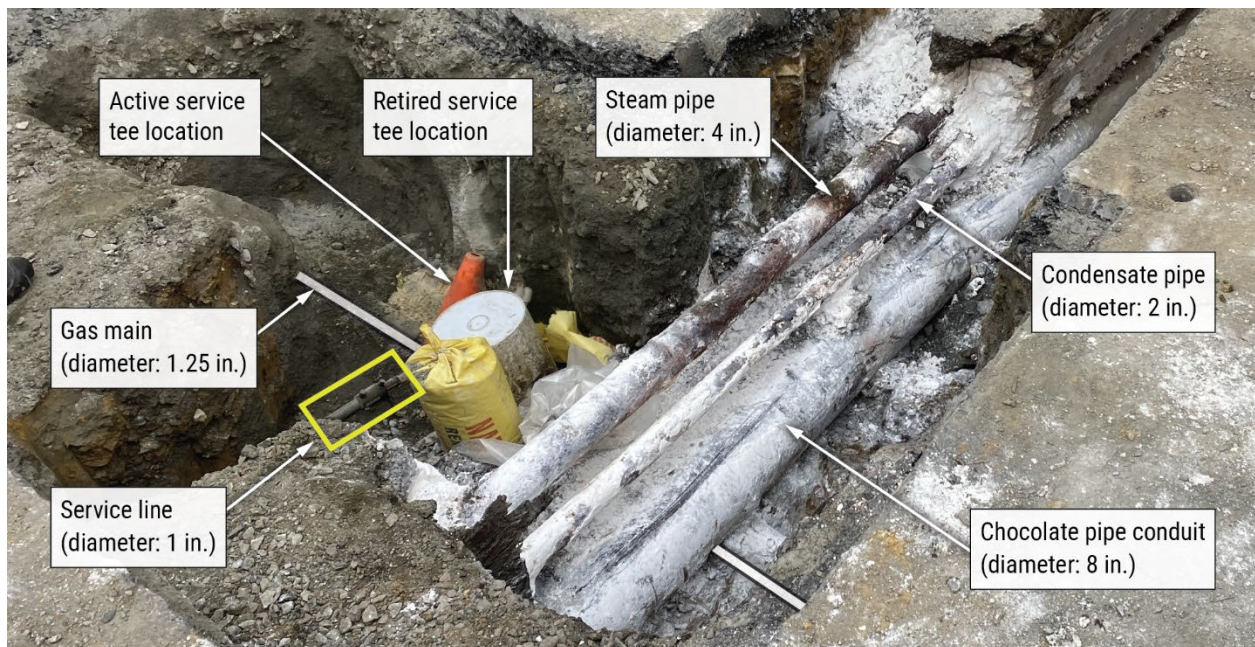
On April 26, the excavation of Cherry Street just south of Building 2 exposed the natural gas pipelines and other components, along with Palmer’s chocolate conduits, steam pipe, and condensate line, shown in figure 11.

Figure 11. Excavation of pipes at the accident location.

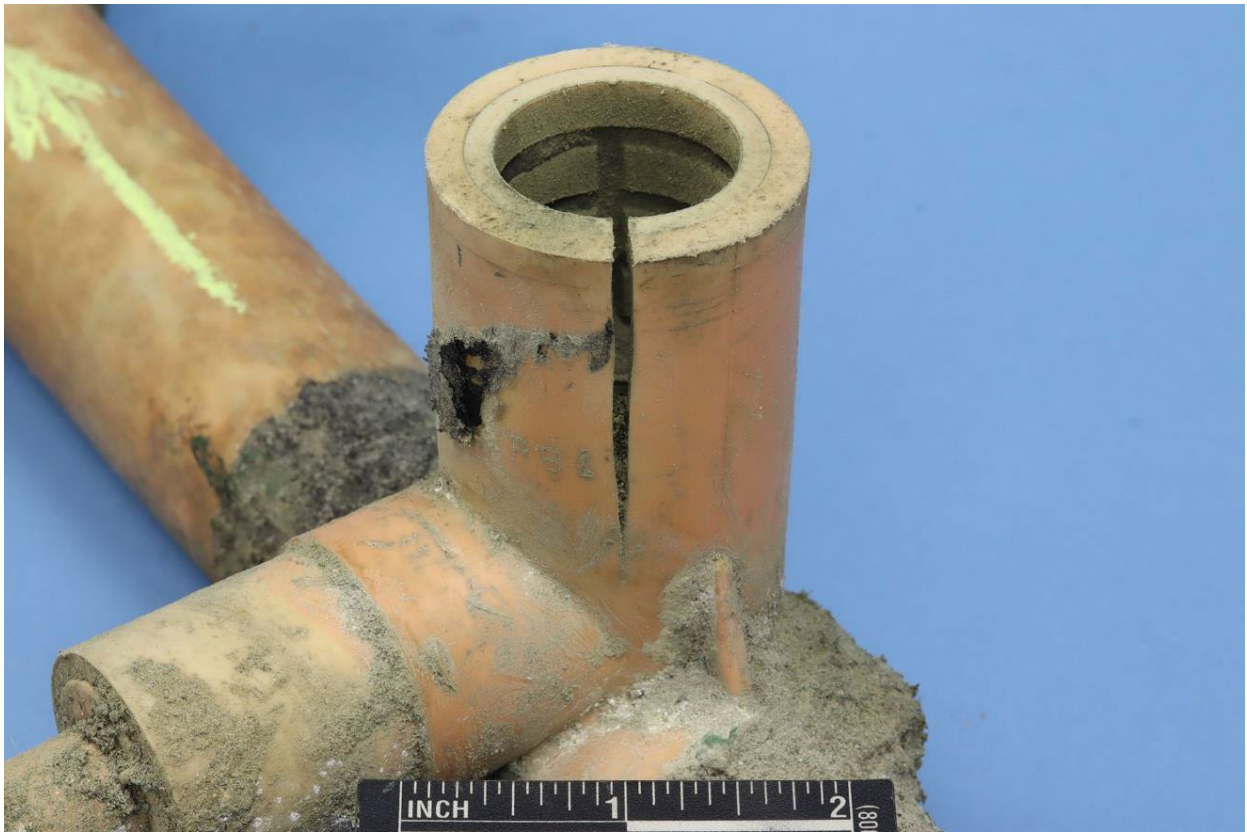
As the retired service line to Building 2, which was under pressure, was being unearthed, the NTSB observed that air was coming from the top of the retired 1982 service tee. The service tee's cap and a portion of its insert were missing.⁴³ The NTSB oversaw as UGI sifted the soil from the excavation but did not recover the cap or the upper portion of the insert; the lower portion of the insert remained with the service tee. The NTSB removed the remaining portions of the retired service tee, along with the section of 1.25-inch-diameter Aldyl A gas main to which the tee had been attached, and sent them to the NTSB Materials Laboratory for evaluation (see section 1.6.2).

Figure 13. Longitudinal fracture in retired service tee.

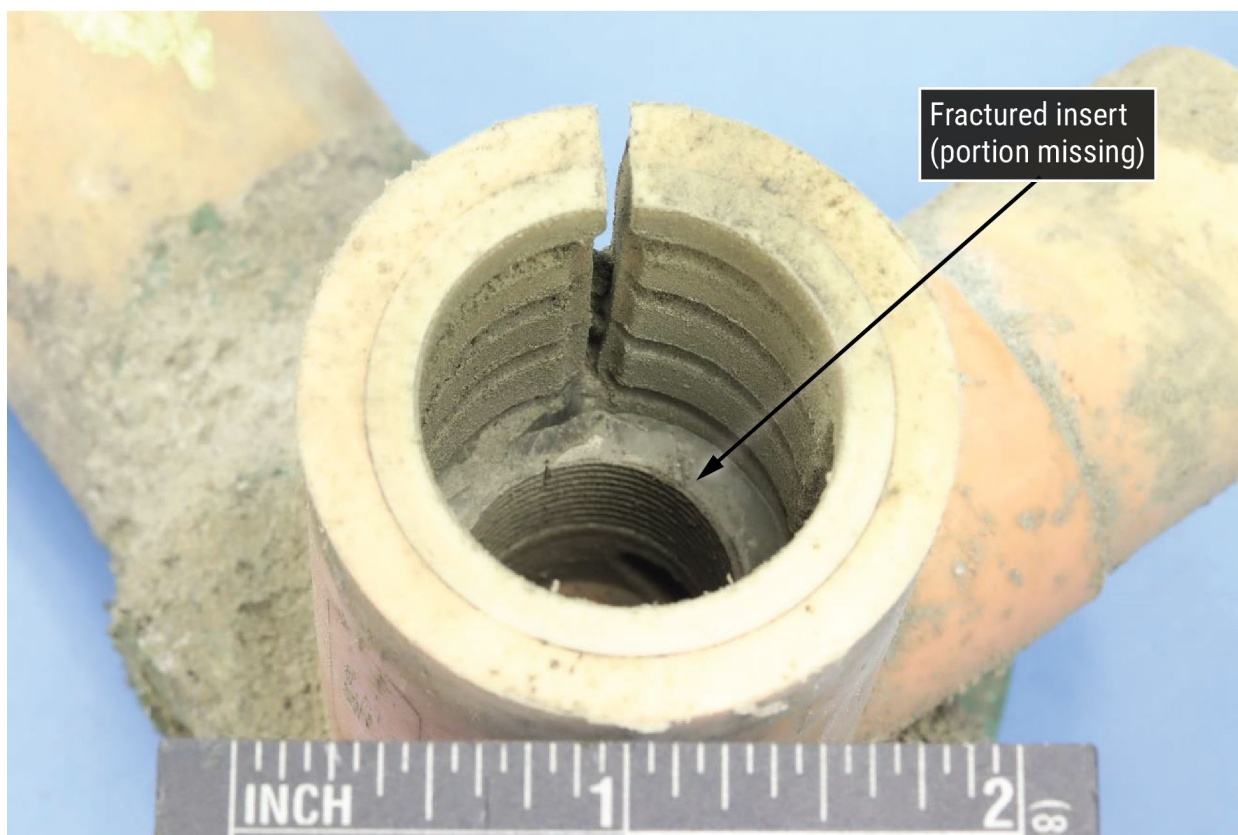
Figure 14. Interior of retired service tee tower with top portion of Delrin insert missing.

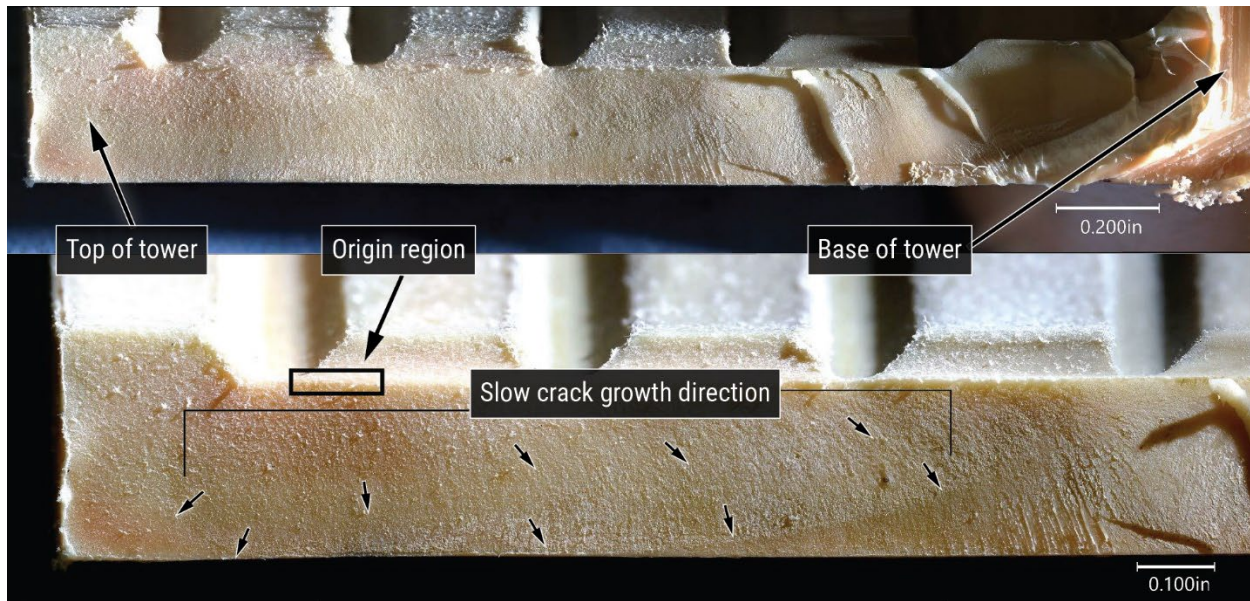
One of the fracture surfaces was cleaned and examined. It exhibited features consistent with fracture initiation from slow crack growth.⁴⁸ The slow crack growth region originated on the interior surface of the shell, between 0.325 inches and 0.430 inches from the top of the tower. From there it progressed through the wall, to the top of the tower and toward its base. Toward the top of the tower, the fracture surfaces were flat, comparatively featureless, and exhibited fibrils.⁴⁹ Near the base, the flat, featureless regions of the fracture surface transitioned to hackle consistent with a fast fracture following slow crack growth.⁵⁰ (See figure 15.)

Figure 15. (Top image) Longitudinal fracture from top to base of tower. (Lower image) Detailed image of slow crack growth region.

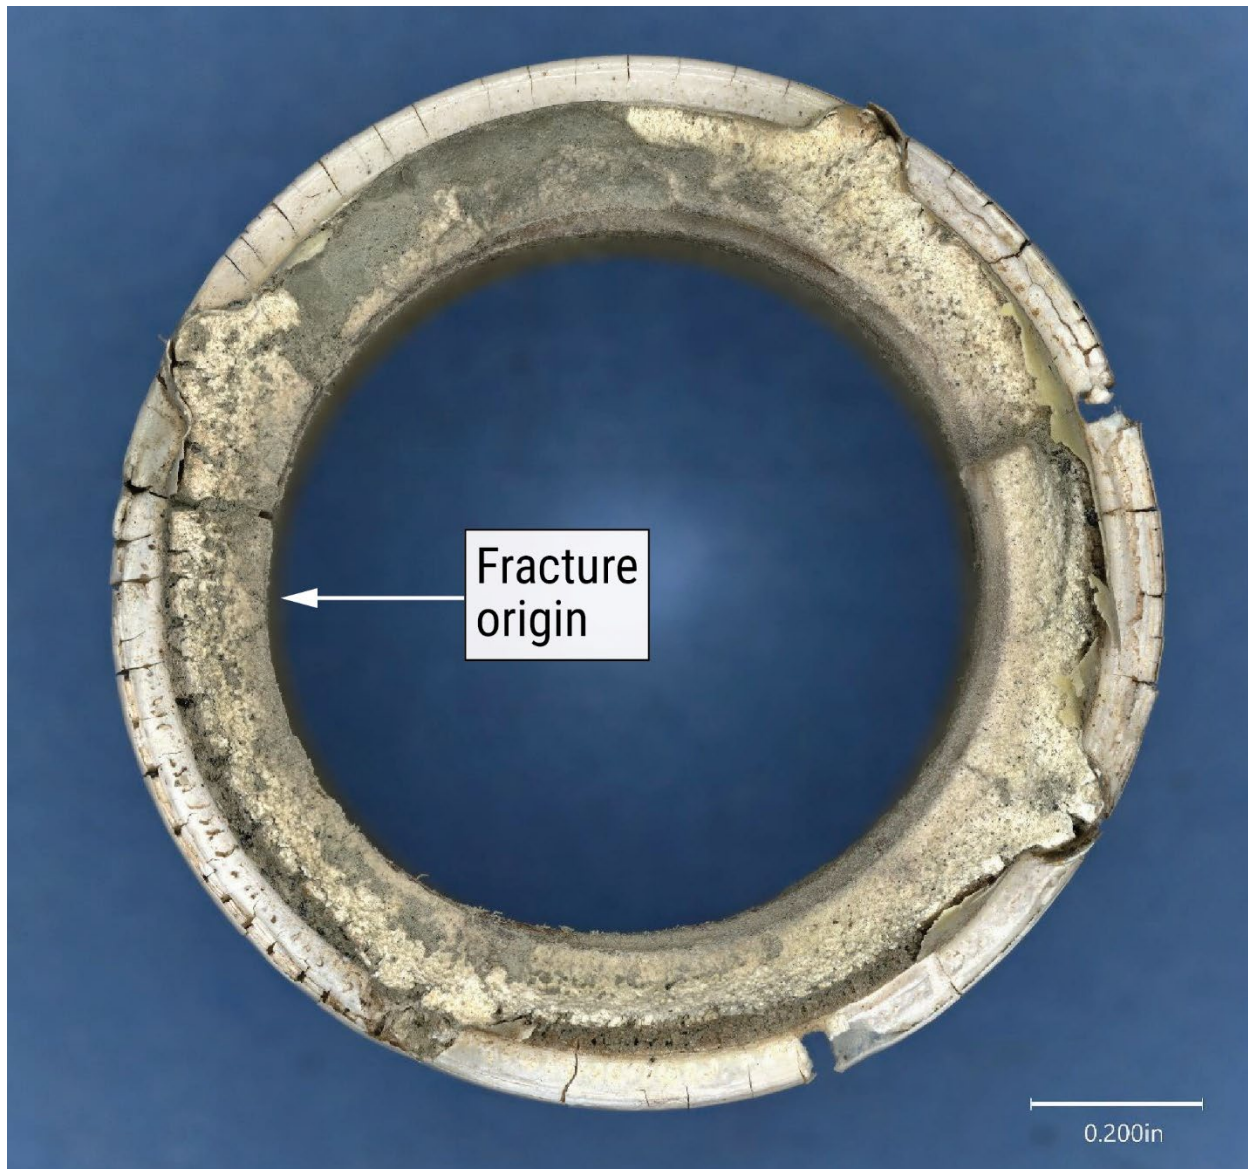
A visual assessment of the retired service tee's Delrin insert showed that it too was fractured, with a transverse fracture located near the bottom of the insert. A region of the fracture, which was closest to the steam pipe before the accident, had a crazed and fibrous appearance.⁵¹ Elsewhere, the fracture had a granular and porous appearance. The outer surface of the insert showed surface cracking and volume loss, which is visible in figure 16 along with the fracture origin. This was the first accident NTSB has investigated involving a longitudinal fracture from thermal degradation of an Aldyl A service tee with Delrin insert.

Figure 16. Image of fracture surface on Delrin insert for retired service tee.

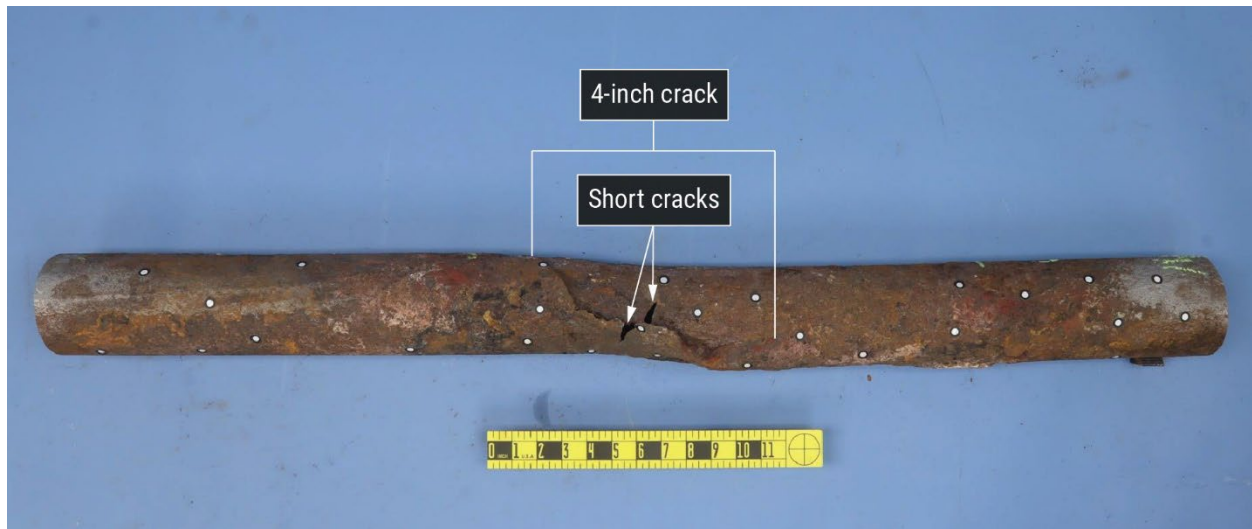
Investigators also observed corrosion and a through-wall crack of approximately 4 inches on the underground steam pipe that had been exposed in the NTSB’s postaccident excavation. This pipe was located about 15.5 inches above and 23 inches to the west of the retired service tee.⁴⁵ Visual observation of the length of the exposed pipe showed external corrosion, which can also be seen in figure 11. The NTSB oversaw as UGI removed surface rust from the steam pipe (outside of the section containing the through-wall crack) to take wall thickness measurements. The thickest measurement was 0.216 inches and the thinnest was 0.148 inches. The

inches long and had formed along a compressive buckle within the sheared region.⁵⁵ Two shorter cracks branched off the 4-inch crack. (See figure 17.)

Figure 17. Through-wall cracks in steam pipe.

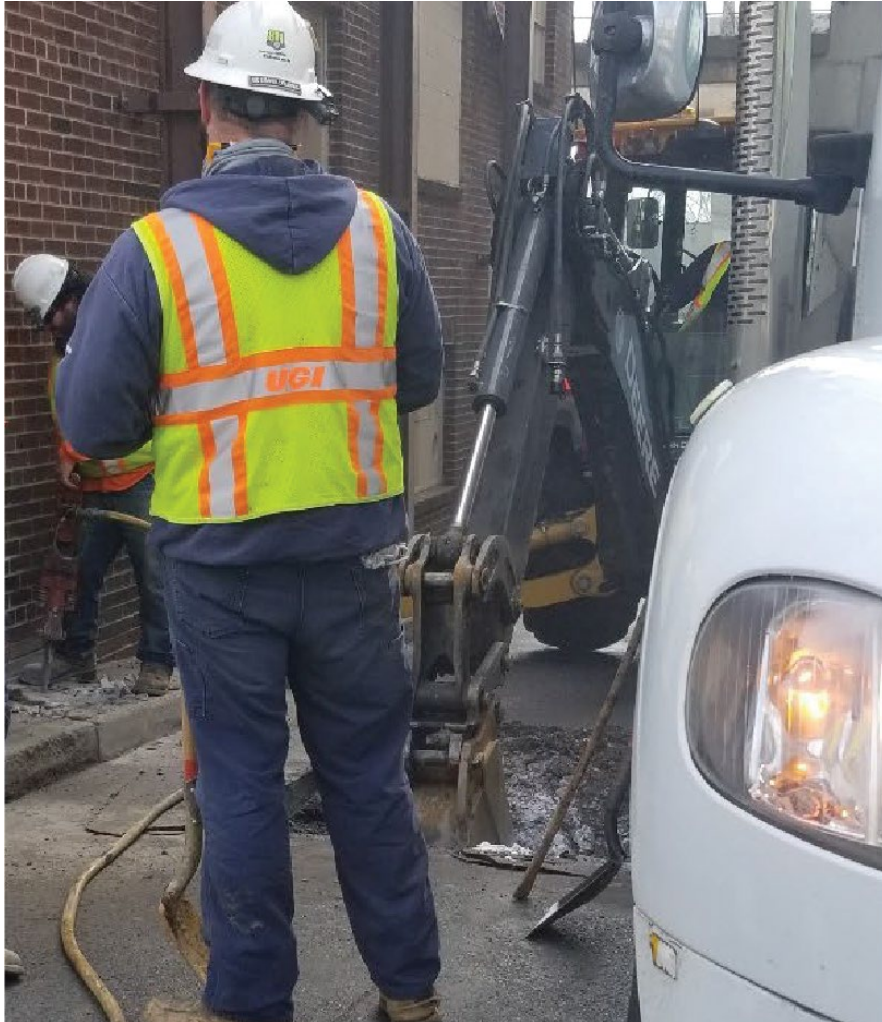
(See figure 18.) The NTSB reviewed the photograph to estimate the extent and location of excavation with mechanized equipment, and the photographic study showed that the excavation took place around the same location as the crack in the steam pipe. (See section 1.6.2.5.) The study showed that the west edge of the excavation was located within about 1 foot of the location of the steam pipe and that the excavation extended south of the location of the crack. The study was unable to determine the depth of the excavation.

Figure 18. UGI crew during service line replacement project, 2021. (Photo courtesy Palmer.)
