Pipeline Investigation Report: PIR-25-03

Enbridge Inc. Natural Gas–Fueled Building Explosion

Location	Youngstown, Ohio
Date	May 28, 2024
System type	Natural gas distribution
Accident type	Rupture/release
Pipeline operator	Enbridge Gas Ohio (Enbridge Inc.)
Hazardous materials	Natural gas
Fatalities	1
Injuries	9
Property damage	\$42 million

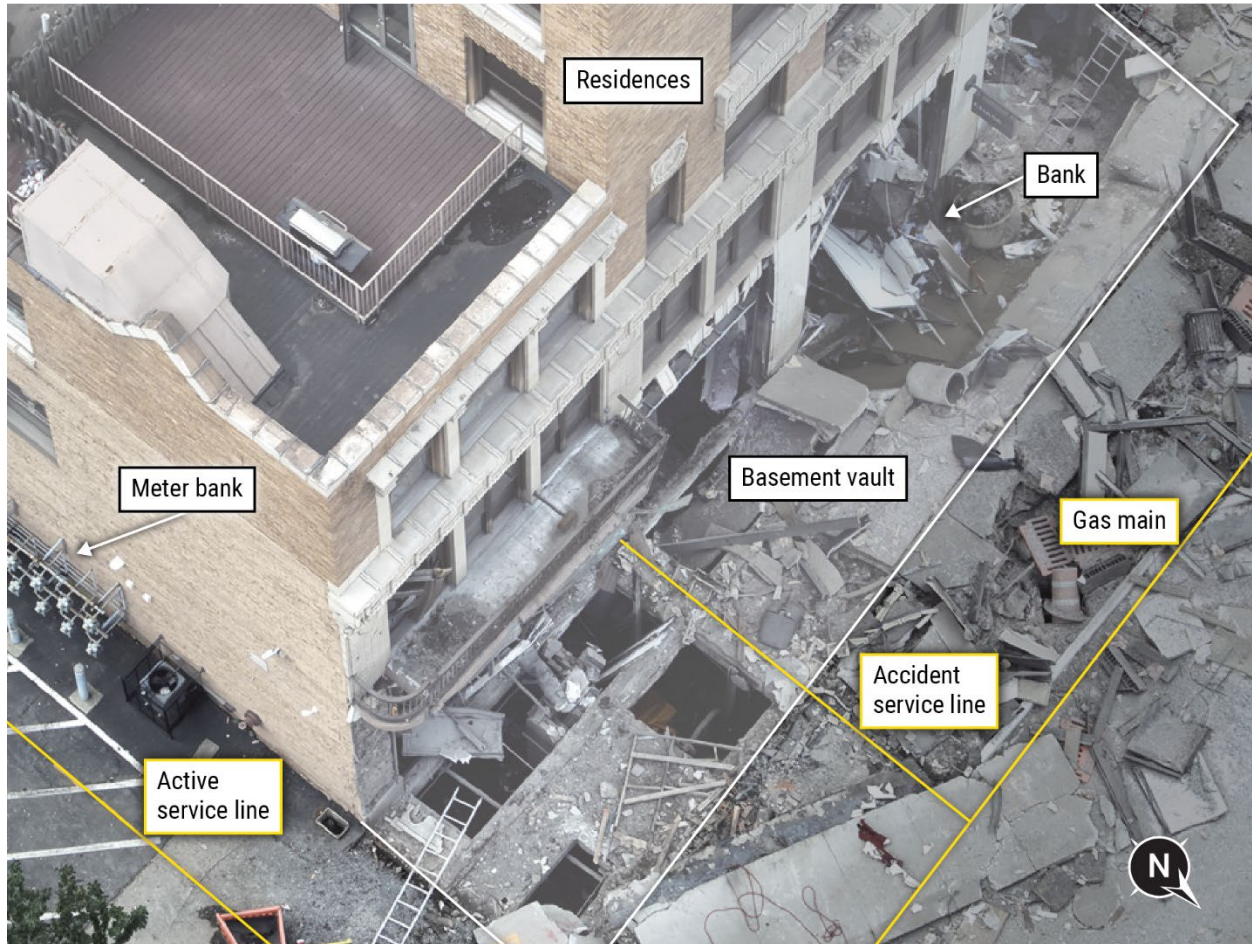
Figure 1. Realty Building after the explosion, with approximate locations of underground assets depicted in yellow. (Source: Mahoning County Sheriff's Office.)

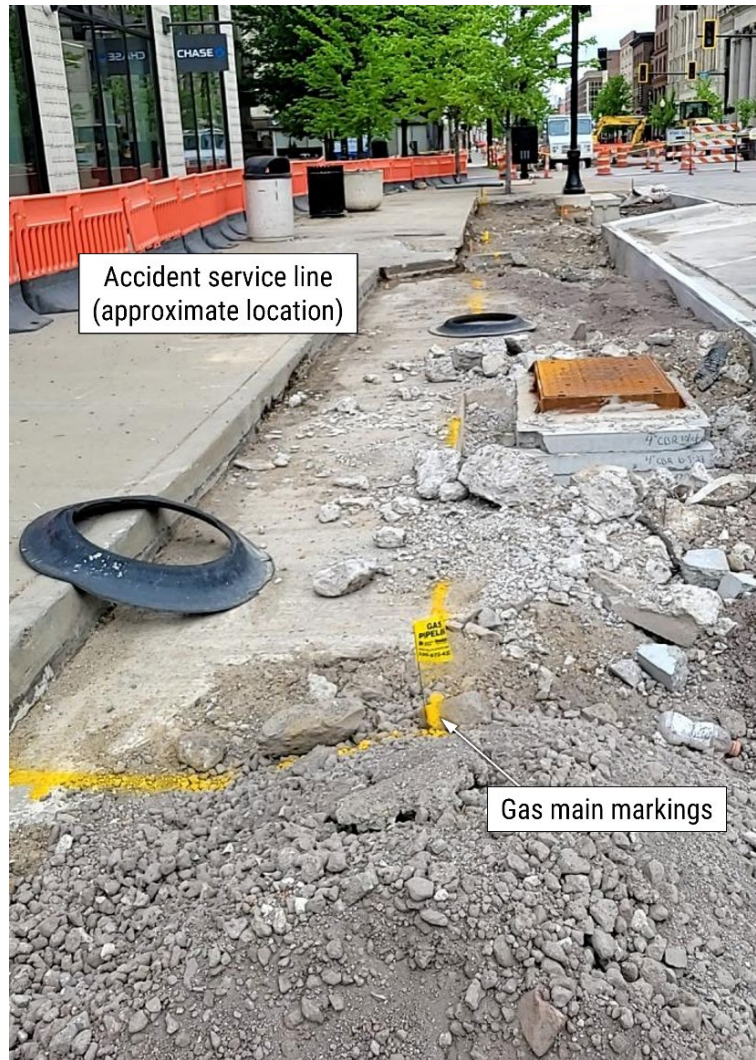
A January 18, 2024, design locate request, to the utilities protection service Ohio 811 on behalf of the City of Youngstown, described the planned work as the abandonment of utilities vaults.⁷ An Enbridge contract locator had marked some of the nearby natural gas assets in yellow paint on January 23, 2024, and again on May 4, 2024, but the accident service line was not marked either time.⁸ (See figure 2.)

Figure 2. Pavement markings on May 4, 2024. (Source: Ohio 811.)

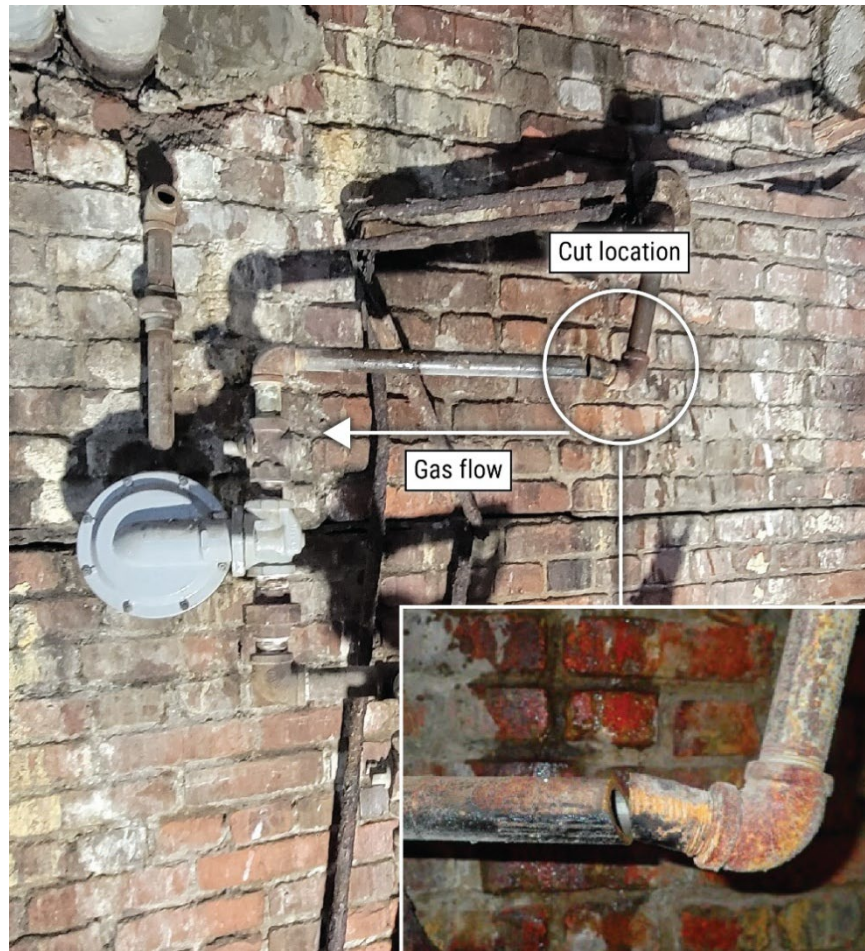
In interviews with the NTSB, GreenHeart employees stated that they were not aware that there was natural gas in any of the pipelines in the Realty Building basement, noting that the accident service line appeared old and rusty and did not have a gas meter. (See figure 3.) The scrap-removal crewmember stated he used a saw to cut into one of the pipes that his project supervisor had told him was inactive, or “dead,” but partway through the process, the crewmember heard a loud whistling sound and felt gas blowing into his face from the cut pipe.

Figure 3. The accident service line. (Source: Public Utilities Commission of Ohio.)

NTSB evaluations indicated that the accident service line was still connected to the main, and the curb valve to the accident service line was in the open position, allowing gas to flow from the main into the service line.¹² As part of Enbridge's response to the design locate request, they located the main and active service lines to the

indicated the curb valve had been closed, but NTSB investigators found the valve in the open position after the accident. Further, although the 2015 records indicated the accident service line had been disconnected from the main, the gas flowing through the pipeline after the scrap-removal crew member cut into it, as well as a postaccident pressure test, indicated that the service line was still connected to the gas system and contained natural gas. Enbridge's procedures regarding service line abandonment required curb valves to be removed or closed and service lines to be disconnected as close to the main as possible. The procedure did not include a requirement for the work crew to visually confirm the service line was disconnected from the main before processing the service line cut order.

In August 2024, Enbridge issued a pipeline safety alert advising crews about a revised practice for disconnecting and abandoning service lines. According to the revised practice, before completing a service line cut order, the pipeline must be exposed for visual confirmation that the service line has been effectively cut from the main and capped off. Training materials have been updated to reinforce the revised practice. Enbridge also is installing warning tags on their interior piping assets to alert customers of the presence of pressurized gas and how to contact the gas company.
