Pipeline Investigation Report PIR-26-01

Atmos Energy Corporation Natural Gas-Fueled Home Explosions and Fires

Jackson, Mississippi

January 24, 2024, and January 27, 2024

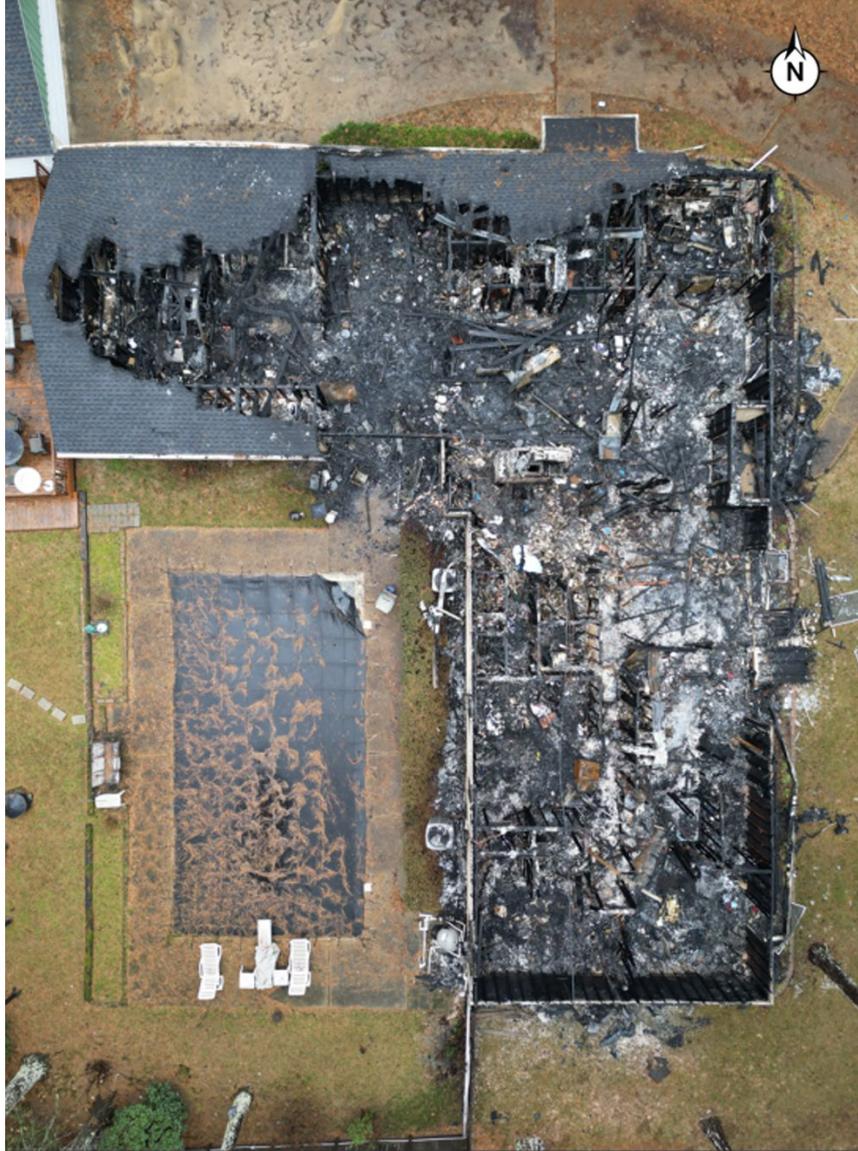
The explosion and fire destroyed the Bristol Boulevard accident home. (See figure 4.) Emergency medical services arrived on the scene and treated the Bristol Boulevard accident homeowner for a minor injury. After the Jackson Fire Department extinguished the fire, they found the Bristol Boulevard accident

Figure 4. Aerial photograph of the Bristol Boulevard accident home after the explosion and fire. (Courtesy of Atmos.)

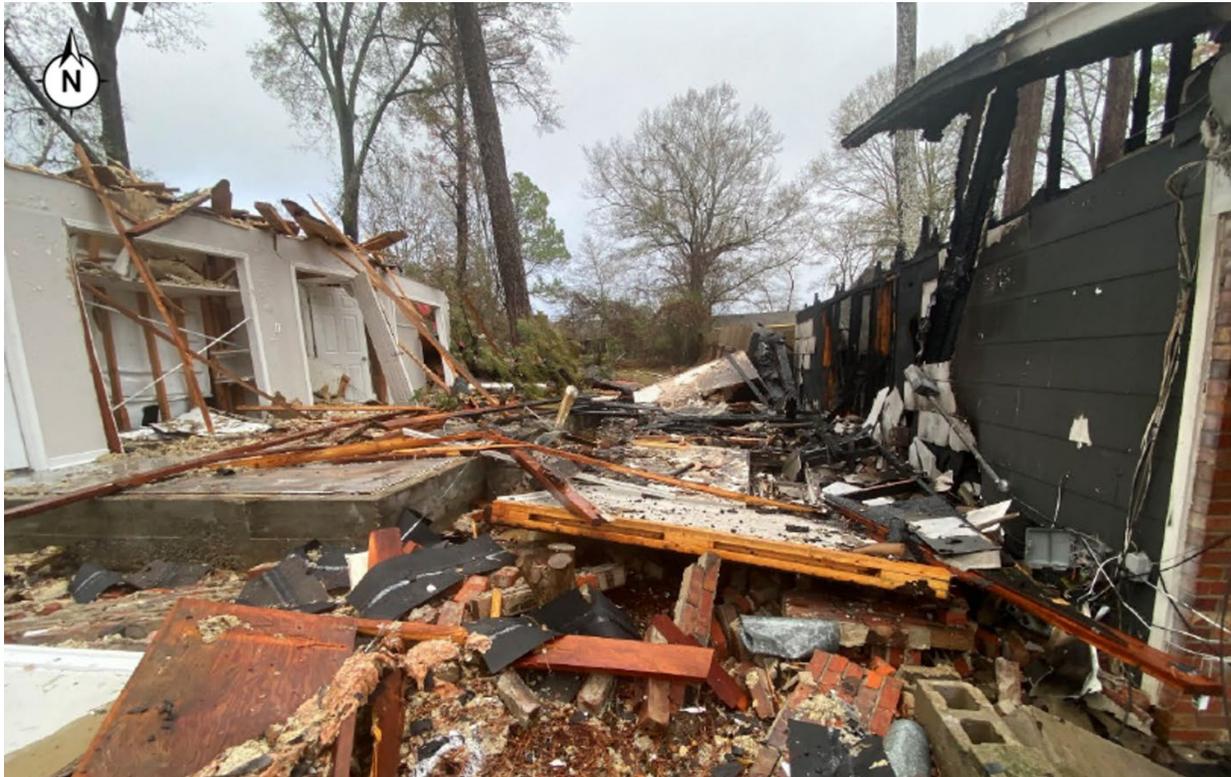
The explosion and fires destroyed the Shalimar Drive accident home and the Shalimar Drive affected home. (See figure 7.) Table 2 shows a timeline of the Shalimar Drive accident events.

Figure 7. The Shalimar Drive accident home (left) and the Shalimar Drive affected home (right) after the explosion and fires. (Courtesy of the Mississippi Public Service Commission.)

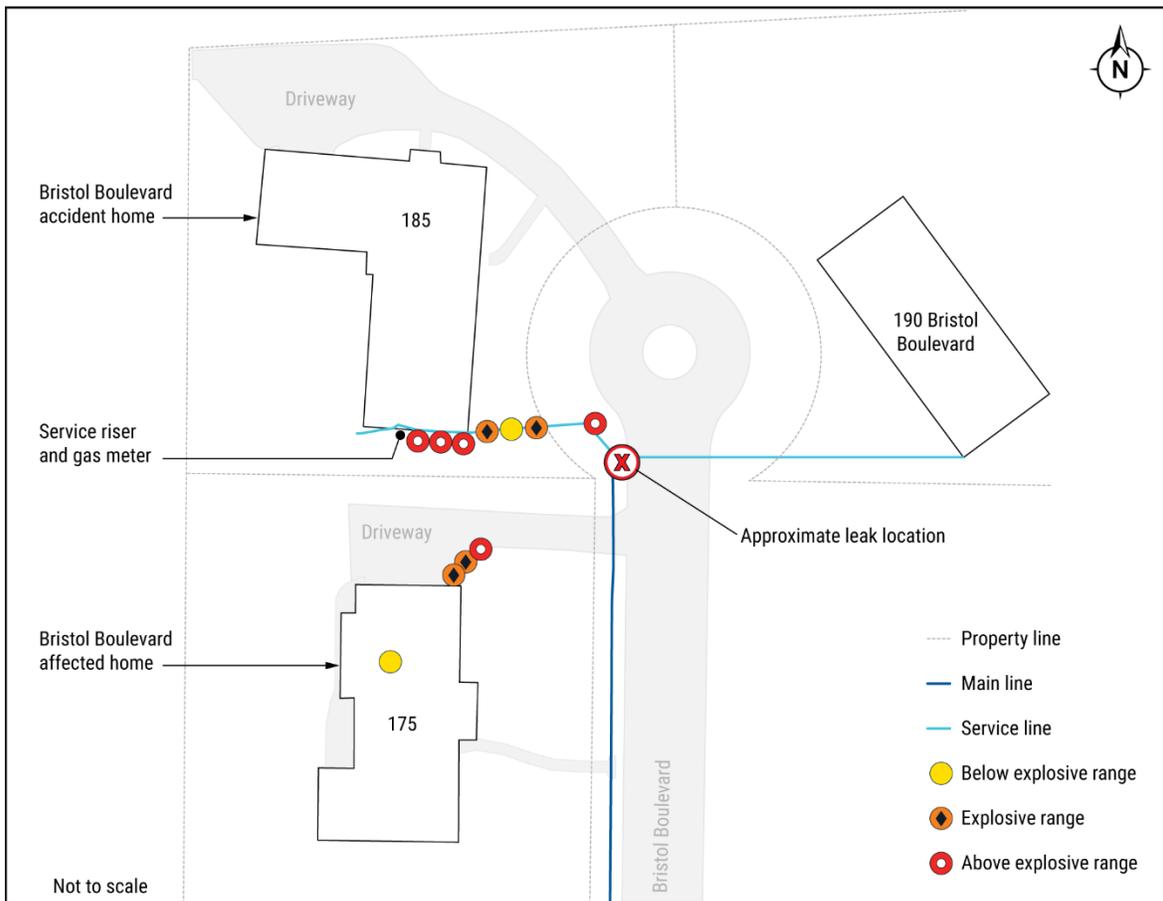
Figure 10. Postaccident bar-hole testing and open-air testing conducted at Bristol Boulevard on January 24, 2024, about 12:42 p.m.

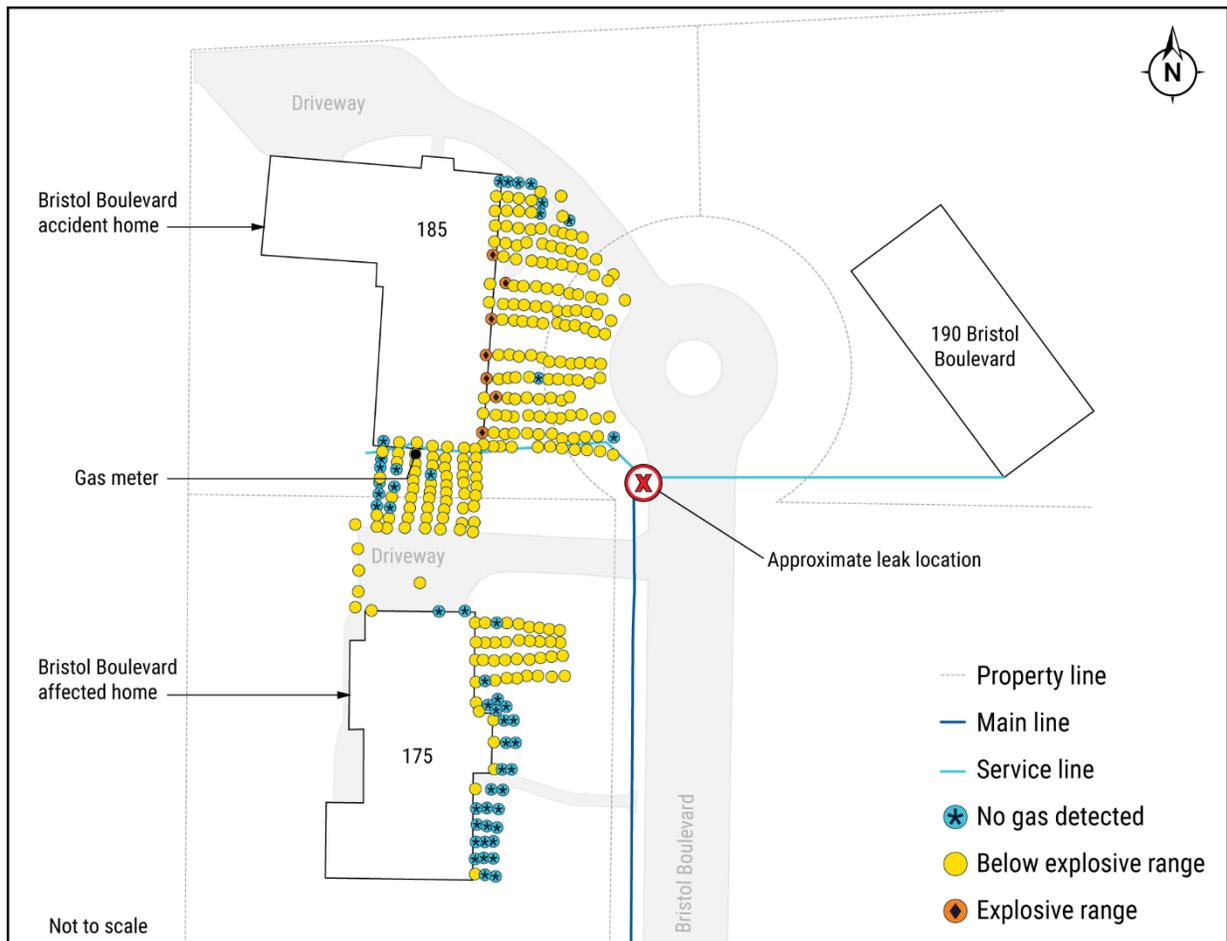
On January 29, 2024, 5 days after the explosion, about 9:15 a.m., Atmos conducted bar-hole testing and open-air testing under NTSB direction at the Bristol Boulevard accident location. This testing detected subsurface natural gas around the Bristol Boulevard accident home and the Bristol Boulevard affected home. This was residual gas that was still present in the soil in the days following the accident. Atmos had not restored natural gas service at the time of these tests. Test readings ranged from 0.0015% to 5.8% gas in air by volume. Figure 11 shows the results of this testing.

Figure 11. Postaccident bar-hole testing and open-air testing conducted at Bristol Boulevard on January 29, 2024, about 9:15 a.m.

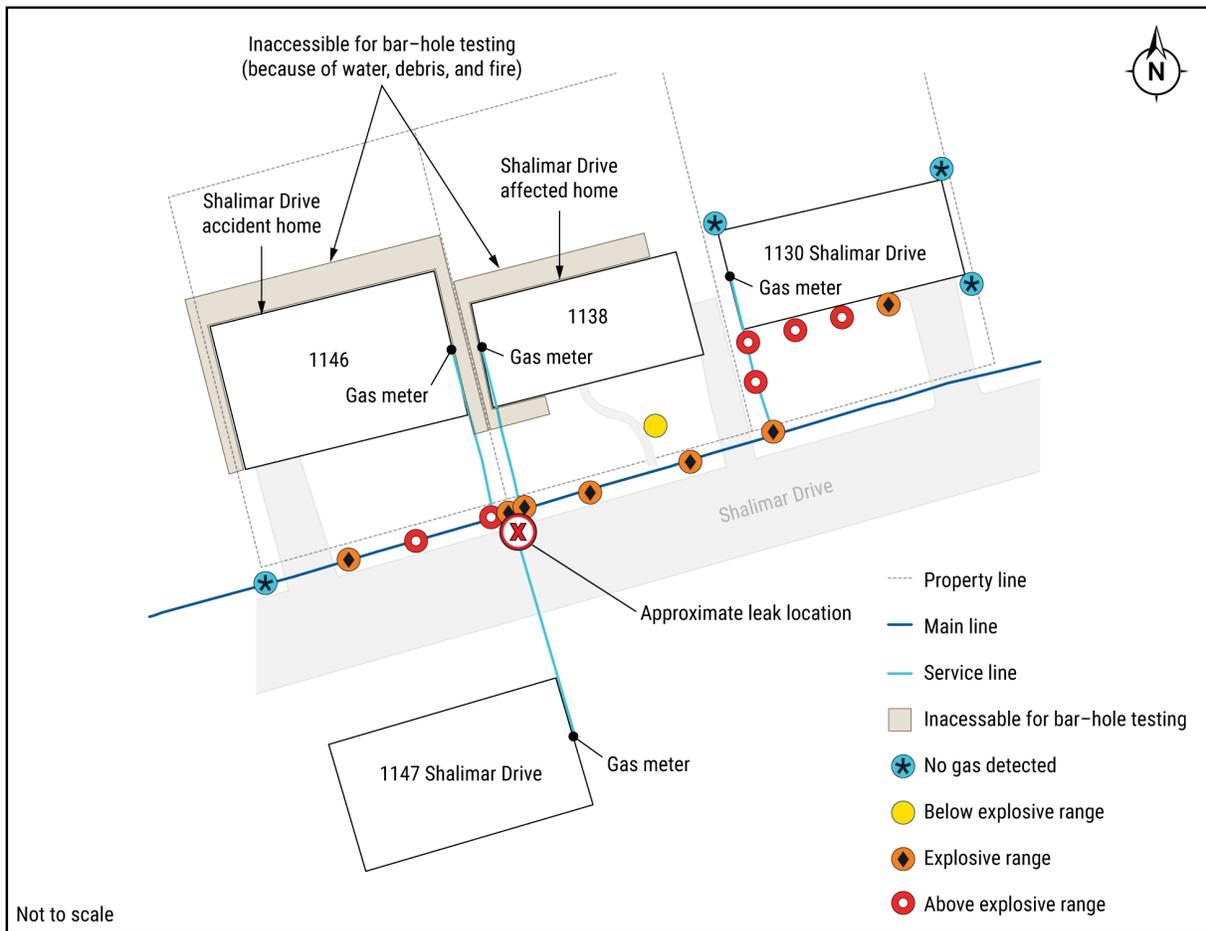
On January 27, 2024, shortly after the explosion, about 5:30 a.m., Atmos conducted bar-hole testing and open-air testing at the Shalimar Drive accident location. Atmos detected subsurface natural gas near the main in front of the Shalimar Drive accident home, the Shalimar Drive affected home, and the home at 1130 Shalimar Drive. Atmos also detected subsurface gas between the main and the Shalimar Drive accident home and the Shalimar Drive affected home. Test readings ranged from 0.25% to 50% gas in air by volume. Figure 12 shows the results of this testing and indicates whether each result was above, below, or within the explosive range of natural gas, which is between 5% and 15% gas in air by volume.

Figure 12. Postaccident bar-hole testing and open-air testing conducted at Shalimar Drive on January 27, 2024, about 5:30 a.m.

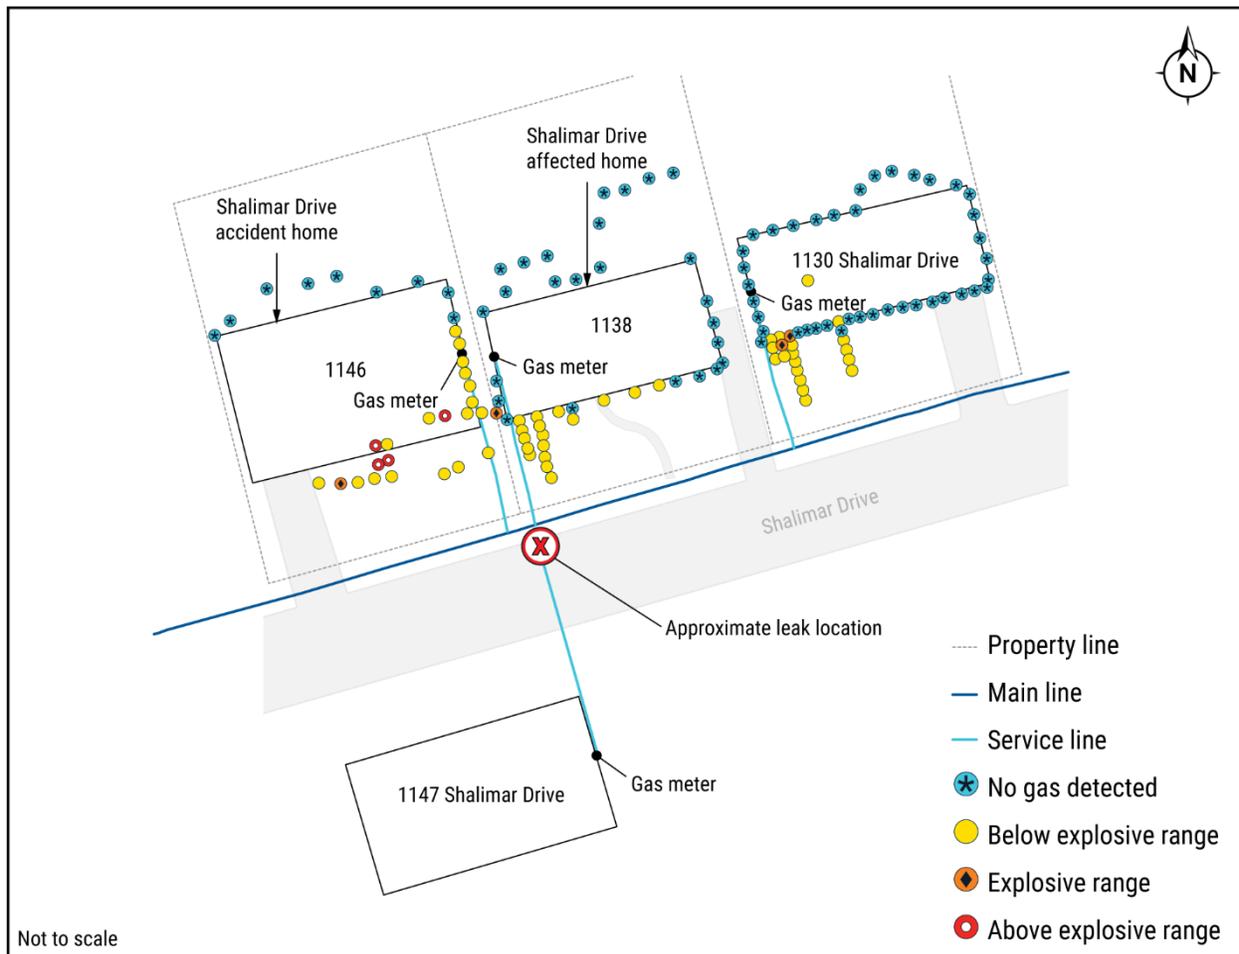
On January 29, 2024, 2 days after the explosion, about 9:40 a.m., Atmos conducted bar-hole testing and open-air testing under NTSB direction at the Shalimar Drive accident location. This testing detected subsurface natural gas near the Shalimar Drive accident home, the Shalimar Drive affected home, and the home at 1130 Shalimar Drive. The testing also identified open-air natural gas concentrations inside the home at 1130 Shalimar Drive. This was residual gas that was still present in the soil and air in the days following the accident. Atmos had not restored natural gas service at the time of these tests. Test readings ranged from 0.005% to 50.7% gas in air by volume. Figure 13 shows the results of this testing.

Figure 13. Postaccident bar-hole testing and open-air testing conducted at Shalimar Drive on January 29, 2024, about 9:40 a.m.

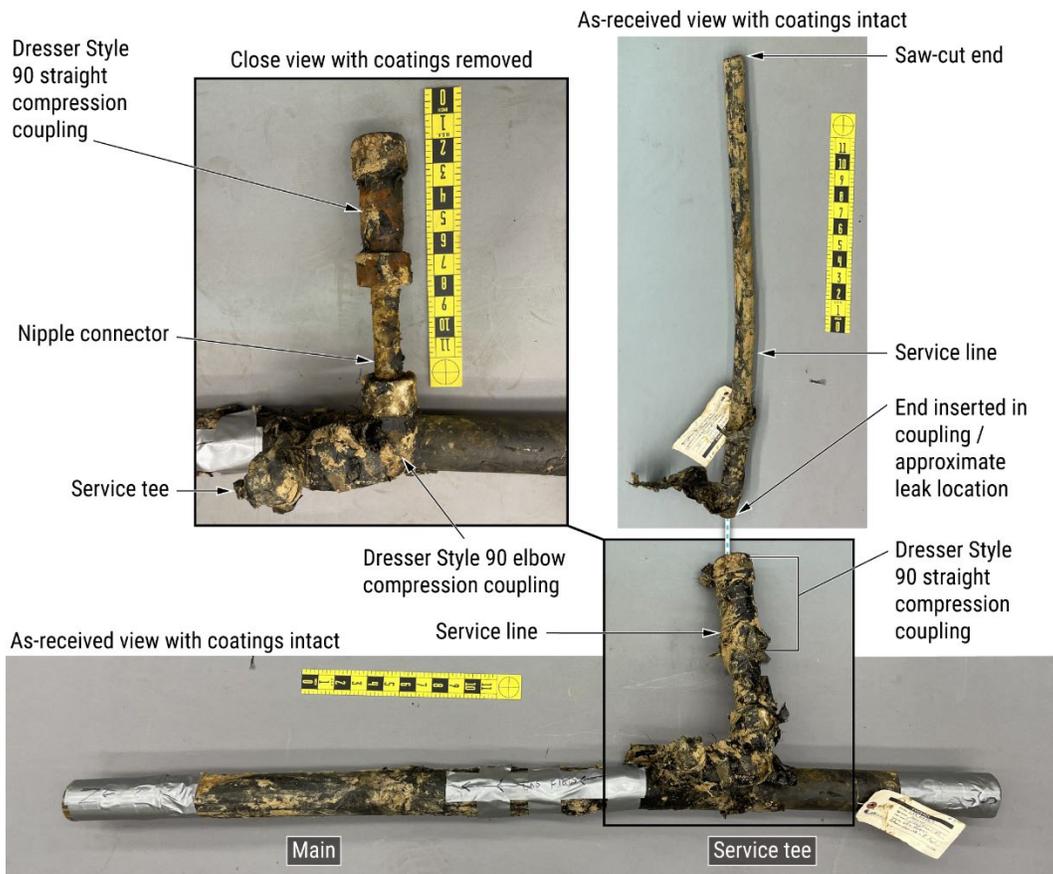
⁴⁵ The figure also indicates the approximate leak location.

Figure 14. The Bristol Boulevard natural gas pipeline assembly.

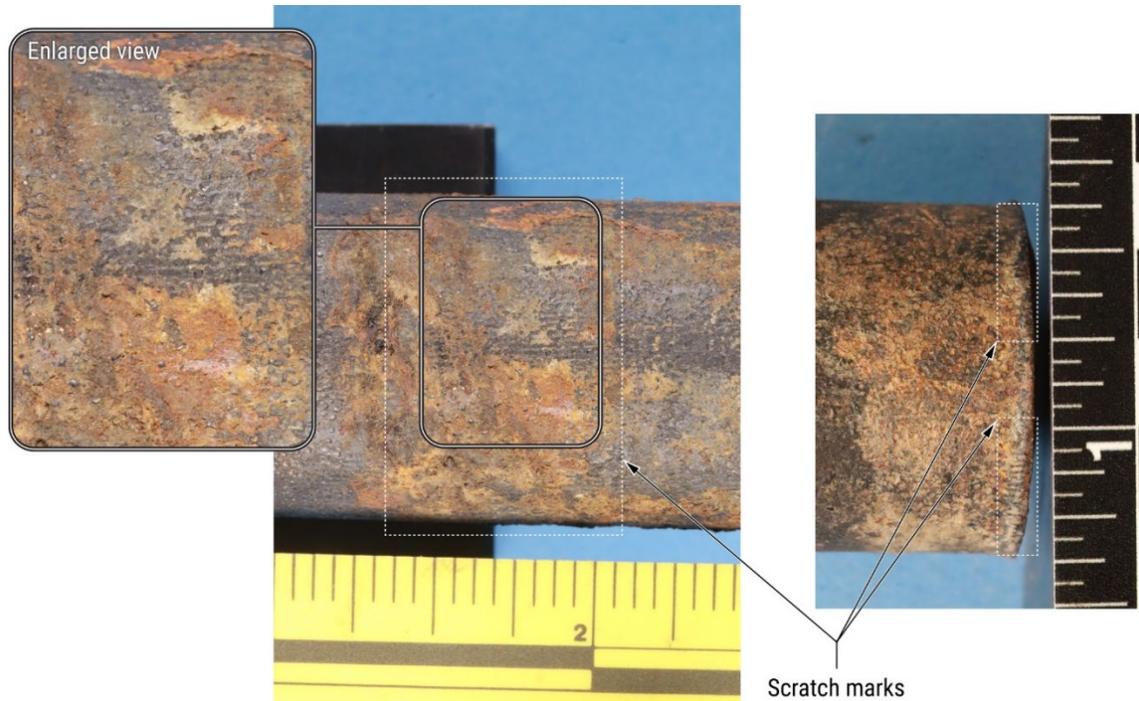
approximately 0.02 inches apart. The examination found scratches of similar size and shape at the end of the service-line pipe.⁴⁸ (See figure 15.)

Figure 15. Scratches on the upstream end of the service line at Bristol Boulevard.

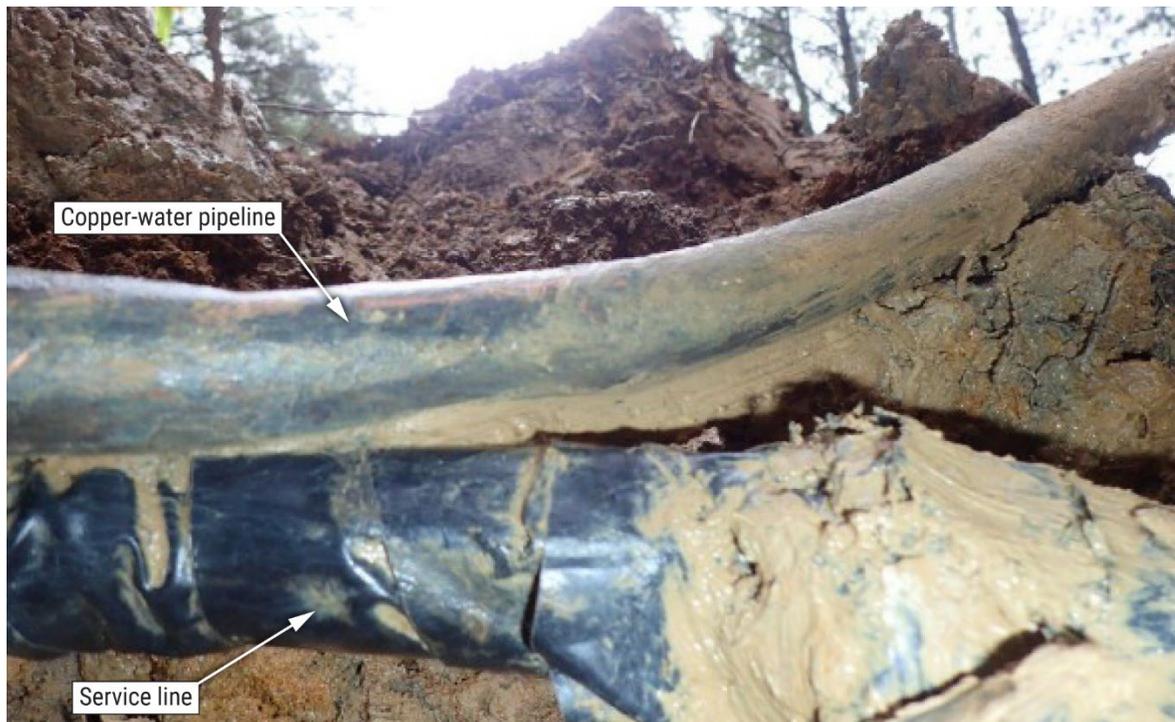
The NTSB examined a copper-water pipeline assembly that was installed above the service line to the home at 190 Bristol Boulevard and had rested near the connection between the compression coupling and the service-line pipe. The examination did not reveal any significant evidence of contact either on the top of the service line or on the bottom of the copper-water pipeline, such as evidence of rubbing, local deformation, or material transfer. Figure 16 is a postaccident-excavation photograph showing the copper-water pipeline traversing over the service line.

Figure 16. Excavation photograph of the copper-water pipeline and the service line near the Bristol Boulevard accident location. (Courtesy of Atmos.)

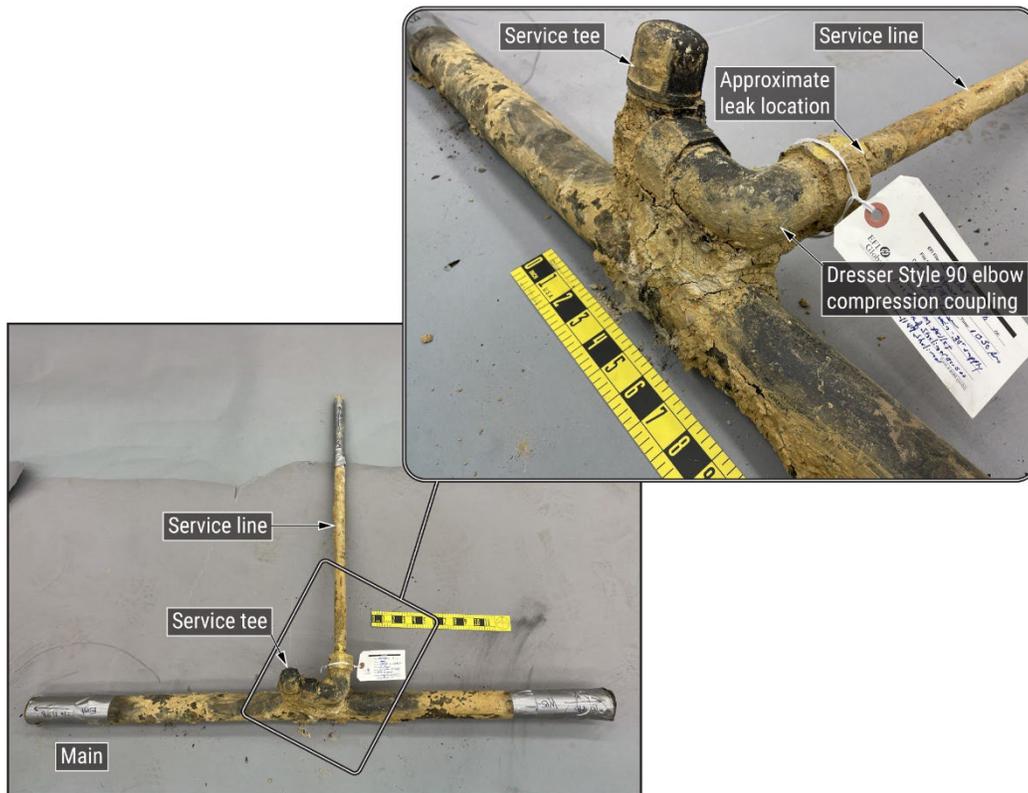
(See figure 17.)⁵⁵ NTSB pressure tests confirmed Atmos pressure testing on the scene, which found the leak on the Dresser Style 90 elbow compression coupling, pinpointing the connection between the compression coupling and the service line to the home at 1147 Shalimar Drive.

Figure 17. The Shalimar Drive natural gas pipeline assembly.

⁵⁵ The figure also indicates the approximate leak location.

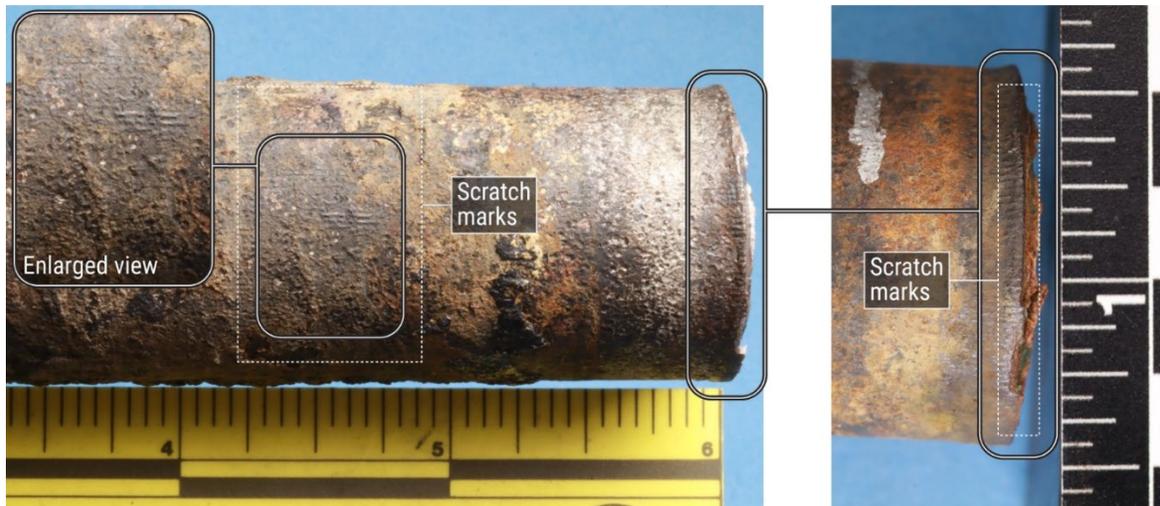
Figure 18. Scratches on the upstream end of the service line at Shalimar Drive.

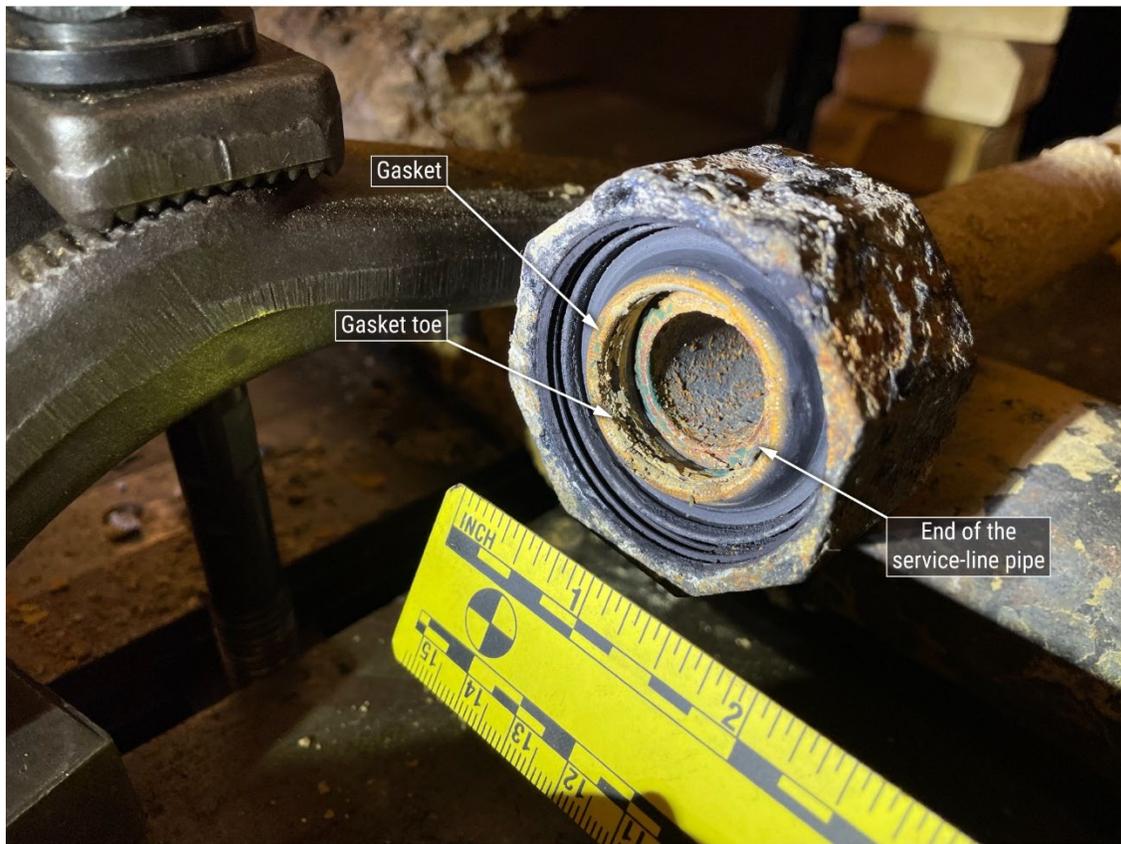
the compression coupling, meaning the service-line pipe was not fully inserted into the coupling, it had partially pulled out. (See figure 19.)⁵⁶

Figure 19. The Shalimar Drive service-line pipe and gasket.

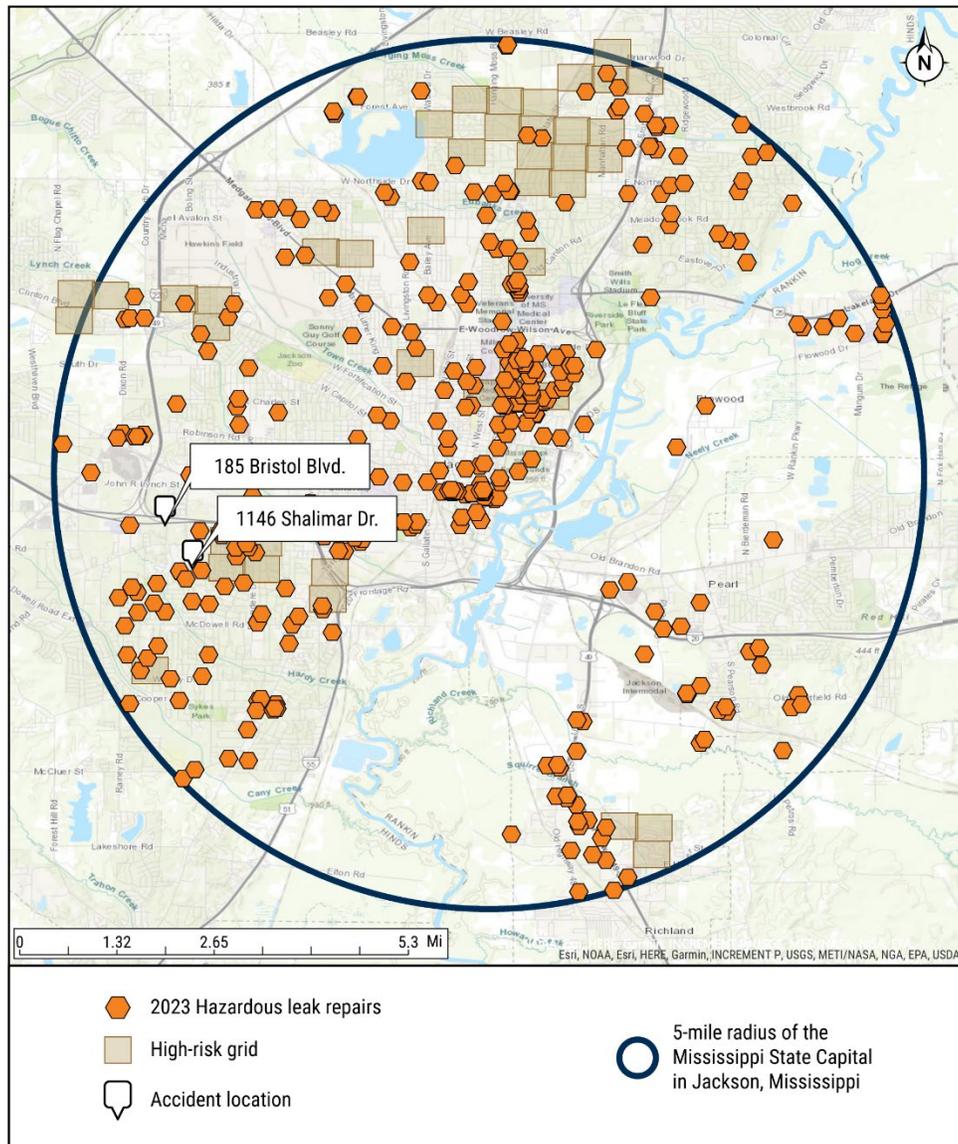
before the two accidents, Atmos repaired 182 hazardous (grade 1) leaks in Jackson. Although the repaired hazardous leaks were confirmed risks to Atmos’s system, its risk model, in large part, did not rank the locations of the hazardous leaks as high risk. Figure 23 shows the hazardous leaks that Atmos repaired in 2023 within a 5-mile radius of Jackson overlaid with the Atmos risk model’s high-risk grids that were current on that date; not many of the hazardous leaks are in high-risk grids.

Figure 23. Map of hazardous leaks within a 5-mile radius of Jackson that Atmos repaired in 2023 overlaid with Atmos high-risk grids current on that date. (Courtesy of ESRI ArcGIS and Atmos with NTSB annotations.)
