Pipeline Investigation Report: PIR-26-02

Enbridge Inc. Natural Gas–Fueled Home Explosion and Fatality

Location	South Jordan, Utah
Date	November 6, 2024
System type	Natural gas distribution
Accident type	Rupture/release
Pipeline operator	Enbridge Gas Utah
Hazardous materials	Natural gas
Fatalities	1
Injuries	0
Property damage	\$1,030,443

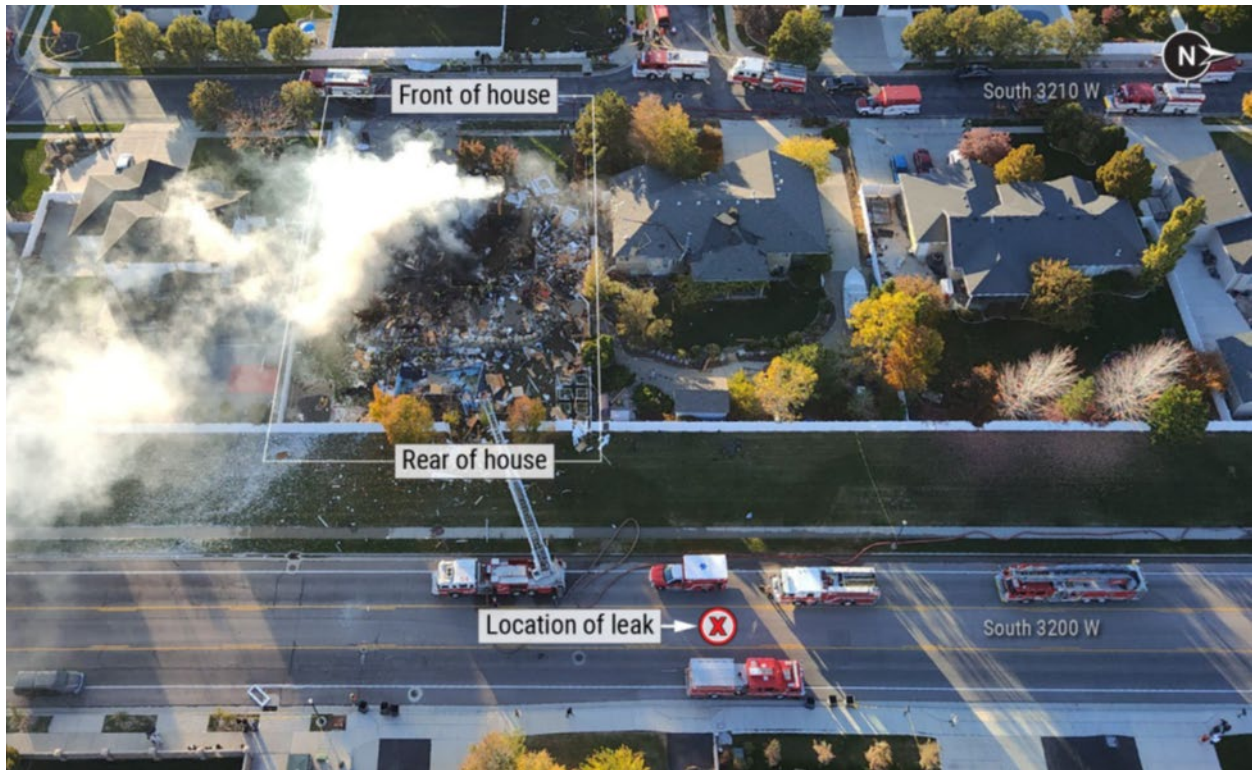
On November 6, 2024, about 3:09 p.m., a natural gas–fueled explosion fatally injured one person and destroyed a home in South Jordan, Utah.¹ Several nearby residences were damaged, and families displaced. (See figure 1.) The South Jordan Fire Department responded, arriving on scene about 3:15 p.m. Technicians from Enbridge Inc. (Enbridge) subsidiary Enbridge Gas Utah, the natural gas service provider to the home, responded and arrived on scene about 3:45 p.m.² Enbridge isolated the leak about 12:16 p.m. on November 7. At the time of the explosion, conditions were daylight and clear; the temperature was 41°F with no precipitation.

Figure 1. The scene on the day of the accident. (Drone photography courtesy of the South Jordan Police Department.)

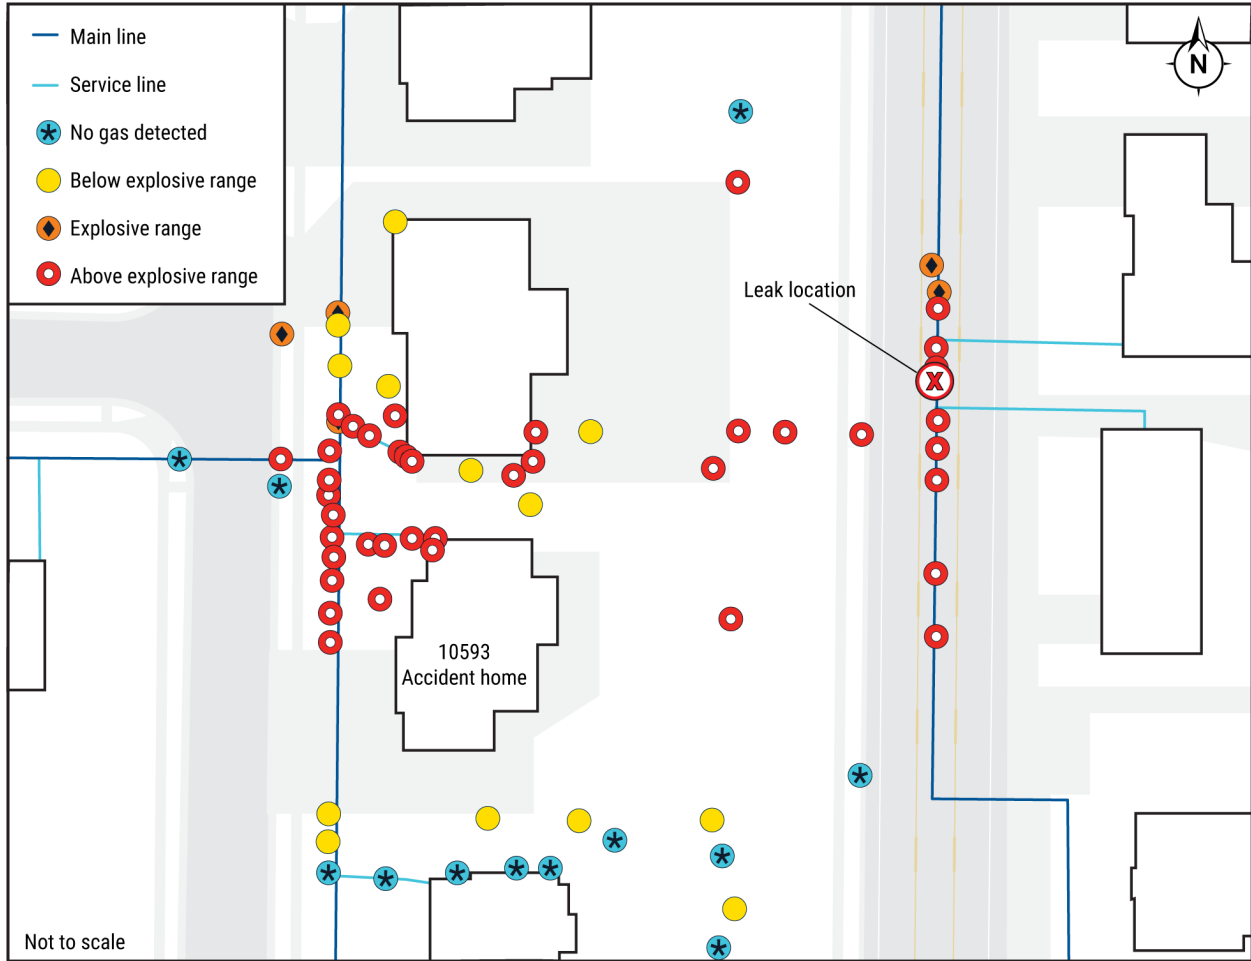
Figure 2. Peak subsurface gas readings before isolation of the gas leak.

After the explosion, Enbridge technicians found gas in the ground in front of the house and again between the accident home and the adjacent home immediately to the north. Further investigation found gas in the ground extending from the rear of the house to the location of the leak in the street to the east, behind the accident home. The subsurface gas extended from the leak location below the street behind the home, through the backyard, and to the front yard of both homes (the accident home and the adjacent home), reaching about 250 feet from the leak. Technicians also detected gas in the atmosphere of the adjacent home after the accident.

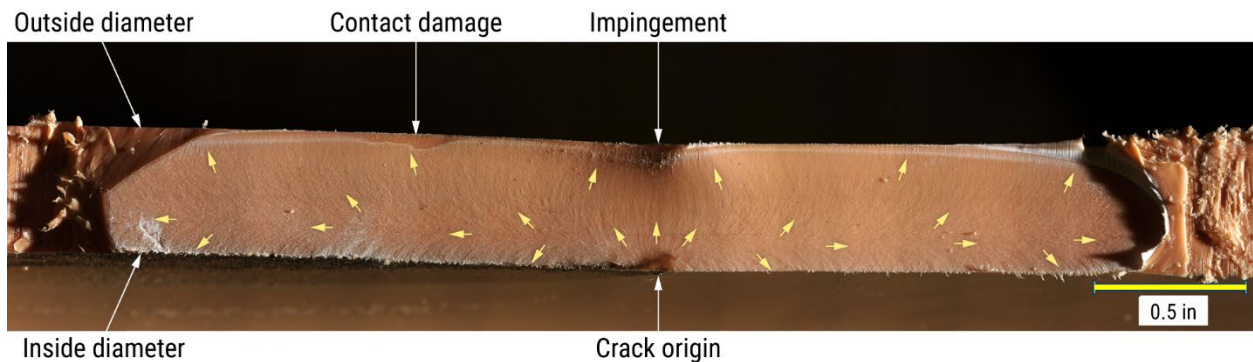
Examination of the damaged pipe by the National Transportation Safety Board (NTSB) Materials Laboratory found crack growth that started at the inner wall of the pipe. The crack growth features were traced back to a single point origin on the inner surface, which aligned longitudinally with an outer surface impingement point. (See figure 3.) The crack growth region extended as much as 3.5 inches along the length of the pipe. Further, flow testing of the damaged pipe in the lab measured a leak rate for natural gas

Figure 3. Crack origin area on inner wall of pipe.

The NTSB found that the crack originated on the inner surface of the pipe and aligned directly with an oblong impression on the outer surface. Investigators determined that a rock impingement likely caused the oblong impression on the outer surface of the pipe and the resulting crack. They also found that the crack growth features indicated that the crack breached the outer surface in a single abrupt event. As a result, the pipe rapidly transitioned from releasing no gas to releasing up to 48.7 scfm,
