Pipeline Investigation Report: PIR-26-03

Atmos Energy Corporation Natural Gas–Fueled Home Explosion

Location	Avondale, Louisiana
Date	December 2, 2024
Accident type	Leak/explosion/fire
Pipeline	Distribution pipeline 2-inch coated steel main carrying natural gas
Fatalities	1
Injuries	5

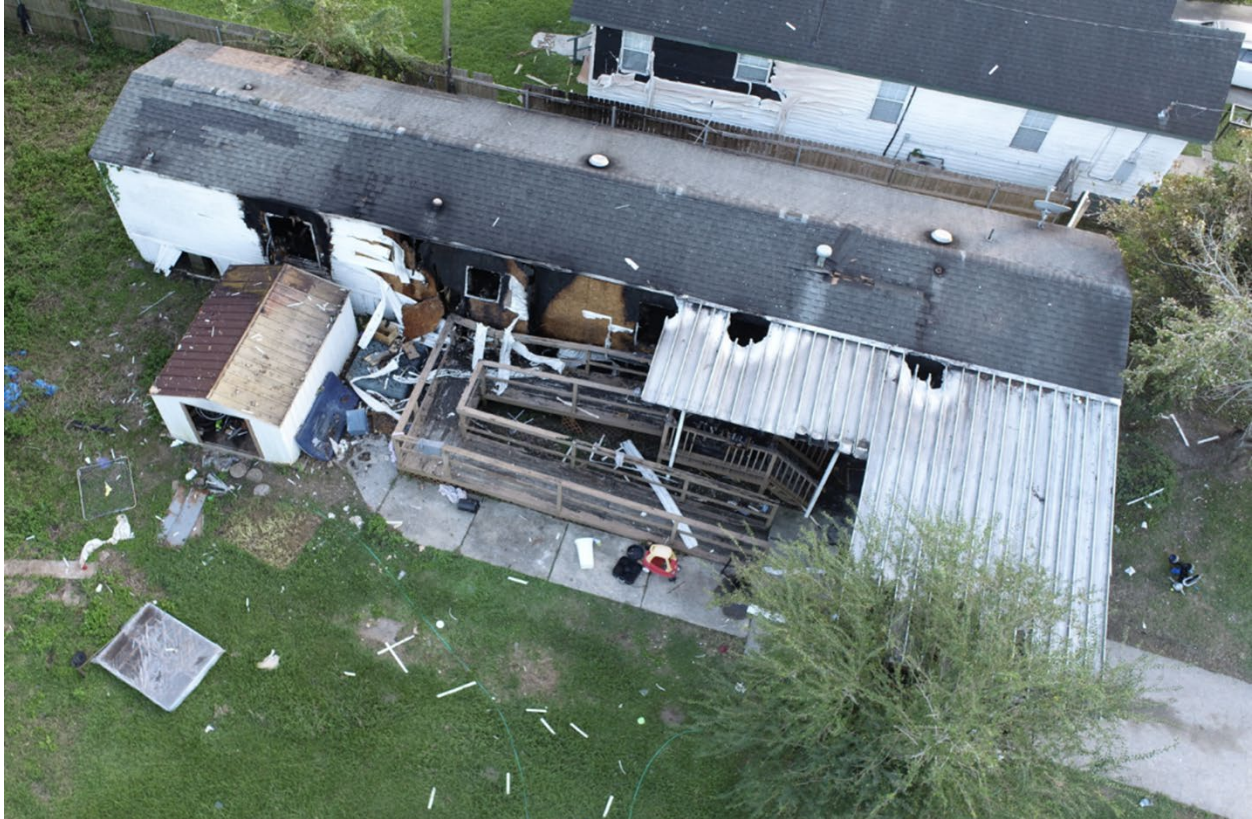
On December 2, 2024, about 6:26 a.m., a natural gas explosion and fire destroyed a single-family residence (the accident home) at 535 Avondale Garden Road in Avondale, Louisiana.¹ (See figure 1.) One person was fatally injured, and five other people sustained injuries. A neighboring residence was damaged, and its residents were displaced. At the time of the explosion, the weather was clear with winds of 11 mph; the weather was 50°F with no precipitation.

Figure 1. Accident home after the explosion and fire. (Source: Atmos.)

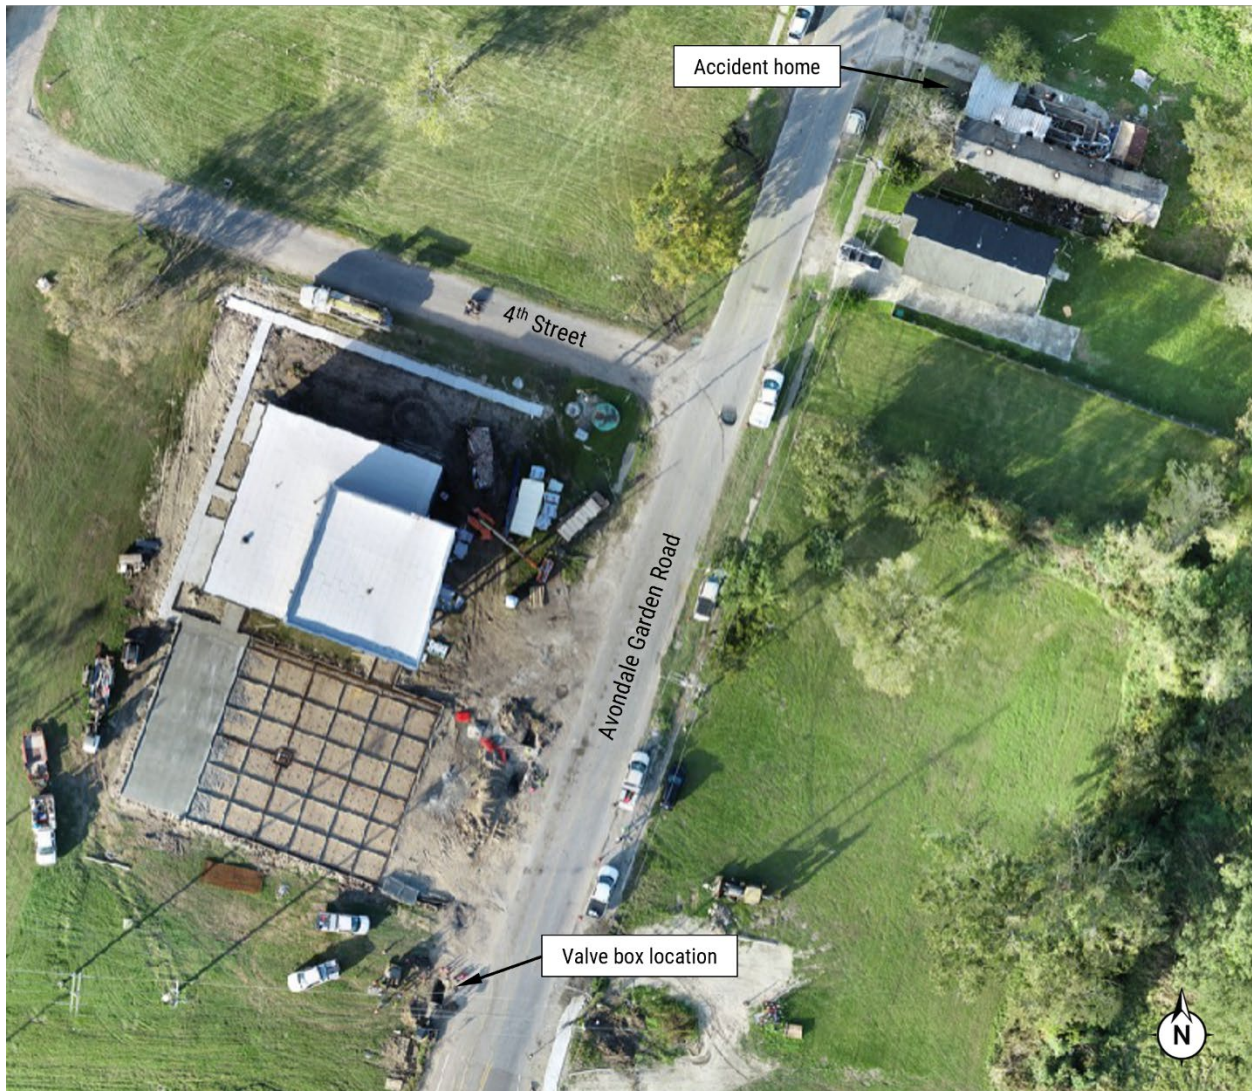
The gas valve mentioned by the construction superintendent was about 2 feet underground and about 340 feet from the accident home. (See figure 2.) The asset at

Figure 2. Overhead view of accident site. (Source: Atmos.)

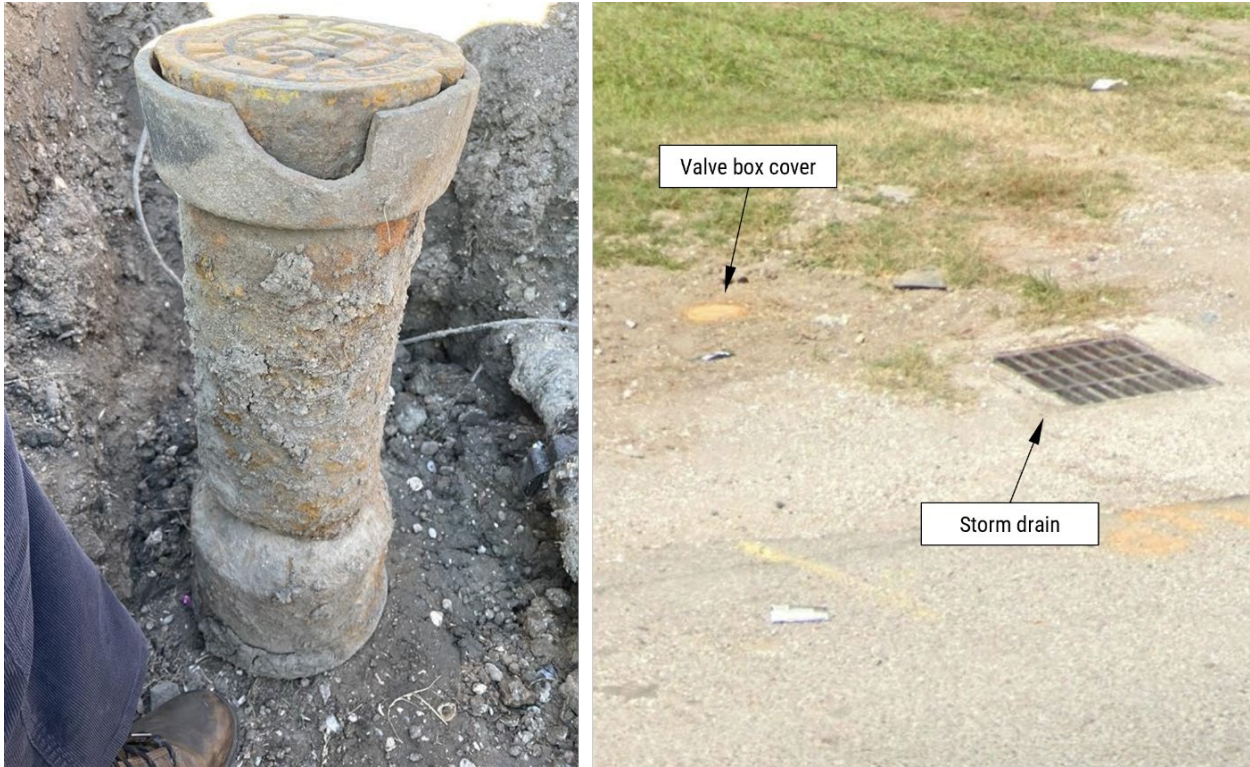
The valve near the leak was a 2-inch threaded valve. The valve box positioned over the valve was a cast iron cylinder 24.75 inches long and varying in diameter along its length. At its base, it had a diameter of 8.375 inches, and its wall was flared to create a rim about 0.95 inches wide. (See figure 3.) Its date of original installation is unknown.

The infrastructure was last excavated on October 9, 2024, when Atmos completed a project to offset the main to accommodate a storm drain for a new library under construction. During this work, Atmos employees unearthed a section of main, greased and turned the valve, and removed and reinstalled the valve box over the valve. According to the Atmos senior field construction coordinator involved in the project, the top of the valve box was level with the surrounding grade and marked to identify the gas valve when the work was completed. (See figure 3.)

Figure 3. Valve box after the accident (left) and October 2024 Google Street View image of valve box cover (right).

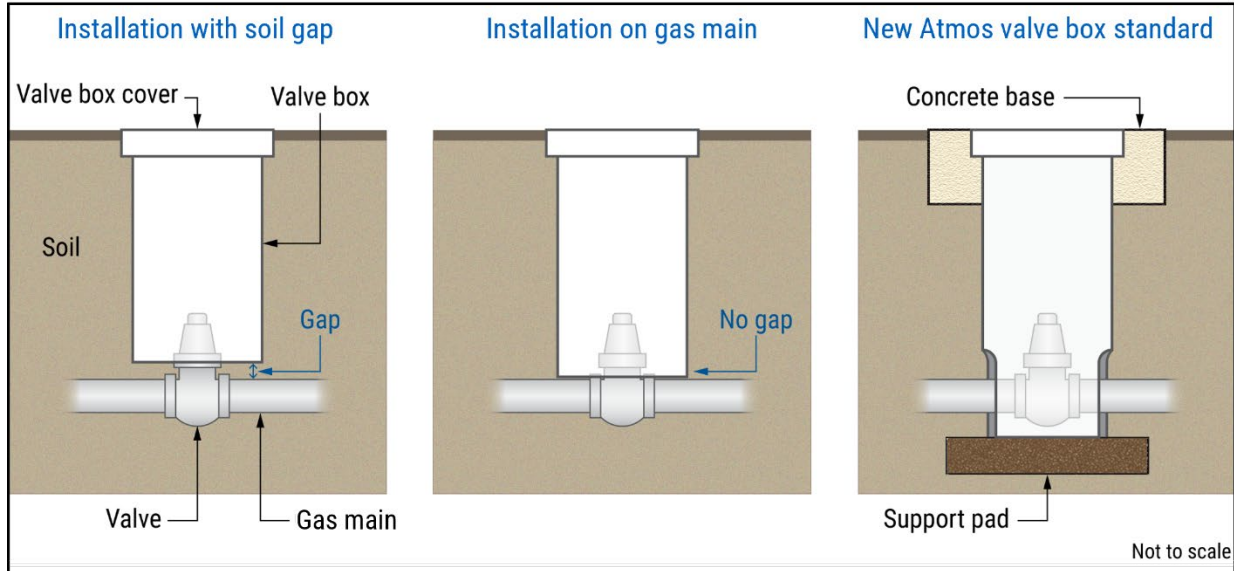
At the time of the last excavation near the accident valve, Atmos was no longer installing new cast iron valve boxes and had adopted plastic valve boxes sandwiched between two pads: a support pad installed below the main and a concrete “base pad” at the grade. The new valve box design has a cutout at the lower edge and rests on the support pad. Atmos did not have a process or rule for replacing existing cast iron valve boxes with the newer design or a written procedure for reinstalling cast iron valve boxes. During a meeting with the NTSB, the Atmos Vice President of Operations for the Louisiana Division Eastern Region said that installing valve boxes in contact with mains was a common practice across Atmos’ Louisiana Division. Later emails from Atmos said that Atmos expected the box structure, rim, and soil to bear loads whenever a valve box was installed level with the surrounding grade. See figure 4 for a comparison of valve box installations.

Figure 4. Valve box installations.

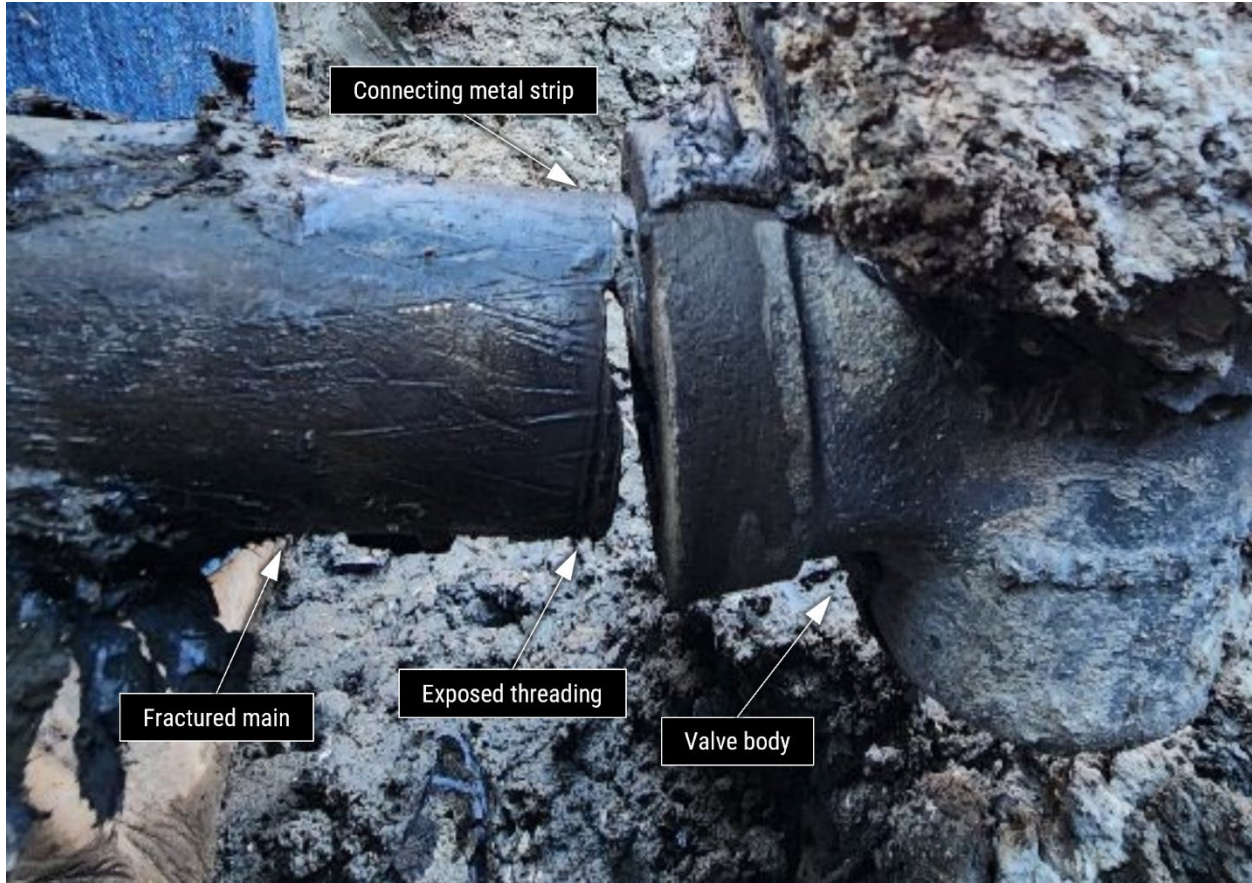
Atmos’s on-scene excavation on December 2, 2025, identified a fracture in the Avondale Garden Road main near a valve at the eastern edge of the construction site. The main was fractured around most of its circumference, with a thin strip of metal remaining at the 12 o’clock position (the top of the pipe) just south of where the main threaded into the valve body. (See figure 5.) Two leak surveys conducted by Atmos along Avondale Garden Road and several nearby streets on December 2 did not identify additional sources of gas.

Figure 5. Excavated gas main.

Postaccident bar-hole testing and excavations found only one source of natural gas: a leak in the gas main near a valve box on the eastern edge of the construction site. On-site examinations of the main found that it was fractured around most of its circumference with a thin strip of metal at the top (12 o'clock position) joining the

southern section of pipe to the section still threaded into the valve body. This indicates tension—a stretching force—at the bottom of the pipe along its long axis. Tension along the bottom of the pipe is consistent with a bending stress created by an external downward force. Based on information provided to Atmos by the construction superintendent, a cement truck ran over a valve box at the leak's location immediately before he heard and smelled natural gas being released. The investigation did not identify another plausible external force that could have damaged the main.

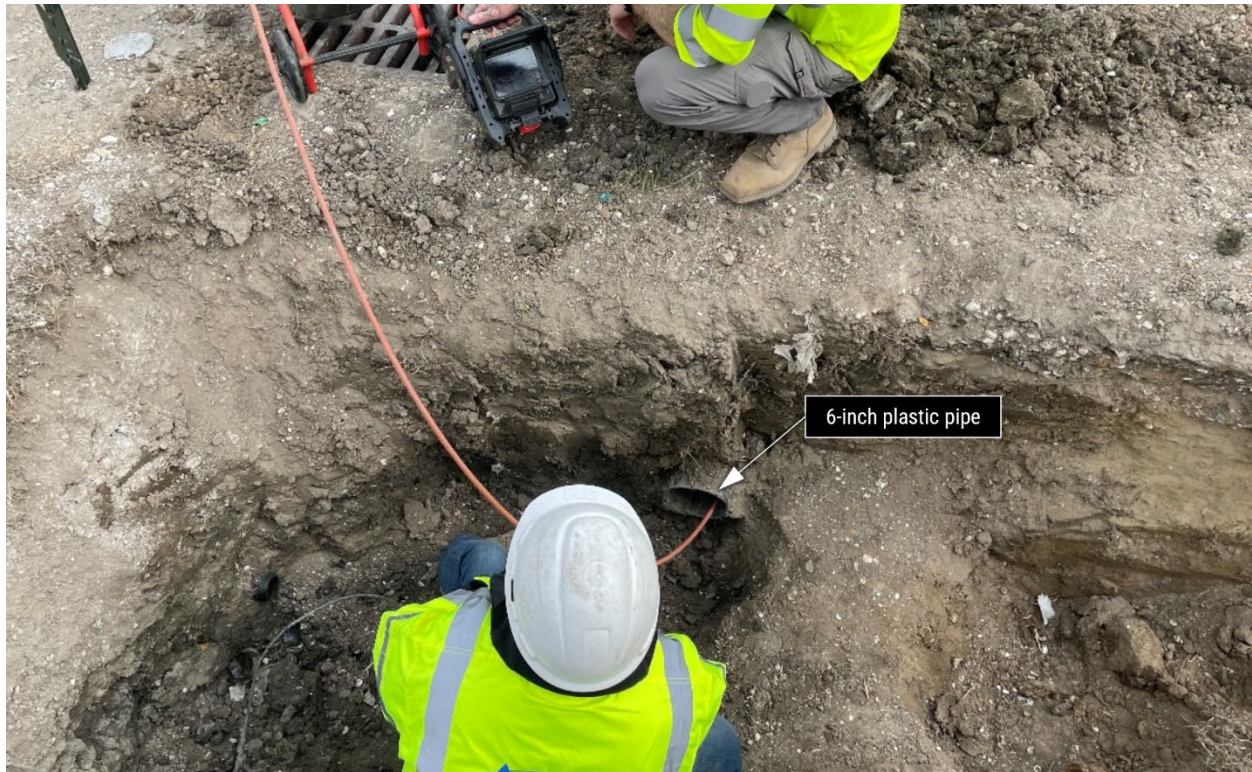
The excavation also unearthed the end of an uncapped, 6-inch plastic pipe about 8 inches from the fracture. (See figure 6.) Investigators sent inspection cameras through this pipe and found that it was a sewer lateral connected to the main sewer system in the area but not to any other structure, like a house or business. A series of camera inspections identified a continuous path between this uncapped pipe and the accident home.

Figure 6. Uncapped pipe near gas main fracture.

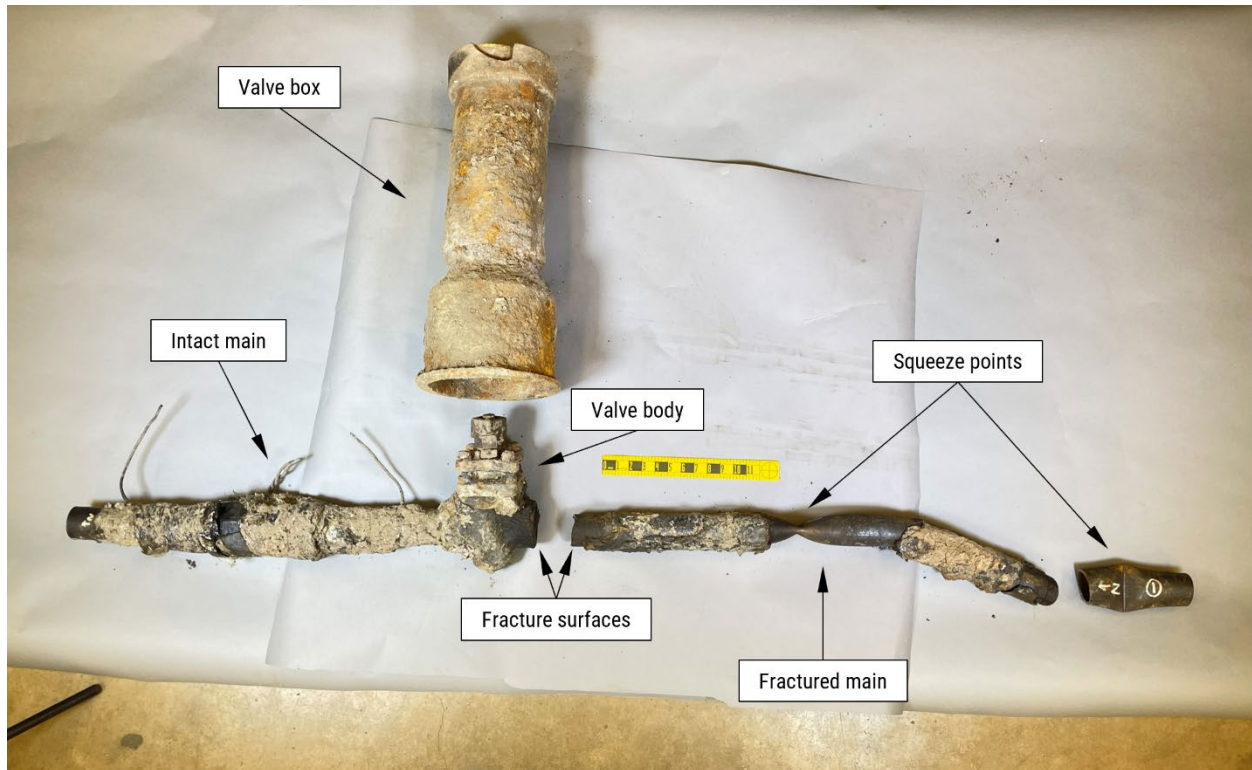
The NTSB recovered the valve box and three sections of main near the fracture for examination in the Materials Laboratory. (See figure 7.) The thin strip of metal shown in figure 5 broke during recovery.

Figure 7. Recovered assets.

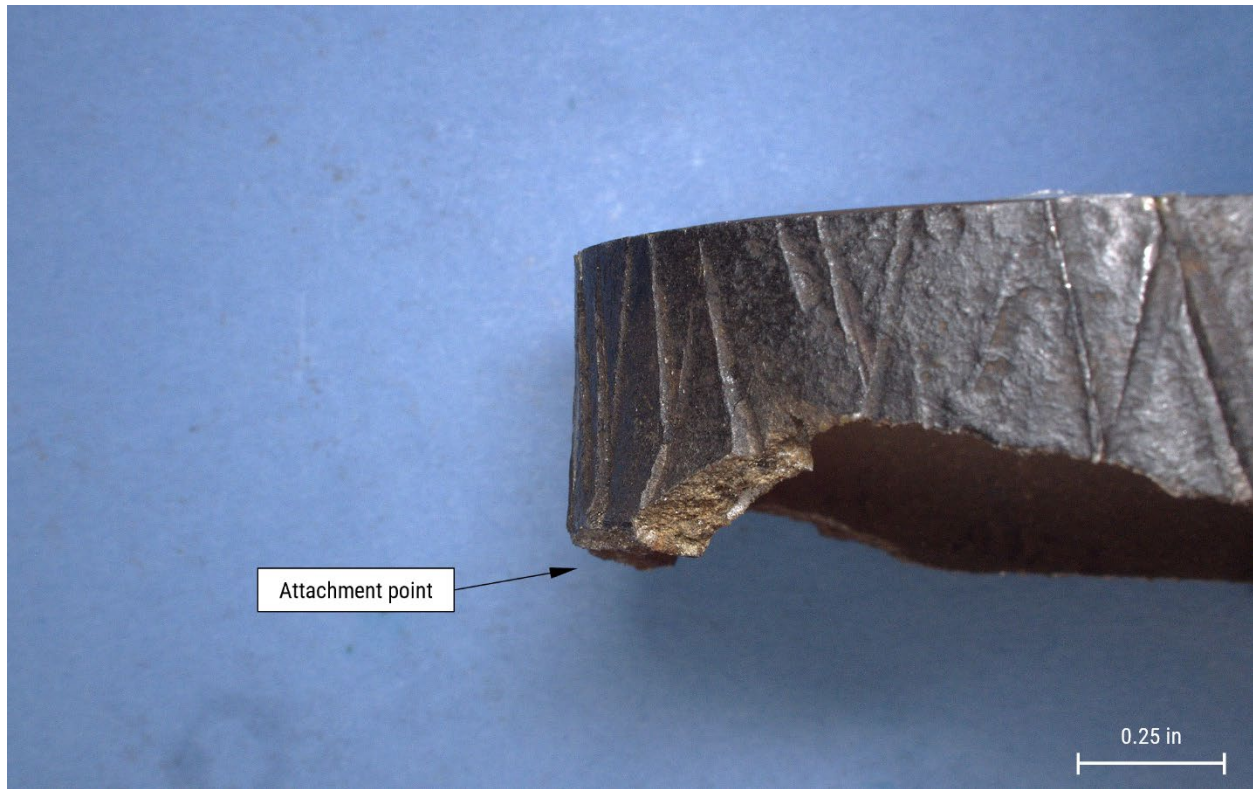
The Materials Laboratory removed a section of the fractured main by making a cut about 0.75 inches from the fracture. There was a slight outward bend in the fracture surface near the 12 o'clock position where the thin strip of metal had connected pieces of the fractured main before recovery from the scene. (See figure 8.) No other significant deformation was noted in the main near the fracture surface.

Figure 8. Sectioned main with fracture surface and outward bend.

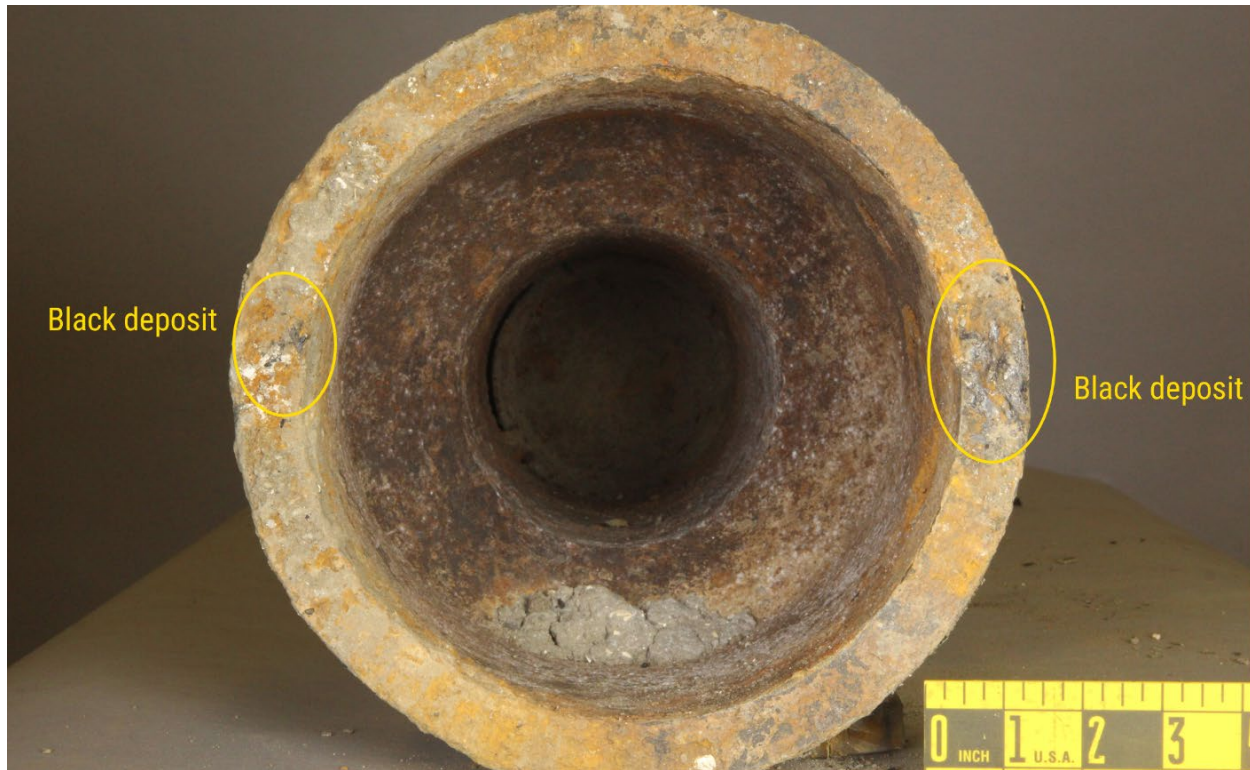
Examination of the valve box found hard black deposits of material at two locations on the bottom rim. (See figure 9.) The deposits were 180° apart around the rim of the valve box and resembled the coating on the pipeline itself. Spectroscopic examination of the material identified it as coal tar.

Figure 9. Black deposits on the valve box before cleaning.
