Pipeline Investigation Report: PIR-26-05

# ONE Gas, Inc. (Kansas Gas Service) Natural Gas–Fueled Commercial Building Explosion

| Location | Hutchinson, Kansas |
| Date | February 22, 2025 |

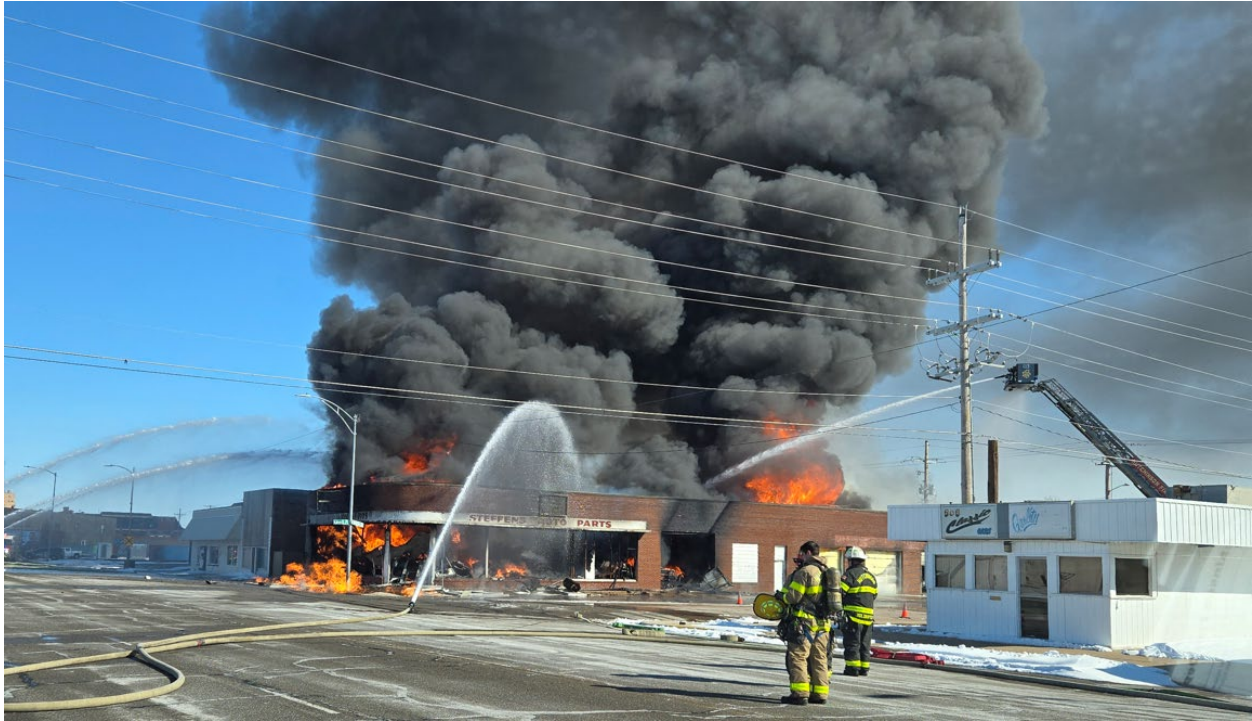
On February 22, 2025, about 10:05 a.m. local time, an explosion and subsequent fire occurred at the Steffens Auto Parts commercial building in Hutchinson, Kansas.<sup>1</sup> (See figure 1.) The event resulted in the evacuation of about 16 businesses and 51 residences and destruction of the building. There were no injuries or fatalities. Property damages were about \$875,000. Weather conditions at the time of the accident were clear, with a temperature of 20°F and 9-mph southwest winds.

**Figure 1.** Steffens Auto Parts commercial building after the natural gas leak and explosion.  
(Source: Hutchinson Fire Department.)

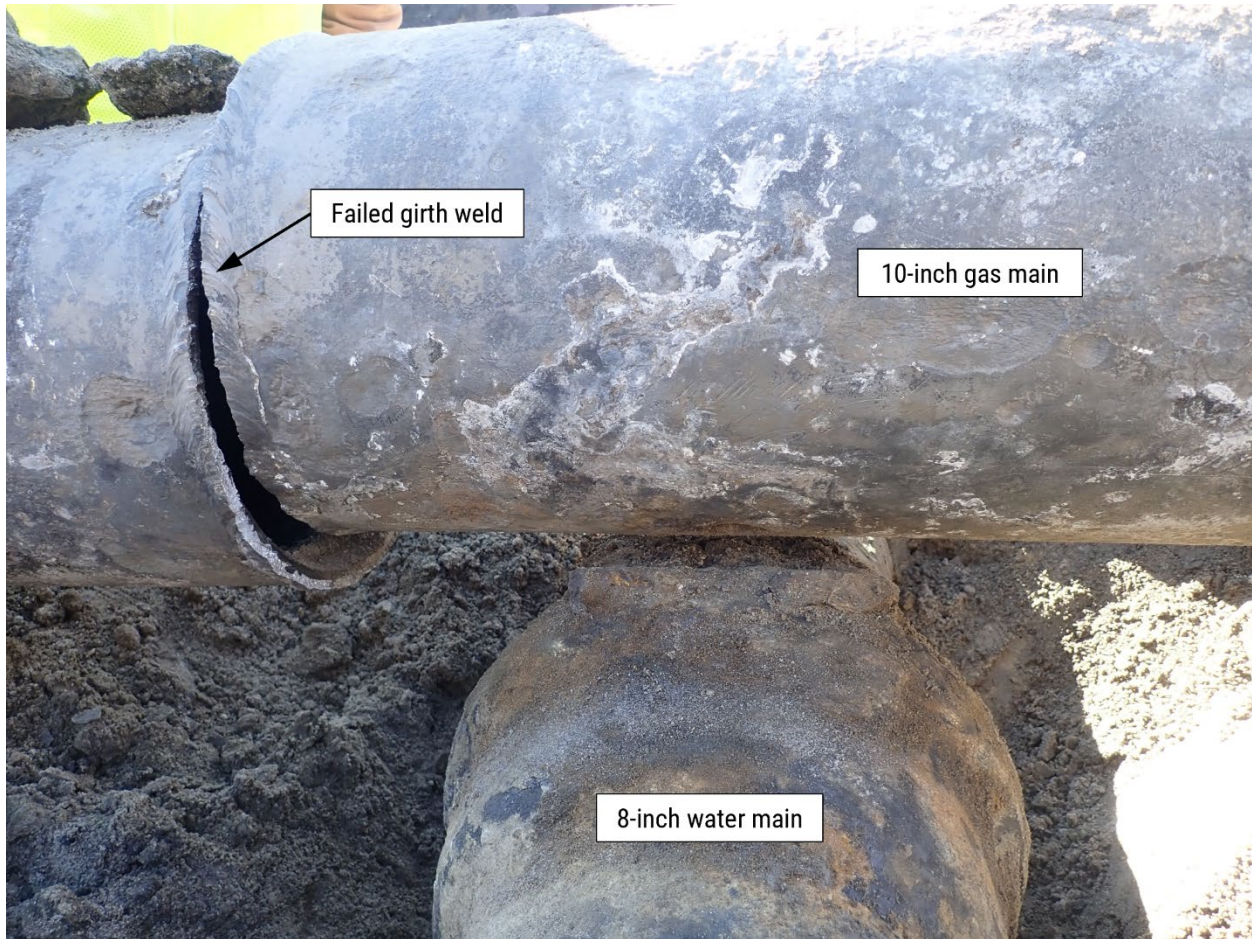
The day following the accident, February 23, 2025, a ONE Gas crewmember excavated the main in the vicinity of the failure and identified the source of the leak on a 10-inch diameter gas main about 2:57 a.m. The main was originally constructed in 1936 and crossed over an 8-inch diameter, 1908 vintage water main near the failure point. ONE Gas observed a girth weld that had separated at the top of the pipe.<sup>4</sup> As excavation progressed around the weld location, the weld continued to separate until the main was completely severed. (See figure 2.)

**Figure 2.** Ten-inch diameter gas main girth weld crossing over the 8-inch vintage water main.  
(Source: Baker Risk.)

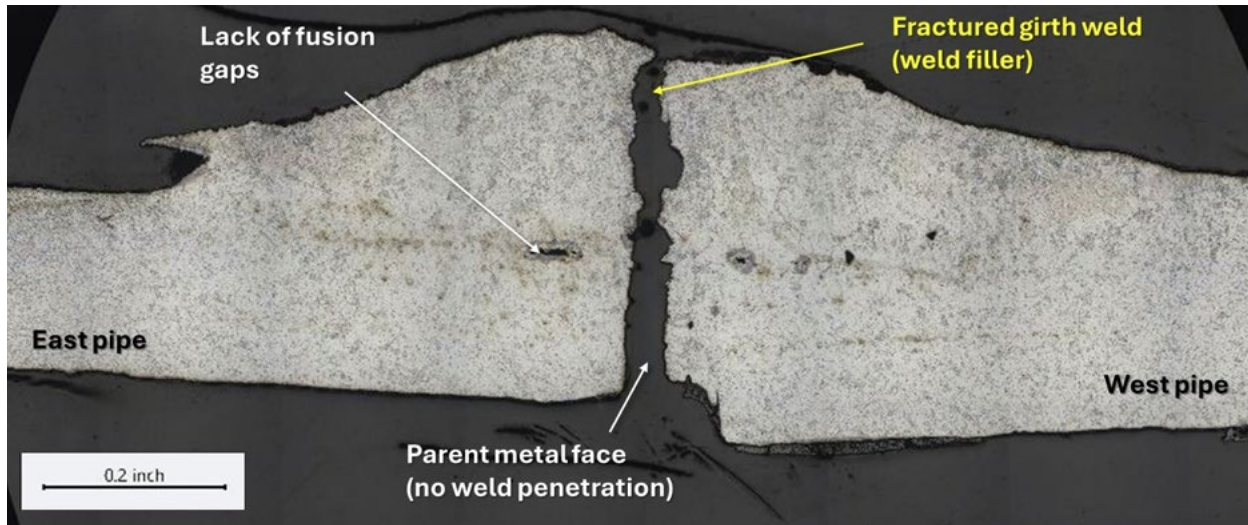
Examination of the damaged pipe by the National Transportation Safety Board (NTSB) Materials Laboratory determined that the fractured girth weld was consistent with a low ductility overstress fracture.<sup>5</sup> The weld, completed prior to the establishment of American Petroleum Institute (API) 1104 welding standards and federal pipeline safety regulations, exhibited lack of penetration and a lack of fusion in multiple locations along the fracture surface.<sup>6</sup> (See figure 3.) Metallurgical examination confirmed that the weld

characteristics were consistent with a manual oxy-acetylene torch weld performed by rolling the pipe during fabrication prior to installation in the ditch.

**Figure 3.** Weld cross section through the mating surfaces showing a lack fusion and lack of weld penetration.

The NTSB determined that the girth weld exhibited severe lack of penetration and fusion, meaning the molten weld metal failed to penetrate the joint root and failed to fully bond with the parent material. The pipeline was installed in 1936, prior to the development of API 1104 and the establishment of federal pipeline safety standards governing weld quality. Welds constructed during this period may exhibit manufacturing and construction deficiencies, such as porosity, incomplete penetration, and lack of fusion, that would not meet modern welding standards.

The lack of penetration and lack of fusion identified in the failed girth weld in this accident created a significant internal stress concentration that had likely been present since the pipe's installation in 1936.<sup>10</sup> NTSB investigators considered changes in loading conditions that could have exerted a force on the pipe at the girth weld sufficient to result in an eventual overstress fracture. However, there was no indication of a recent overpressure event, and the in-service gas pressures were too low for internal gas pressure to have played a role in the fracture. There were no visual signs of erosion, settlement, or recent construction, and the NTSB could not determine which external force led to this failure. Because the gas pipe was immediately above and in contact with the water main since construction, the gas pipe would have been supported by the water main, limiting movement at that location. The failure was likely initiated by changes

in external forces acting on the pipe and weld, such as soil freezing and thawing cycles, surface loading changes, or soil movement.
