# National Transportation Safety Board

## Safety Recommendation Report

### Installation of PermaLock Mechanical Tapping Tee Assemblies

<b>Accident/Incident Number:</b>	DCA17FP006
<b>Operator:</b>	UGI Utilities, Inc.
<b>Accident:</b>	Residential Natural Gas Explosion
<b>Location:</b>	Millersville, Pennsylvania
<b>Date:</b>	July 2, 2017
<b>Recommendation Number:</b>	P-18-1 through -4
<b>Adopted:</b>	June 18, 2018

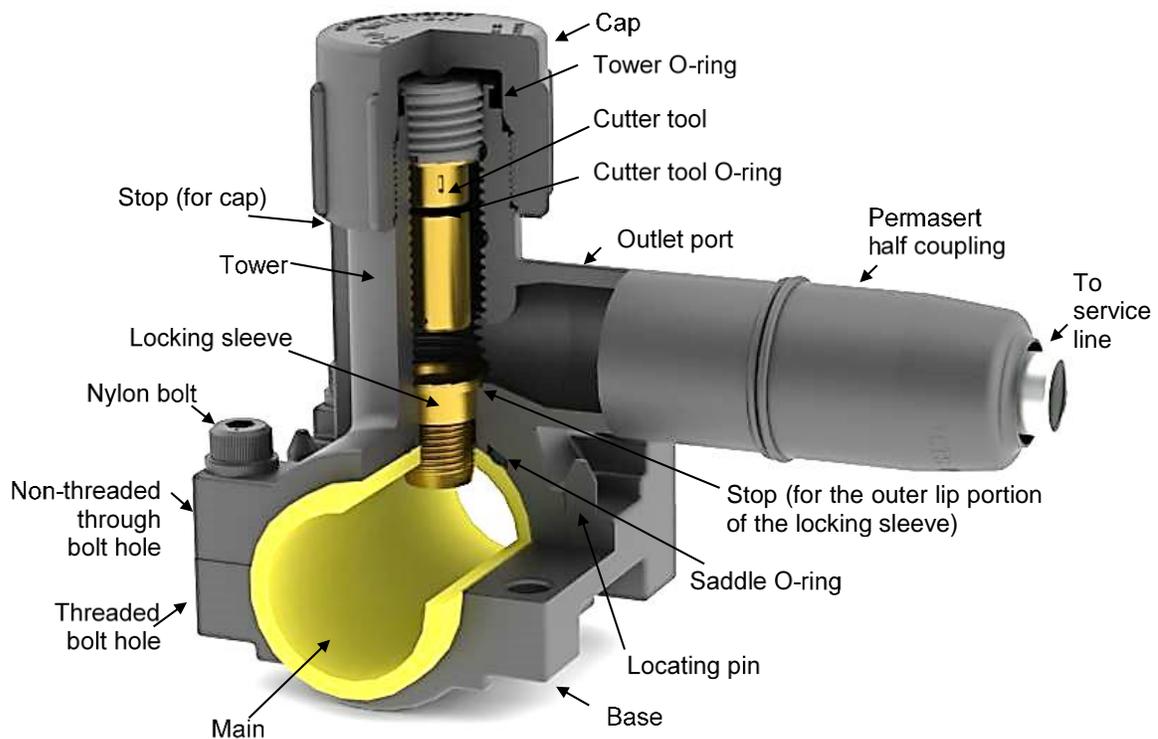
**Figure.** Cross-section diagram of an exemplar PermaLock mechanical tapping tee assembly, provided by Honeywell.

NTSB examination of the PermaLock tee assembly involved in the accident has revealed that the tee assembly was incorrectly installed. Although the cutter tool pierced a hole in the main, the locking sleeve did not progress down far enough into the tower to form threads in that hole. As a result, the locking sleeve was not attached to the main.<sup>6</sup> The NTSB also found that two of the four Nylon bolts on the tee assembly were fractured in a manner consistent with *slow crack growth*.<sup>7</sup> These findings indicate the likelihood of varying tee assembly installation techniques.

According to a Honeywell representative, the locking sleeve is the primary means of securing a PermaLock tee assembly tower to a main. A saddle O-ring, made from an elastomer, is located under the tower of the tee assembly (see figure). When the tower is attached to the main, the saddle O-ring forms a seal between the tower and the main that prevents gas from escaping out of the tee assembly. If the locking sleeve within the tower is not attached to the main, additional tensile stress is placed on the four Nylon bolts, which are used to join the tower and the base together around the outer surface of the main. The four Nylon bolts then become the fail-safe feature holding the tee assembly in place. When the locking sleeve is not attached to the main, fracture of one or more of the Nylon bolts can be sufficient to allow a gap to open in the saddle O-ring area between the tower and the main where gas can escape out of the tee assembly.
