# National Transportation Safety Board

## Railroad Accident Brief

Accident No: DCA-02-FR-013  
Railroad: Norfolk Southern Railway  
Train: Train 15T  
Location: Farragut, Tennessee  
Accident date and time: September 15, 2002, 11:20 a.m. eastern daylight time  
Type of Accident: Derailment  
Fatalities/Injuries: No fatalities or serious injuries  
Property Damage: \$1.02 million

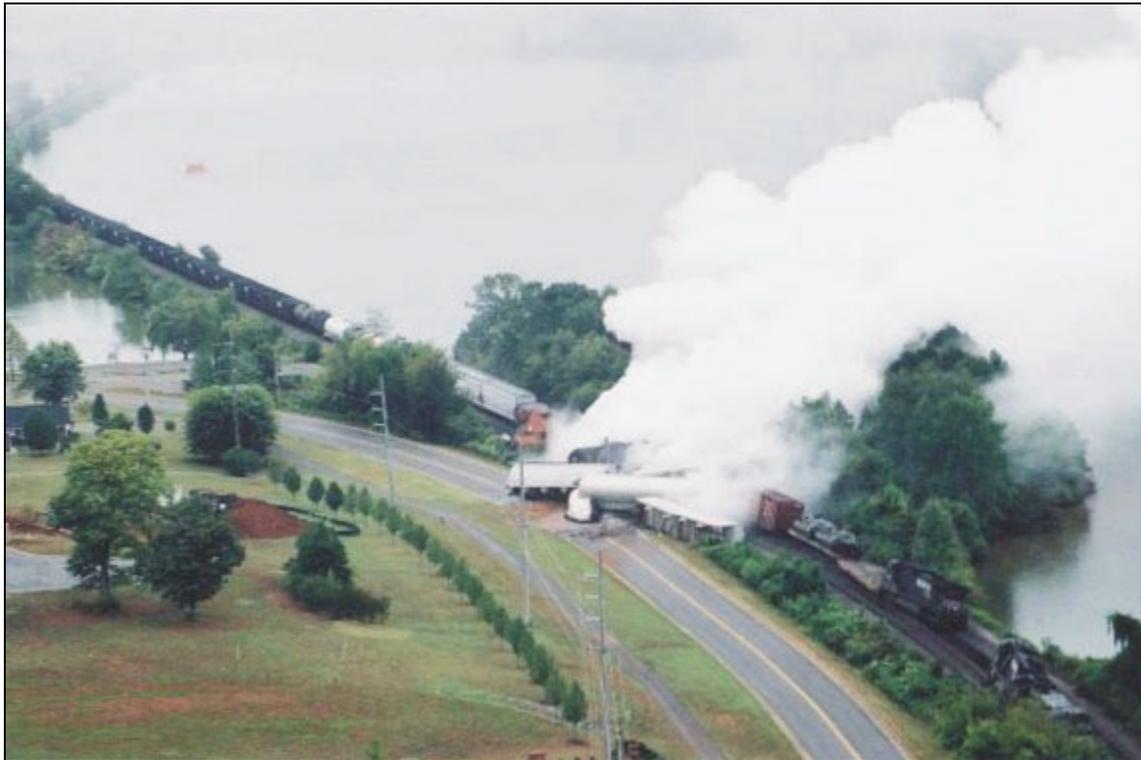
About 11:20 a.m. eastern daylight time on September 15, 2002, westbound Norfolk Southern Railway (NS) train No. 15T derailed in Farragut, Tennessee, while moving at 38 mph. The train was made up of 3 locomotives, 56 loads, and 86 empties; a total of 142 cars with a gross weight of 9,948 tons. Two locomotives and the first 25 cars derailed. A tank car containing sulfuric acid was punctured, releasing a cloud of toxic fumes that prompted local responders to evacuate about 2,600 people from a 4.4-square mile area around the site. The evacuation lasted for about 2 1/2 days. Several local residents were treated for minor respiratory difficulties. There was no fire. Damages were estimated to be \$1.02 million. (See figure 1.)

**Figure 1.** Looking east at the derailment of NS train 15T showing fuming sulfuric acid from ruptured tank car.

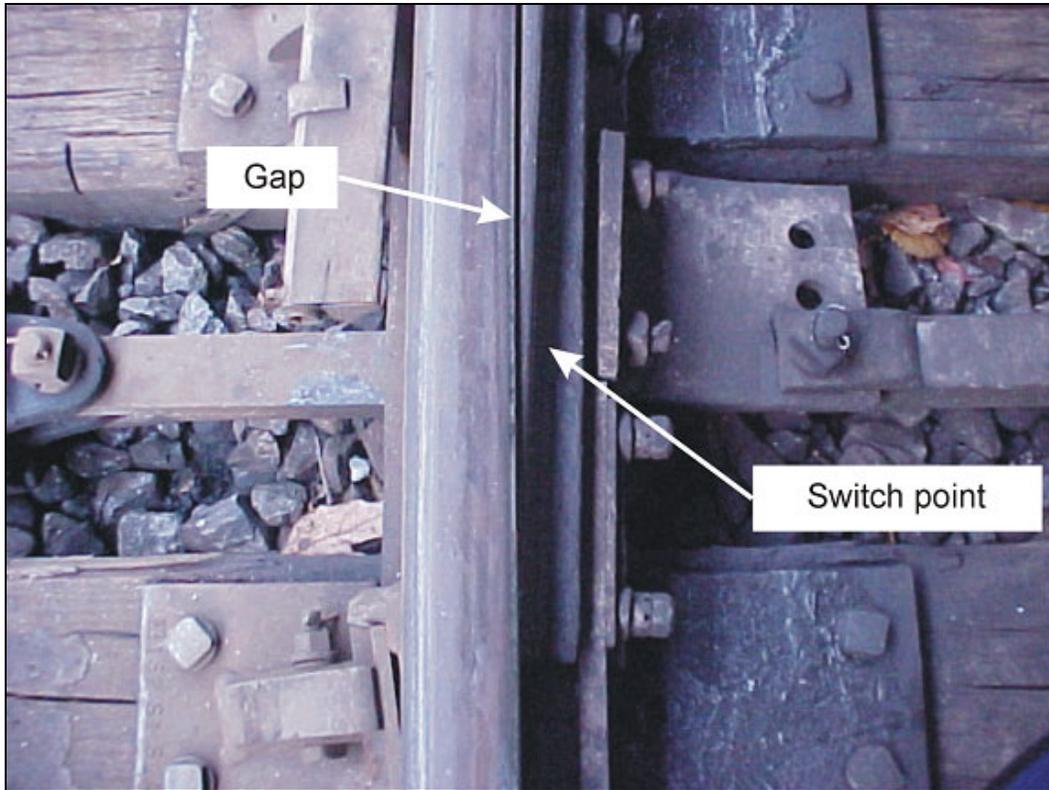
At the east end of the siding, the crew of train 703 stopped short of the spring switch so the conductor could look at the switch before proceeding. He found that the left switch point (when facing west) was not seated tightly against the stock rail but instead had a 1/4-inch gap.<sup>3</sup> A spring switch can be thrown manually by moving a lever beside the track. After operating the spring switch through its motion several times, the conductor found that the left switch point still failed to close completely, leaving about a 1/8-inch gap between the switch point and the stock rail. (See Figures 2 and 3.)

<sup>3</sup> Such a gap could cause the wheel flange of a westbound train to strike the end of the switch point, thereby damaging the switch or causing a derailment. The gap would also account for the *restricting* indication the crew had received from the automatic block signal.

**Figure 2.** Gapped switch point.

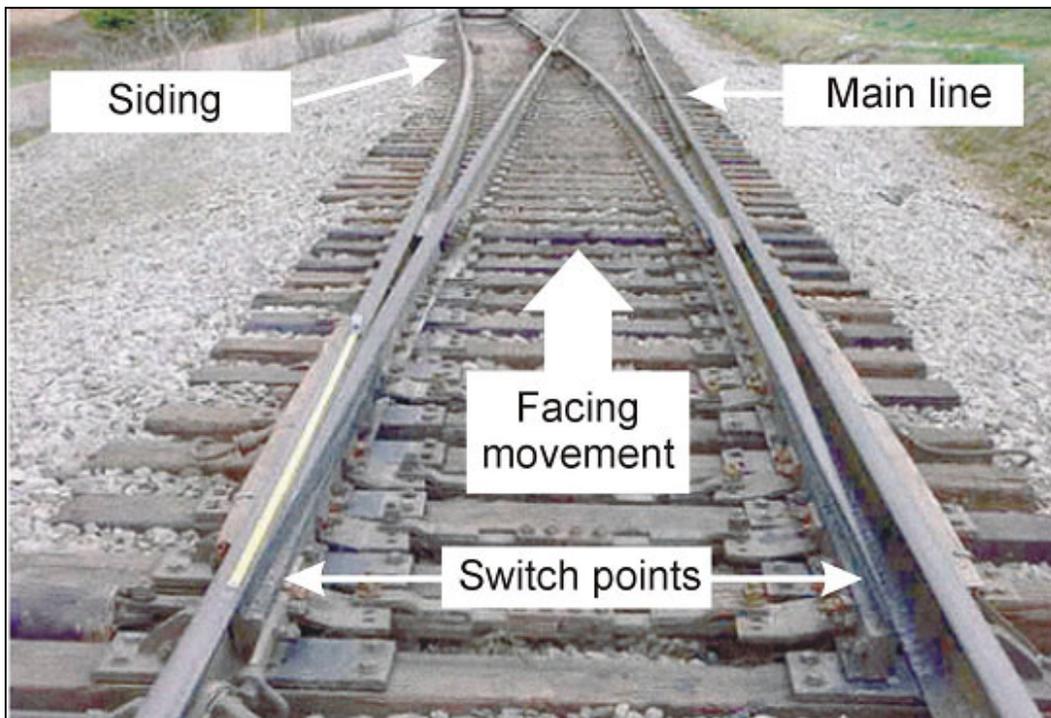
**Figure 3.** Spring switch similar to the East Boyd Siding switch where derailment occurred. Switch is aligned for main line movement.

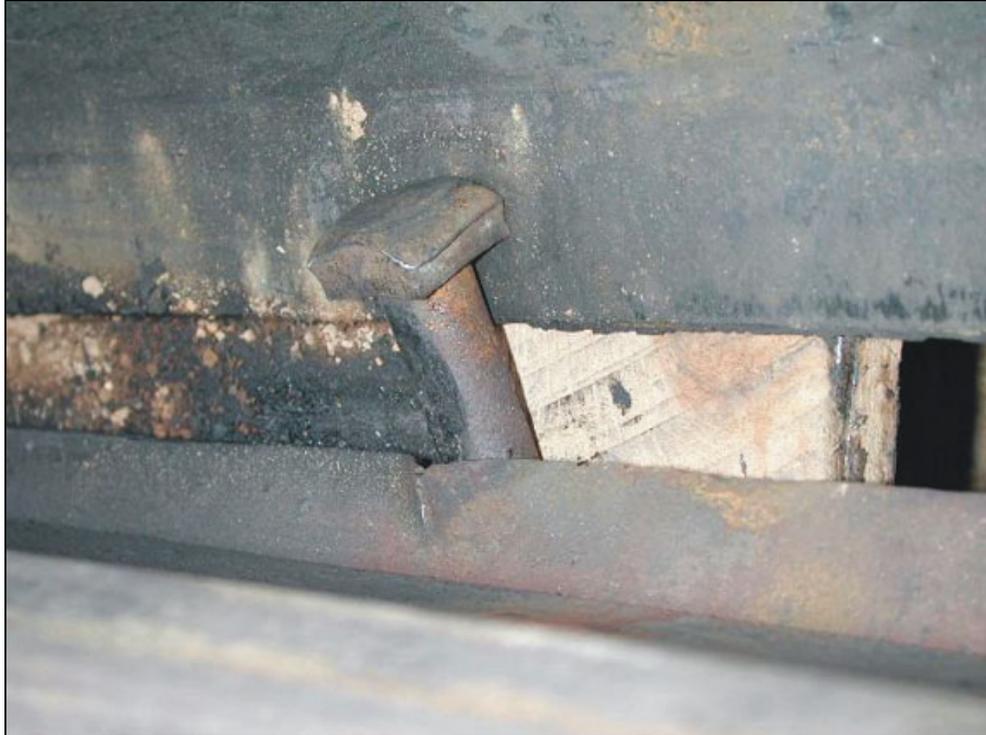
Postaccident inspection of the East Boyd spring switch revealed that a bolt was missing from the No. 4 throw rod. The missing bolt was 4 3/4 inches long and 3/4 inch in diameter. During the inspection, a 2 7/8-inch-long piece of the head section of what was believed to be the missing bolt was found approximately 80 inches back from the switch point, lodged between the base flanges of the left switch point rail and the left stock rail. (See figure 5.)

The head section of the switch throw rod bolt and the base of the stock rail and the base of the switch point showed marks and abrasions that were evidence of the bolt being lodged and thus obstructing the normal alignment of the two rails. At this location, the broken bolt section could interfere with the movement of the left switch point rail (when facing west) and cause a gap between the switch point and the stock rail. Although the switch points could be forced into alignment by a train making a trailing (eastbound) movement over the switch, the interference created by the lodged bolt made the points susceptible to gapping if they were disturbed, such as by a train making a facing (westbound) movement over the switch.

Because the bolt section was lodged at the base of the closed rails, it was not visible with the switch positioned as it was when the signal maintainer arrived. When the switch is operated and the rail sections separate, the switch point rail moves about 4 to 4 1/2 inches away from the stock rail. In this position, the heads of the throw rod bolts and the base of the rails are visible. The location of the missing bolt would also have been visible.

**Figure 5.** Postaccident reconstruction of broken bolt section as positioned before the derailment.

The National Transportation Safety Board determines that the probable cause of the September 15, 2002, derailment of Norfolk Southern train 15T was (1) the decision by the train dispatcher and signal maintainer to allow the train to pass over the spring switch at maximum authorized speed before the switch had been adequately inspected or clamped closed and (2) the lack of company procedures requiring that train dispatchers, after receiving a report of a problem involving a main track switch, immediately stop trains or implement an appropriate speed restriction in the affected area.

1. Require that train dispatchers, upon receiving reports of potentially hazardous conditions involving a main track segment or switch, stop train movements or immediately implement an appropriate speed restriction for the affected area and remove the restrictions only after the completion of those inspections and/or repairs that are essential for the safe movement of trains. (R-03-4)

2. Require that your train dispatchers, upon receiving reports of potentially hazardous conditions involving a main track switch, immediately stop train movements or implement an appropriate speed restriction for the affected area and remove the restrictions only after the completion of those inspections and/or repairs that are essential for the safe movement of trains. (R-03-5)
