# National Transportation Safety Board

## Railroad Accident Brief

Accident No.: DCA-04-MR-003  
Location: Kelso, Washington  
Date: November 15, 2003  
Time: 7:40 a.m. Pacific standard time<sup>1</sup>  
Railroads: Burlington Northern Santa Fe Railway Company and  
Union Pacific Railroad  
Property Damage: \$2.7 million  
Injuries: 2  
Fatalities: None  
Type of Accident: Side collision

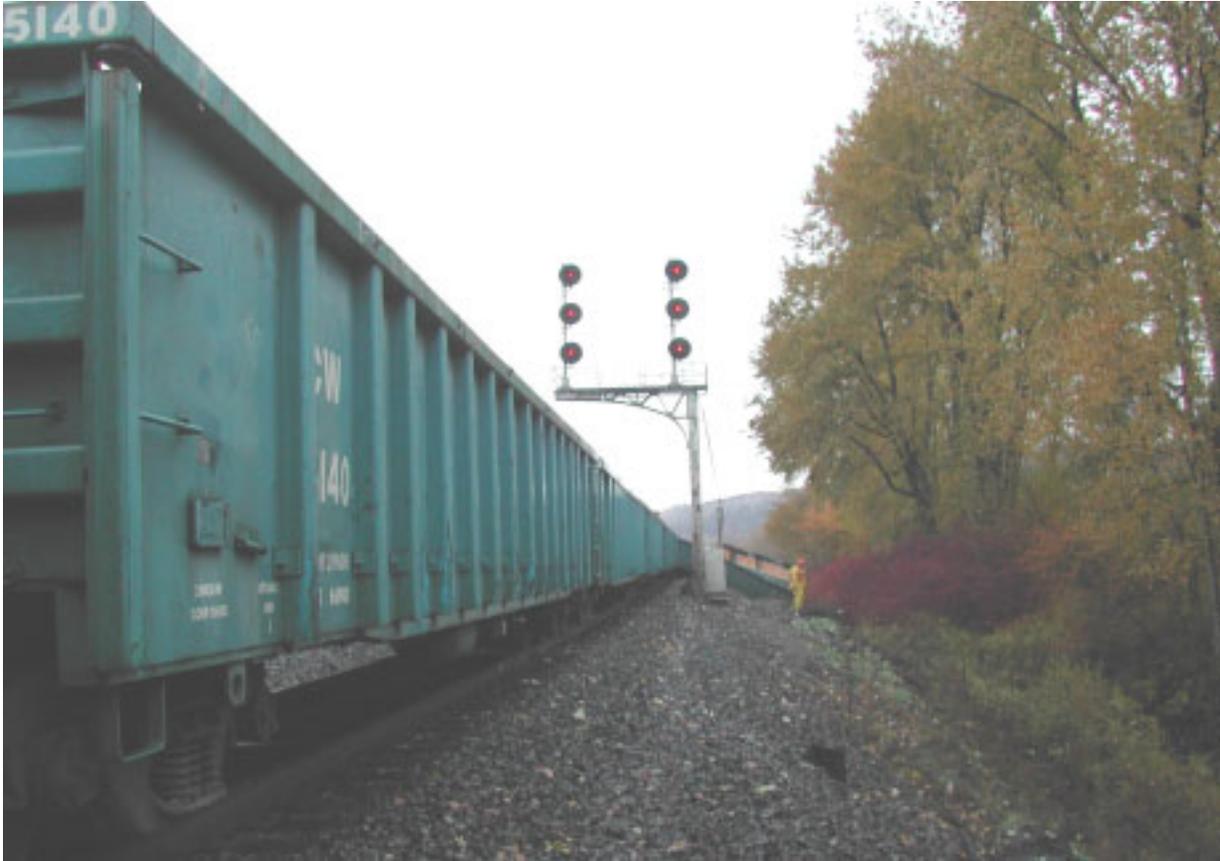
Sight-distance tests indicated that the engineer on the UP train would have had a clear sight of the approach signal at MP 104.6 for 1,519 feet before the train reached the signal. The sight-distance tests also indicated that the UP engineer would have been able to view the stop signal at the Longview Junction South interlocking signal on two separate occasions. The engineer could have observed the stop signal from a distance of 2,618 feet and again from 1,609 feet before reaching the stopping point. (See figure 1.)

**Figure 1.** The signal at Longview Junction South facing north.
