National Transportation Safety Board

Railroad Accident Brief

Accident No.: DCA-06-FR-006
Location: Arcola, Louisiana
Date: June 26, 2006
Time: 3:25 p.m. central daylight time¹
Railroad: National Railroad Passenger Corporation and CN railroad
Property Damage: \$2,500
Injuries: 9
Fatalities: None
Type of Accident: Track misalignment leading to train passenger injuries

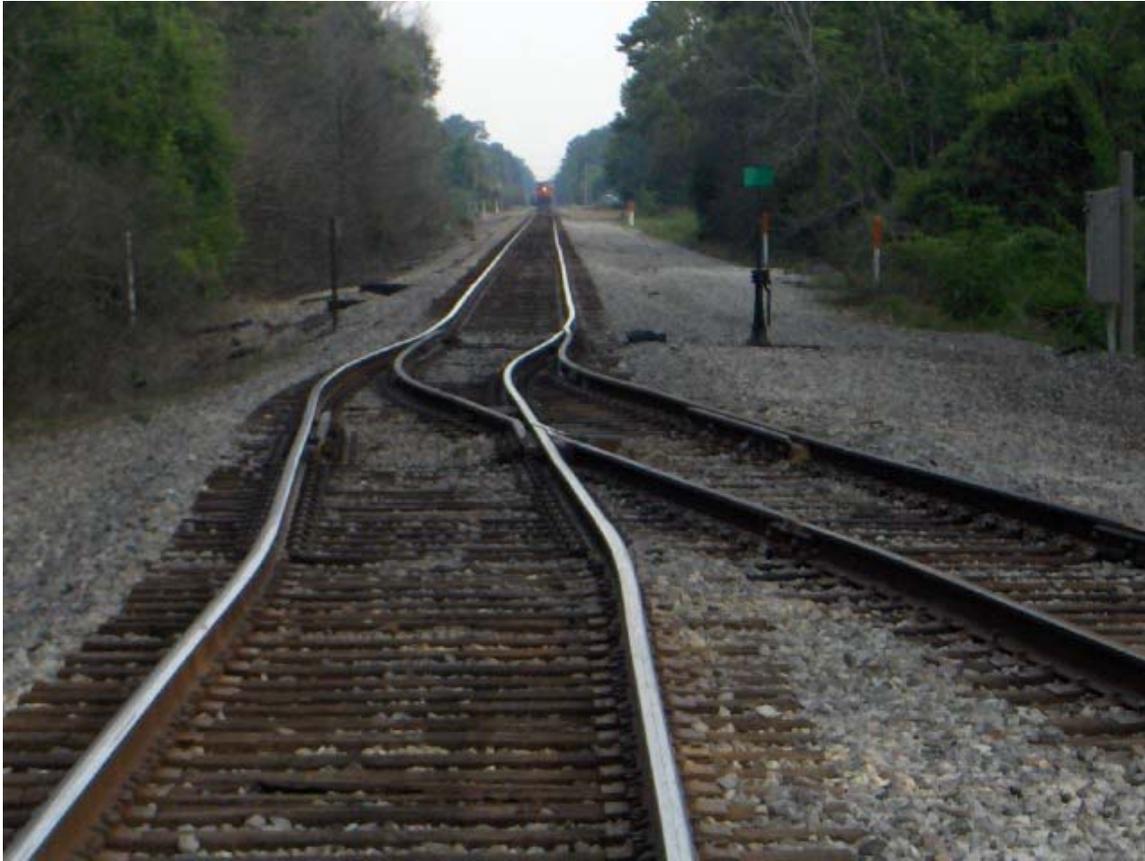
Figure 1. Looking south along the section of misaligned track encountered by the Amtrak train.

Postaccident inspection revealed that the turnout had “kicked-out”⁵ of alignment before the arrival of the Amtrak train. Measurements taken along the entire length of the turnout revealed that at some points the track was misaligned (deviated from its intended geometry) eastward by more than 25 inches. Crewmembers of a southbound train that had crossed the turnout before the northbound Amtrak train said they did not note anything remarkable as they traversed the turnout while traveling about 60 mph.⁶

The National Transportation Safety Board determines that the probable cause of the June 26, 2006, accident near Arcola, Louisiana, involving Amtrak train PO5871-26 was a heat-induced track misalignment that resulted because CN railroad's continuous welded rail procedures failed to ensure that rail was adequately de-stressed during or after the installation of a turnout.

During the investigation of this accident, the CN regional chief engineer reviewed the CN's procedures for de-stressing continuous welded rail. As a result of that review, the CN modified its procedures to require that specific actions be taken to de-stress rail for a distance of 200 feet on either side of a newly installed or rebuilt turnout or grade crossing.
